Inspection Photos

Operator: TEP ROCKY MOUNTAIN LLC - 96850

Location ID: 335542

Garfield County, CO

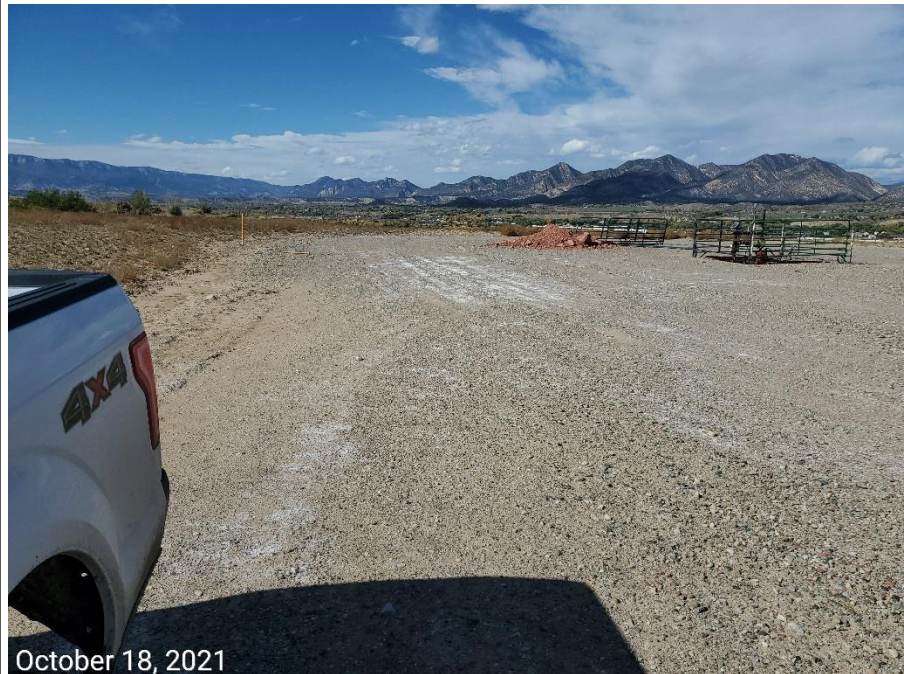
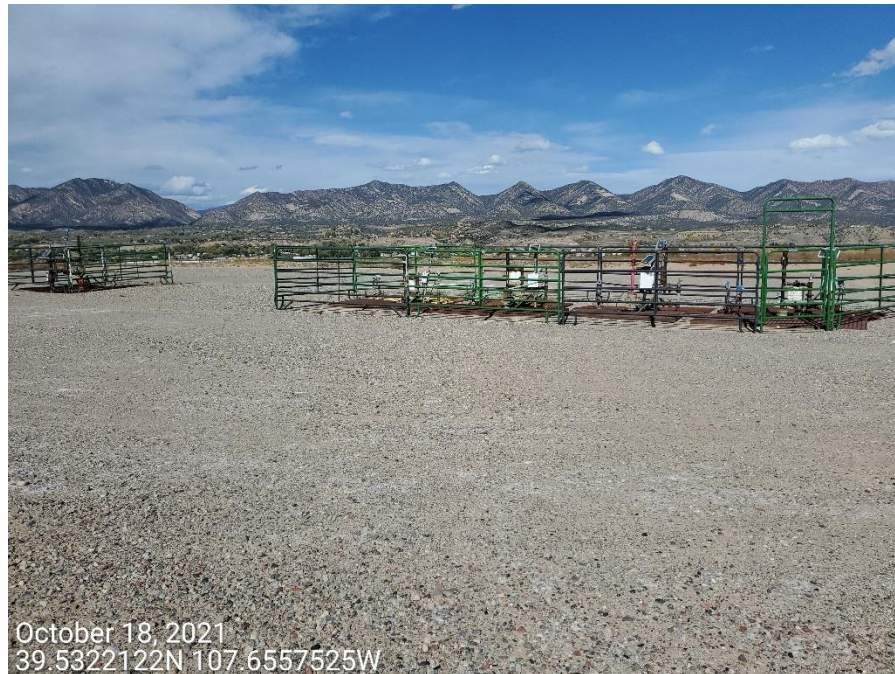
Photo 1: Photos 1-2 provide an overview of the Location facing northwest, north northeast to east.

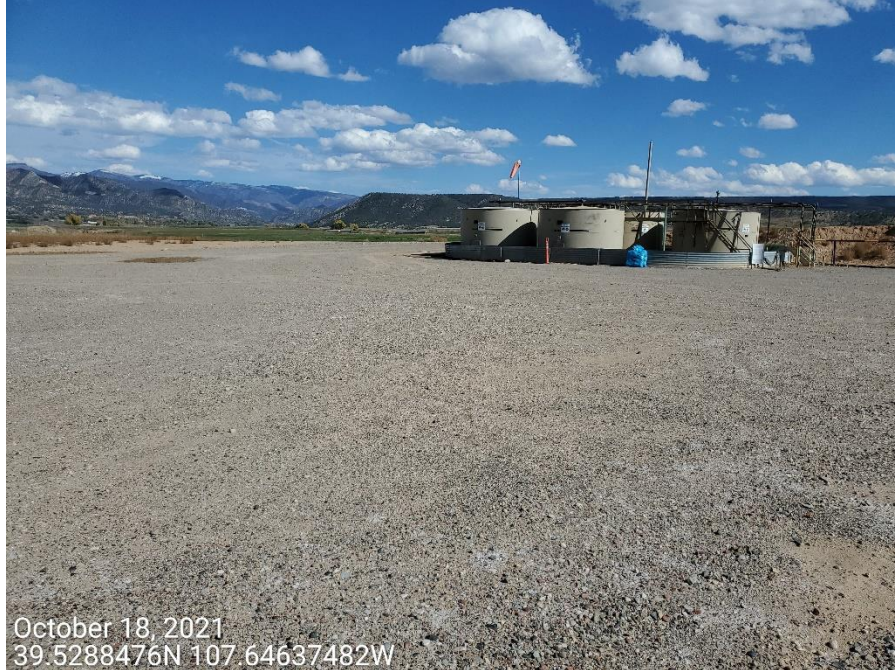
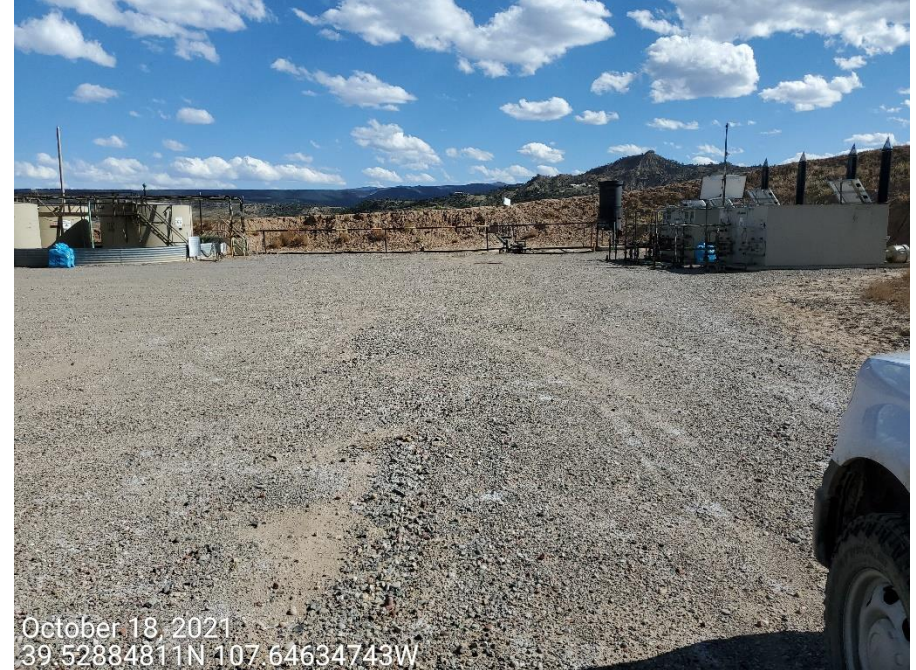
Photo 2: See comments under photo 1.

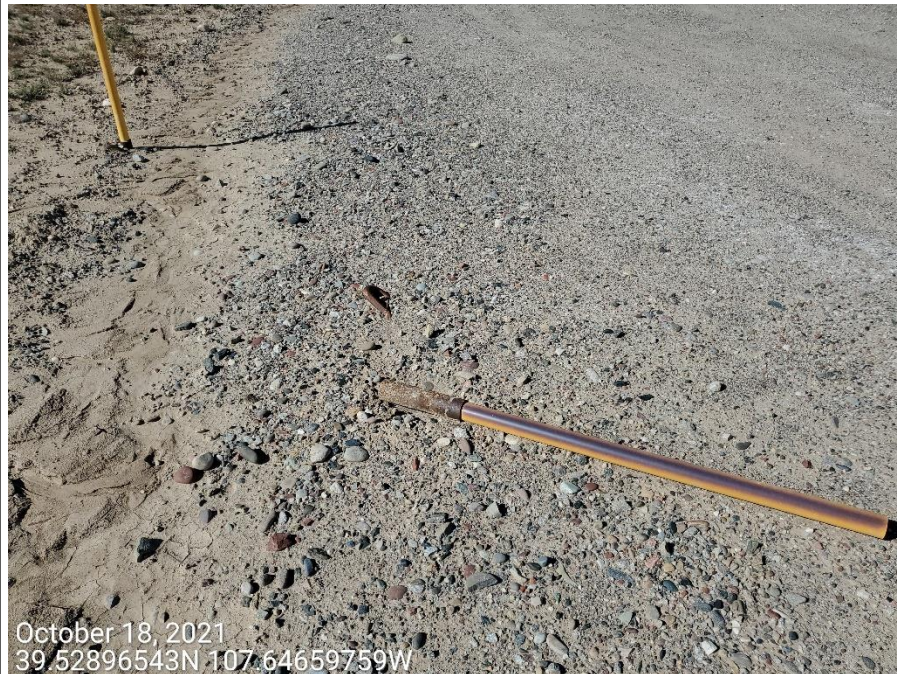
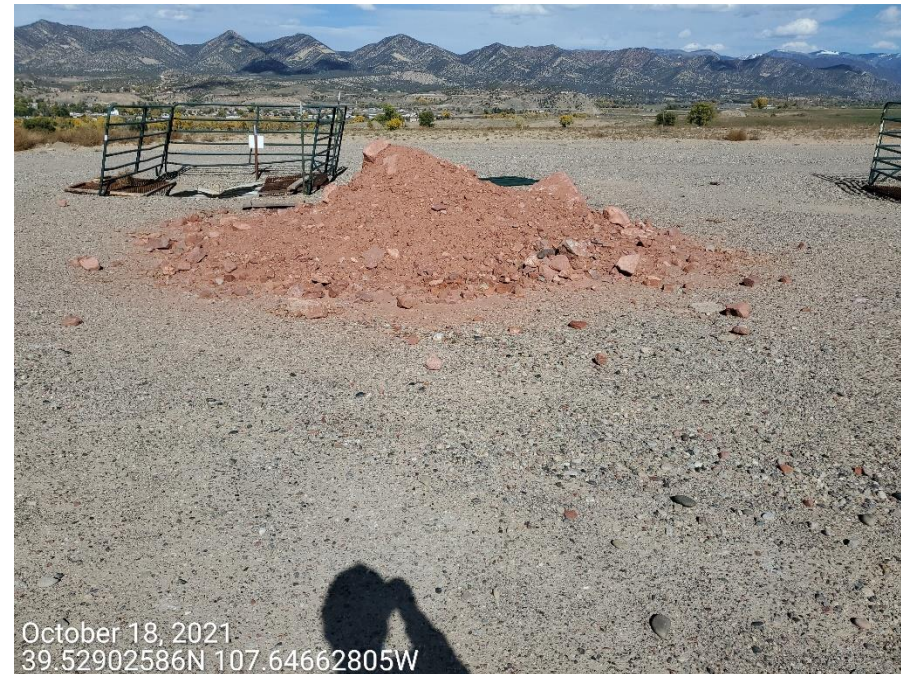
Photo 3: Photo left provides example of anchors improperly marked. Photo right shows a soil stockpile stored next to the Valley Farms E7 well; controls measures to mitigate sediment transport from the stockpile are missing.

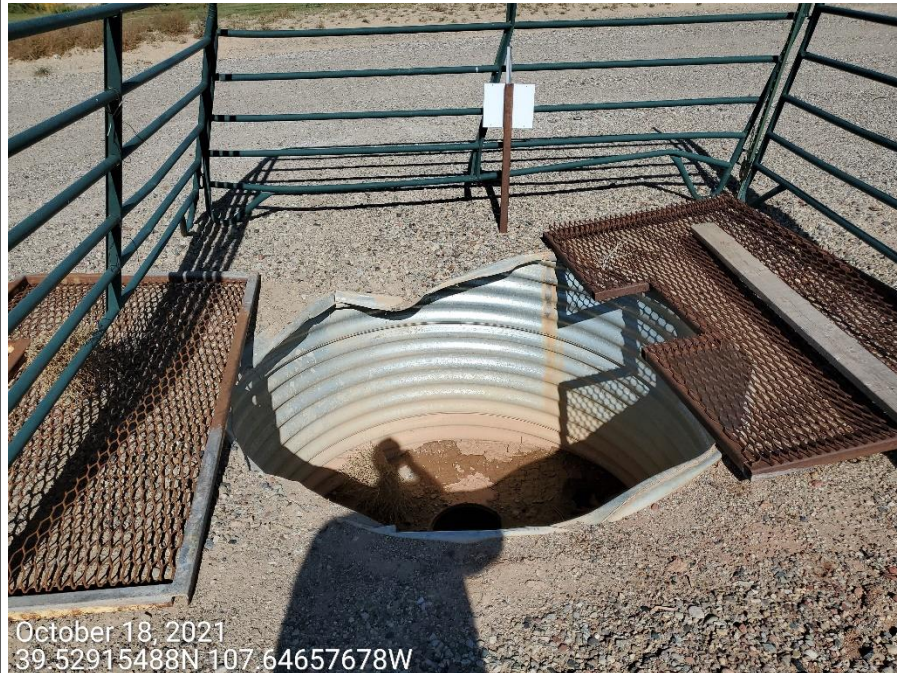
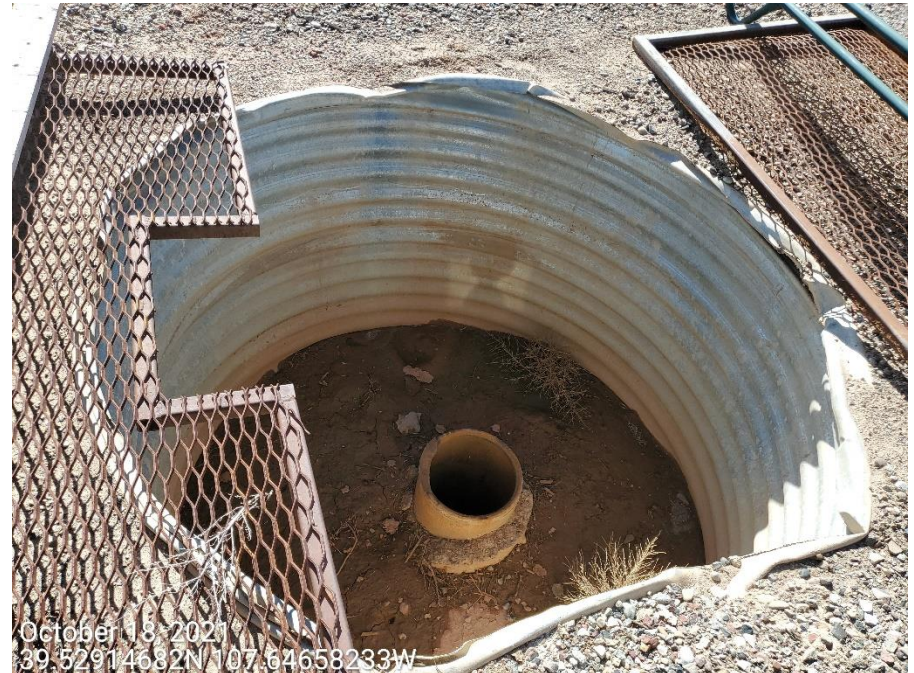
Photo 4: Photos taken from the Valley Farms E7 well (API 045-13225). Photos show controls to prevent access to the cellar/conductor are missing or insufficient; metal plate has not been welded to conductor. Well permit has expired; conductor requires plugging and reclamation in accordance with 406 rules.

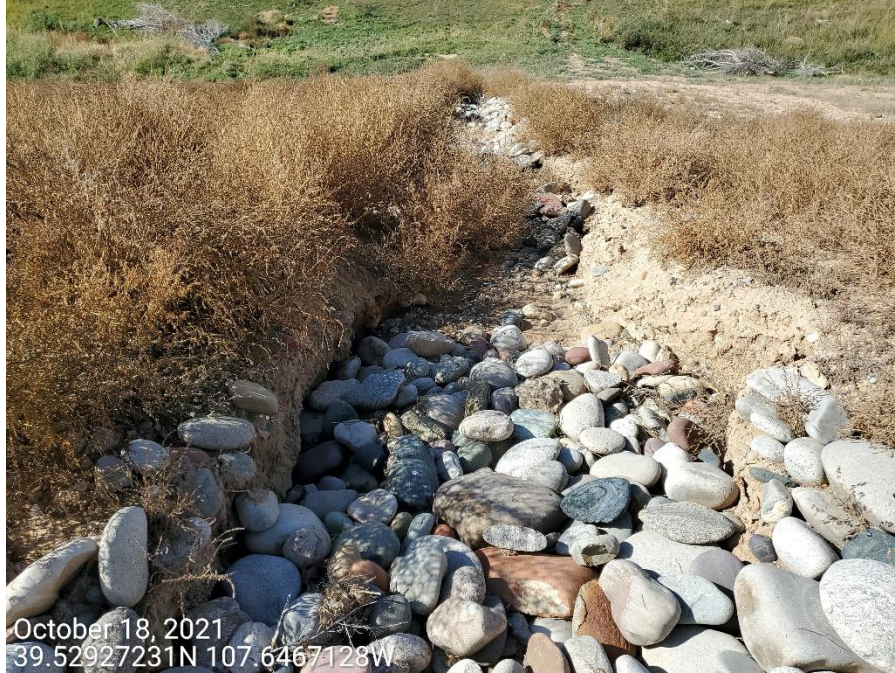
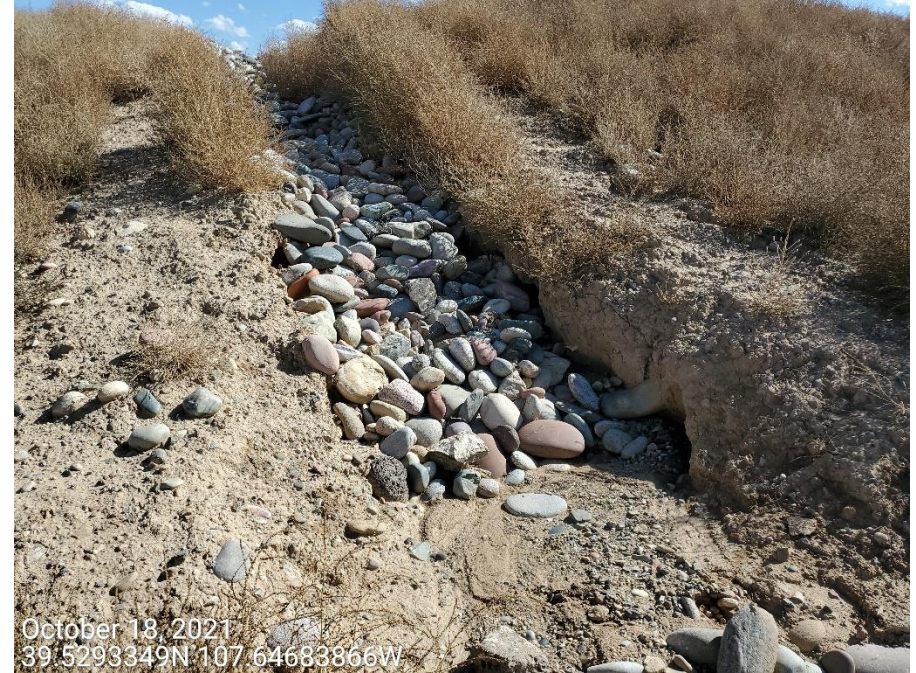
Photo 5: Photos taken from the stormwater outlet on the northwest end of the Location. Outlet has not been constructed in accordance with good engineering practices; use of geotextile under rip-rap not observed; stormwater runoff has resulted in degradation to both the BMP. Photo also shows undesirable plant species established on the Location.

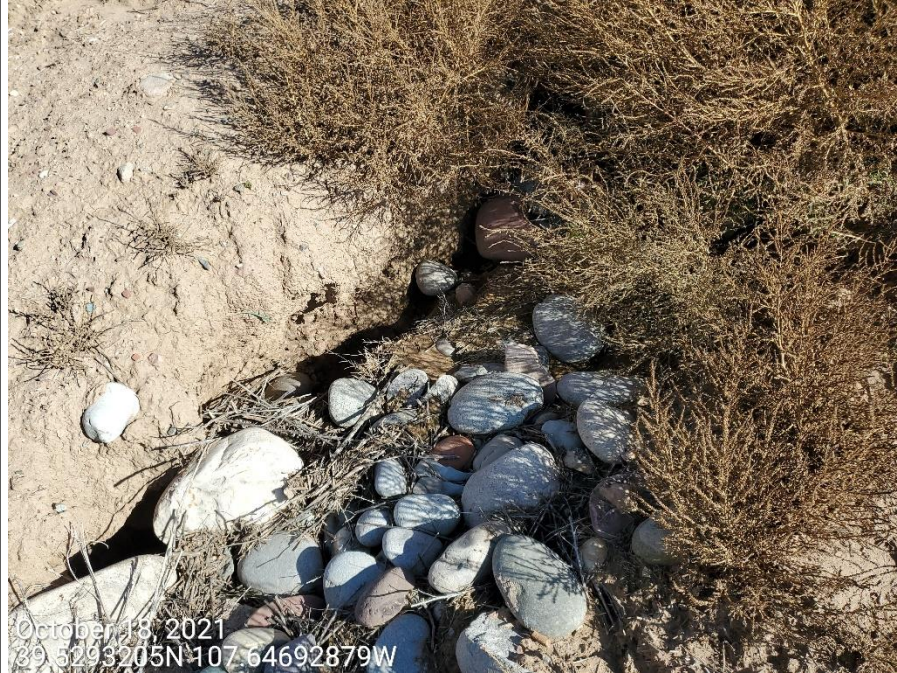
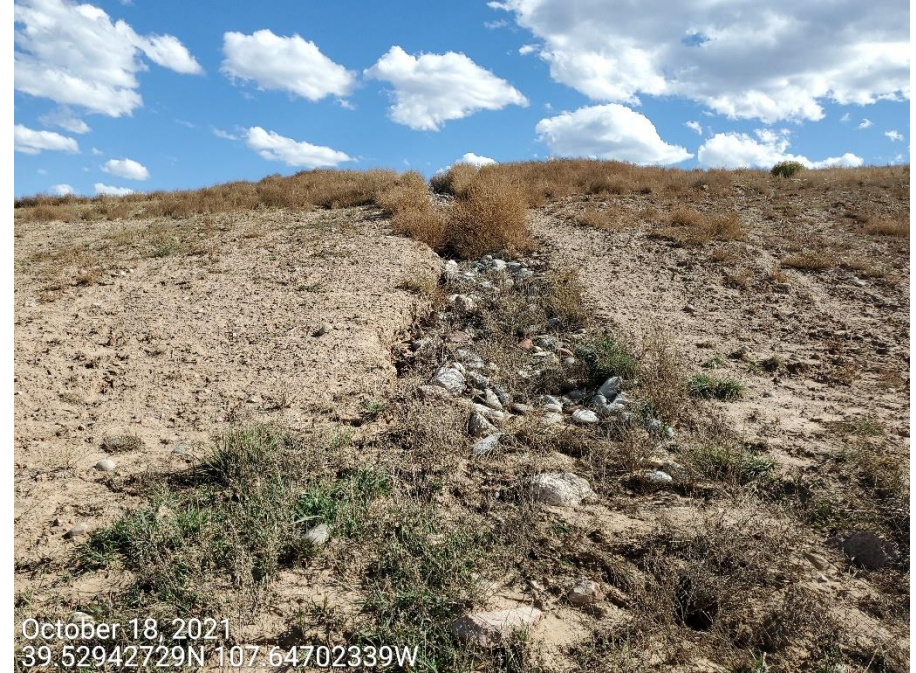
Photo 6: See comments under photo 5.

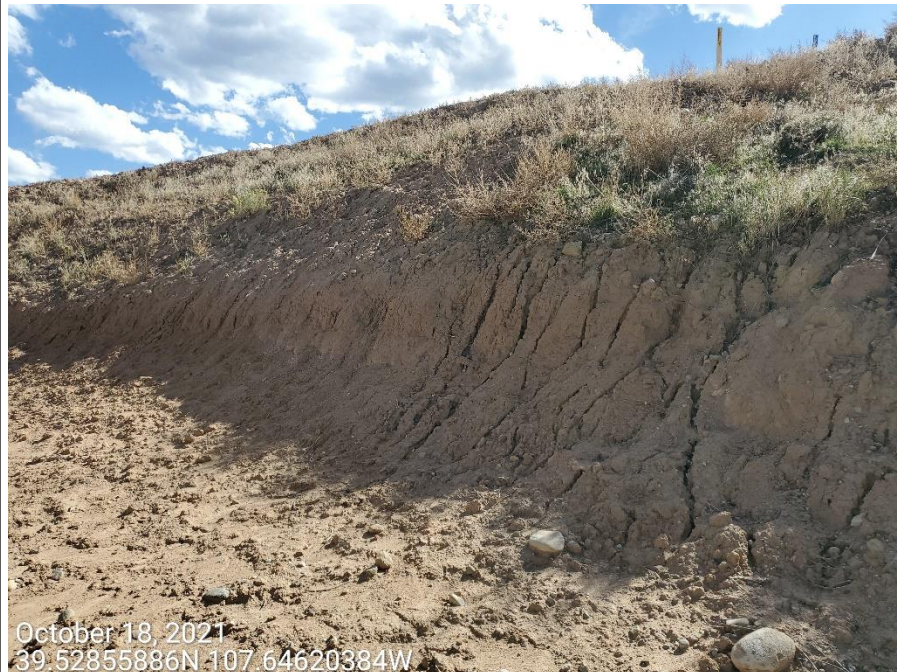
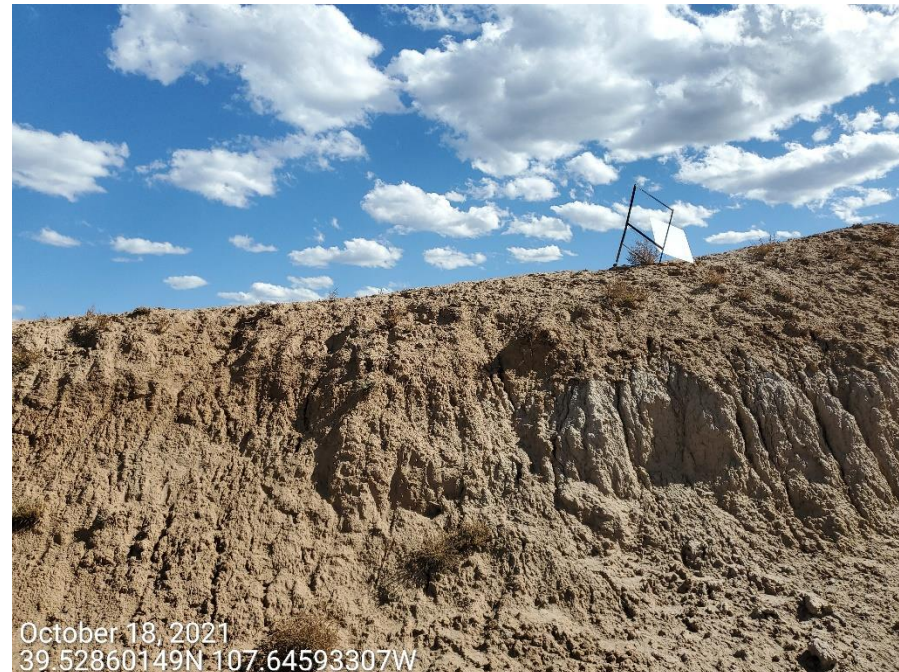
Photo 7: Photo shows cut slopes of the Location; control measures to protect and stabilize slopes of the Location remain missing or insufficient.

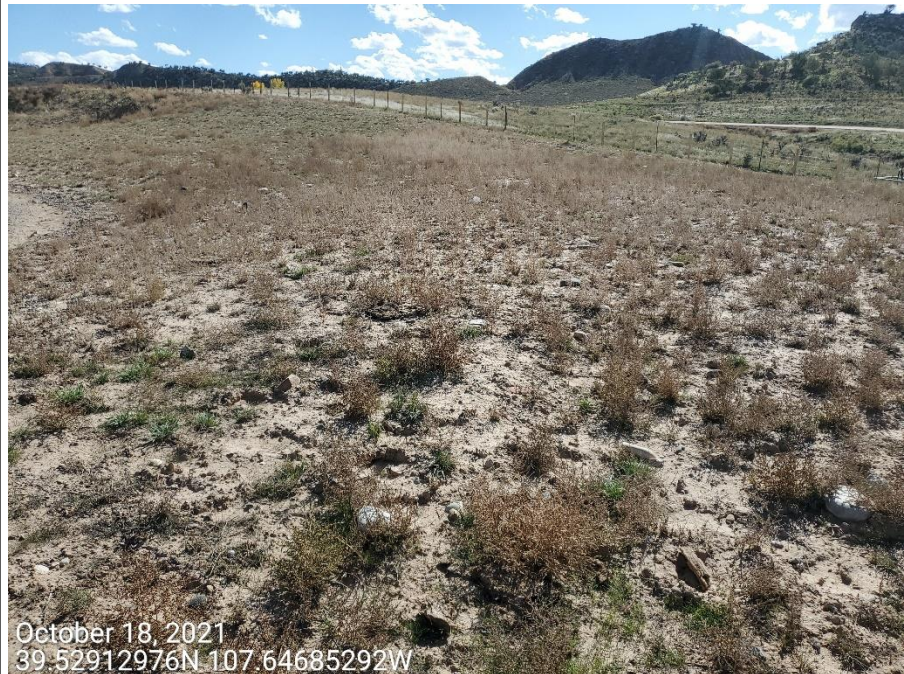
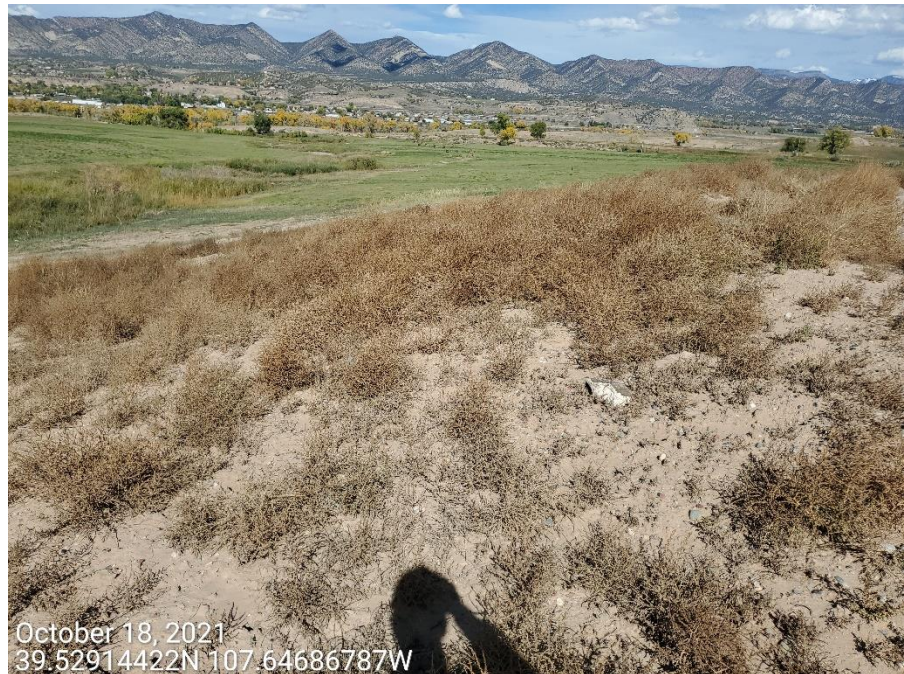
Photo 8: Photos taken from the interim areas of the Location. Interim areas not progressing towards 1003 standards. Vegetation predominantly undesirable plant species such as Kochia sp. And Salsola sp.

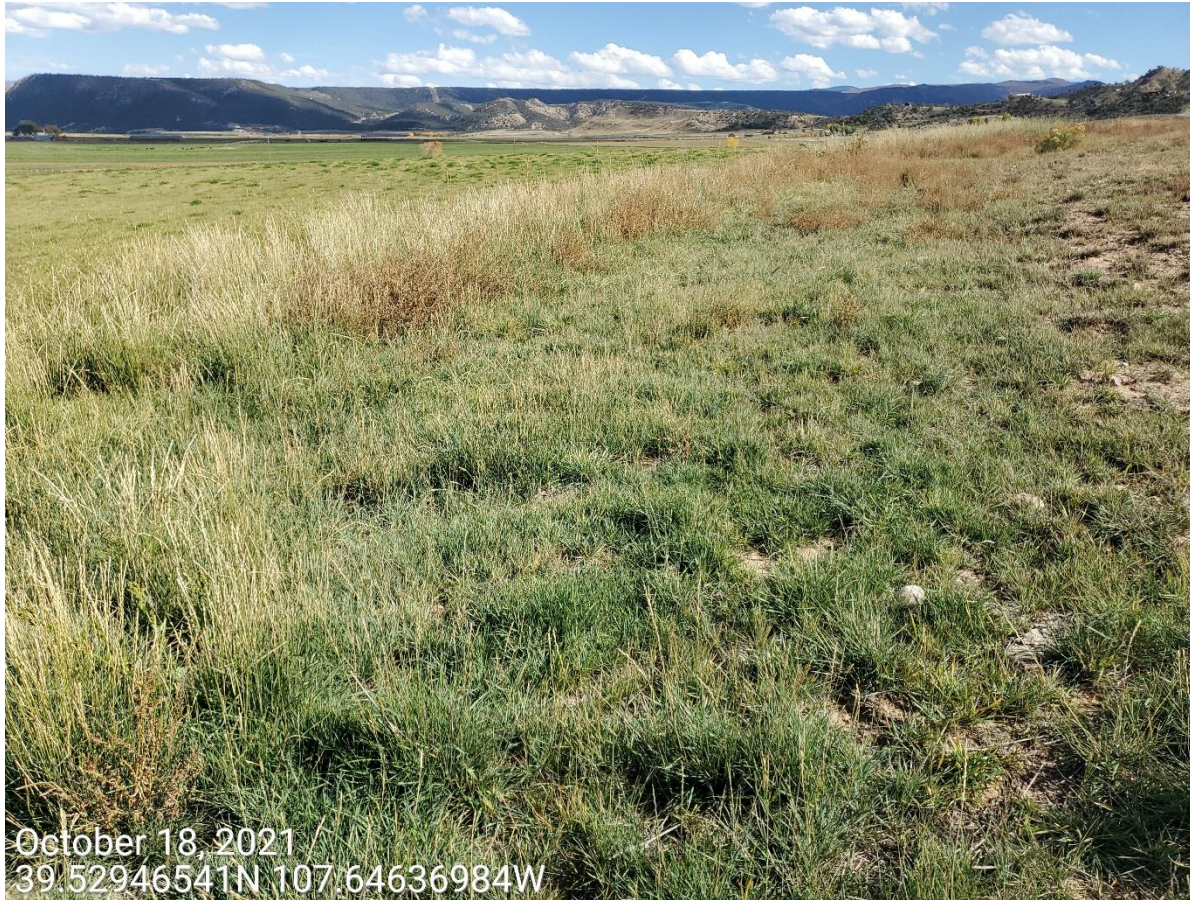
Photo 9: Photo shows vegetation on the adjacent reference areas to compare to the interim areas of the Location. .

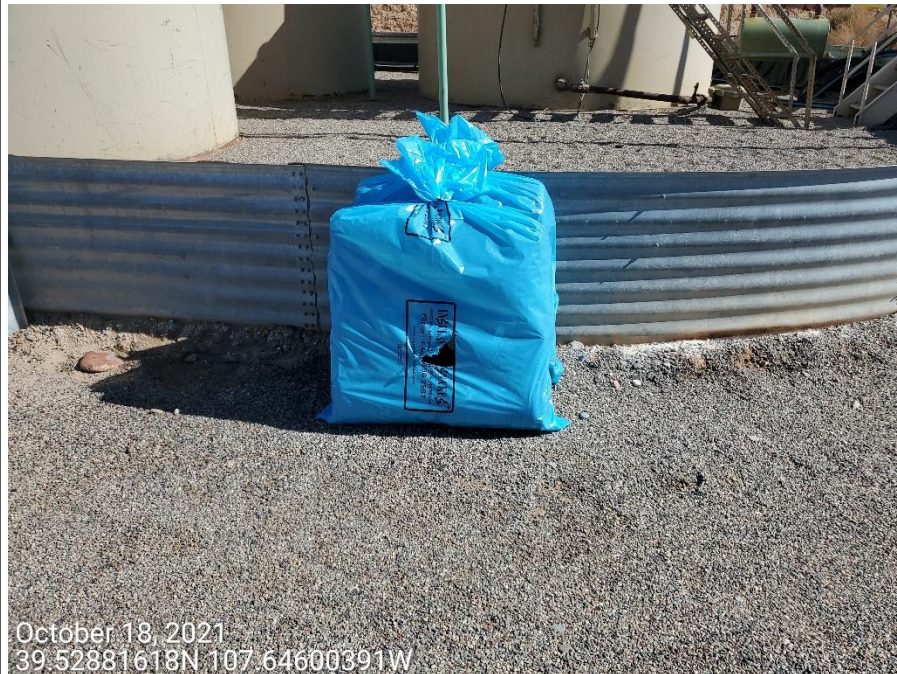
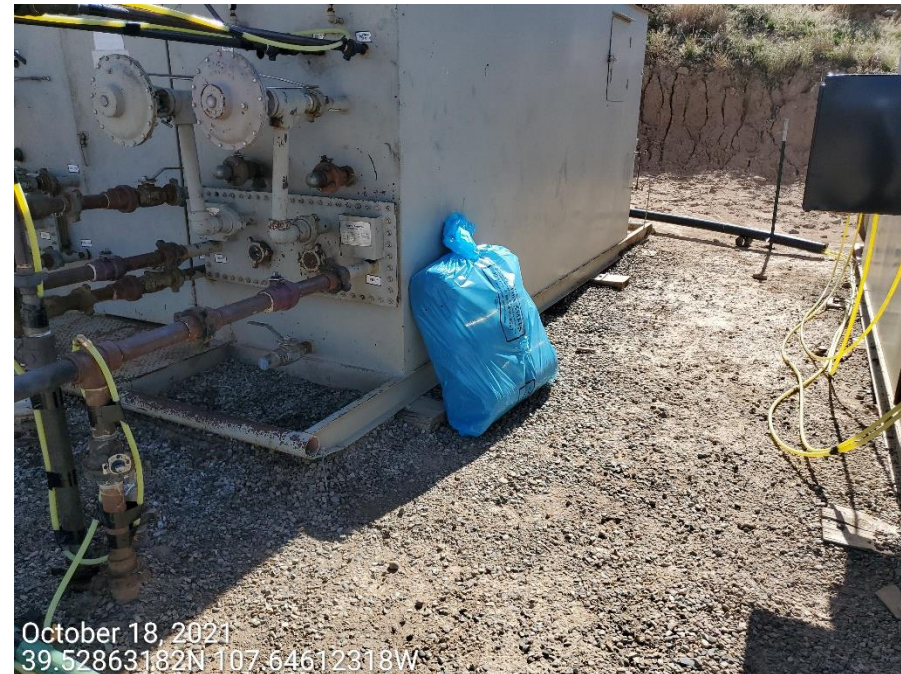
Photo 10: Photo shows unused “insulation snakes” observed stored on the Location.
