**Inspection Photos**  
**Location Name: Seltzer #1-A**  
**Location ID: 311297**

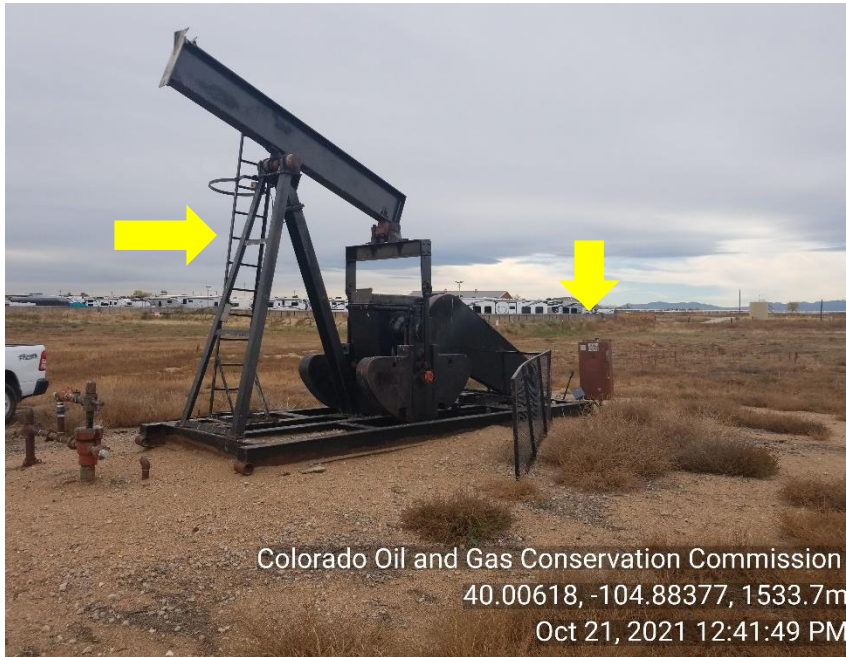
**Photo 1 Unused equipment: Electric control box, Pumping unit.**

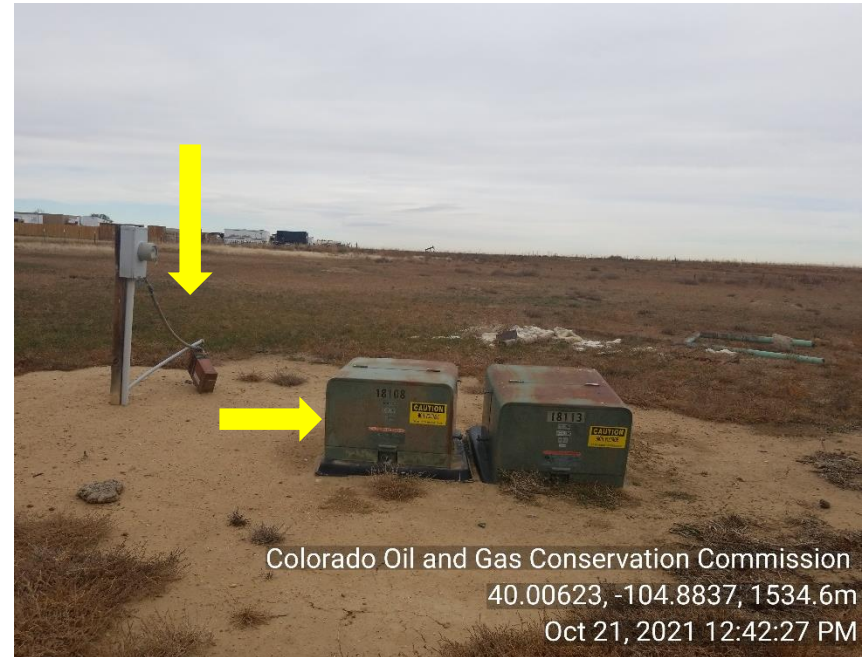
**Photo 2 Unused equipment electric meter and electric panel.**

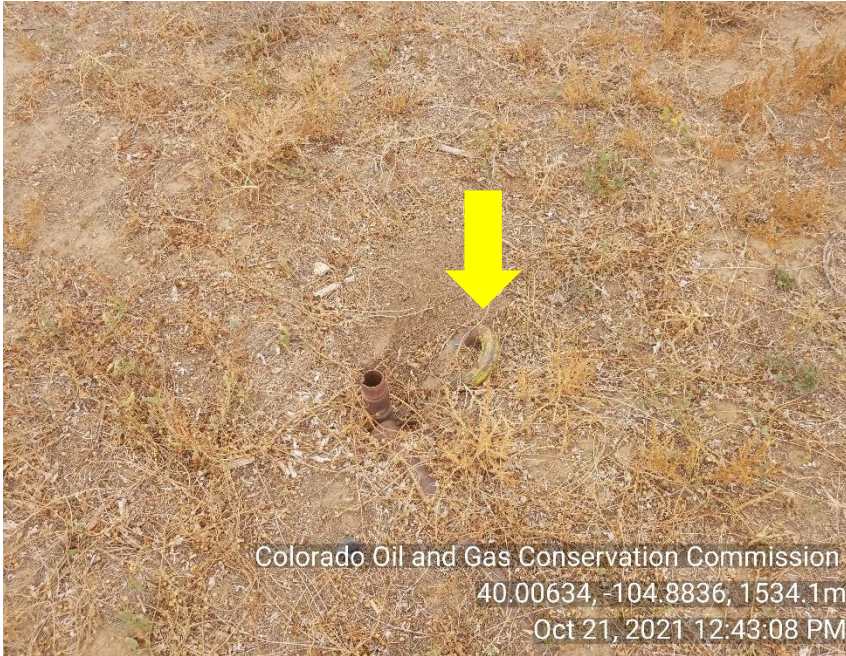
**Photo 3 Guyline anchor not properly marked.**

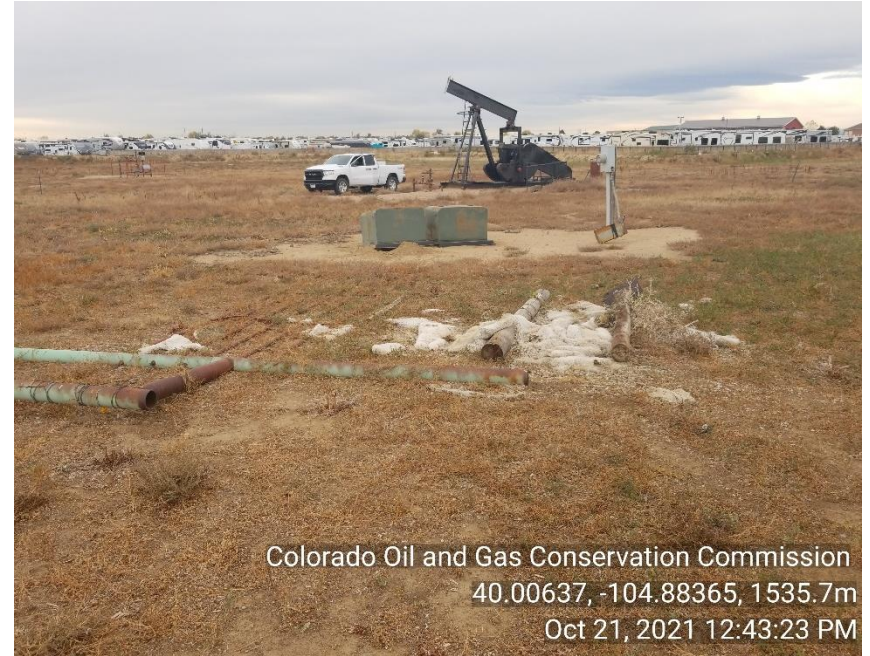
**Photo 4 unused equipment fencing and gate. Trash and debris.**

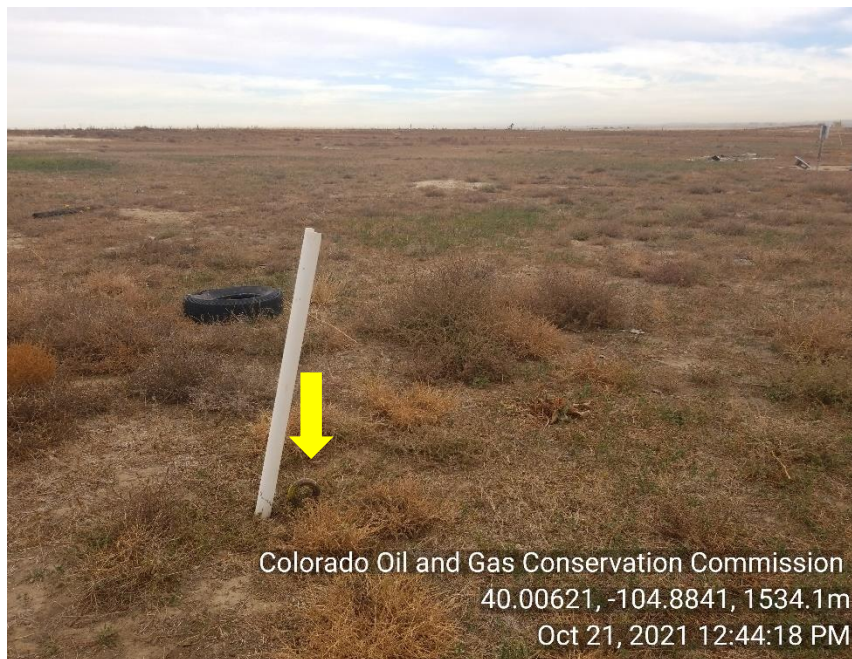
**Photo 5 Guyline anchor not properly marked.**

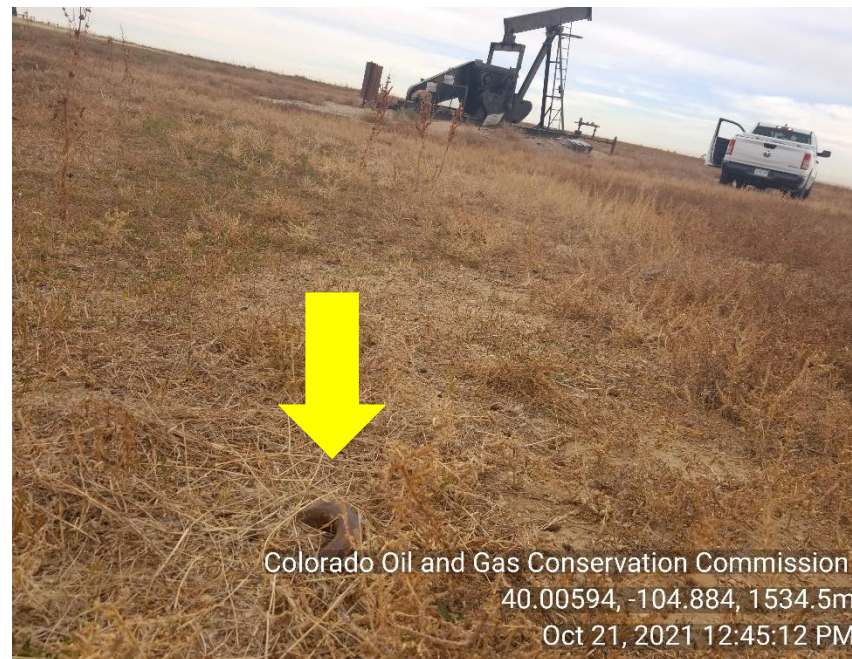
**Photo 6 Guyline anchor not properly marked.**

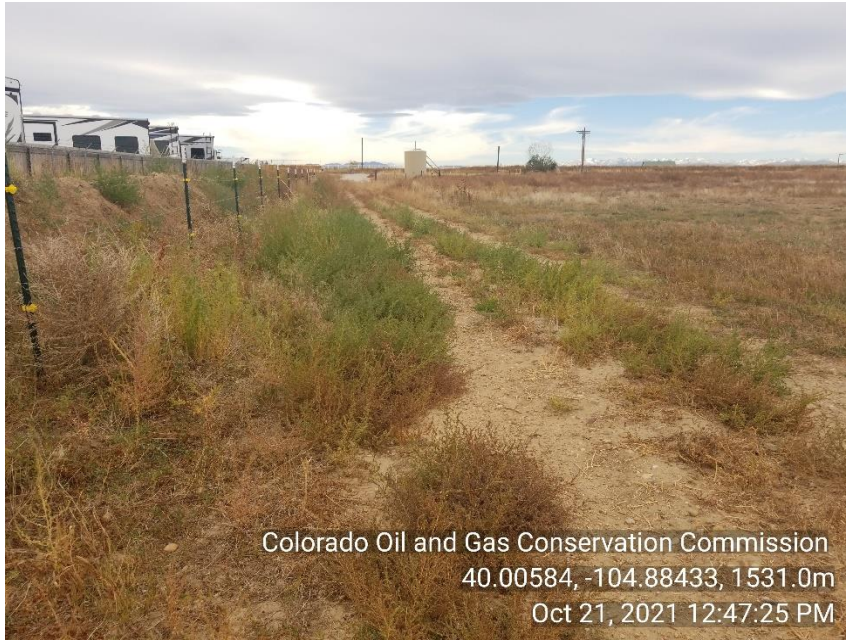
**Photo 7 Debris: dead weeds on access road. Road not properly maintained.**

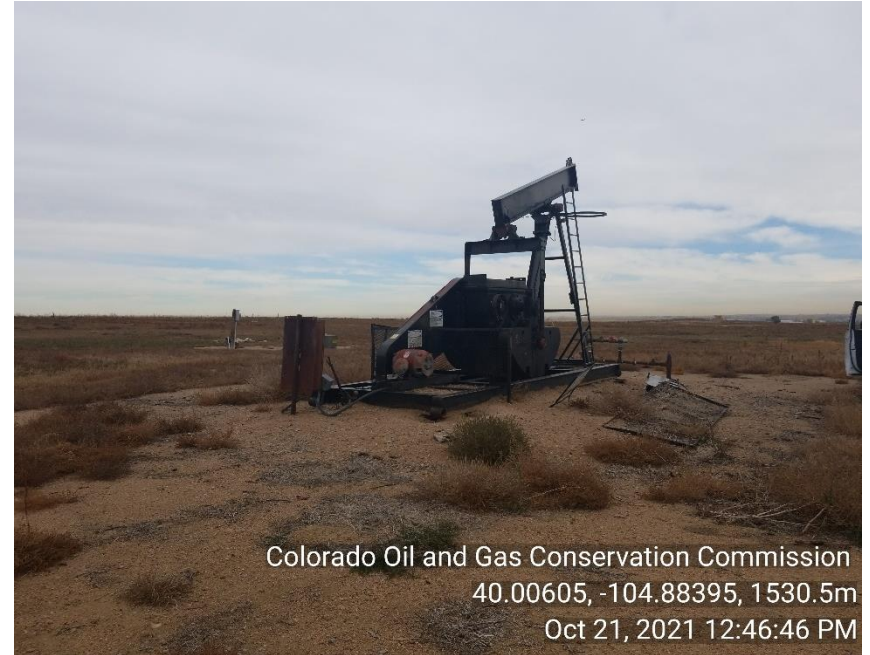
**Photo 8 Loc pic of unused equipment.**

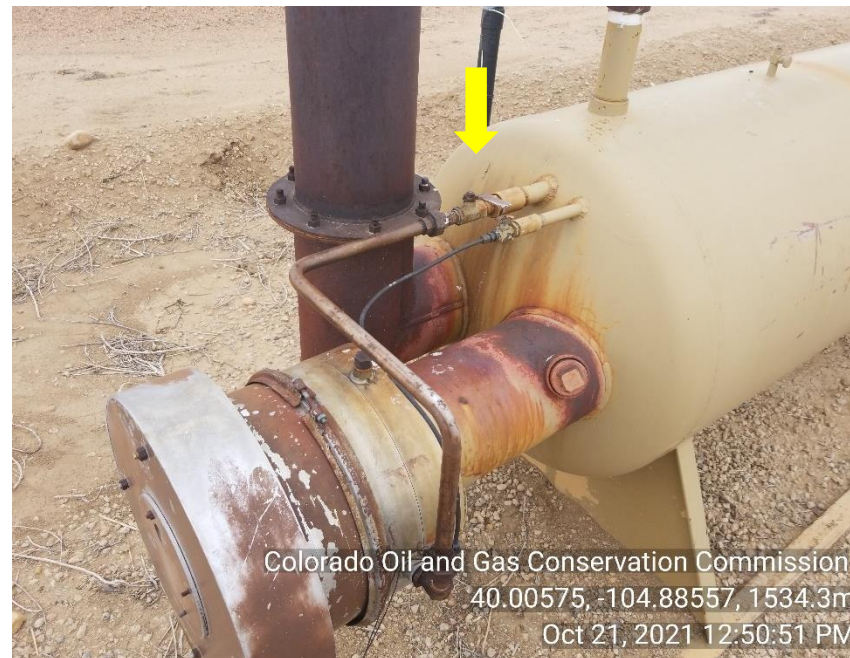
**Photo 12 HOZ Sep not in use fuel gas line is in closed position.**

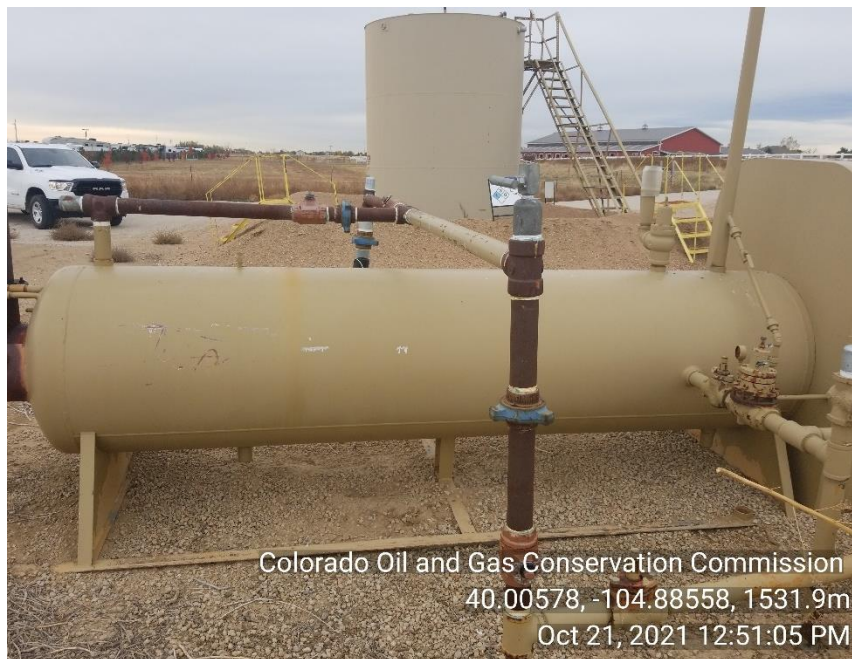
**Photo 13 Supply line for HOZ Sep in closed position.**

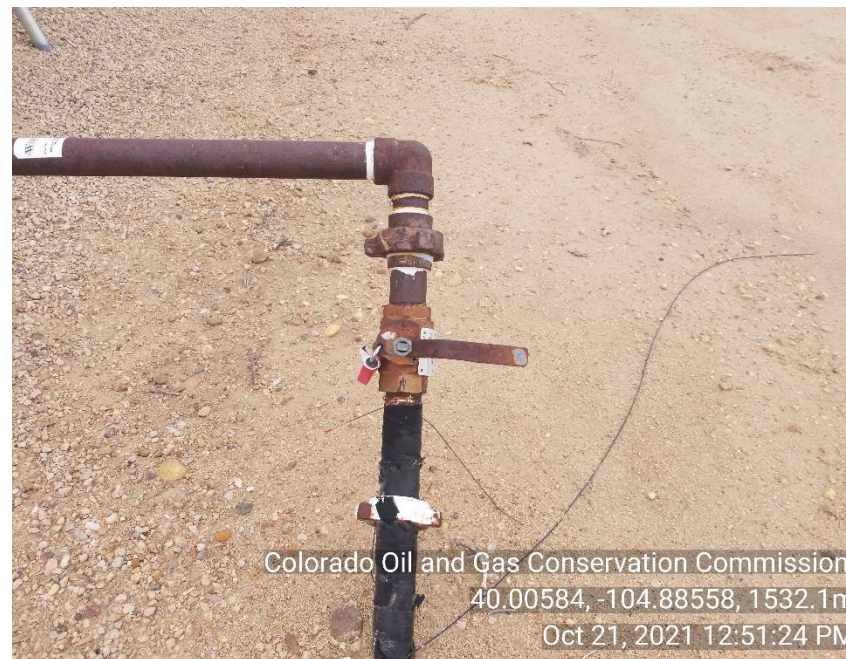
**Photo 14 Gas sales inlet to meter is LOTO**

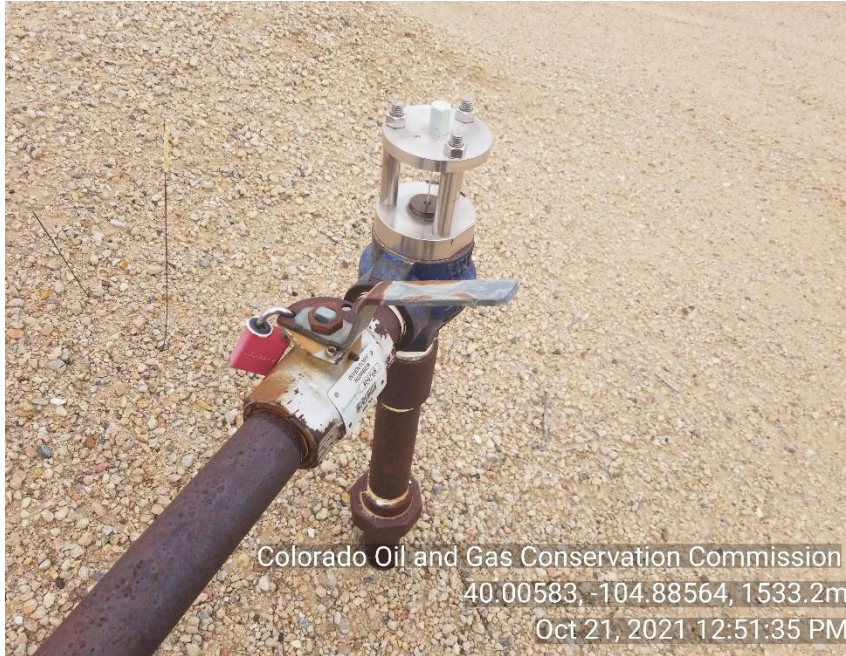
**Photo 15 Gas sales line outlet from meter LOTO**

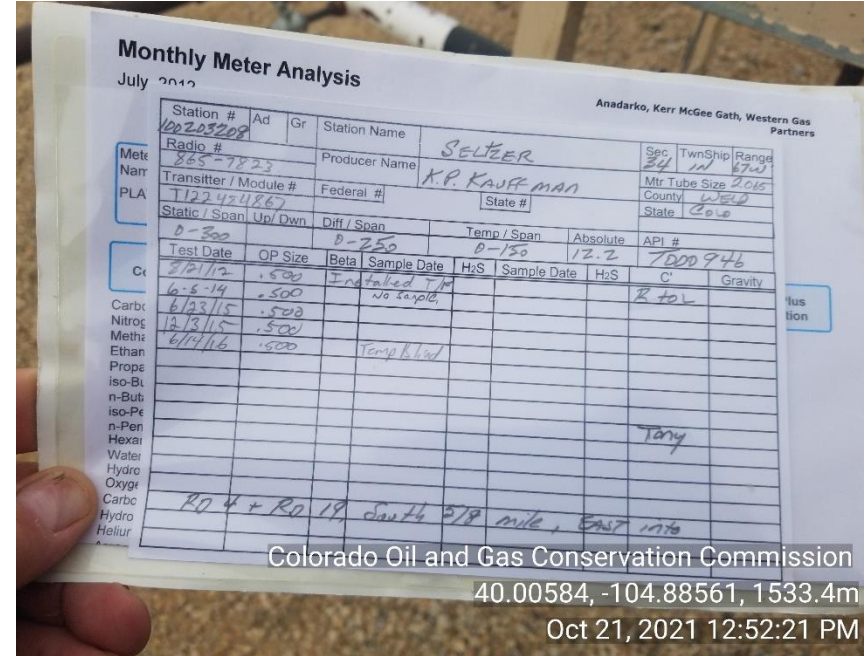
**Photo 16 Sales gas meter calibration card has not been calibrated since 2016.**

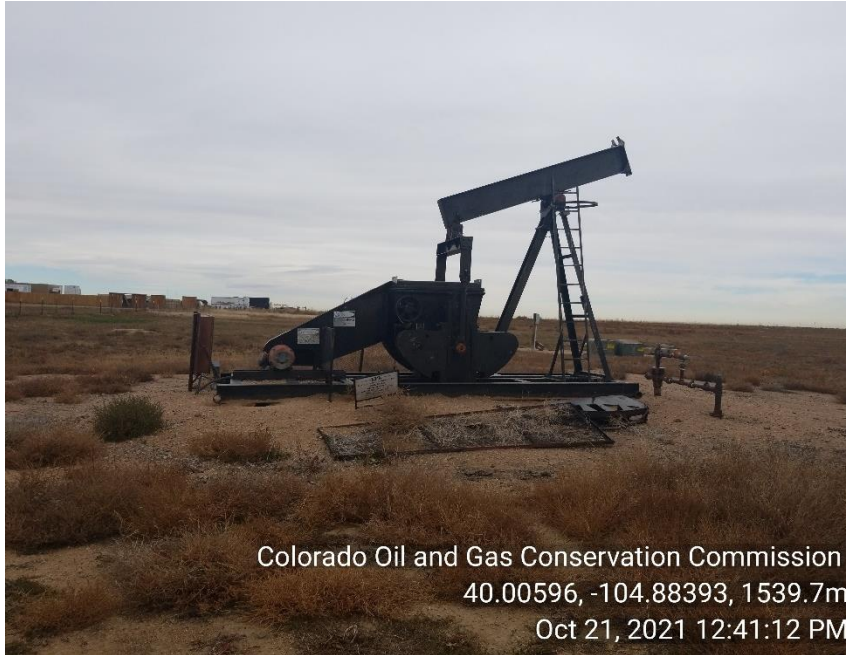
**Photo 17 well site. Debris: Dead weeds on location**

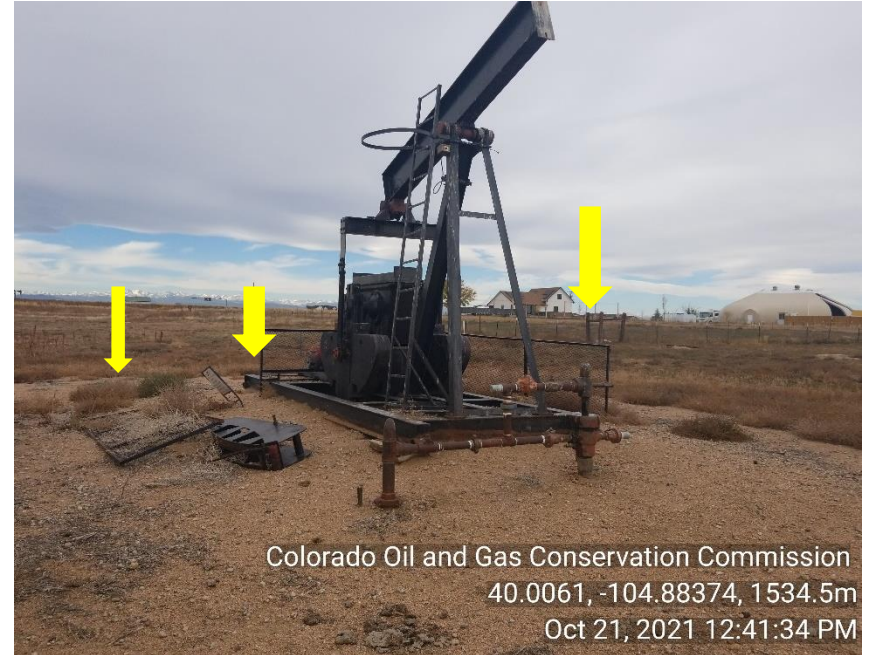
**Photo 18 un used equipment: PU parts and fencing.**
