# Inspection Photos

API: 071-06128

Operator: OGRIS OPERATING LLC

Inspection Date: 10/21/2021

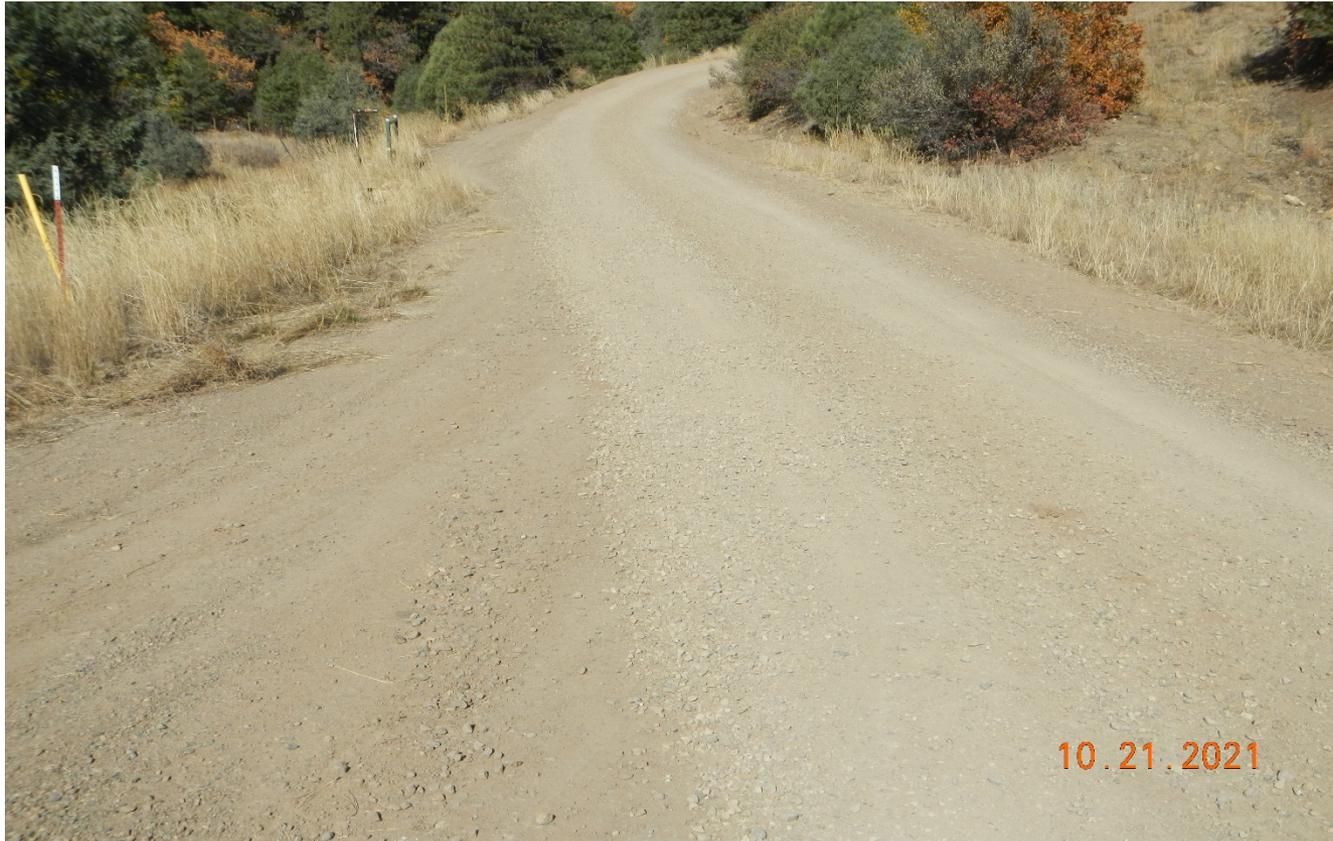
**Photo 1.** There has been road base spread on areas where vehicle rutting had occurred. The road has been regraded and repaired.

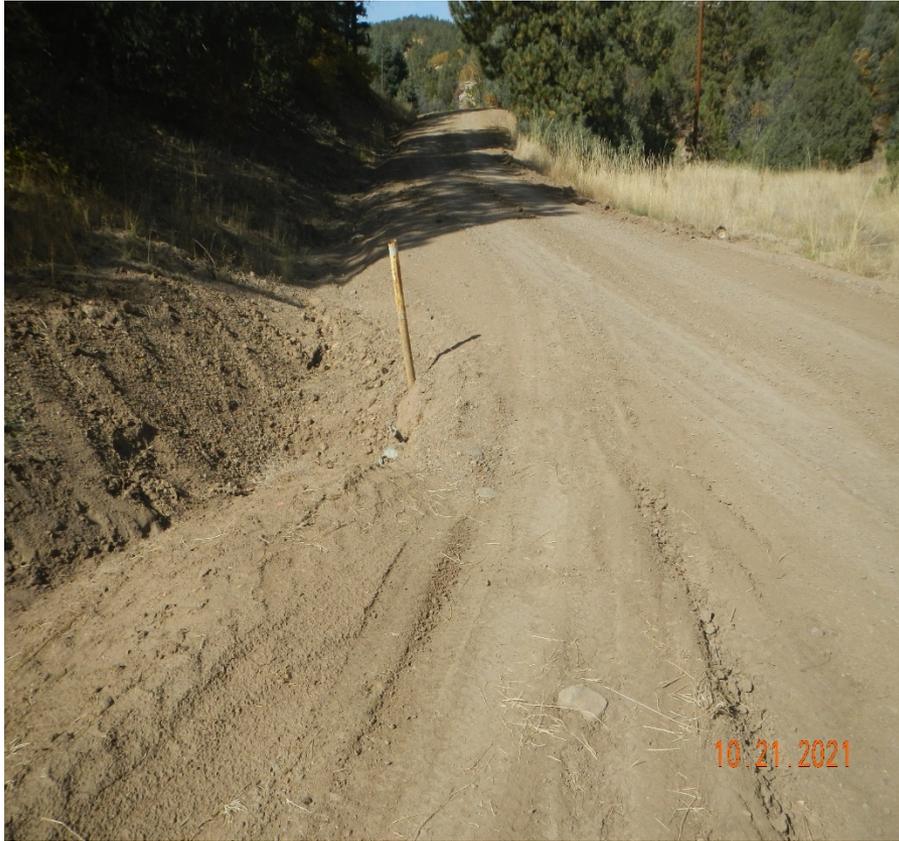
**Photo 2.** The culvert inlet has been cleaned out and repaired.

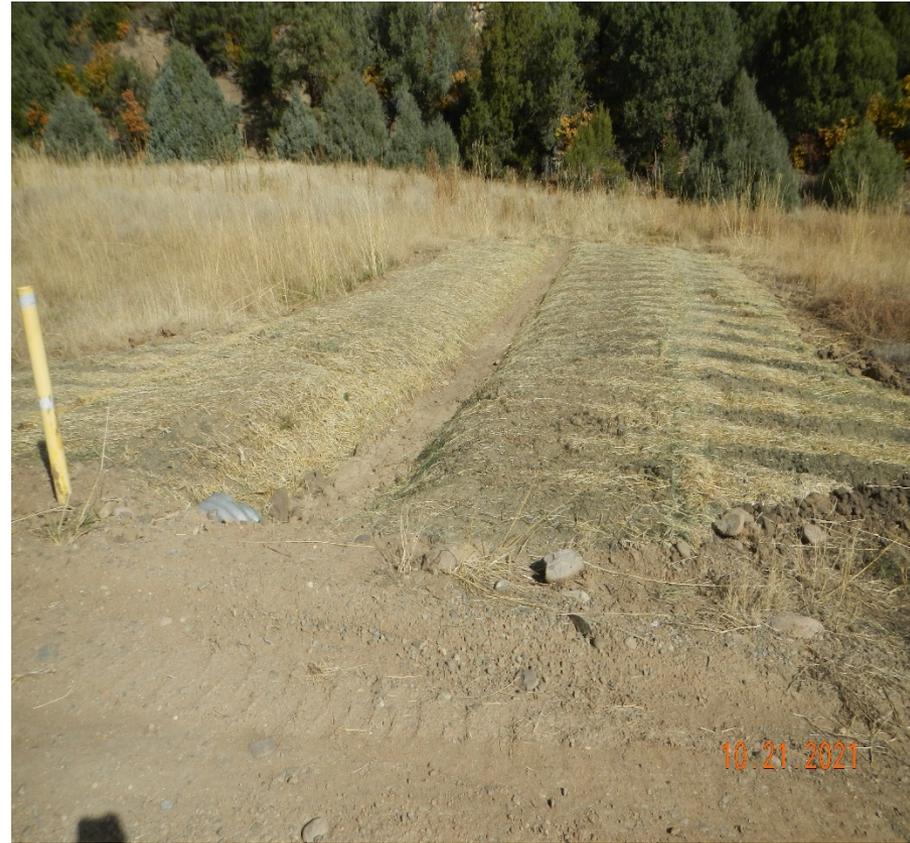
**Photo 3.** The culvert outlet has been repaired to allow stormwater diversion. Disturbance area was seeded and stabilized.

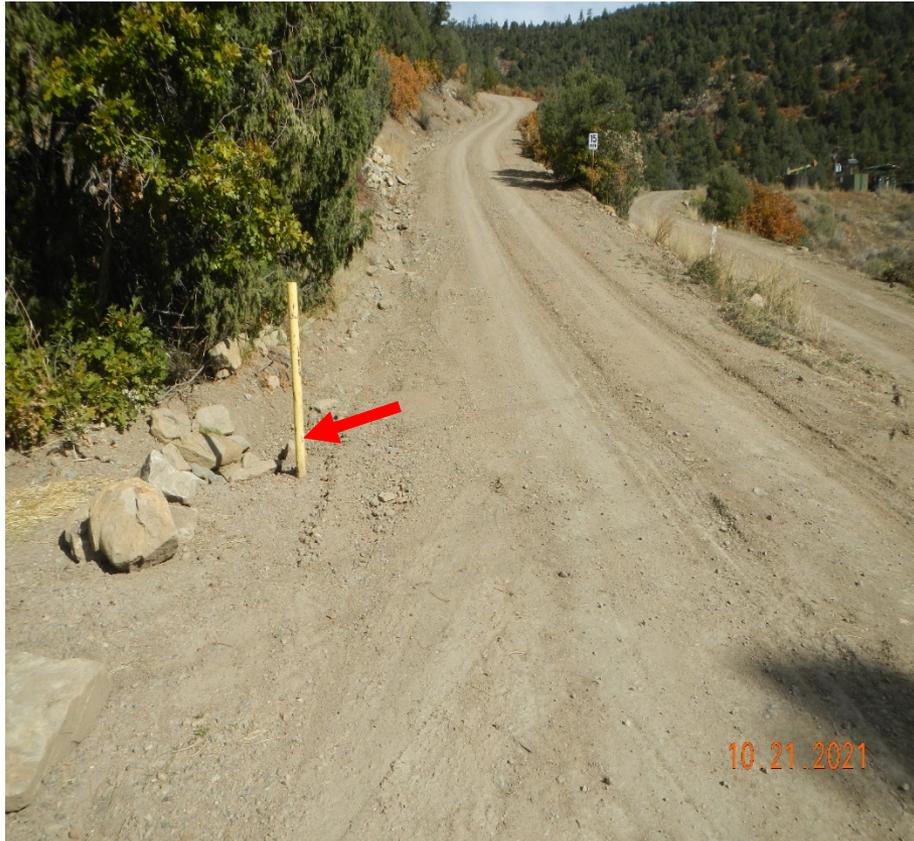
**Photo 4.** Facing north as the road ascends the hill side. A culvert has been installed at red arrow to properly divert stormwater away from the road.

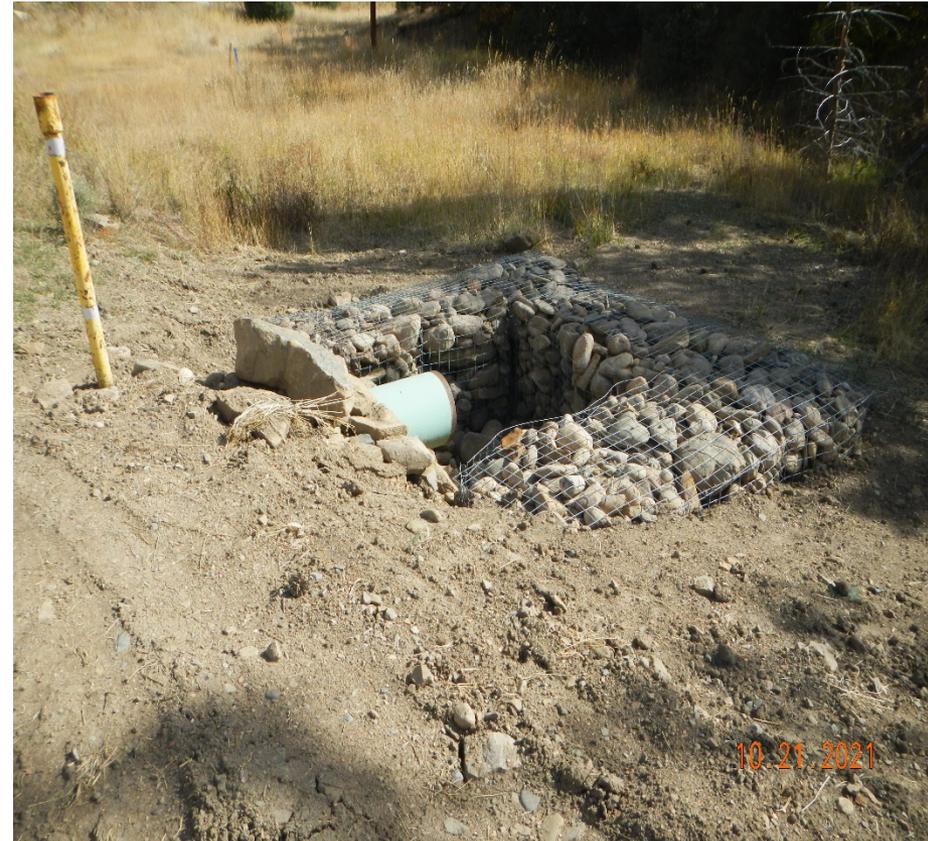
**Photo 5.** The culvert outlet gabion has been installed. This structure will need to be monitored and maintained to prevent sediment accumulation.

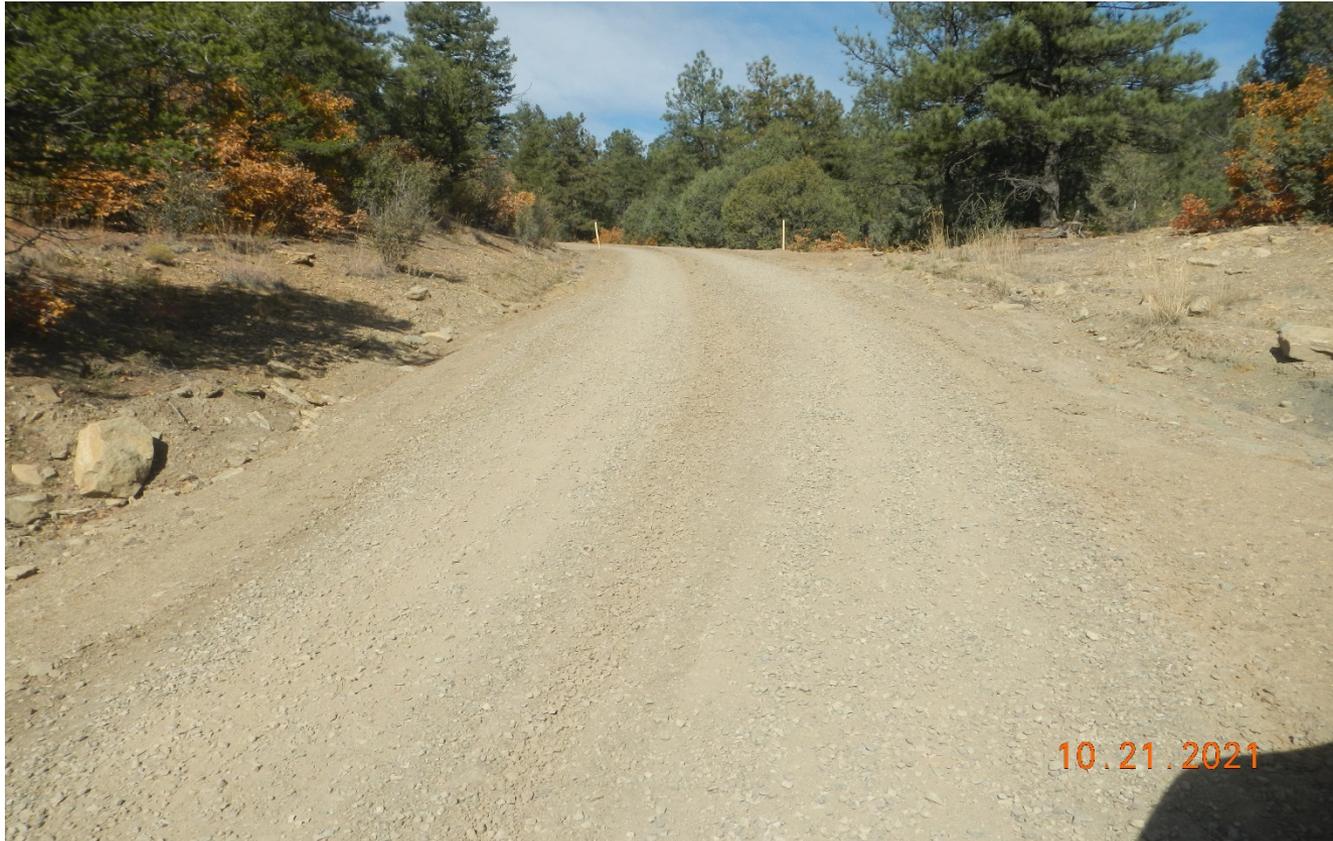
**Photo 6.** There has been road base spread on areas where vehicle rutting had occurred. The road has been regraded and repaired.

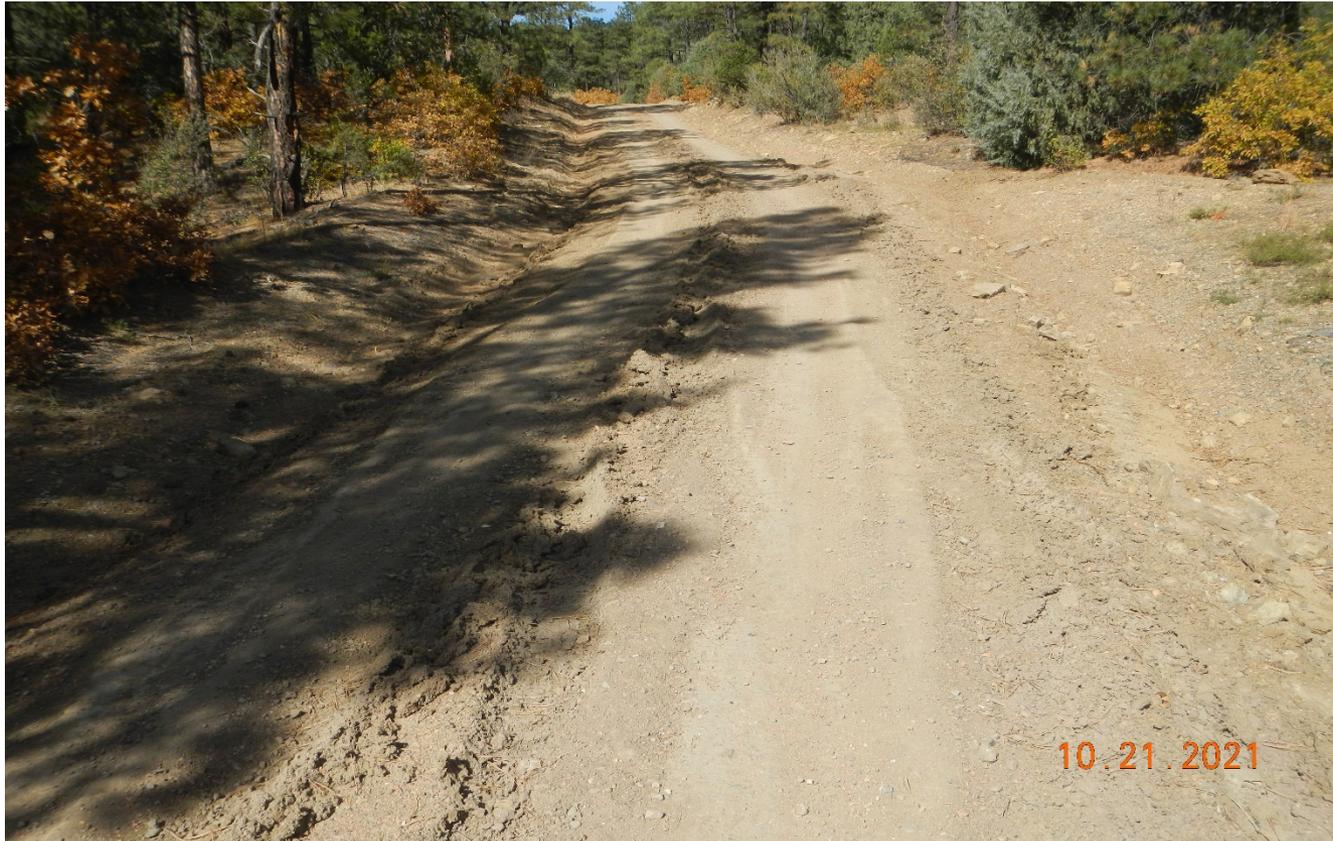
**Photo 7.** Facing northwest further along the road. There is vehicle rutting in this area which was not graveled. Additional gravel is needed in this area.

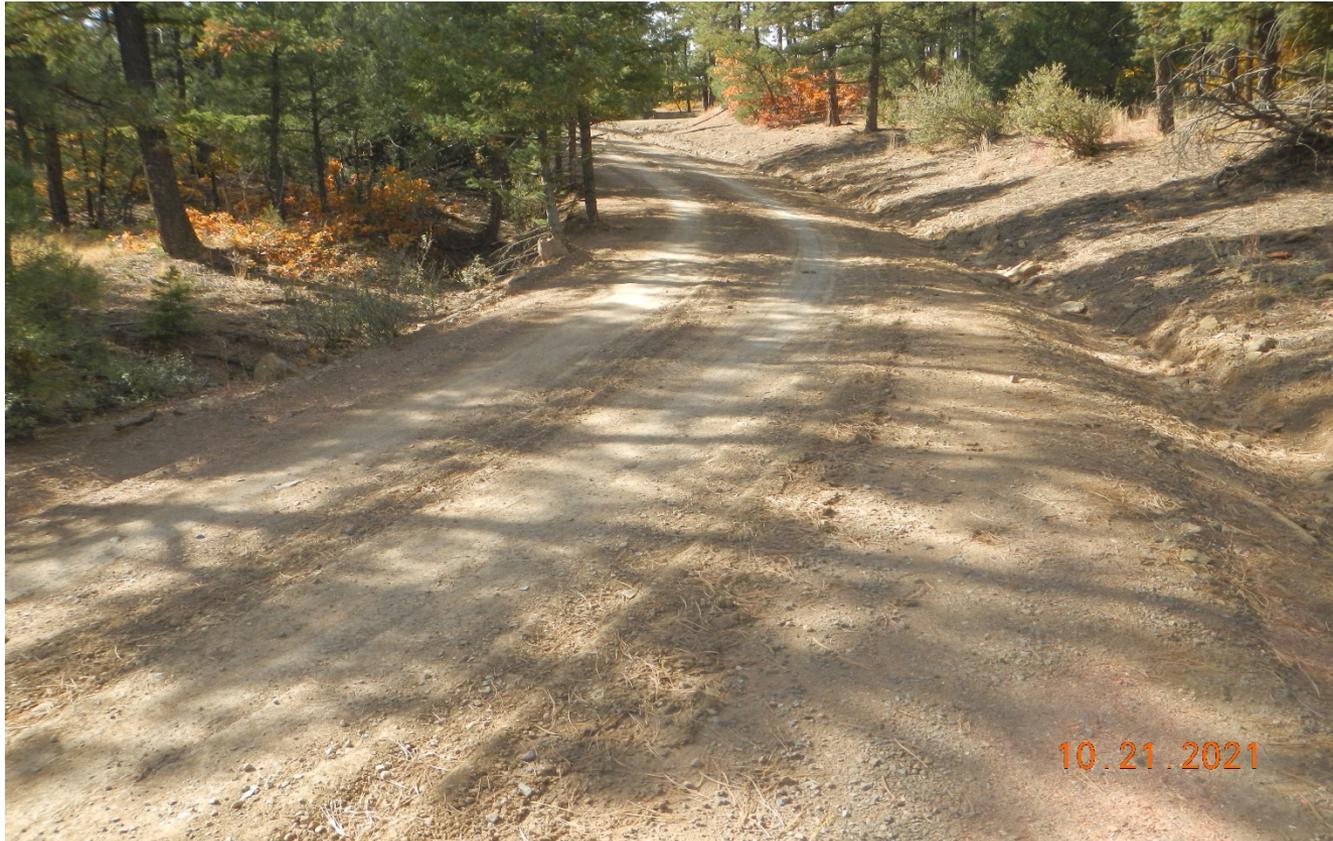
**Photo 8.** The road was graded along this area. The pieces of blue pipe debris were removed from this area.

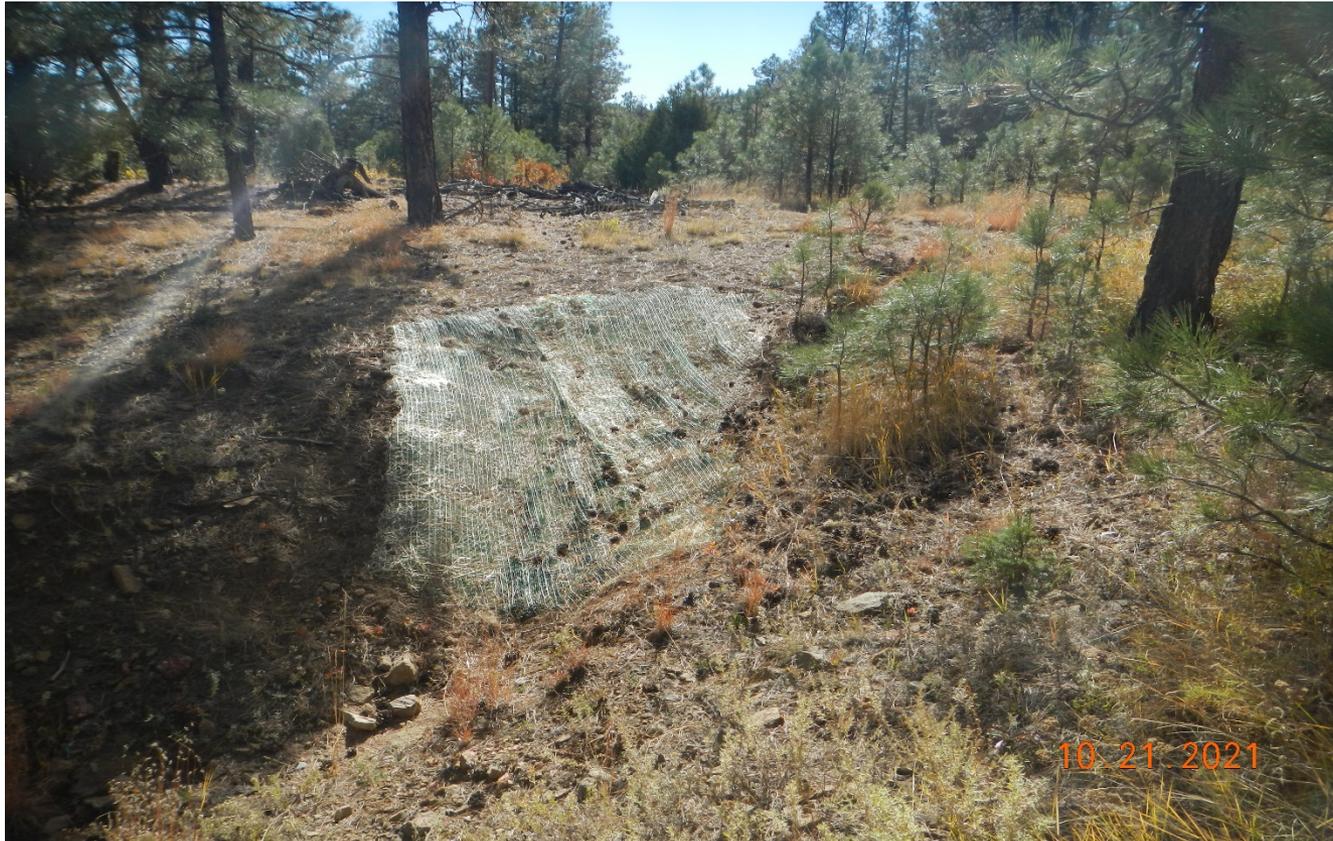
**Photo 9.** The area of erosion previously observed was repaired and stabilized with straw blanket.

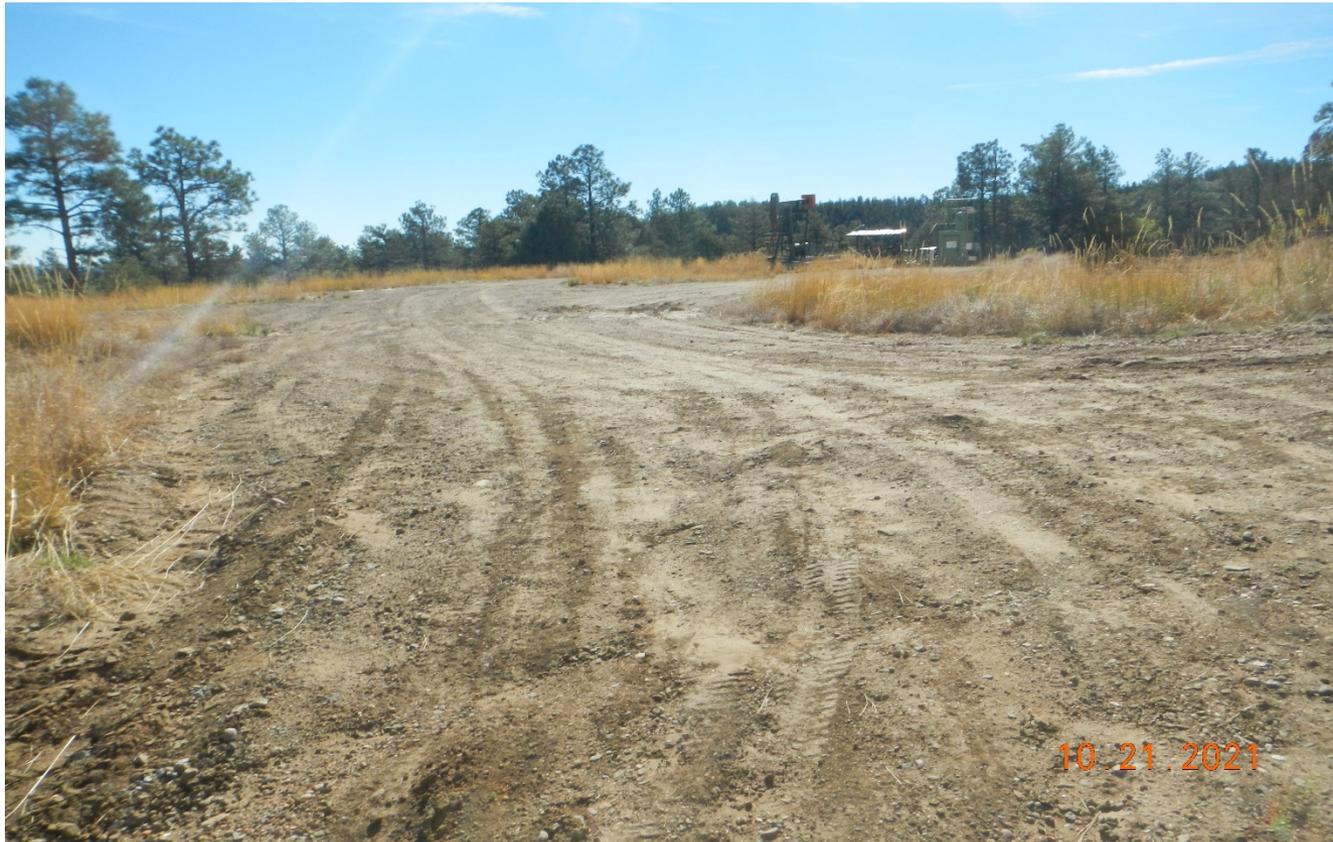
**Photo 10.** Facing southeast toward the location.
