Inspection Photos

Cosslet A 9 Flowline Excavation Access Road/Flowline Header

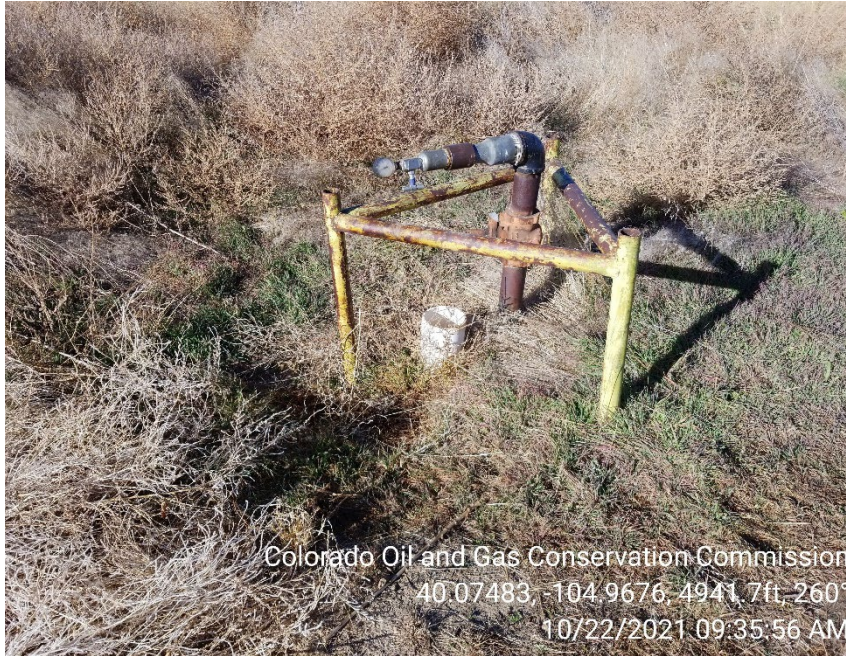
Photo 1 – Stained soil at header

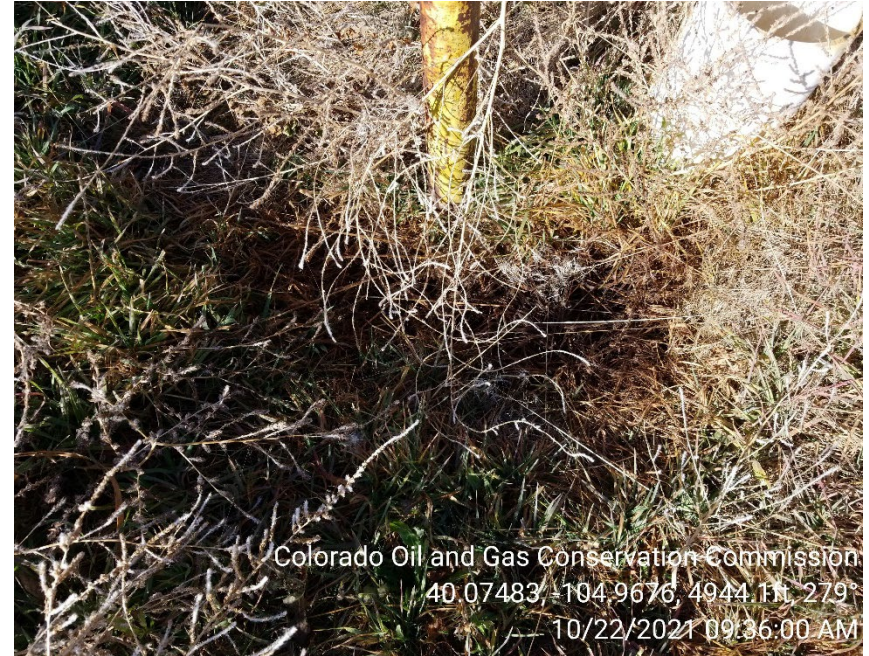
Photo 2 – Stained soil along flowline path

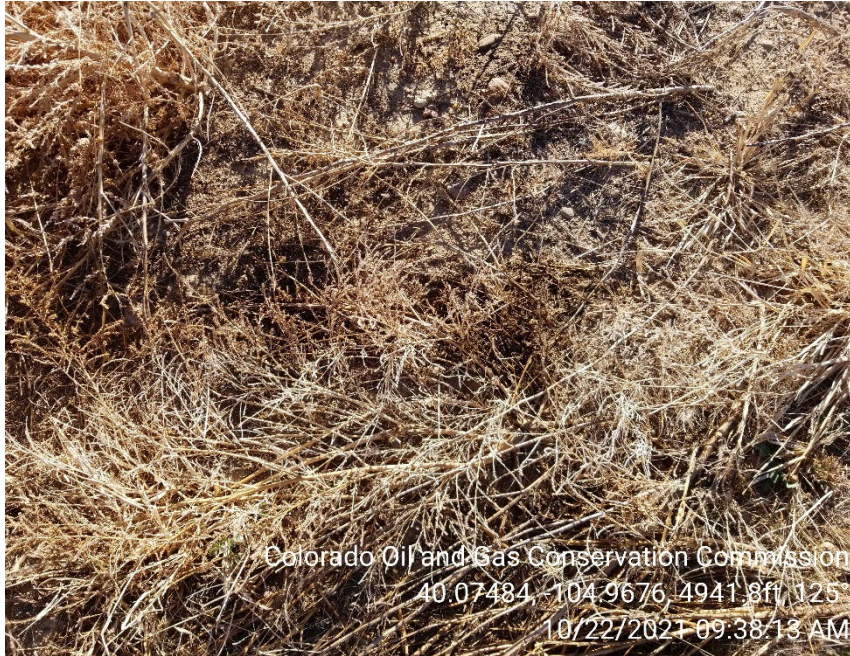
Photo 3 – Stained soil along flowline path.

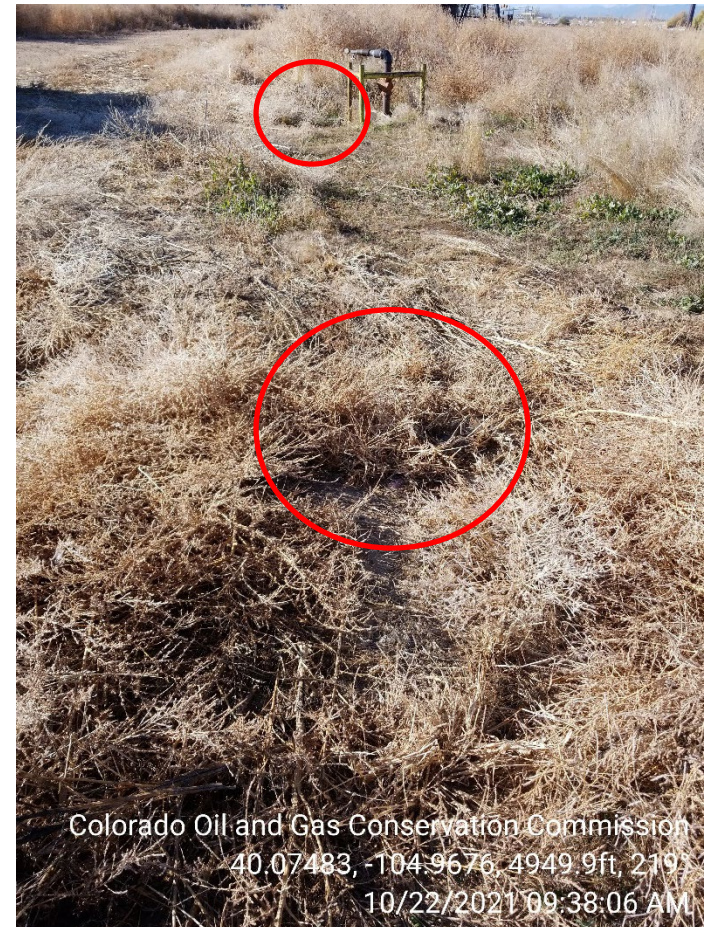
Photo 4 – Two locations of stained soil

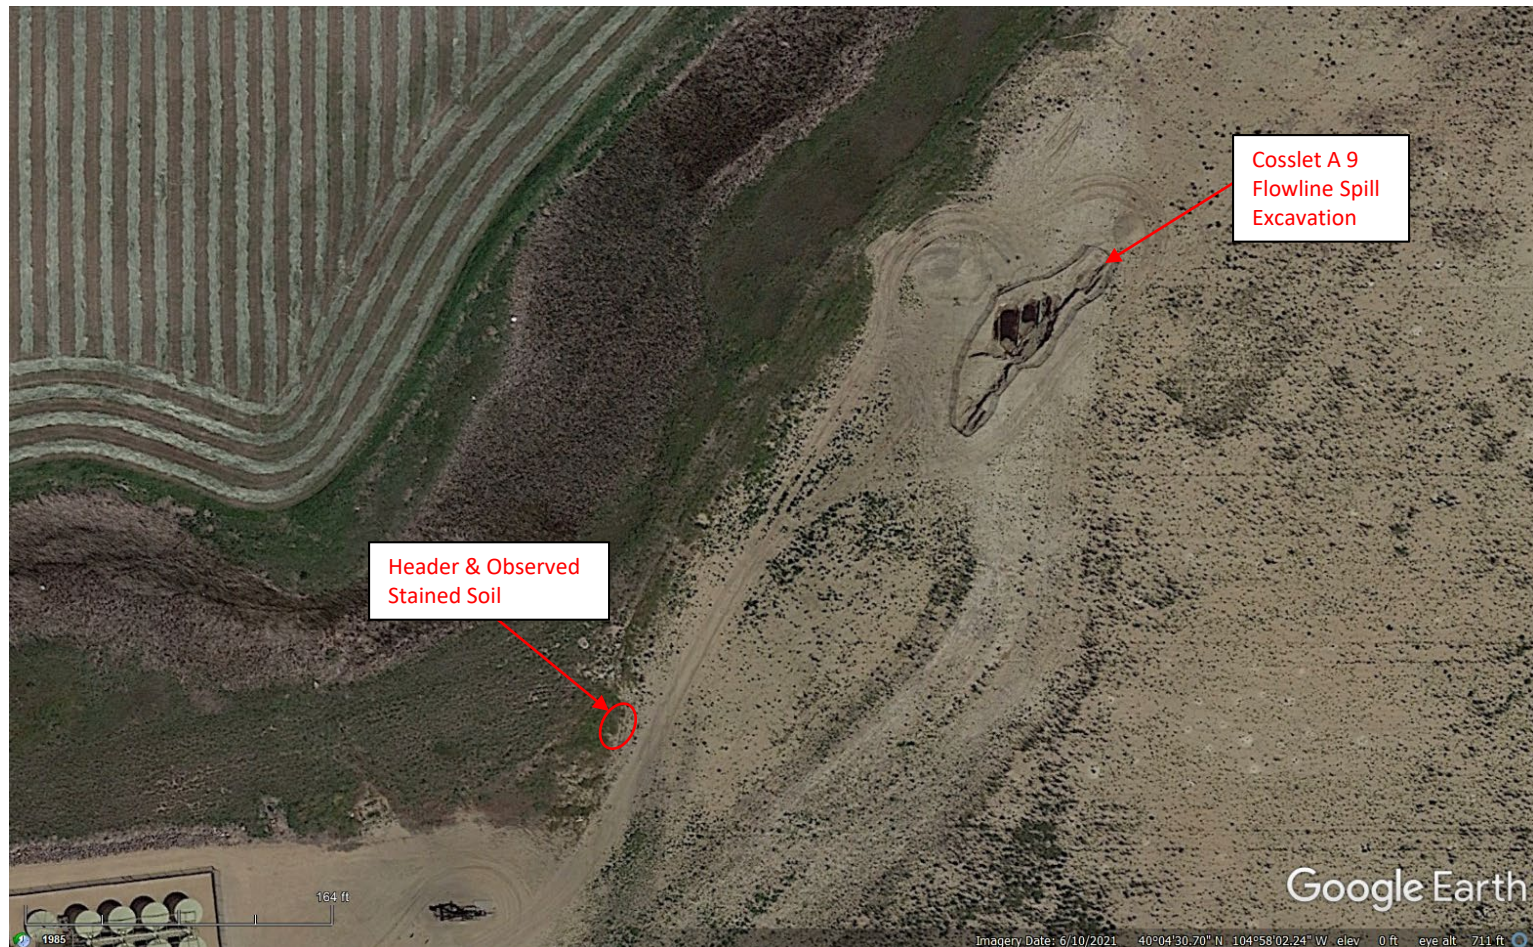
Photo 5 – Map showing location of stained soil
