Inspection Photos
Operator: Logos Operating
API: 067-05267
Date: 10/22/2021

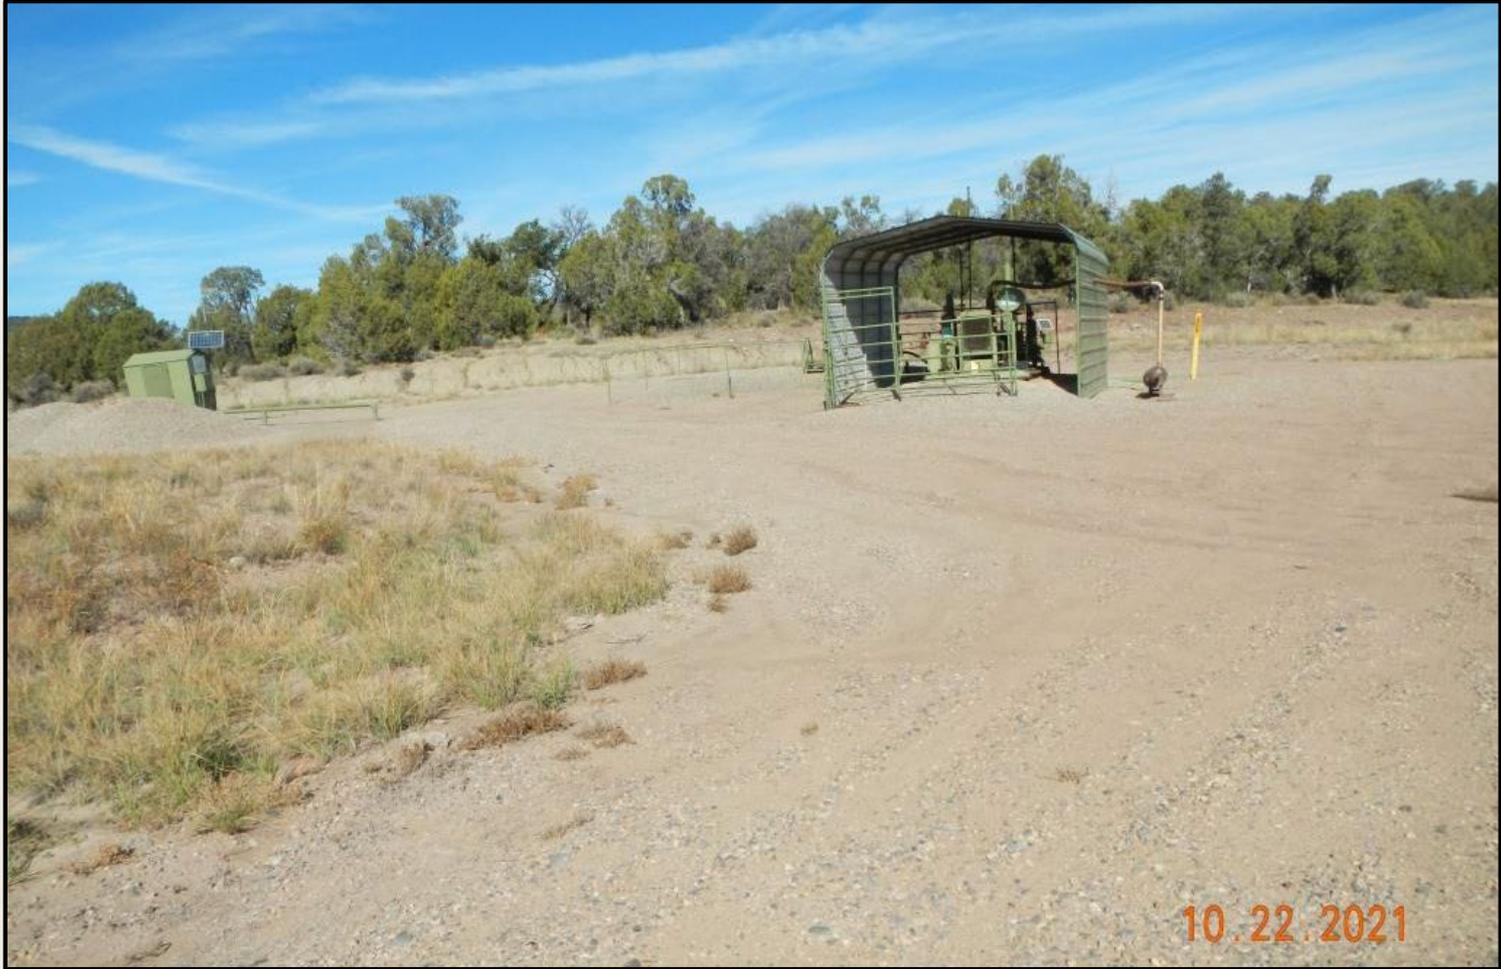
Photo 1. View of the project area from the well pad entrance facing center.

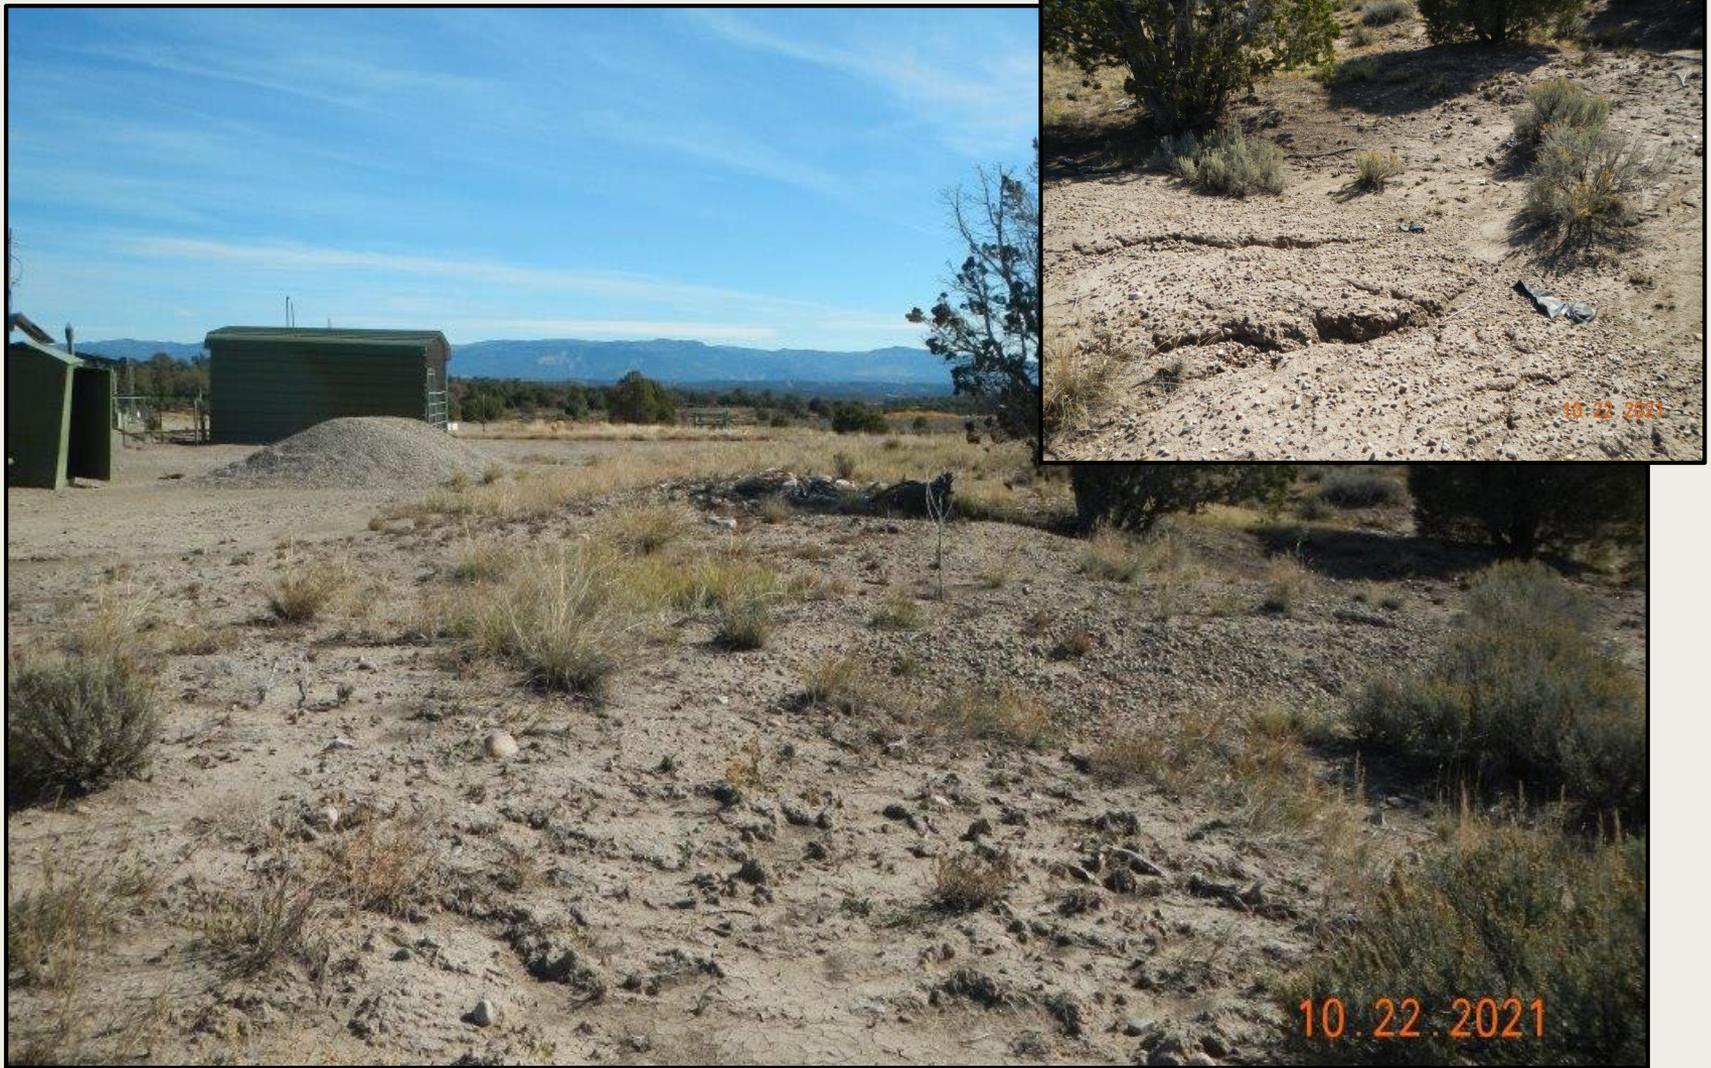
Photo 2. View of the southern project area from the southwestern corner facing eastward. Soils are not stabilized in this portion of the project area, with erosional channeling and sediment transport occurring. Inset shows an erosional channel approx. 12 in wide and deep in the southern fill slope.

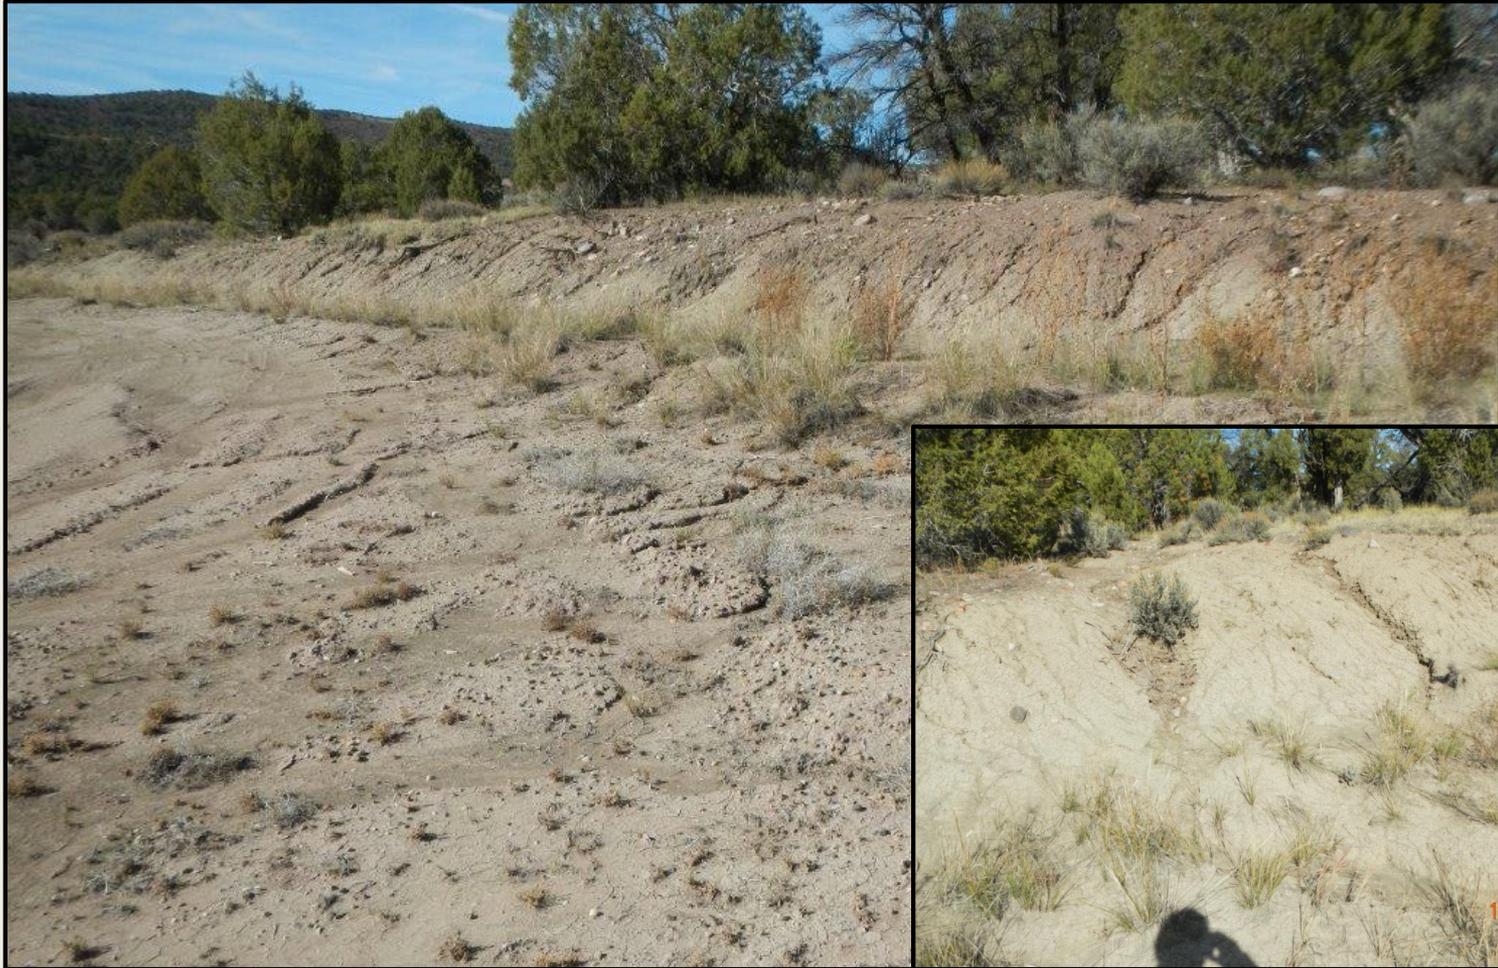
Photo 3. View of the northern cut slope. Multiple erosional channels and sediment deposition occurring. Inset shows more erosional channeling and sediment deposition on the well pad.

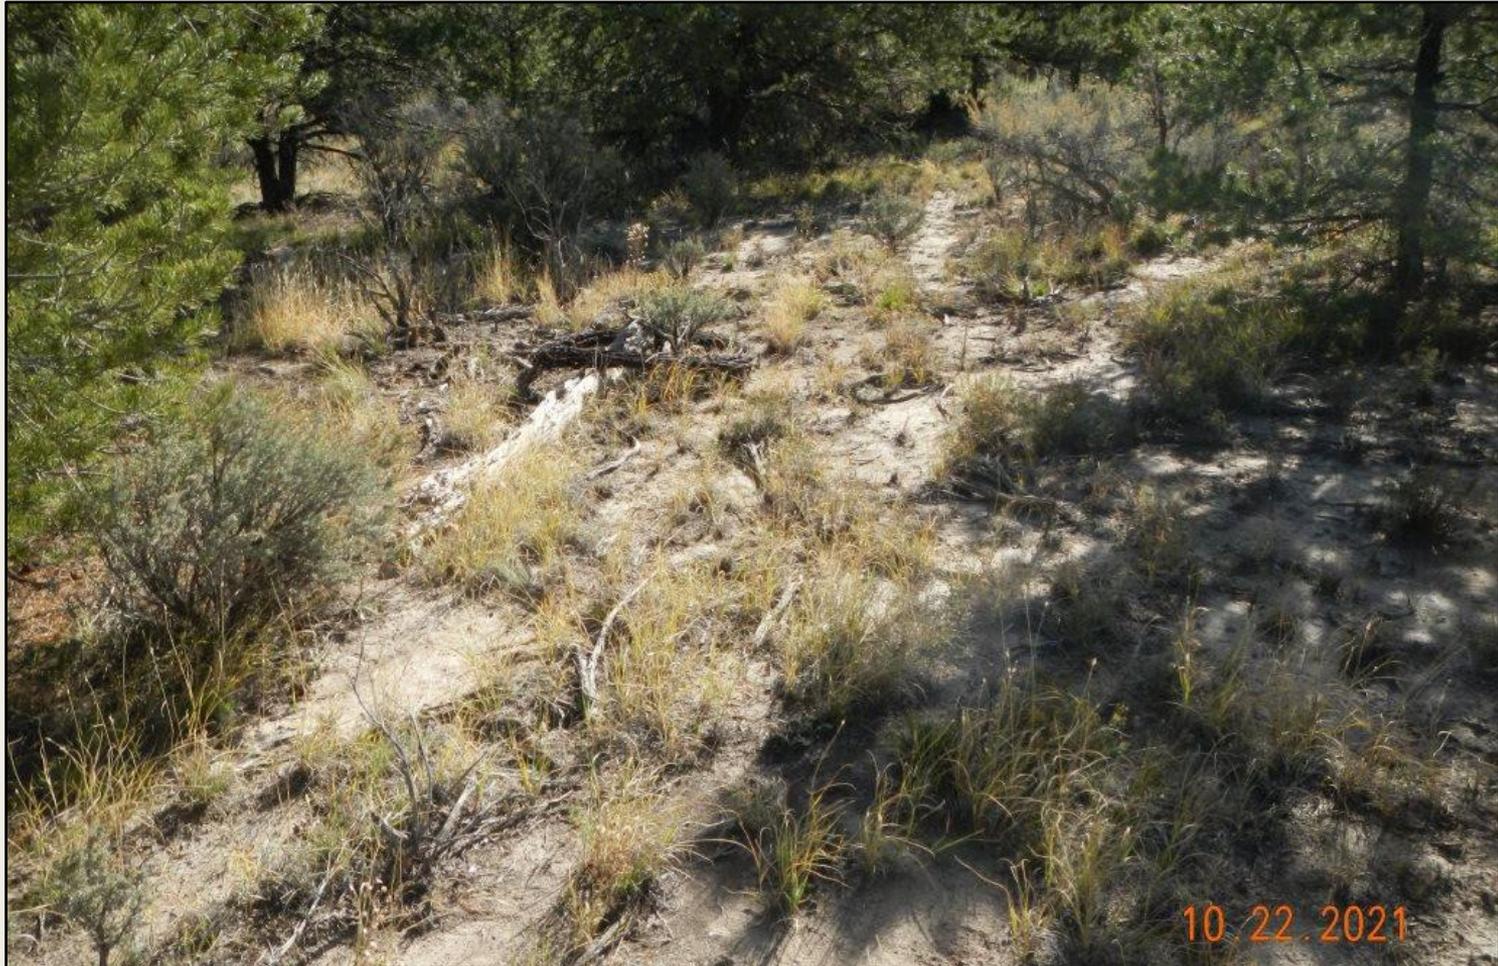
Photo 4. View of the reference area comprised of pinyon and juniper woodland with understory of sagebrush, James galleta, sandberg bluegrass, and prickly pear.
