Inspection Photos
Operator: Simcoe
API: 067-05244
Date: 10/22/2021

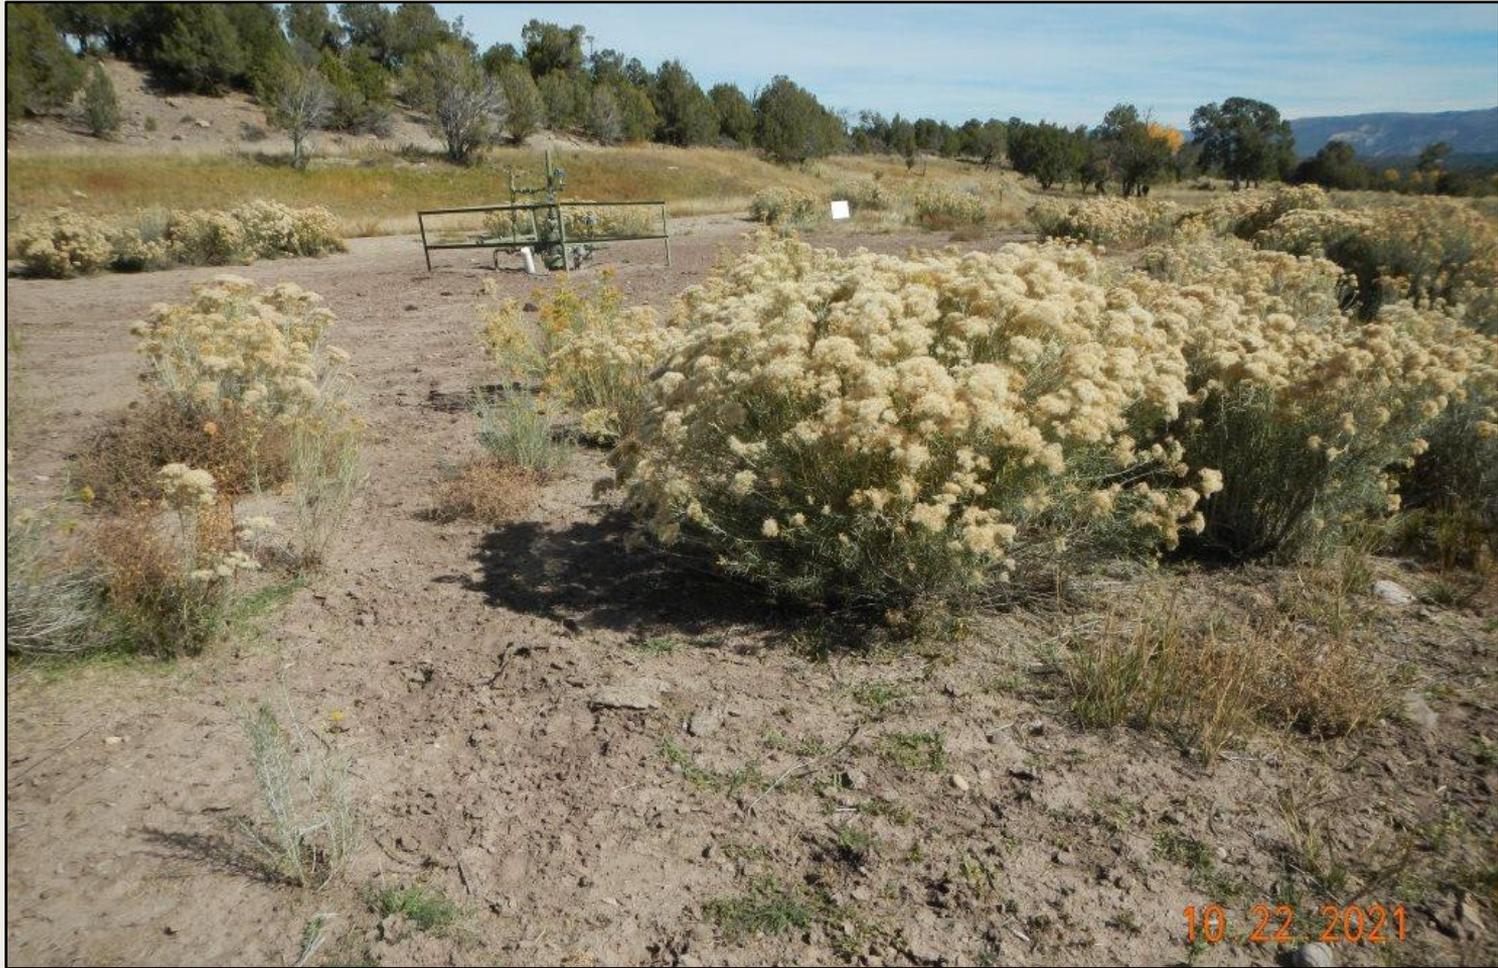
Photo 1. View of the project area from the southwestern corner facing center.

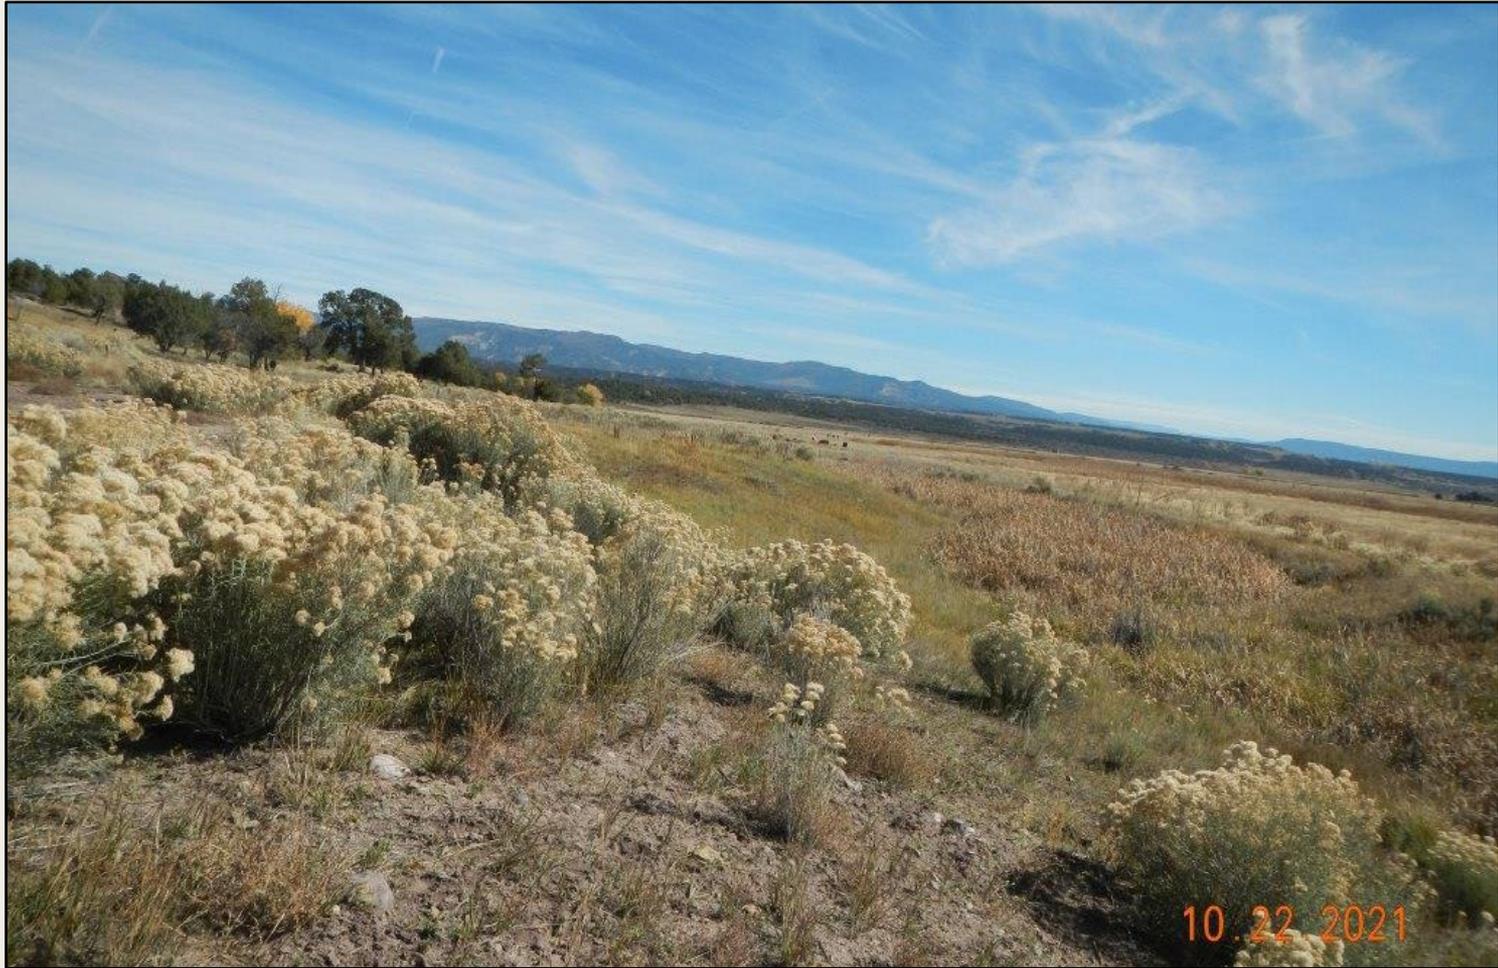
Photo 2. View of the southern fill slope from the southwestern corner facing eastward. Revegetation is progressing with western wheatgrass, ssand dropseed, and rubber rabbitbrush.

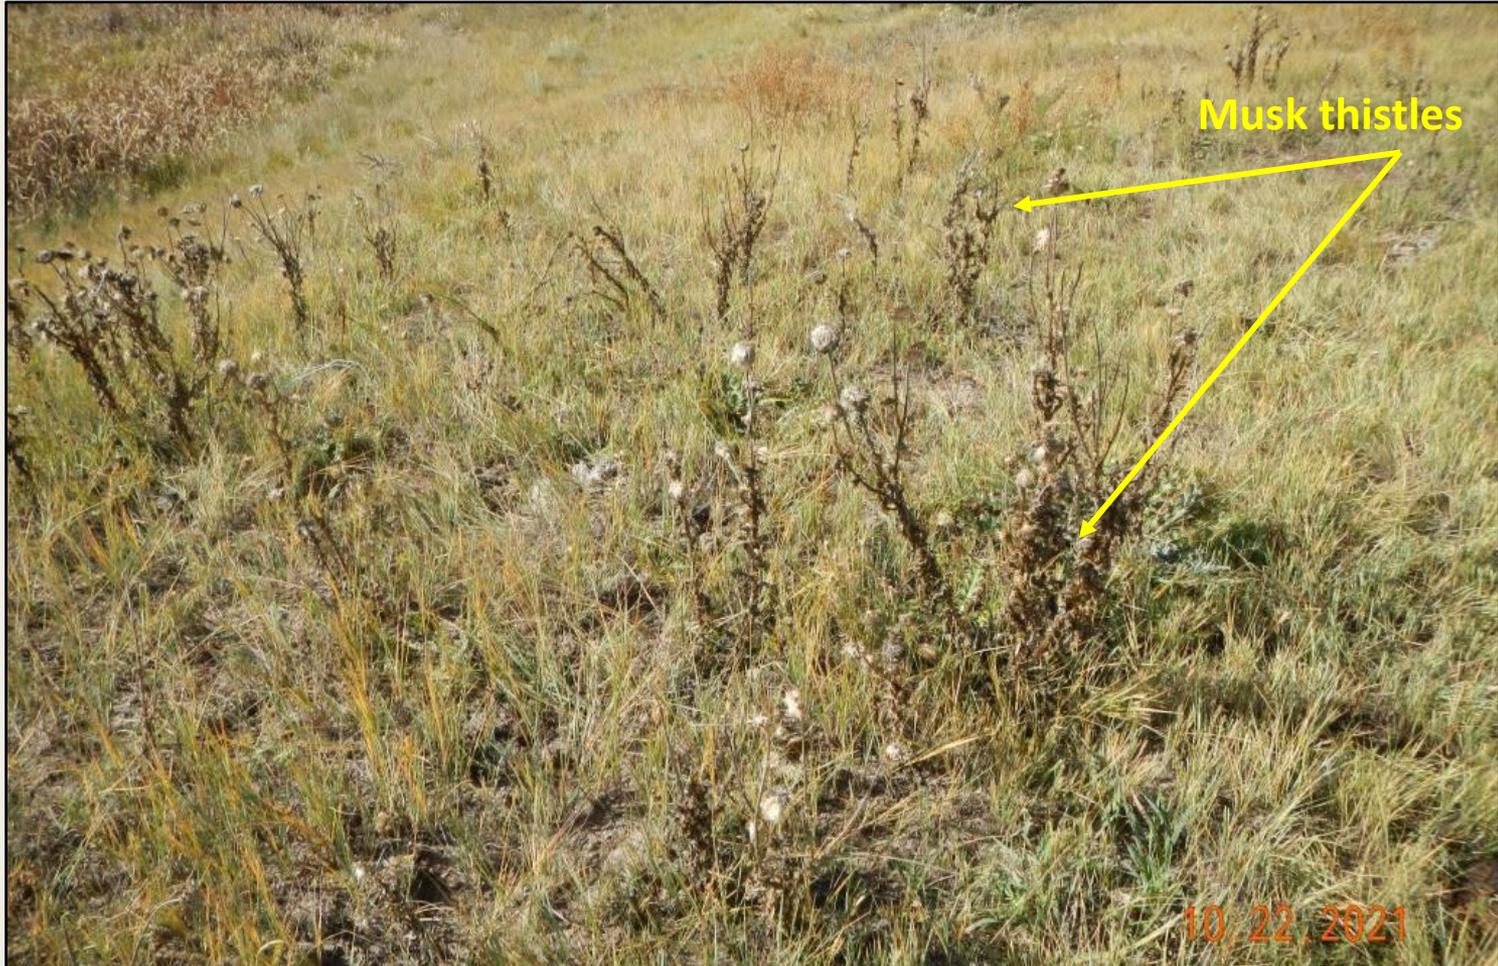
Photo 3. View of musk thistles in post-flowering condition, in the southeastern project area. Approximately 150 individuals observed.

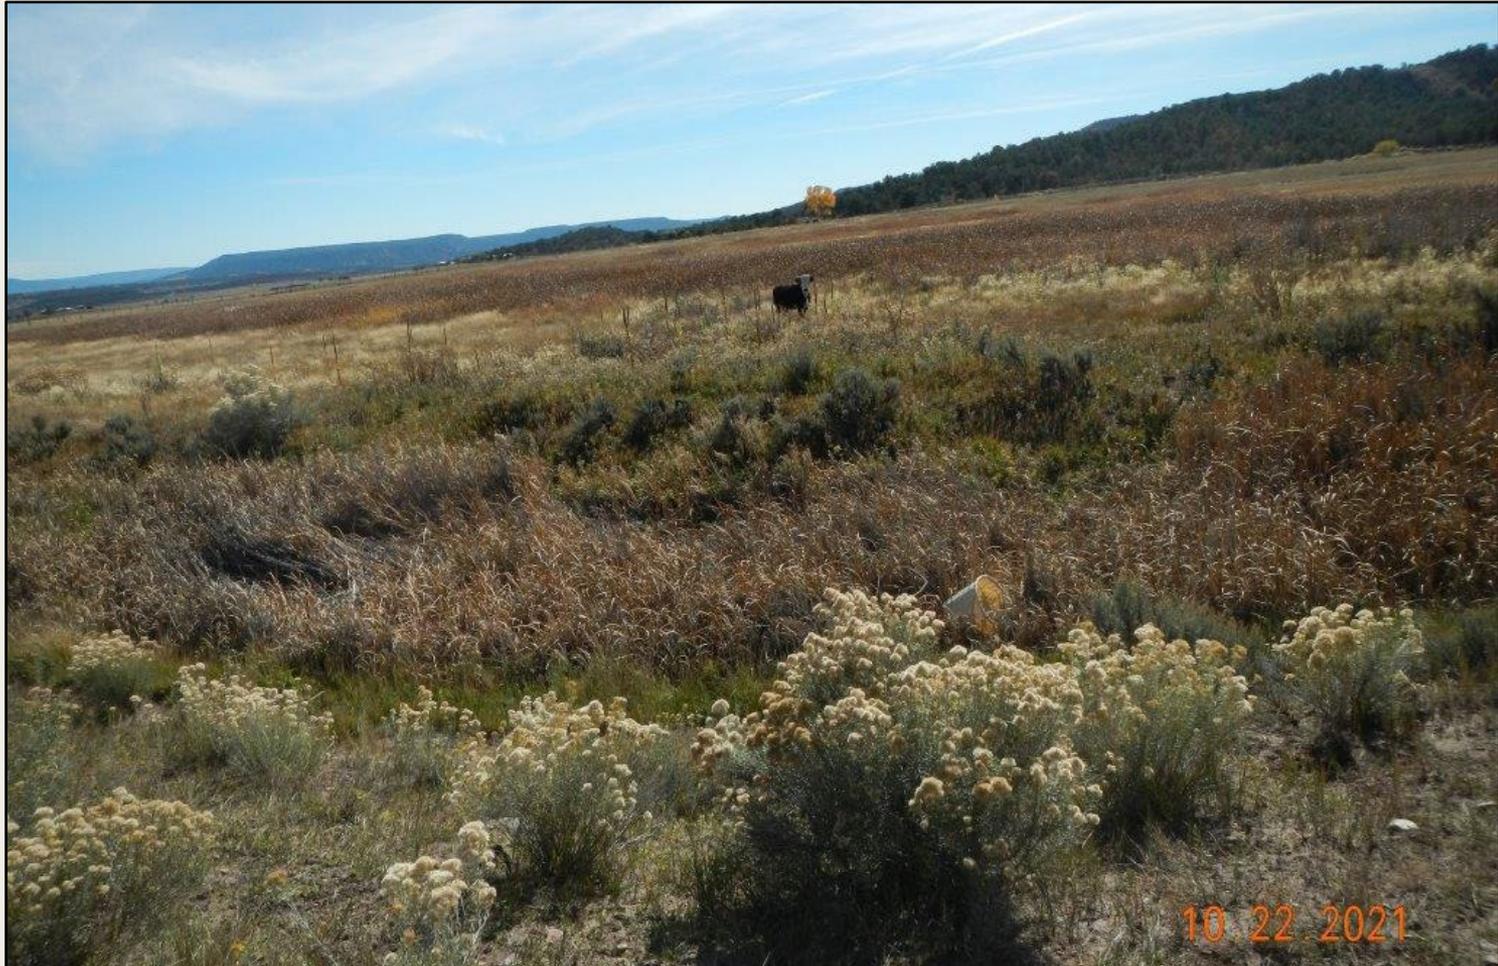
Photo 4. View of the reference area comprised of irrigated grass field with grasses such as smooth brome, orchard grass, and foxtail barley, as well as scattered sagebrush and wetland vegetation such as cattails.
