Inspection Photos

API: 125-06481

Operator: PETRON DEVELOPMENT COMPANY

Inspection Date: 10/25/2021

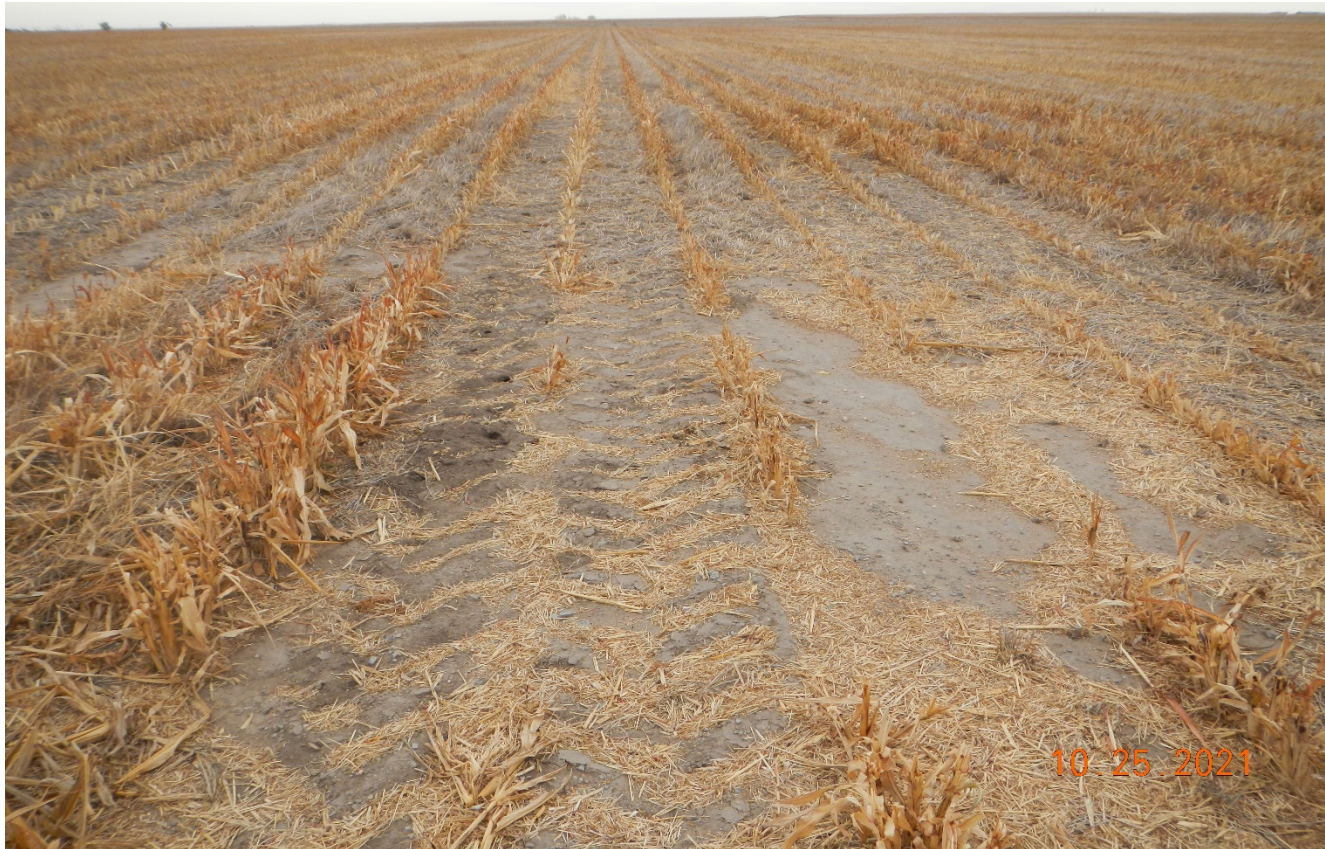
Photo 1. Facing east at the well site. This area at the well site has not re-established a uniform crop cover.

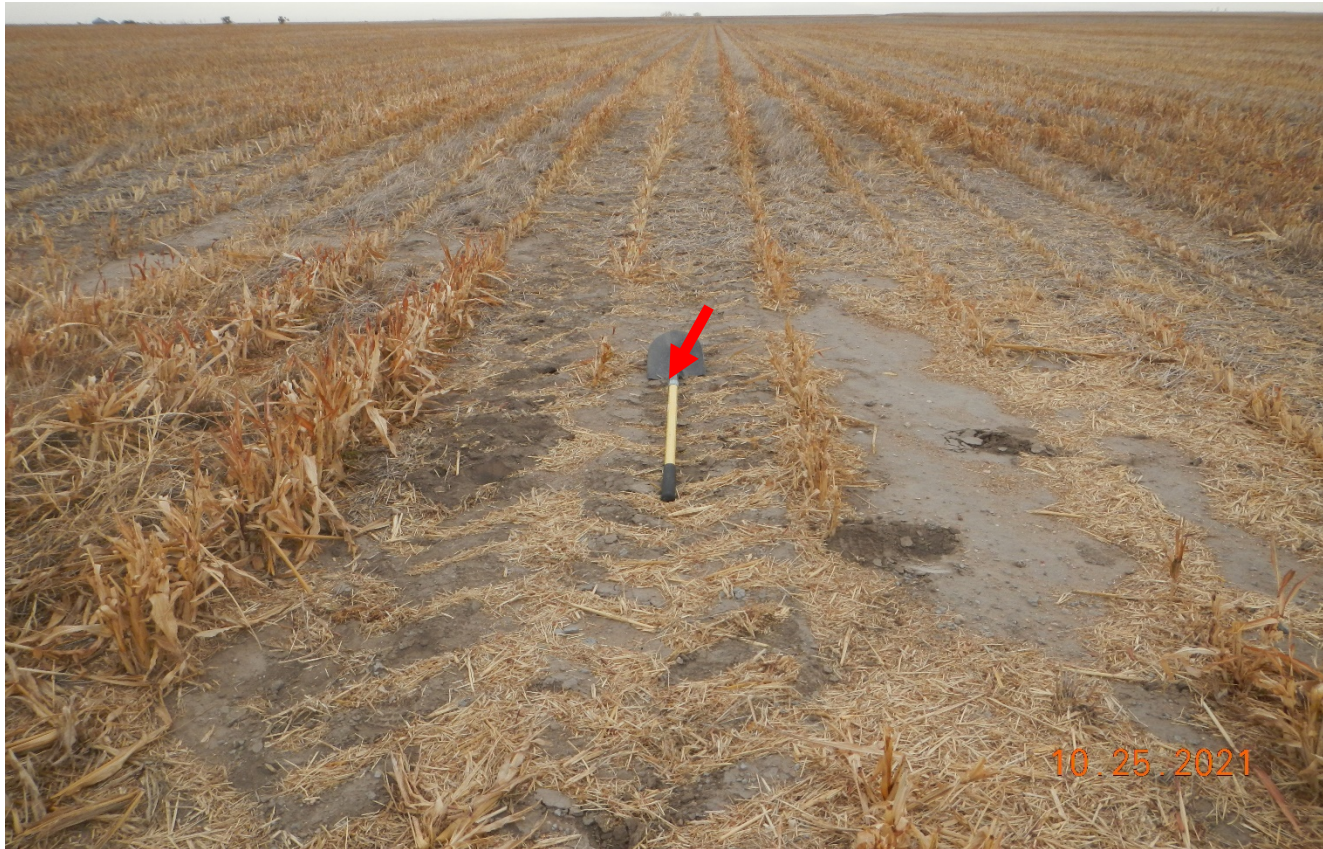
Photo 2. Facing east. The red arrow points to 4.5 ft. shovel for scale. This area of the well site has insufficient crop cover which is approximately 20'x15' in size.

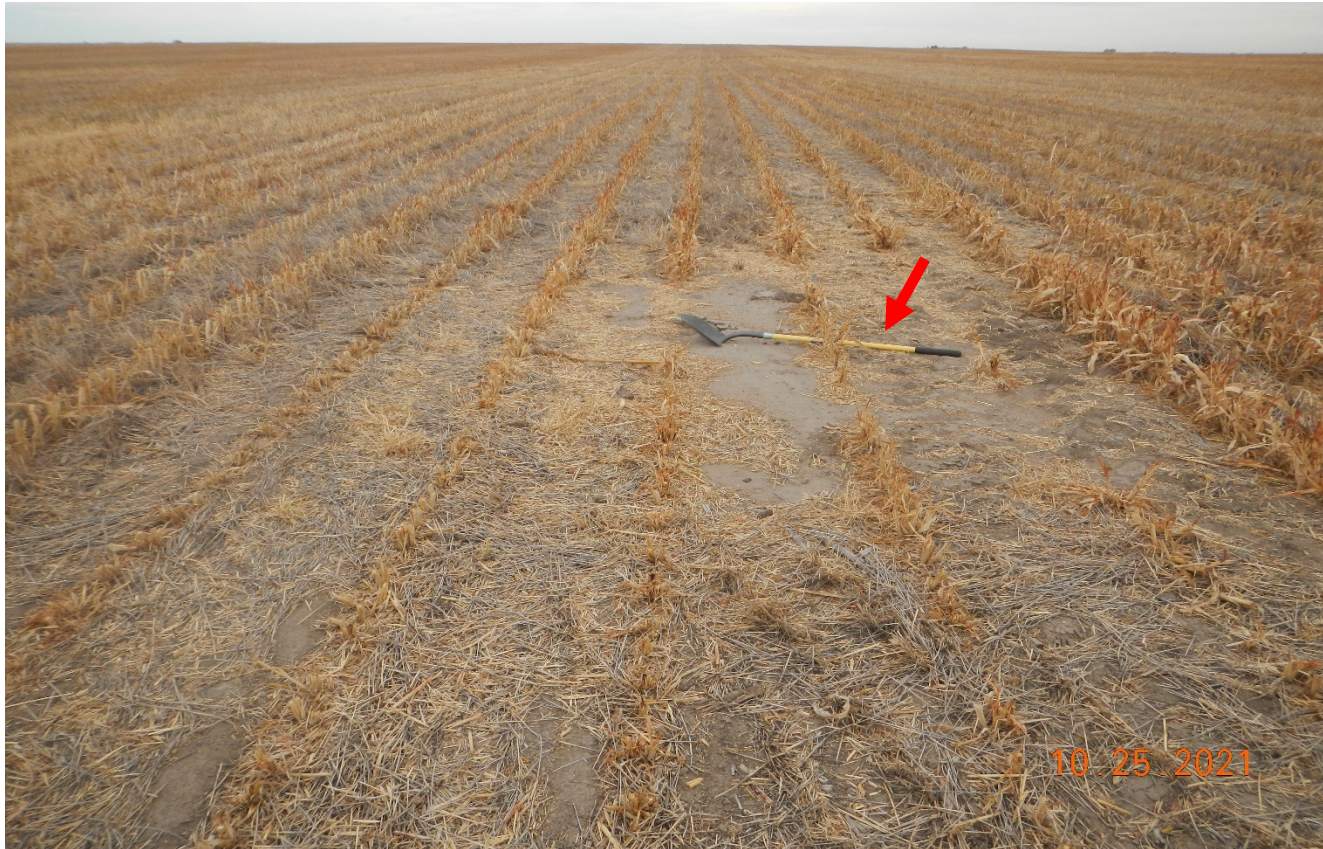
Photo 3. Facing west. The red arrow points to 4.5 ft. shovel for scale. This area of the well site has insufficient crop cover which is approximately 20'x15' in size.

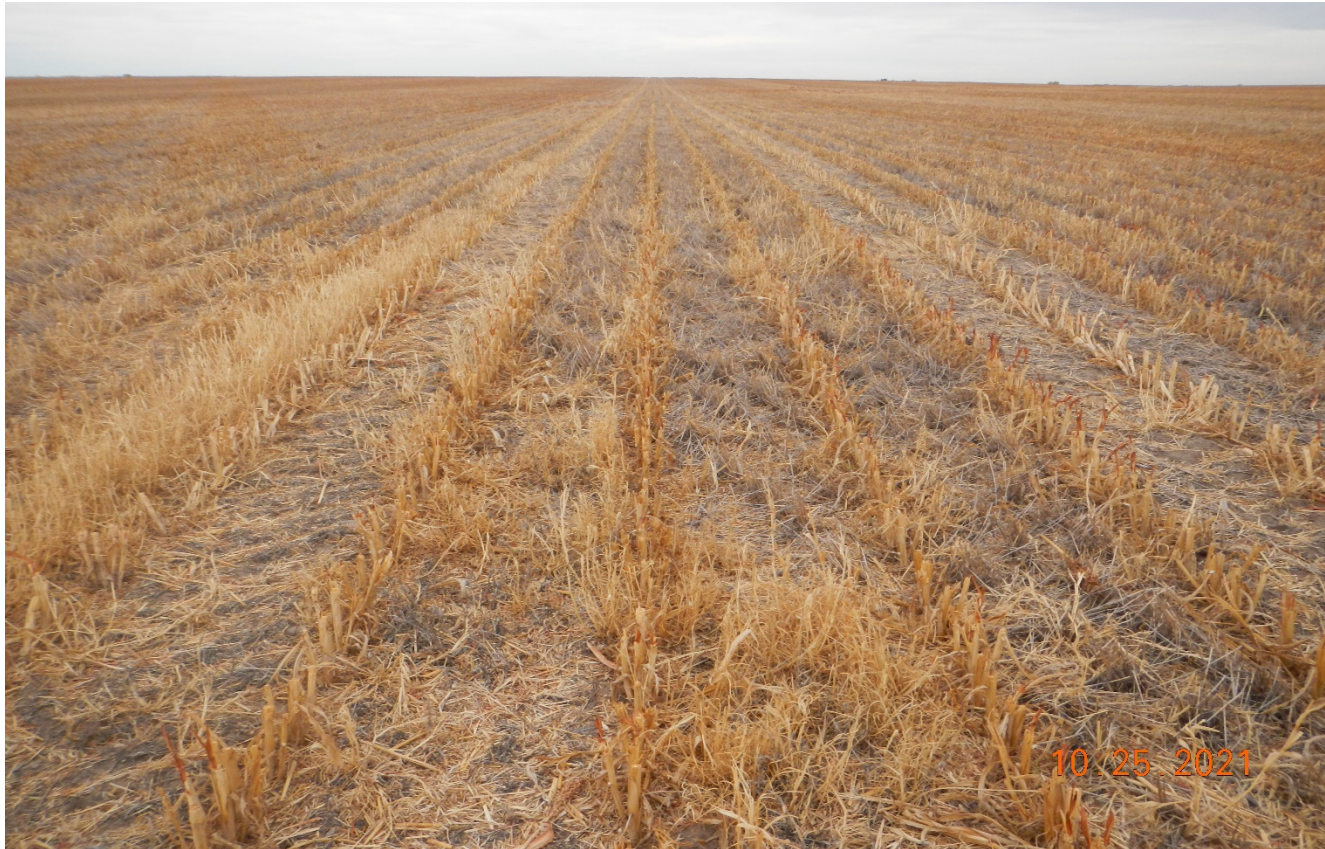
Photo 4. Facing east toward the surrounding undisturbed crop which has uniform crop cover.

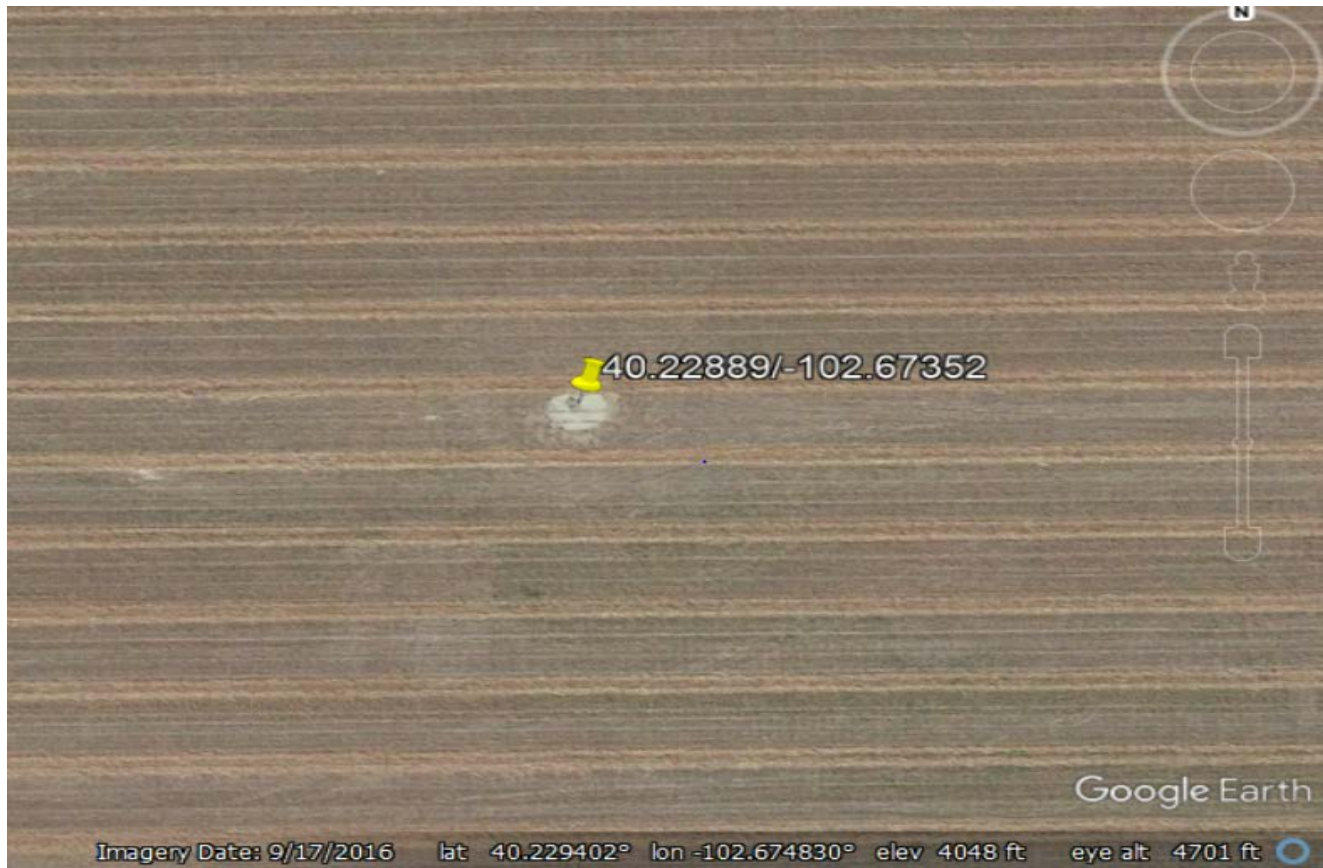
Photo 5. Aerial image shows the area at the well site which has insufficient crop cover shown by the light area.
