## Inspection Photos

Location Name: UPRR 23 PAN AM D 2

Location ID: 319939

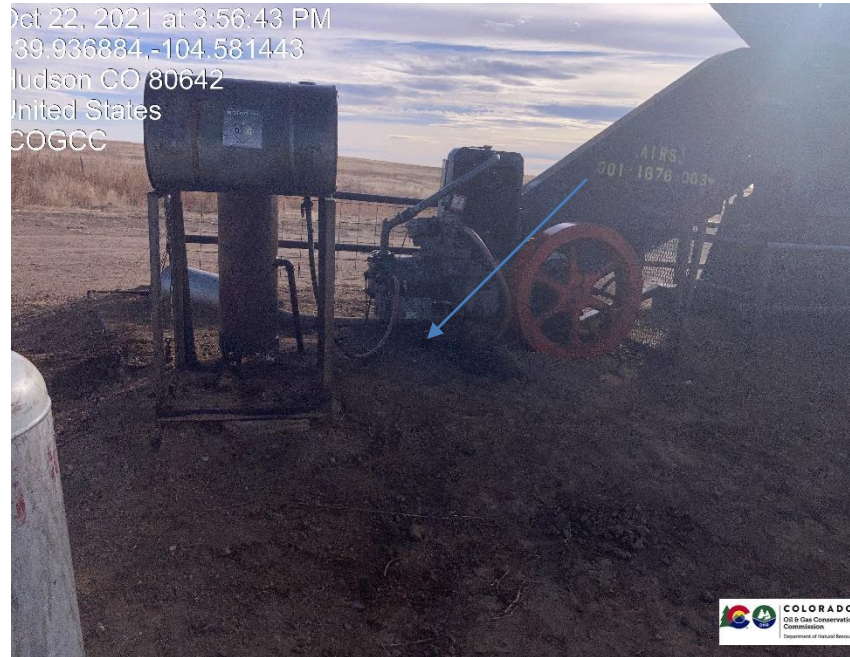
**Pic 1 pumping unit motor, stained soil/mechanical issue**

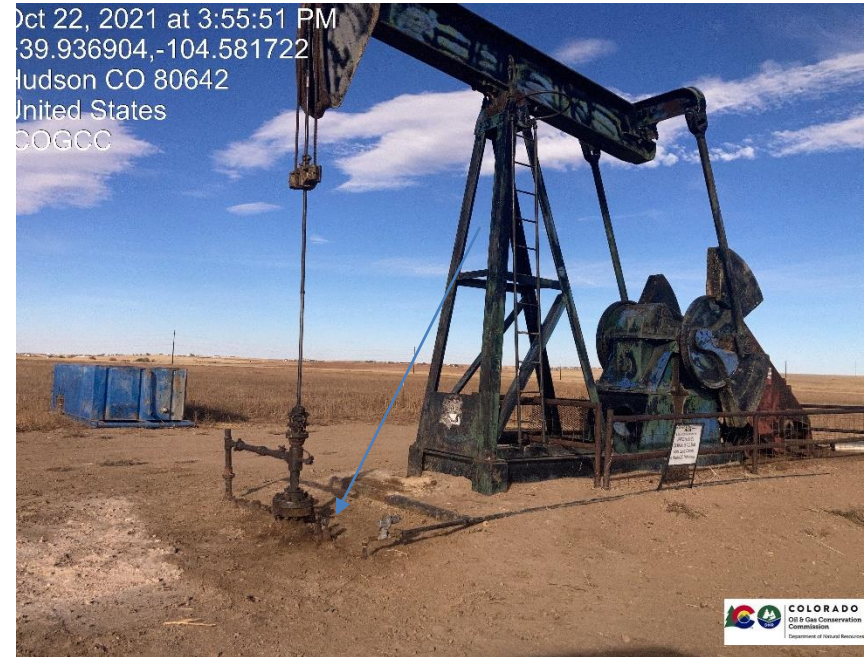
**Pic 2 Pumping unit stained soil next to wellhead**

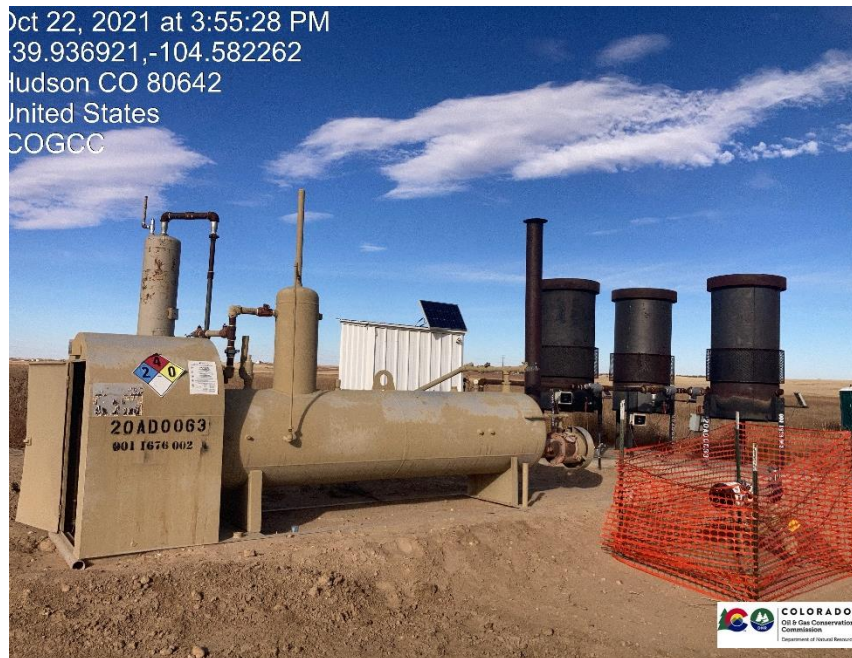
**Pic 3 ECD used to Burn flare gas on location routed from gas meter run on location**
