Inspection Photos

10/25/2021

Operator: TEP ROCKY MOUNTAIN LLC - 96850

Location ID: 480732

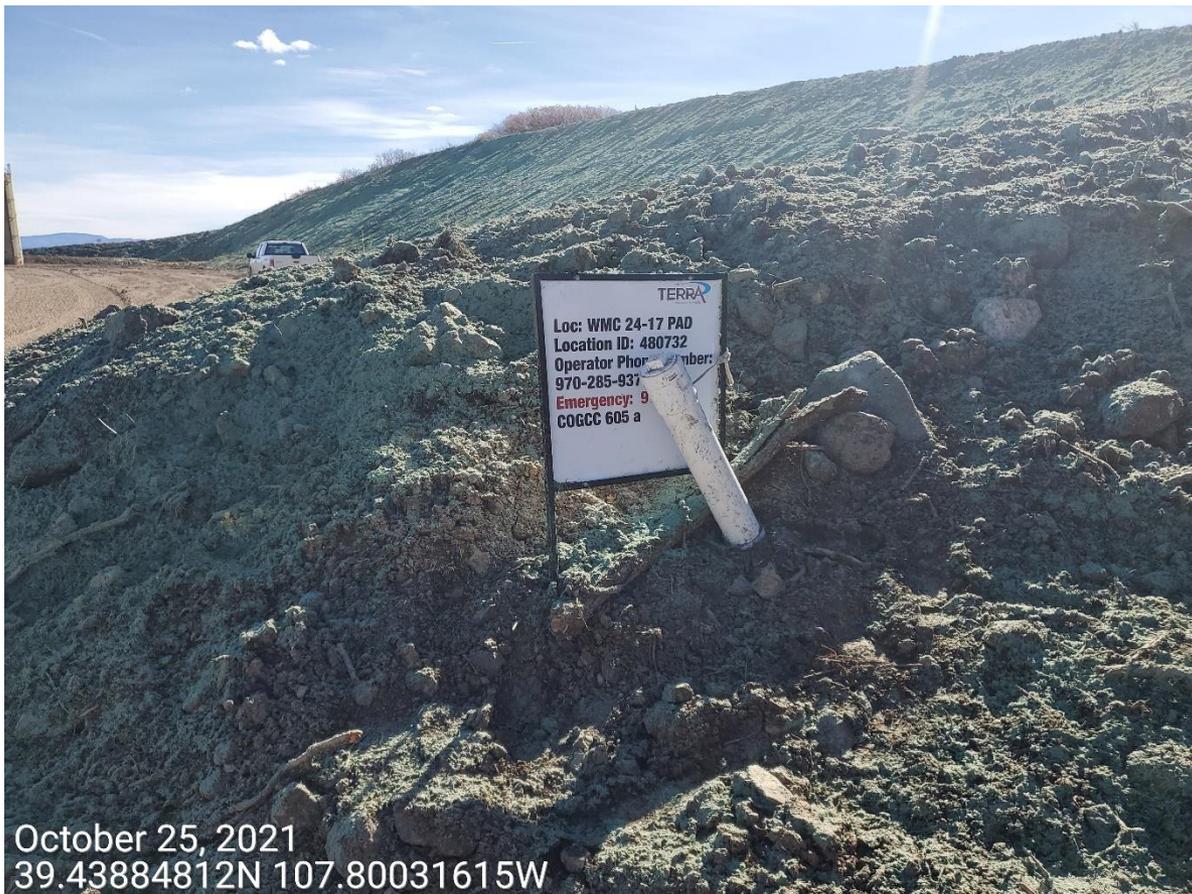
Photo 1: Photo shows signage has been placed at the Location's entrance.

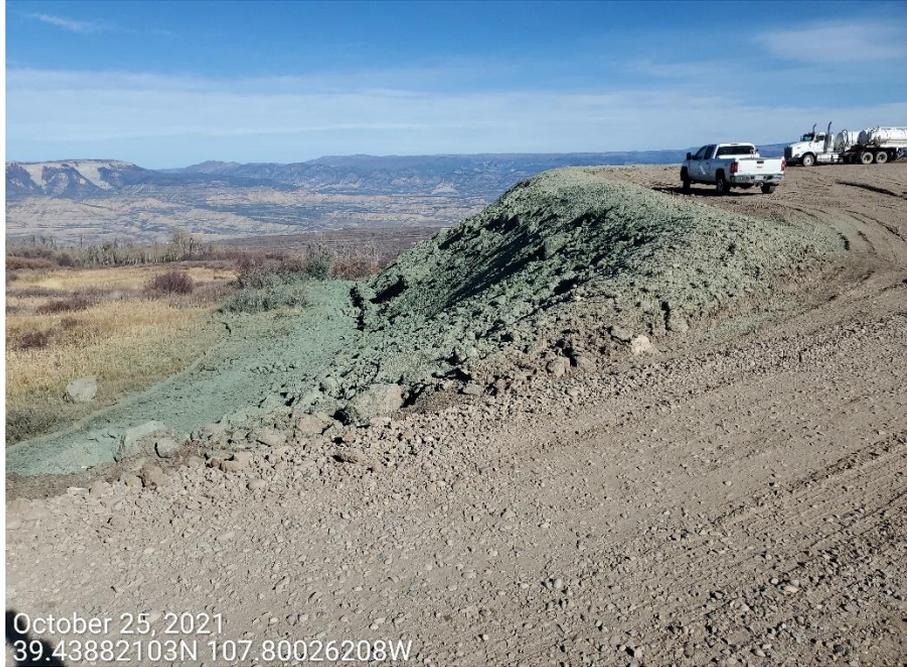
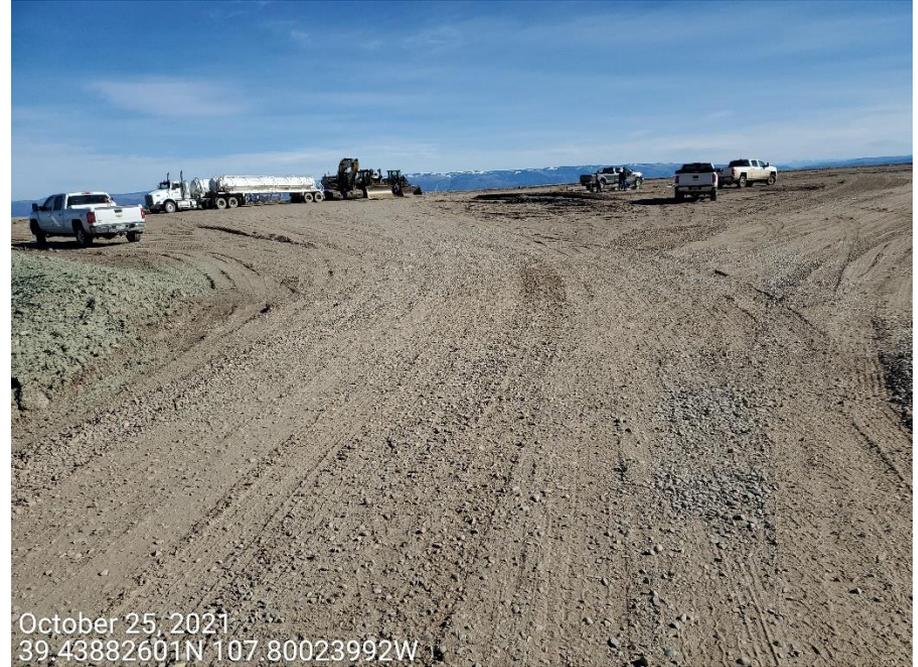
Photo 2: Photos 2-3 taken from the west end of the Location and provide an overview of the site from north, northeast, southeast to south.

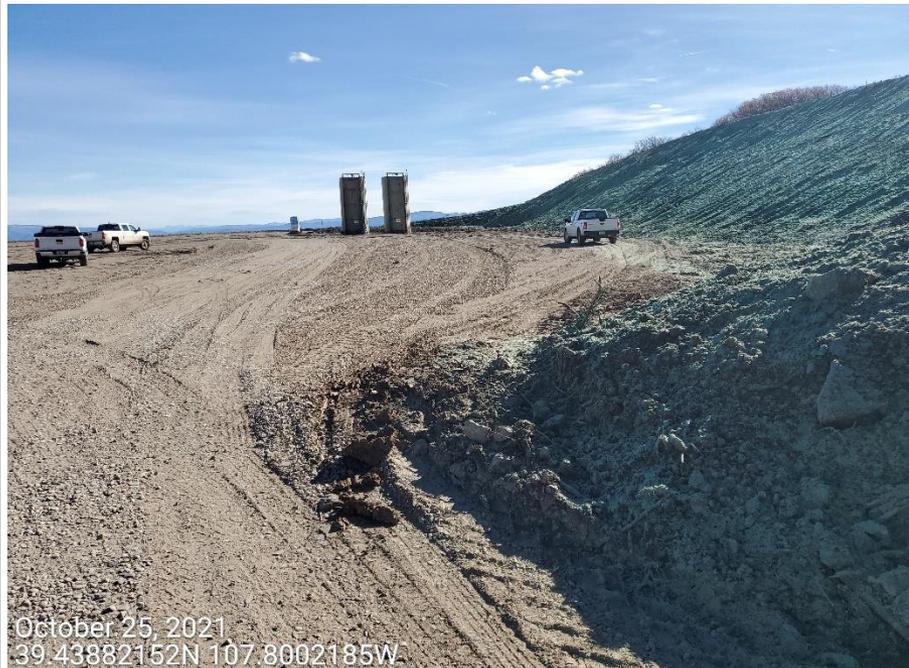
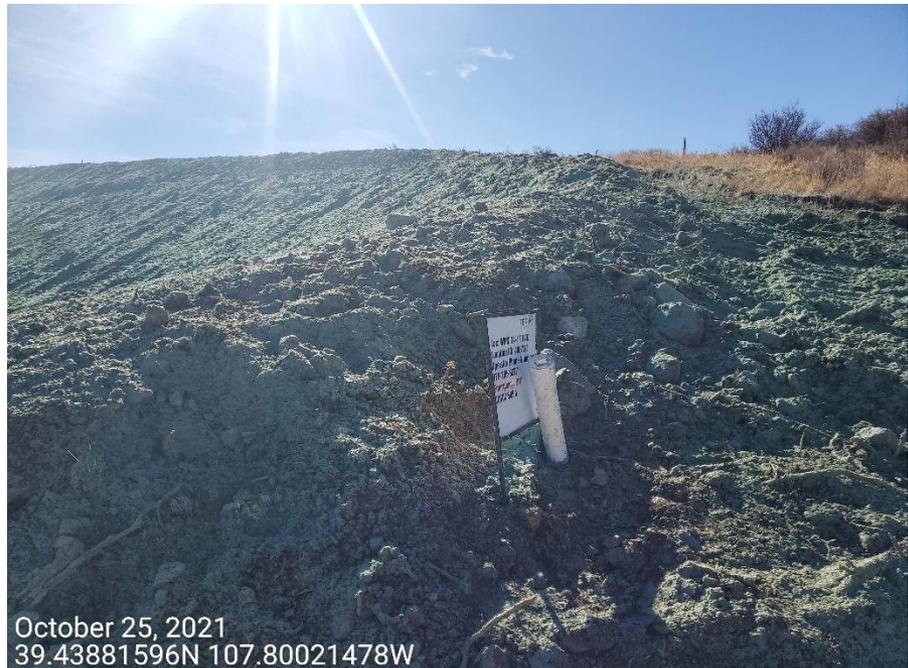
Photo 3: See comments under photo 2.

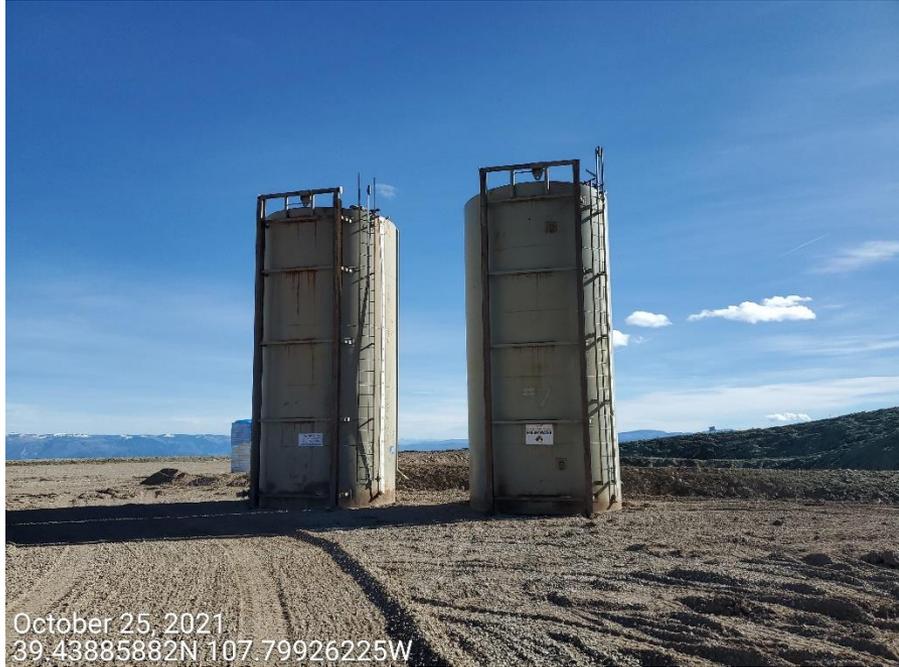
October 25, 2021
39.43885882N 107.79926225W

Photo 4: Photo left shows 2 freshwater tanks brought onto the Location. Photo right shows the cuttings trench/pit on the southwest end of the Location. Pit requires permitting.

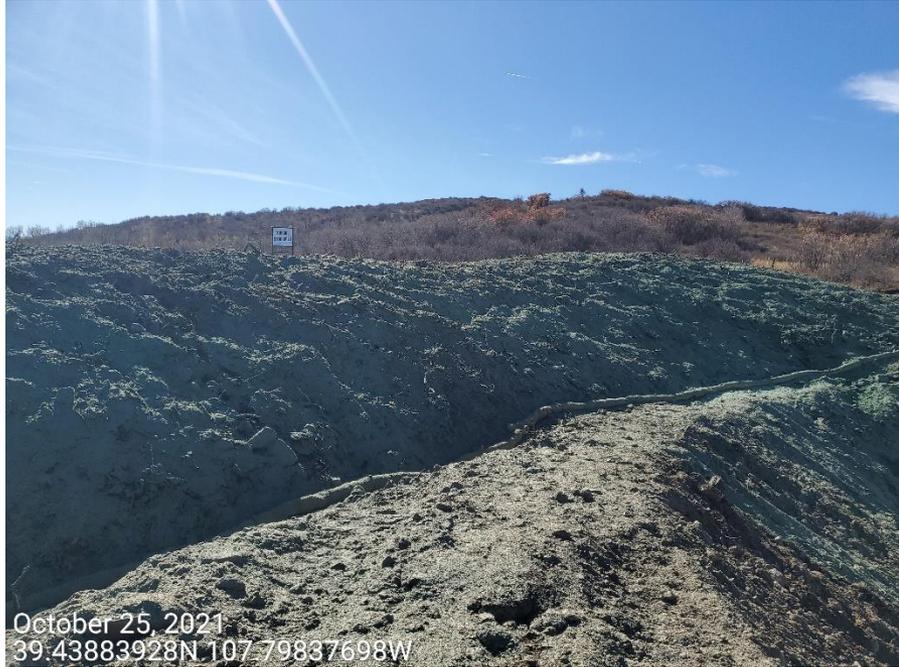
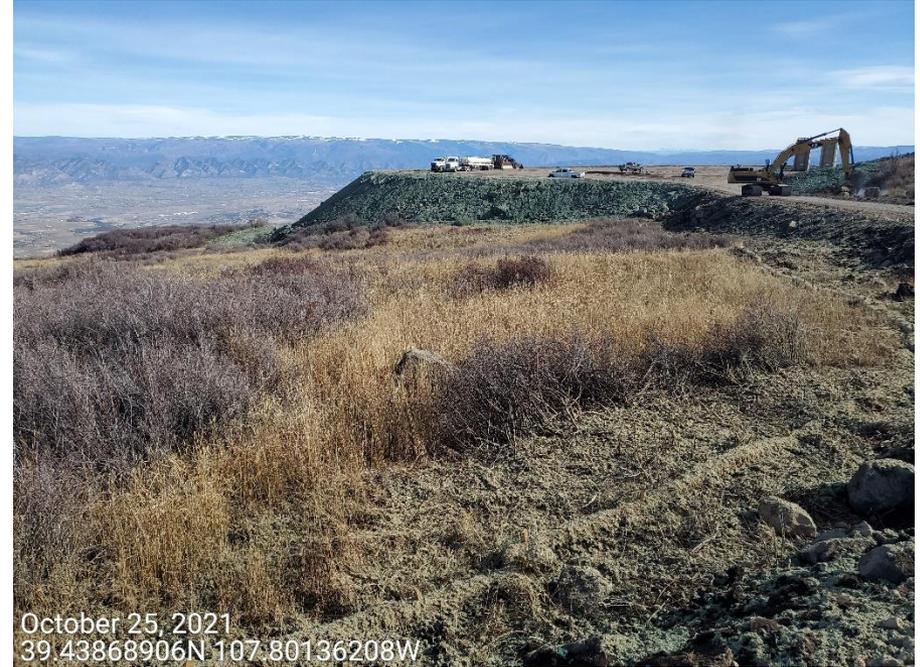
Photo 5: Photos examples showing Operator has implemented a hydro mulch on the cut/fill slopes, and the soil stockpile.

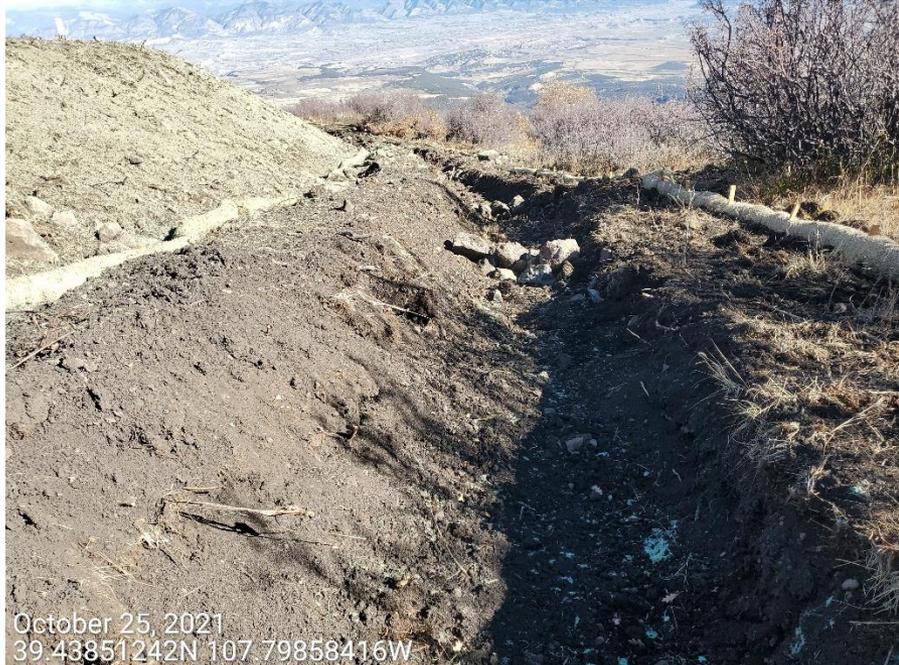
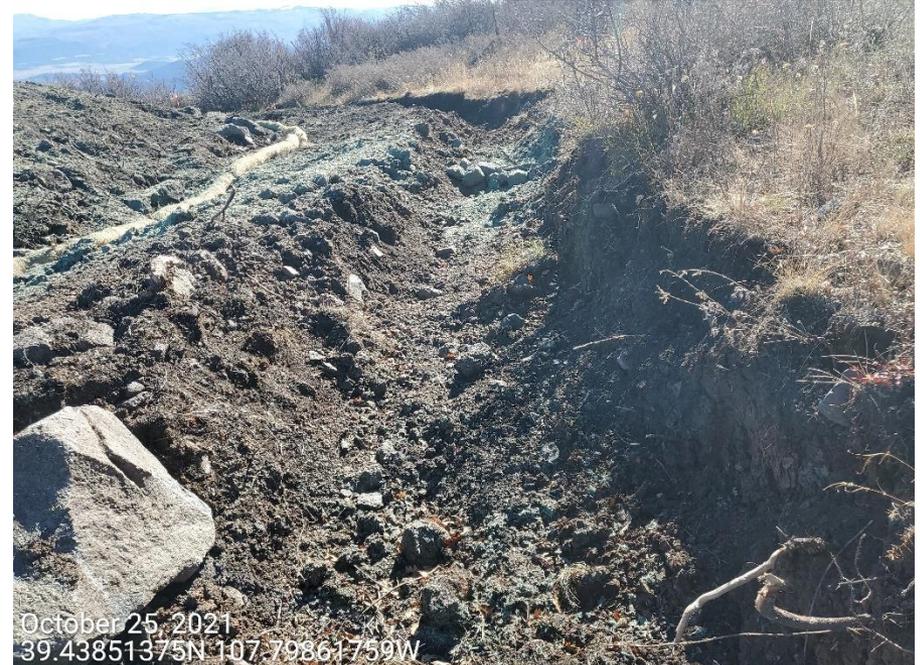
Photo 6. Photos taken from the perimeter stormwater diversion ditch. Photos show that the stormwater diversion ditch has not been constructed in accordance with good engineering practices, and remain improperly constructed with vertical slopes and unconsolidated soils.

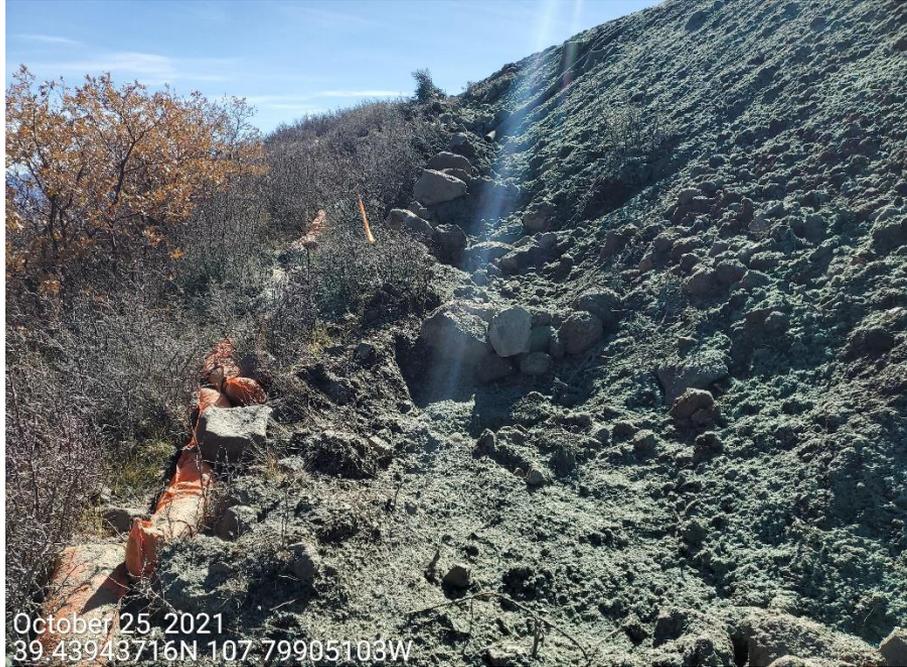
October 25, 2021
39.43943716N 107.79905103W

Photo 7: Photos taken from the perimeter stormwater diversion ditch. Photos show that the stormwater diversion ditch has not been constructed in accordance with good engineering practices, and remain improperly constructed with vertical slopes. There are areas where hydromulch has been applied to the ditch; hydromulch is an inadequate control to stabilize soils in areas that receive concentrated flows. Photo on the right shows soils remain unconsolidated within the ditch.

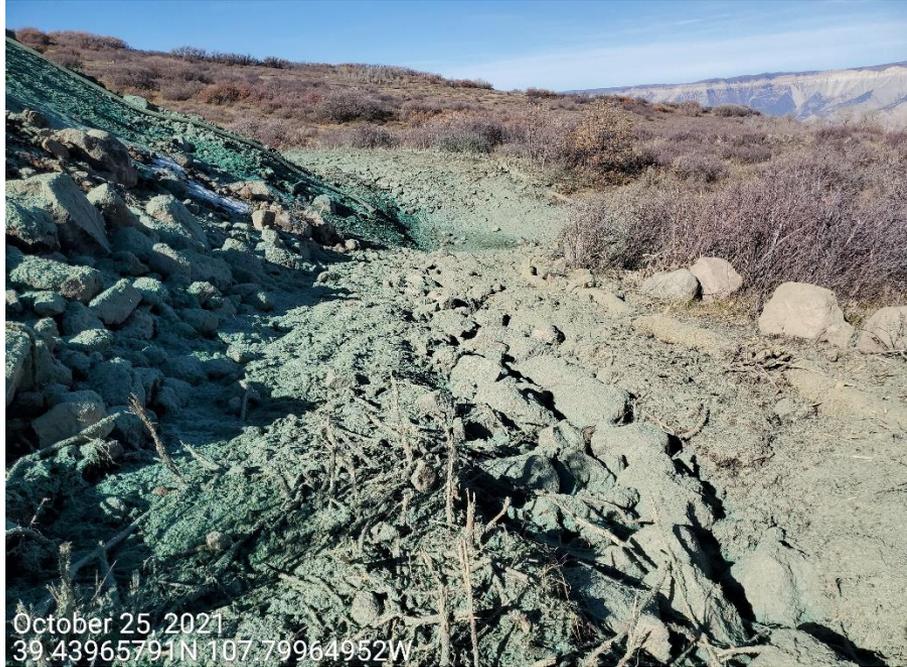
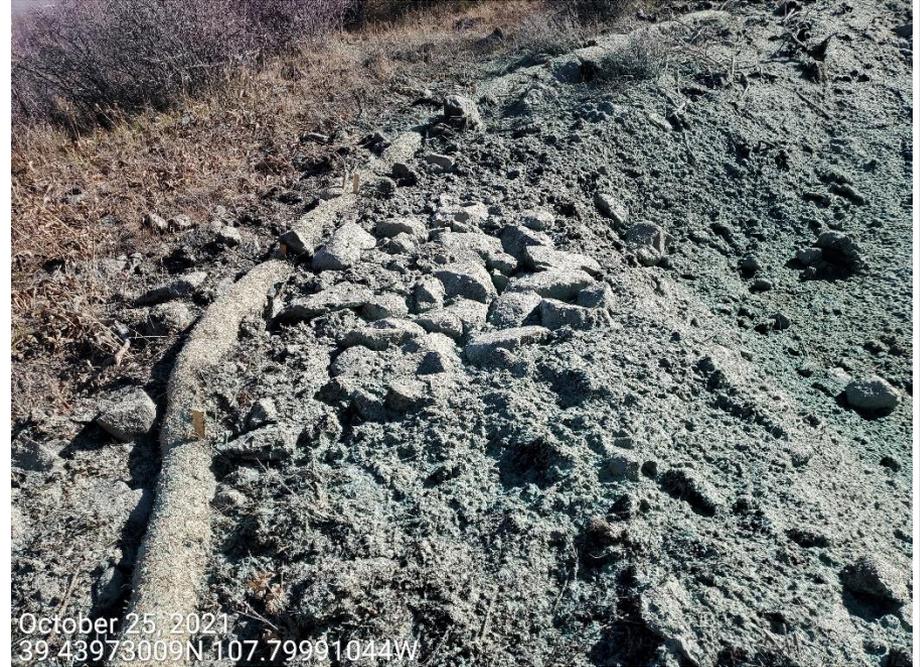
Photo 8: Photos examples showing the sediment traps on the northwest end of the Location. Sediment trap control measures remain unchanged since previous inspection. It is unclear if traps are appropriate in size to manage runoff from the drainage area of the pad and upslope undisturbed areas. Geotextile lining not observed at inlet/outlet.

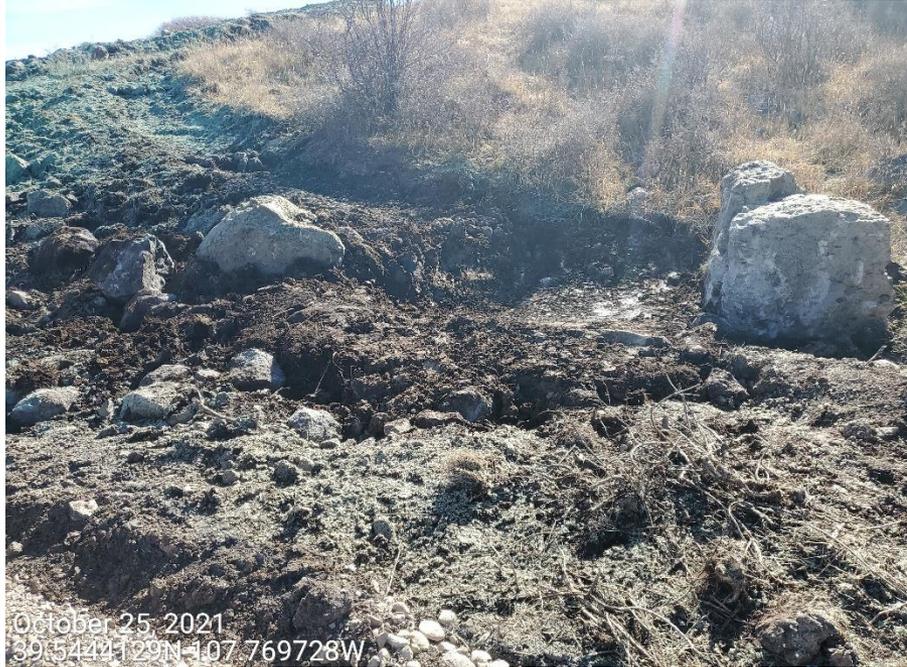
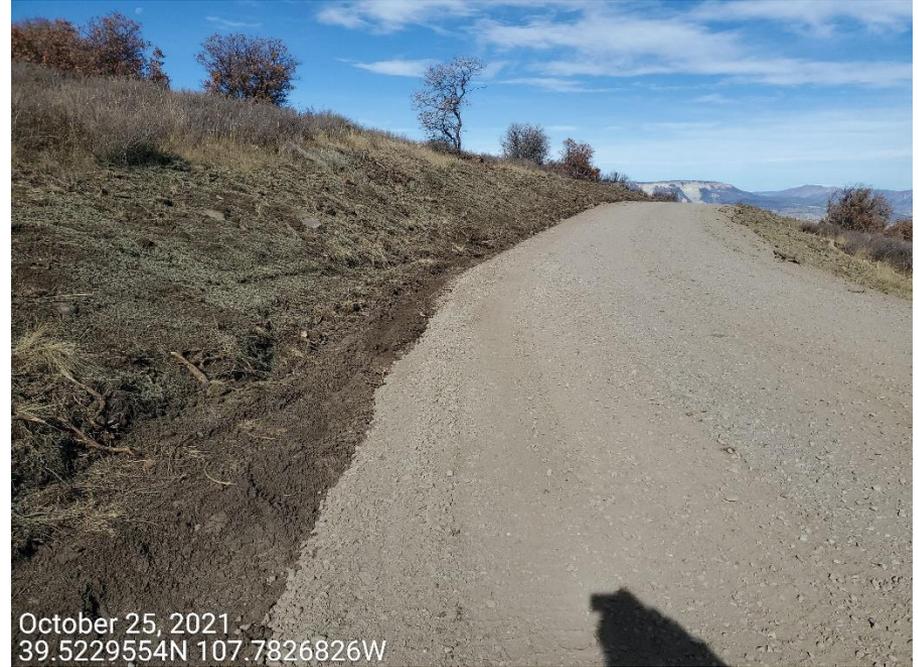
Photo 9: Photo left shows Operator in process of constructing (what appears to be) a sediment trap at the ditch on the southwest end of the Location. Photo right provides example showing hydromulch has been applied along the access road.
