# Inspection Photos

10/25/2021

Operator: TEP ROCKY MOUNTAIN LLC #  
96850

Location ID: 452011  
Garfield County, CO

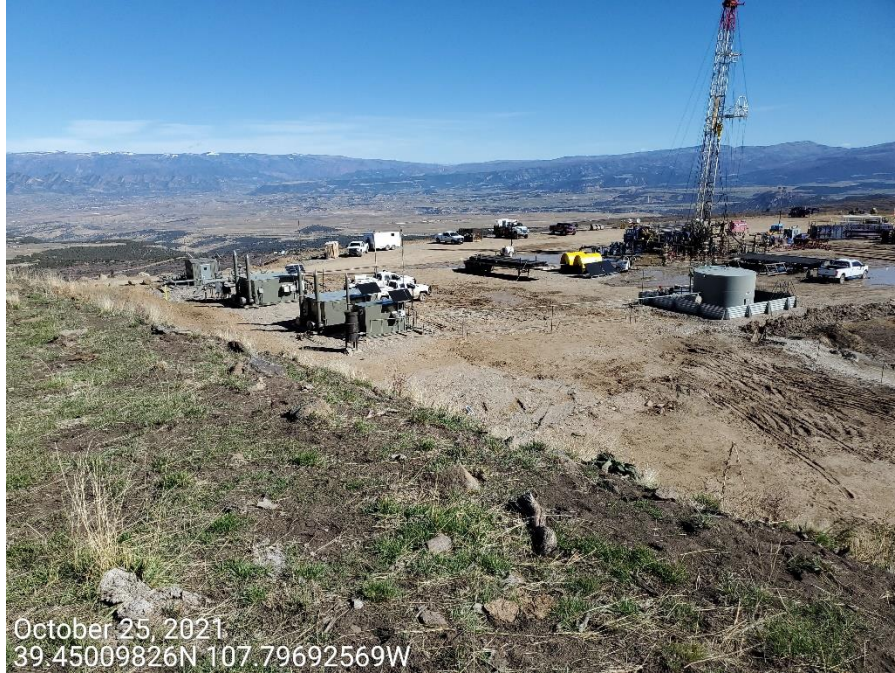
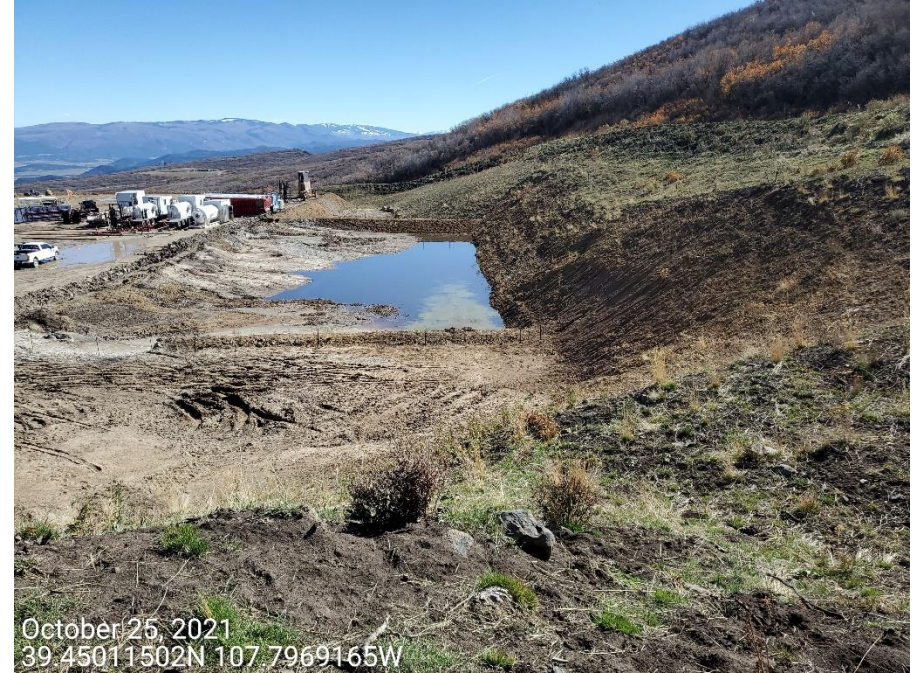
**Photo 1:** Photos taken from the western corner of the Location. Photos provide an overview of the Location from northeast to southeast. Completion operations observed “in process” during inspection.

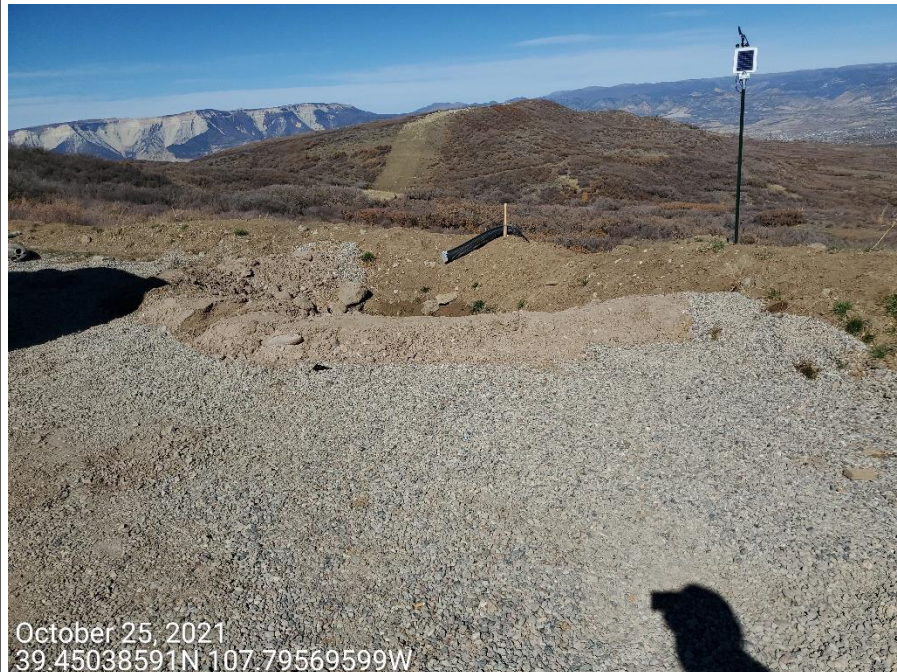
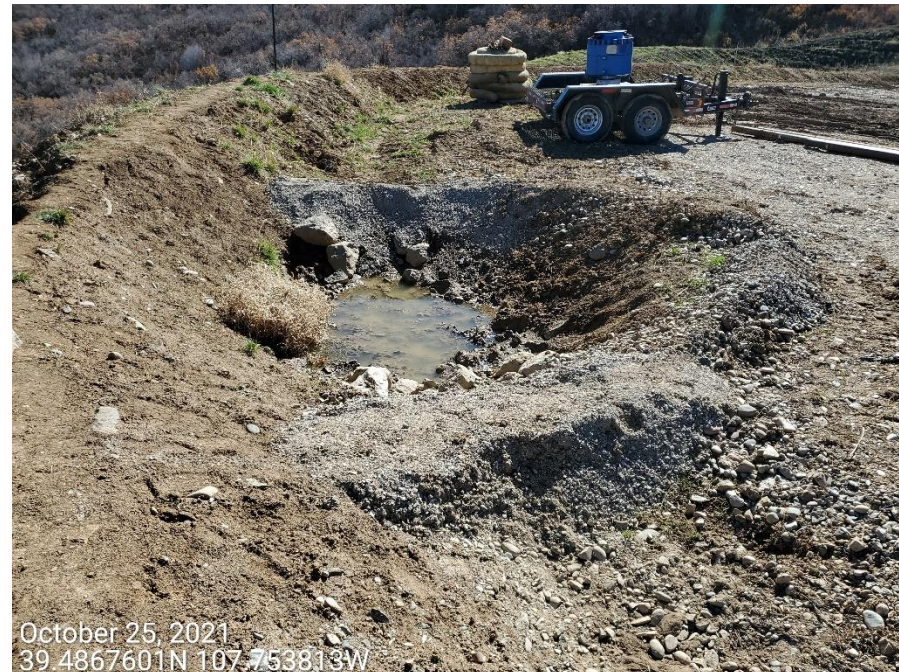
**Photo 2:** Photos provide example of the sediment traps observed on the northern and perimeter of the working pad area. Photos show control measures have not been installed or maintained in proper functioning condition; a berm has been installed at the inlet rendering the traps inoperable.

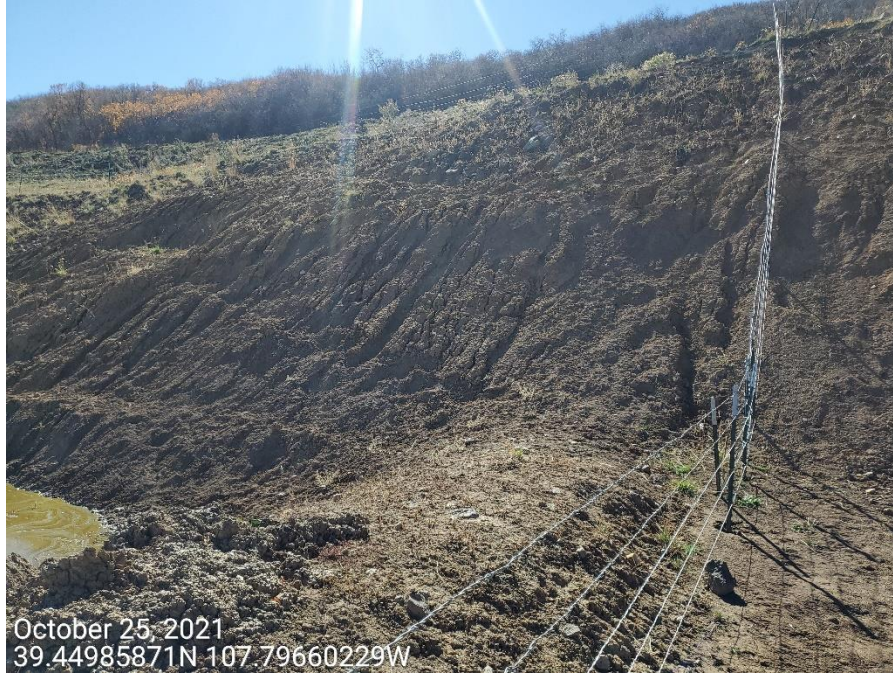
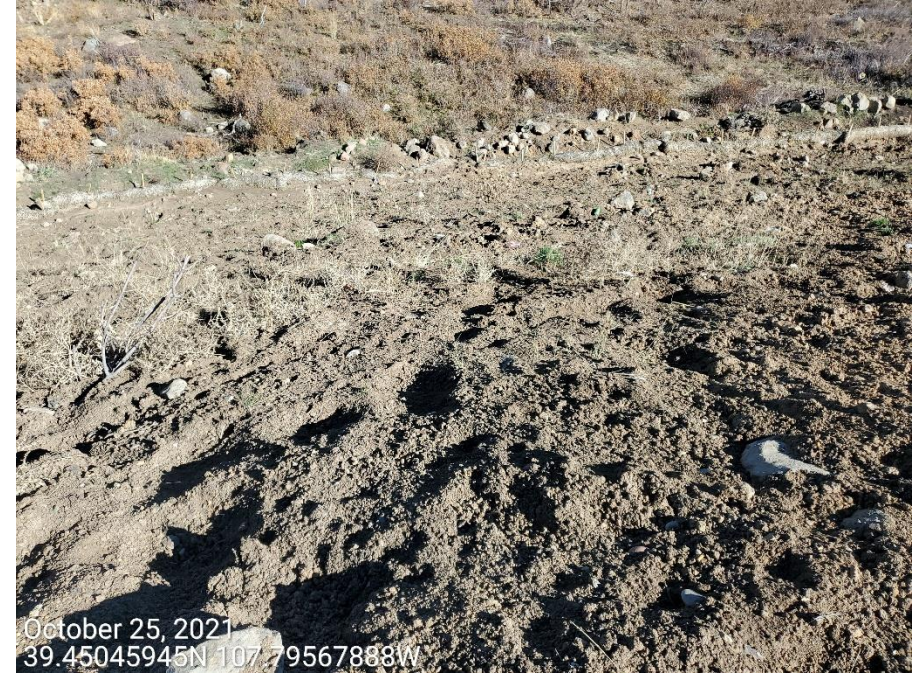
**Photo 3:** Photos provide examples showing control measures to protect and stabilize the cut (photo left) and fill (photo right) slopes are missing or insufficient.

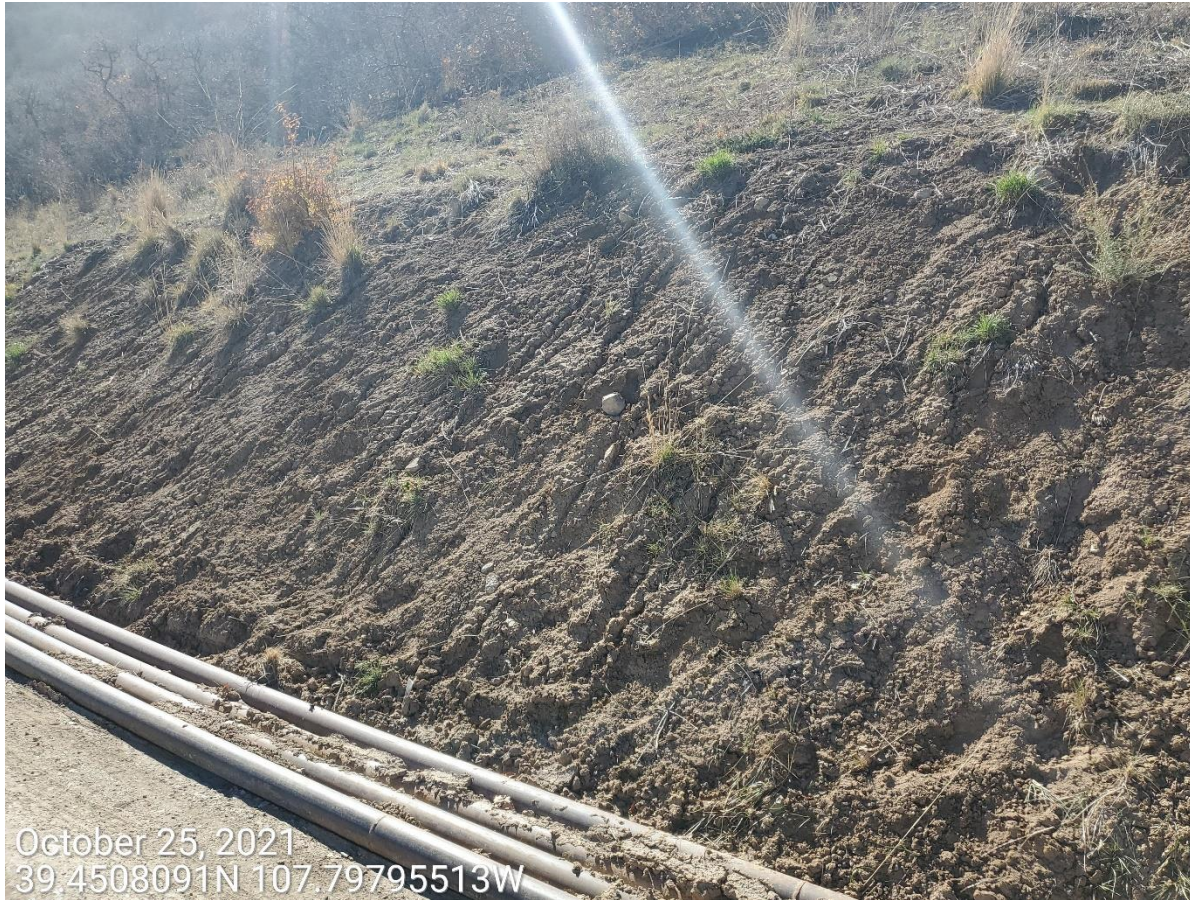
**Photo 3.a:** Photo shows control measures to protect and stabilize the cut slopes along the access road are missing or insufficient.

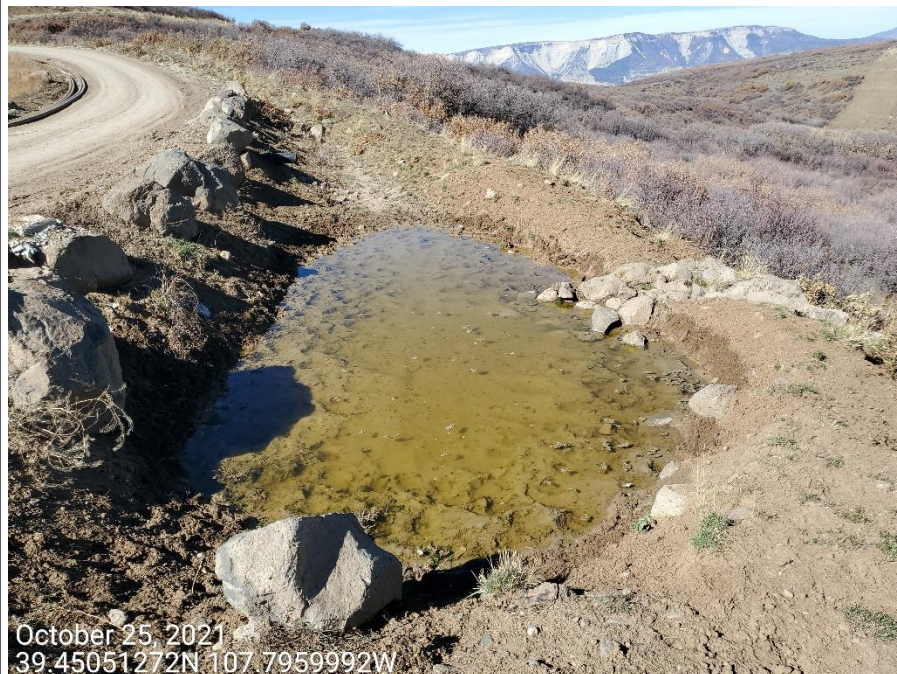
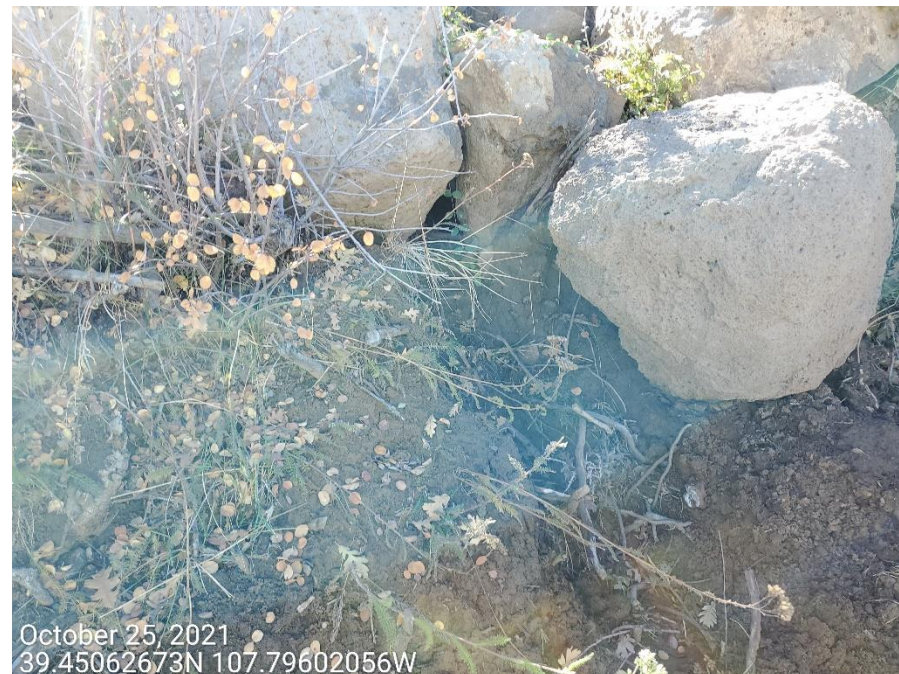
**Photo 4:** Photos taken from the sediment trap at the Location entrance (west end of the Location). Control has not been constructed with and appropriate inlet/outlet per good engineering practices; geotextile lining not observed; erosion degradation under/around rip-rap material evident (photo right); offsite erosion degradation and sediment transport observed below outlet.

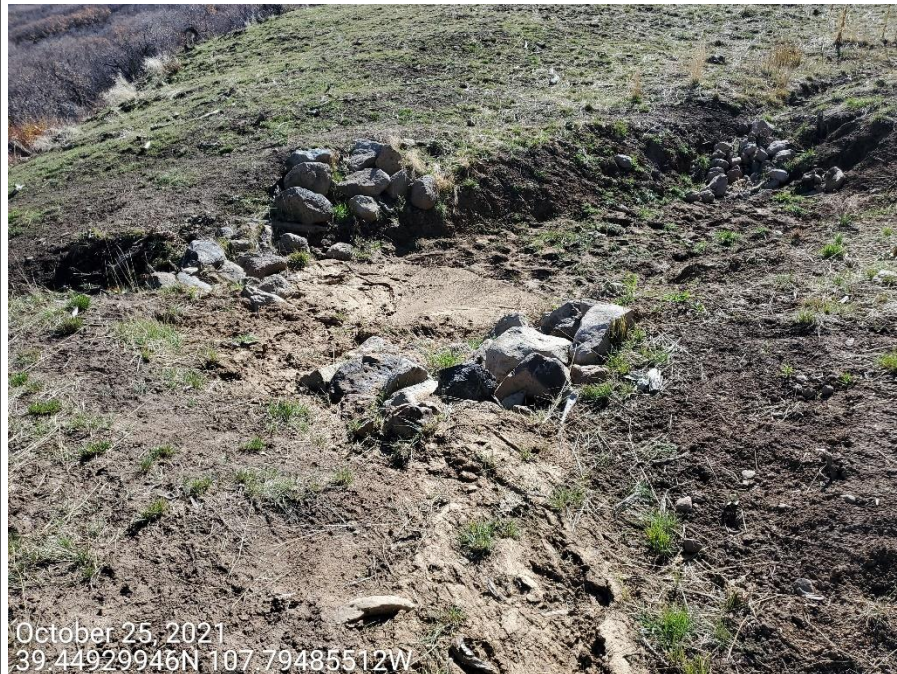
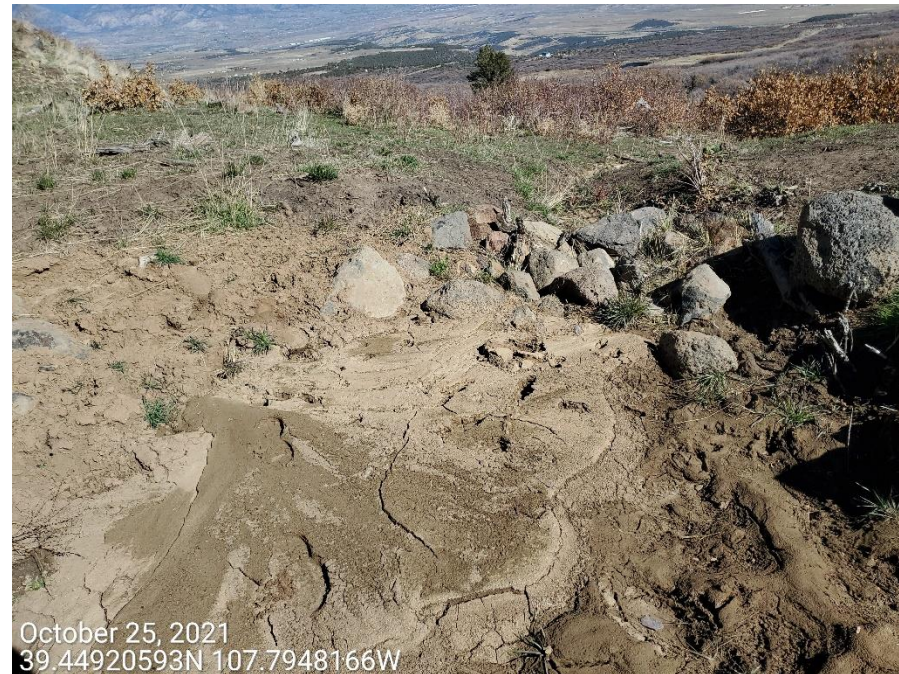
**Photo 5:** Photos taken from the sediment trap on the east end of the Location. Control has not been constructed with and appropriate inlet/outlet per good engineering practices; geotextile lining not observed; erosion degradation under/around rip-rap material evident (photo right); offsite erosion degradation and sediment transport observed below outlet.

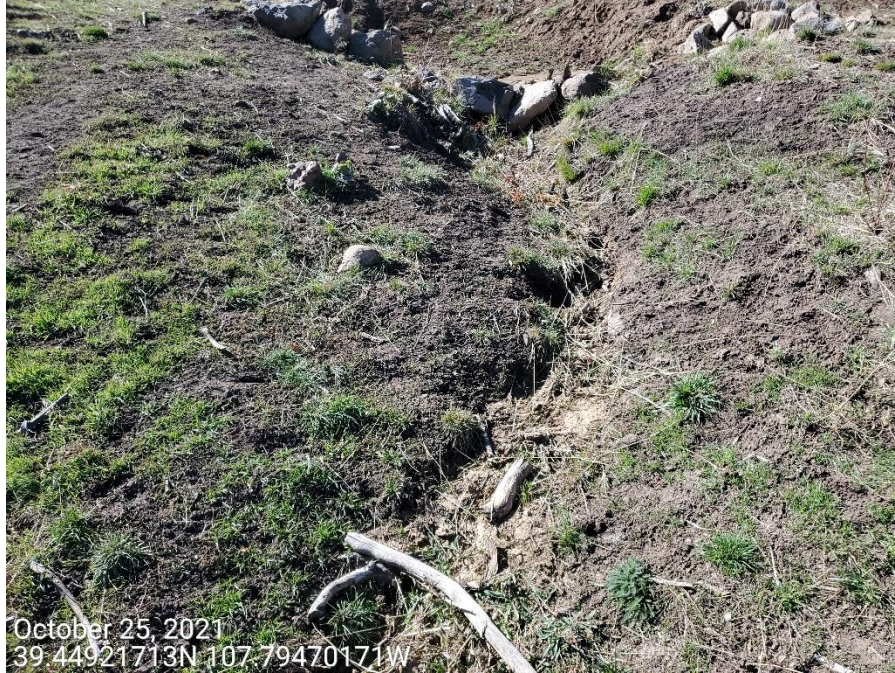
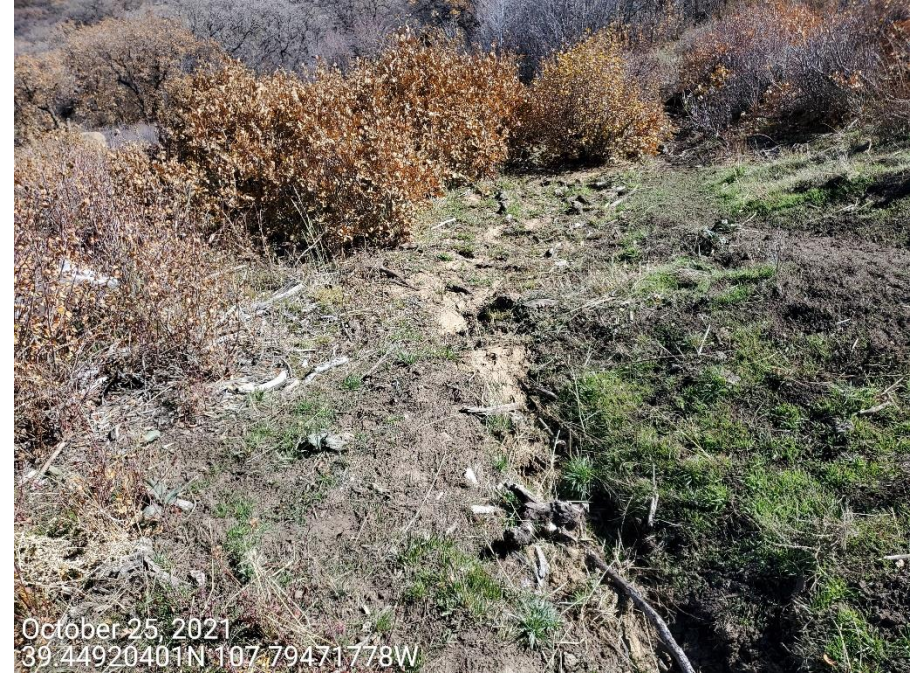
**Photo 6.** Continued from photo 5. Photo shows stormwater erosion degradation and offsite sediment transport below the sediment trap outlet.

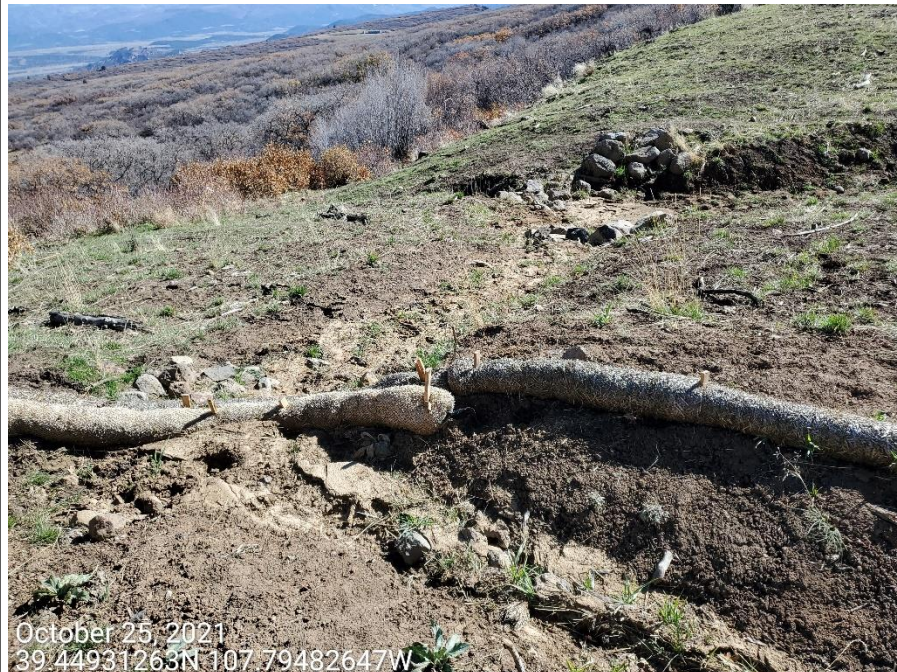
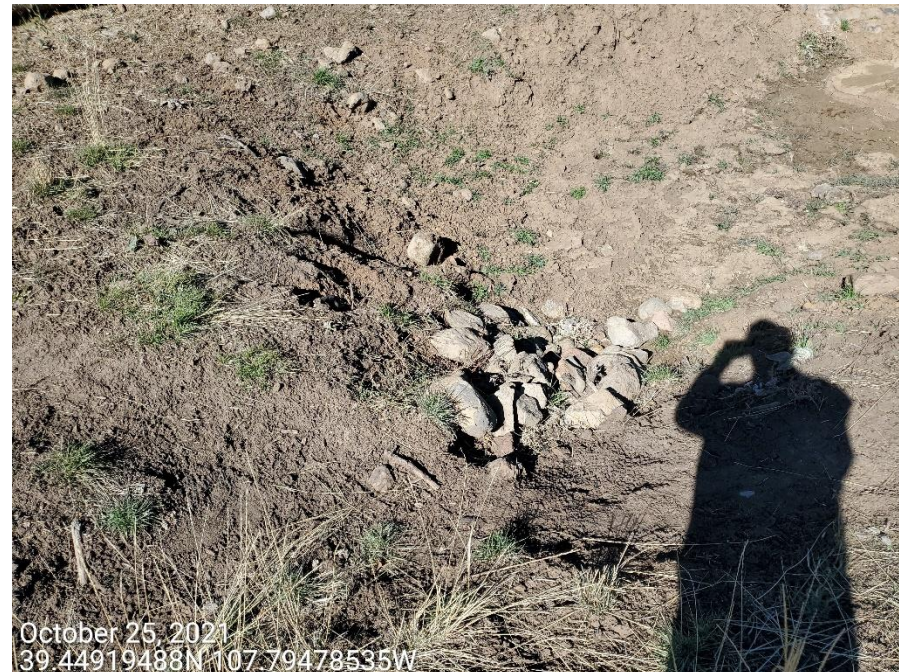
**Photo 7:** Continue from photo 5. Photo shows the to “inlets” at the sediment trap; inlets have not been installed in accordance with good endangering practices, or maintained in proper functioning condition.

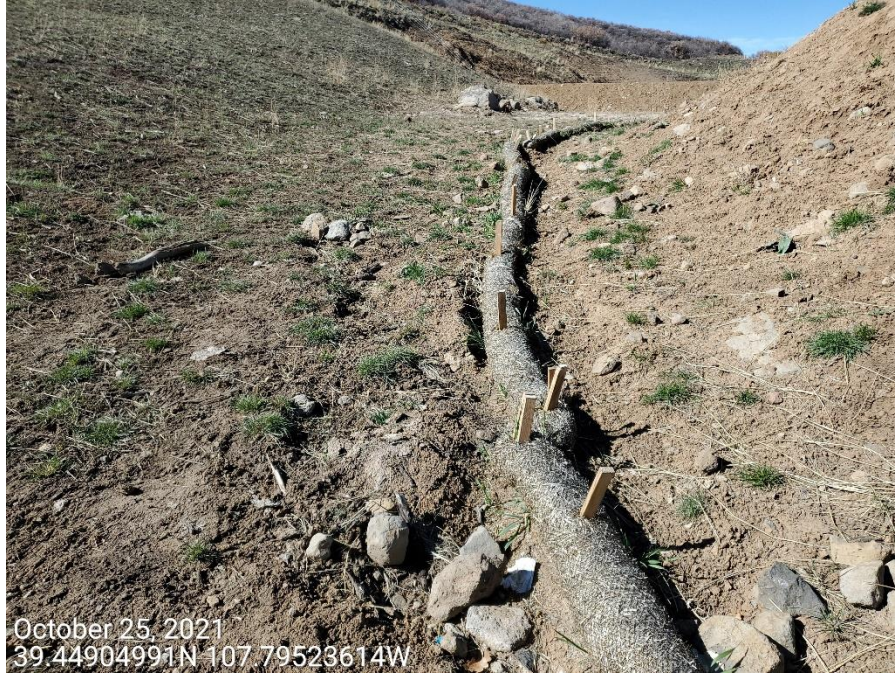
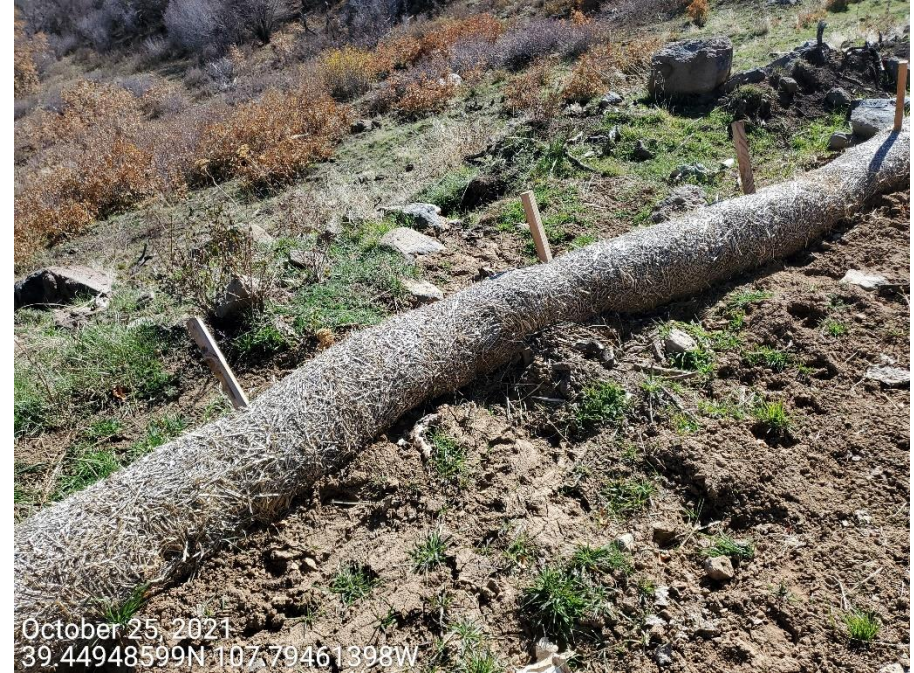
**Photo 8:** Photos provide examples of the single straw wattle erosion log installed along the perimeter of the Location, and at the toe of the fill slopes. Wattle alone inadequate to properly manage runoff from the entire Location, and to allow for sediment laden-free stormwater discharge; wattle observed to be in disrepair along several sections, resulting in offsite sediment discharge, as well as contamination and erosion degradation at the topsoil stockpiles.

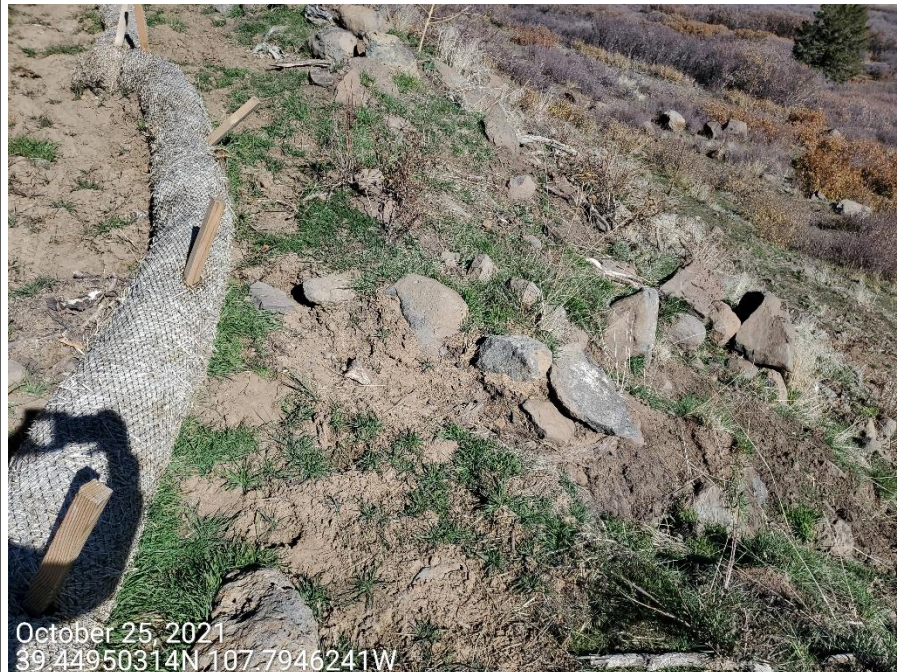
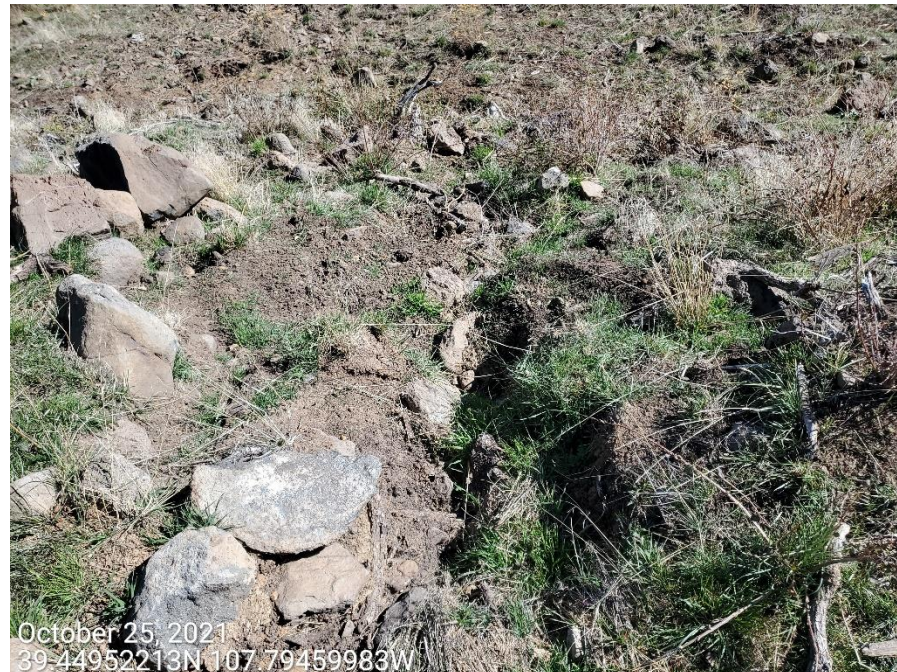
**Photo 9:** Photo provide example of inadequate perimeter control measures resulting in sediment discharge, contamination and erosion degradation to the topsoil stockpiles along the perimeter of the Location.

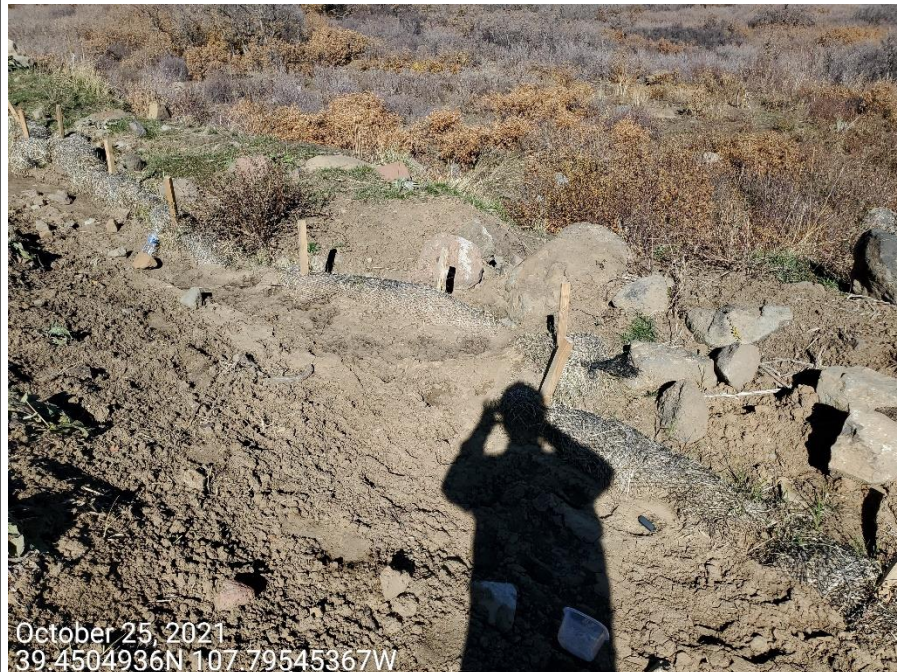
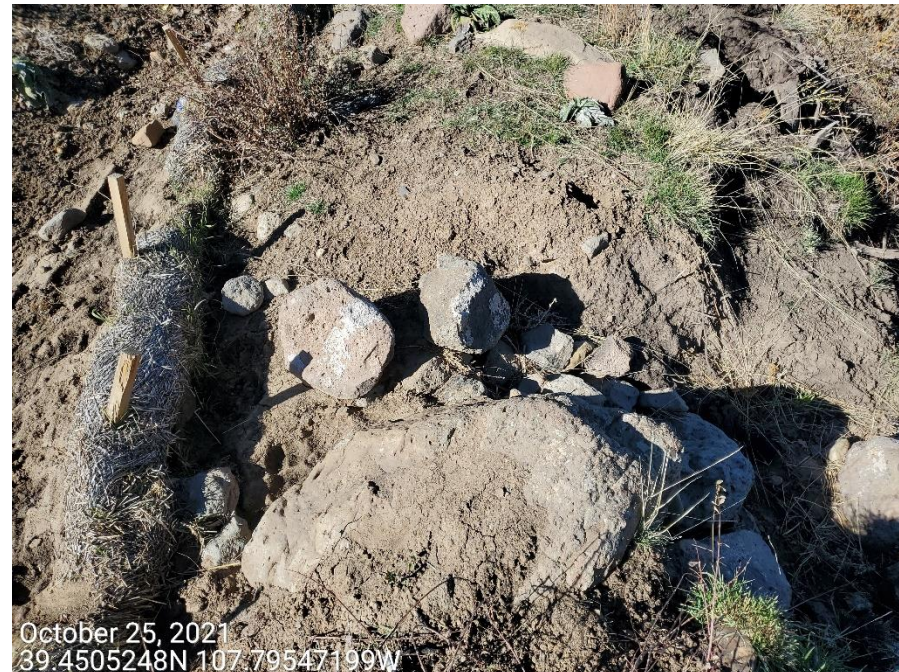
**Photo 10:** Photo provide example of inadequate perimeter control measures resulting in sediment discharge, contamination and erosion degradation to the topsoil stockpiles along the perimeter of the Location. Perimeter stormwater and erosion control measures to allow for sediment laden-free stormwater discharge inadequate.

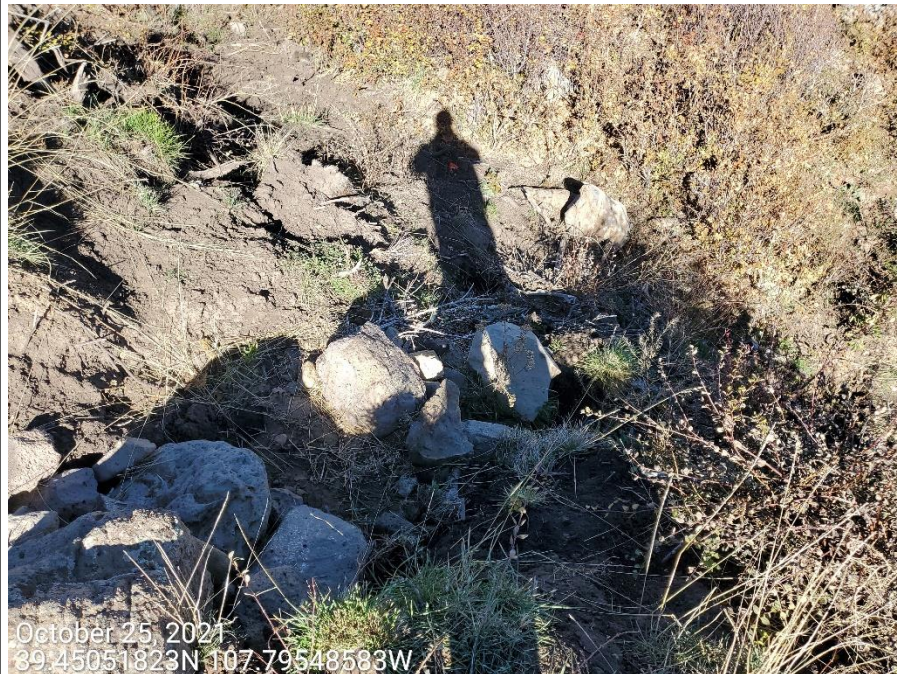
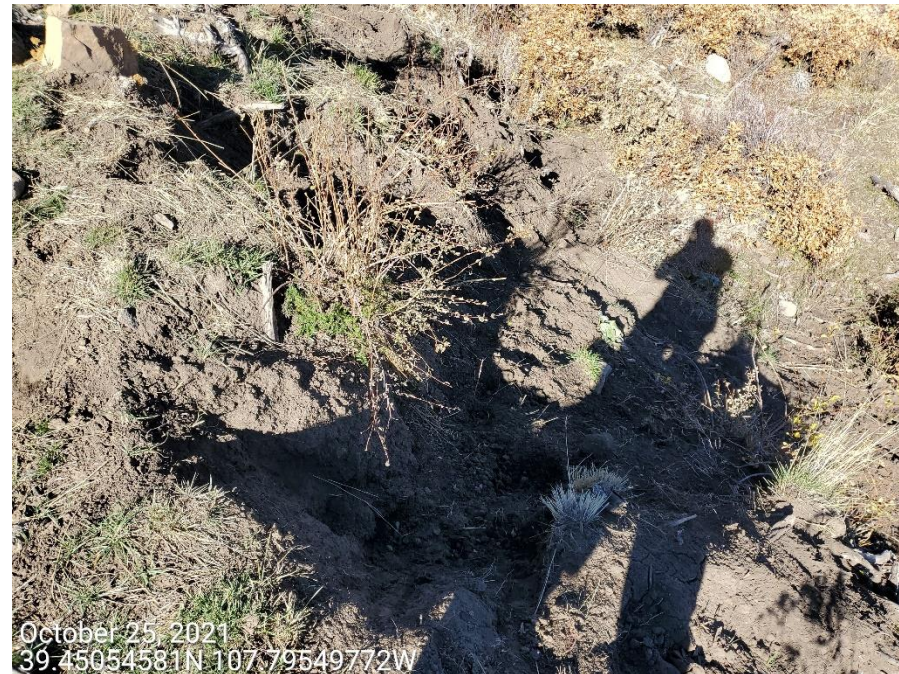
**Photo 11:** Continued from photo 10. Photo shows example of erosion degradation observed at the topsoil stockpiles below the wattle erosion log.

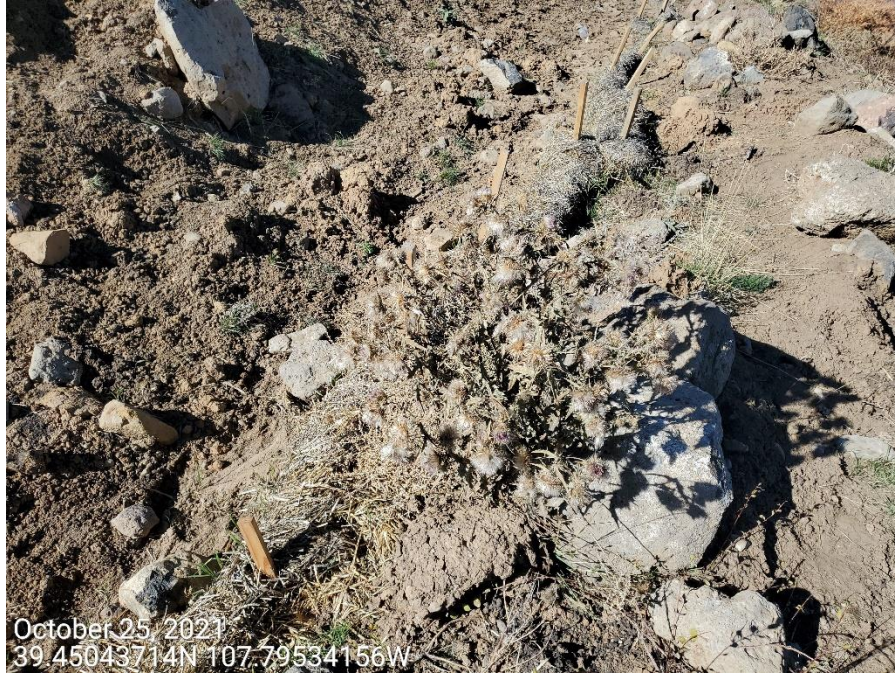
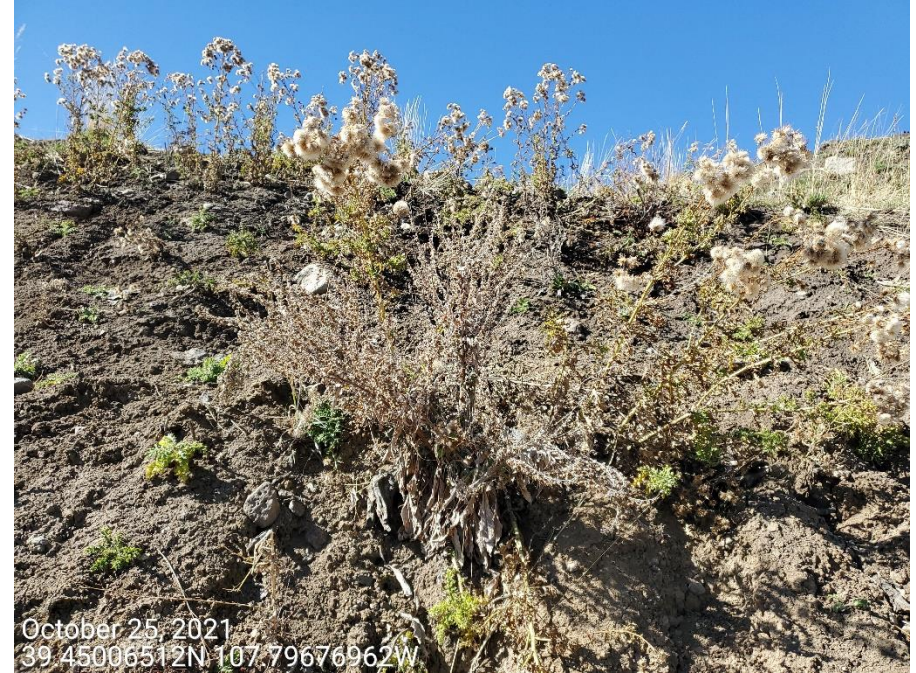
**Photo 12:** Bull thistle (photo left) and Canada thistle (photo right). Photos provide example of noxious weeds including observed established on the topsoil stockpiles and slopes throughout the Location.

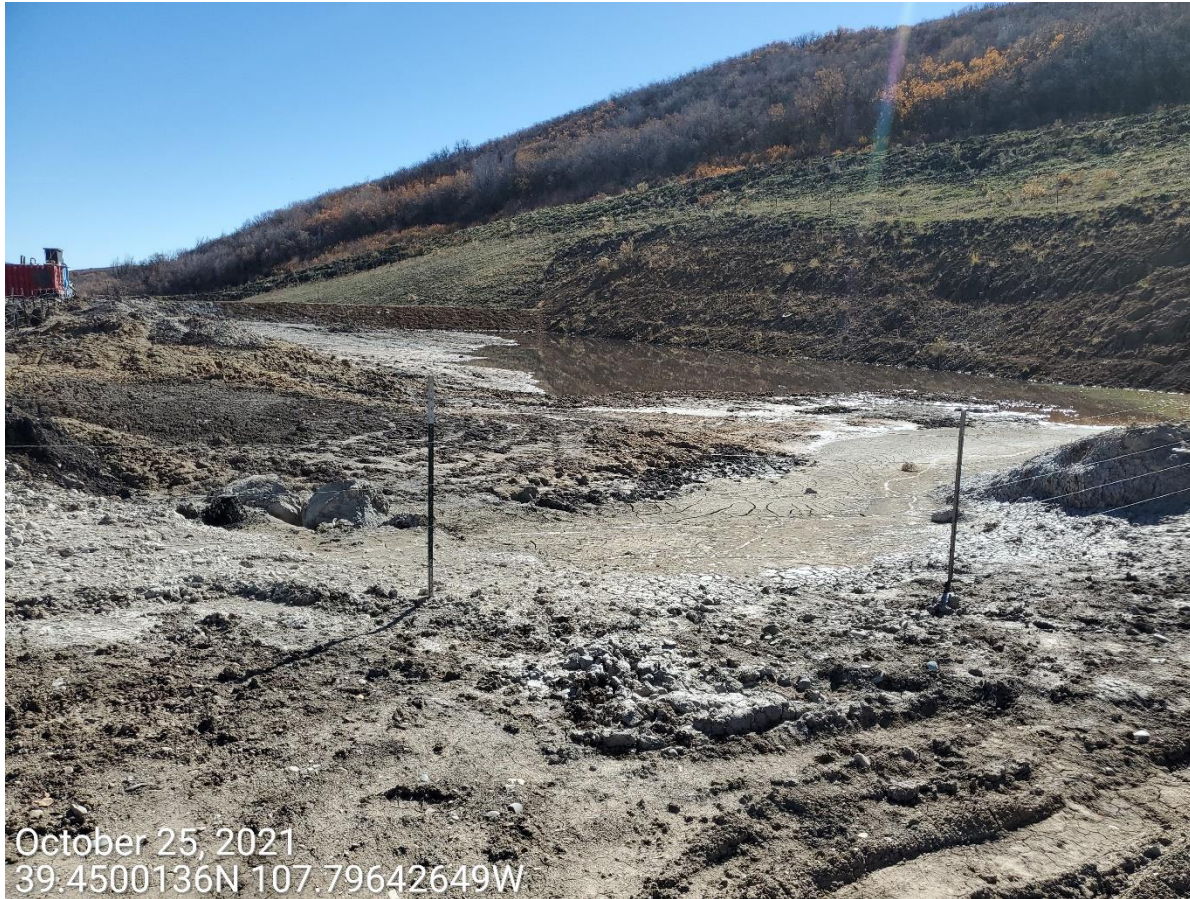
**Photo 13:** Photo shows the cuttings trench on the southwest end of the Location. Trench/pit requires permitting. Photo also shows that stormwater has been allowed to flow into the cuttings trench and is now considered E&P waste; fluids required removal and disposal.

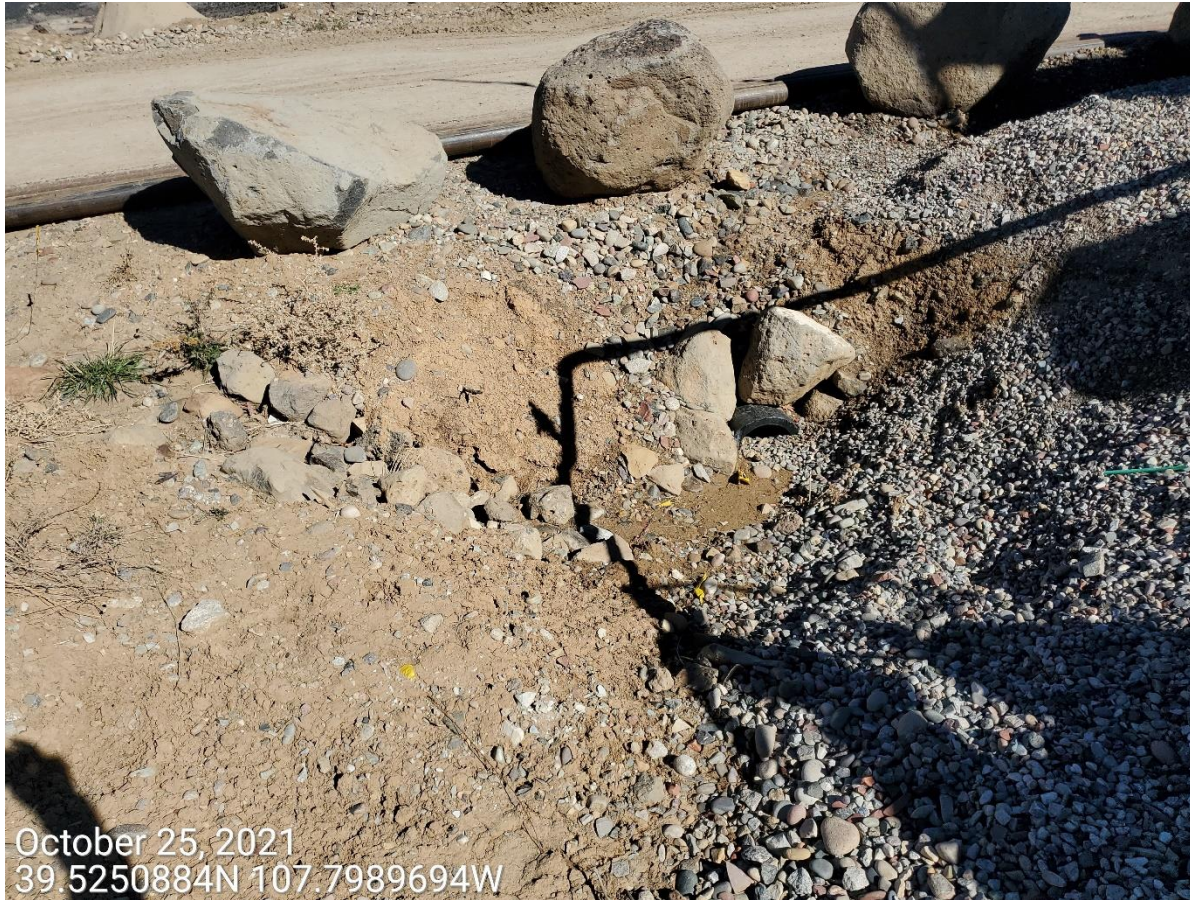
**Photo 14:** Photo shows culvert at the Location entrance has filled with sediment.
