TEP
RGU 323-33-198
Location # 335719

COLORADO
Oil & Gas Conservation
Commission
Department of Natural Resources

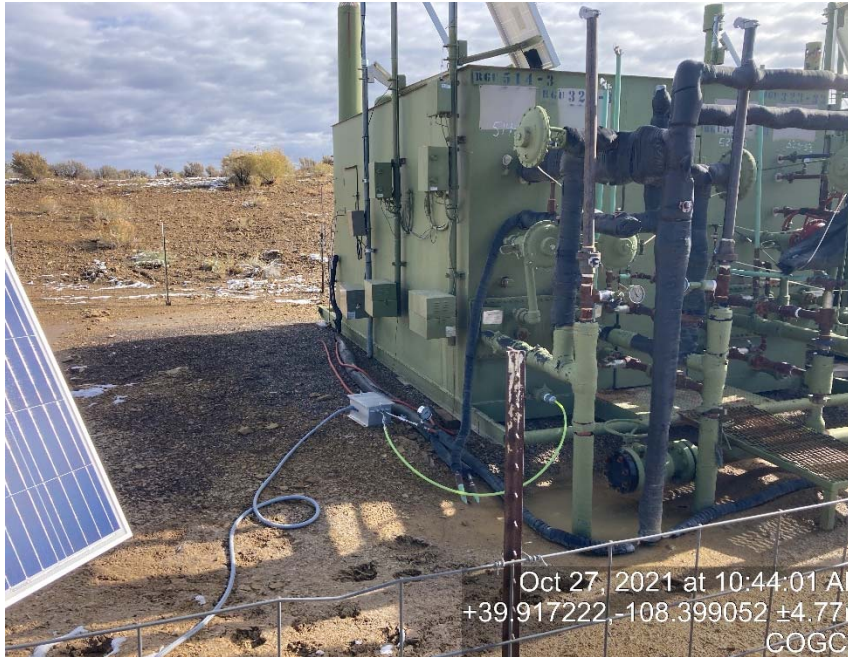
Lack of glycol vessel labeling

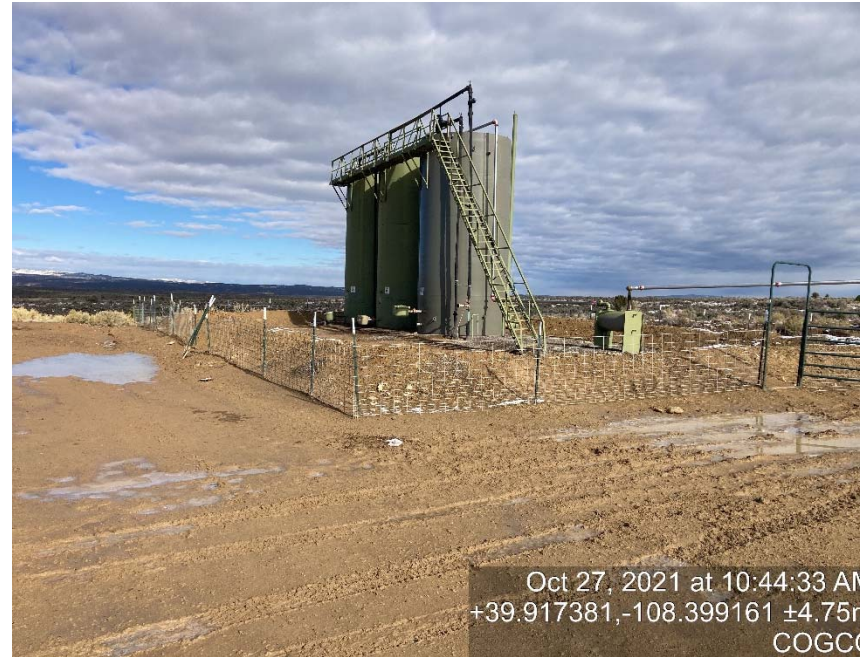
location/lack of battery signage

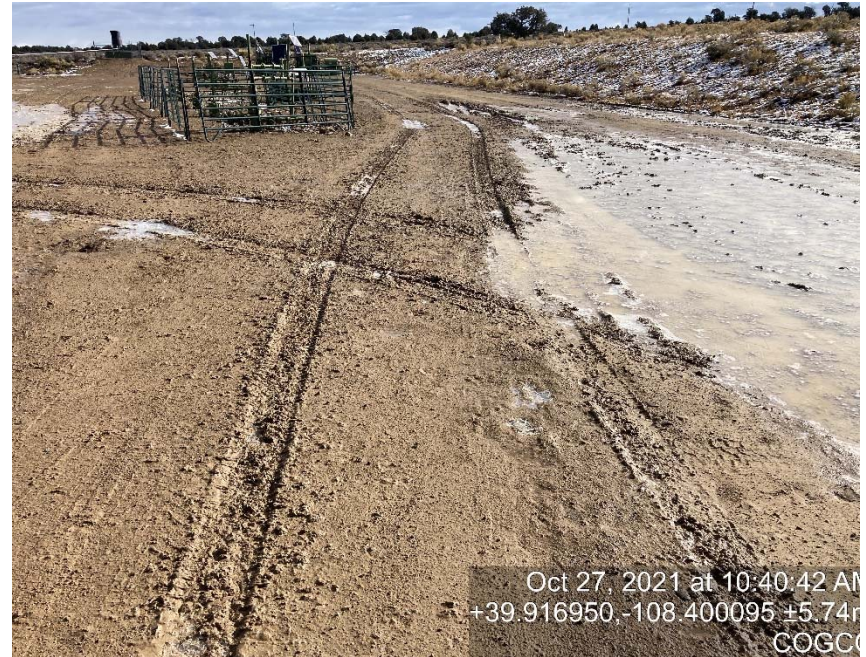
Lack of stabilization/erosion/BMP's failing

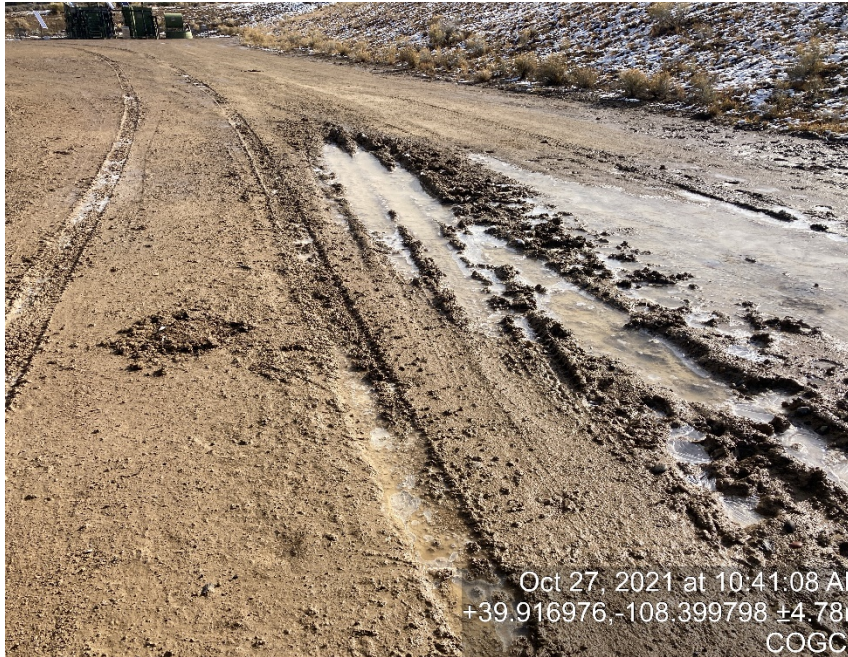
Lack of stabilization/erosion/BMP's failing

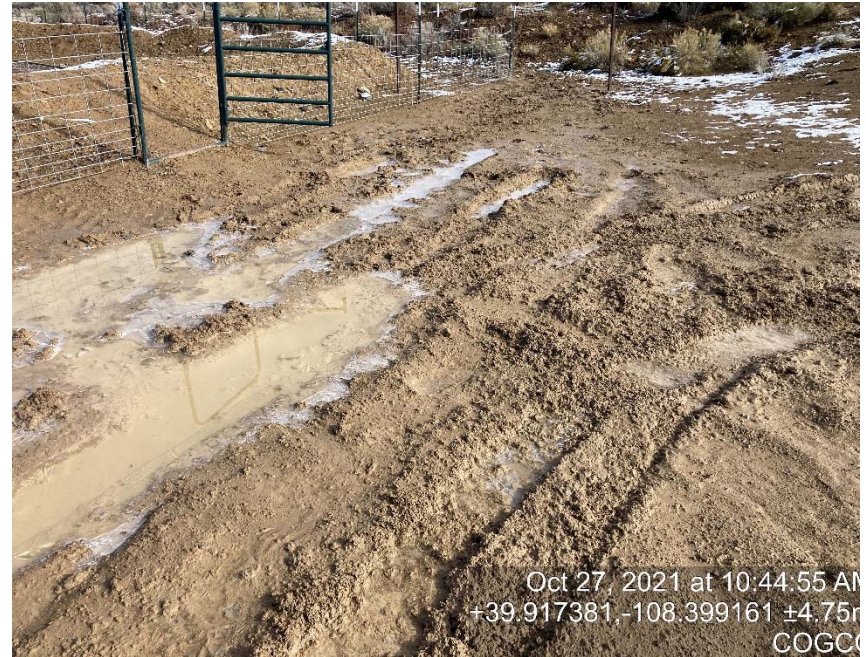
Lack of stabilization/erosion/BMP's failing

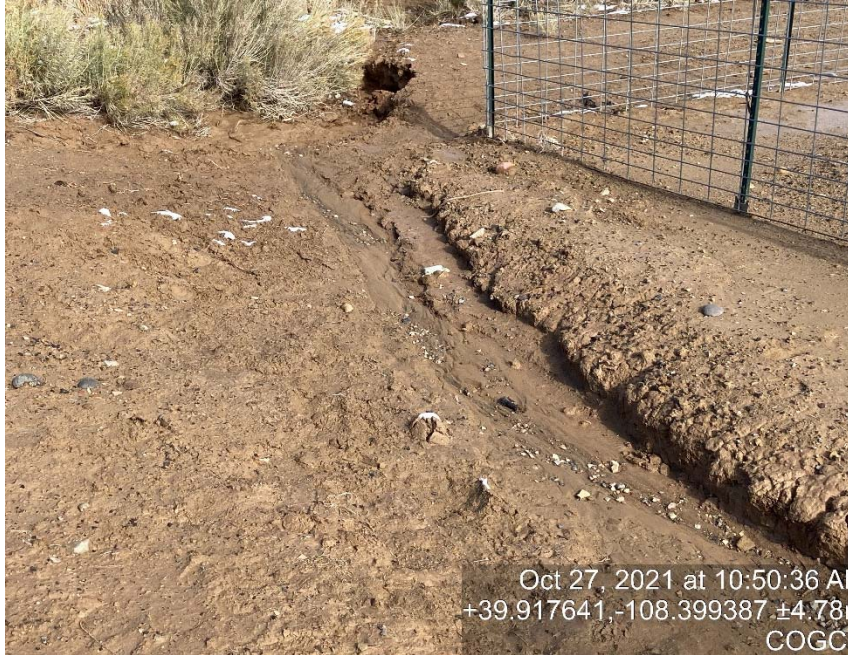
Lack of stabilization/erosion/BMP's failing

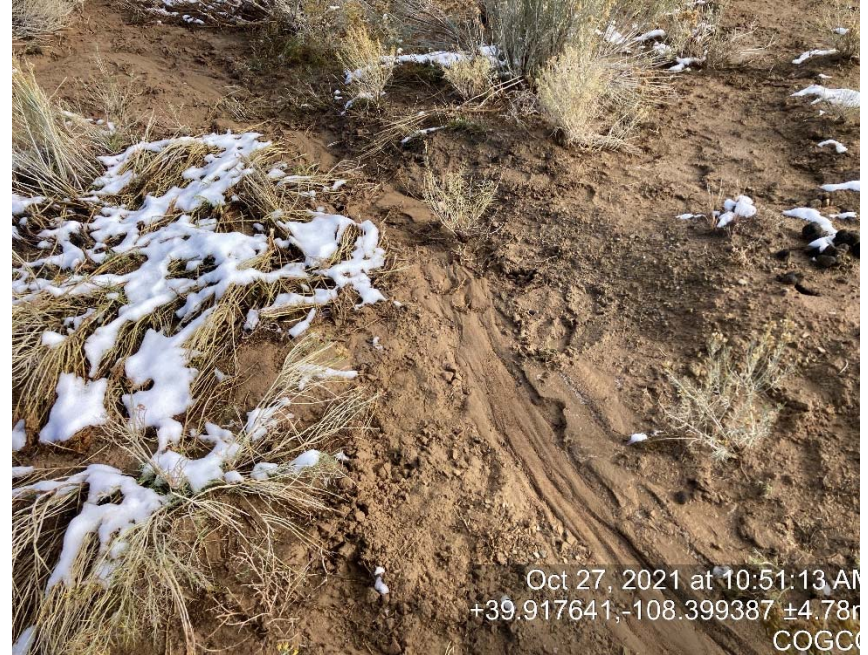
Lack of stabilization/erosion/BMP's failing

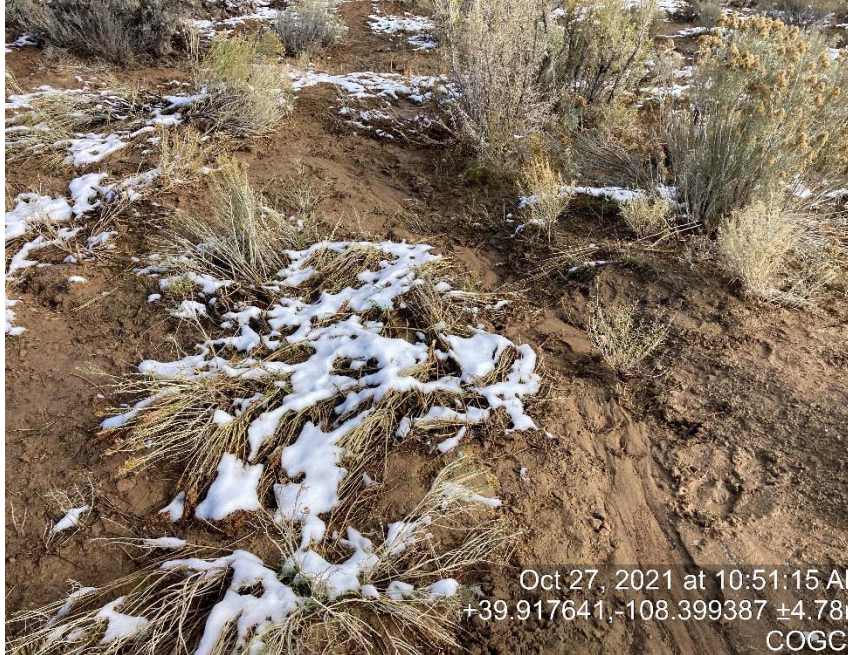
Lack of stabilization/erosion/BMP's failing

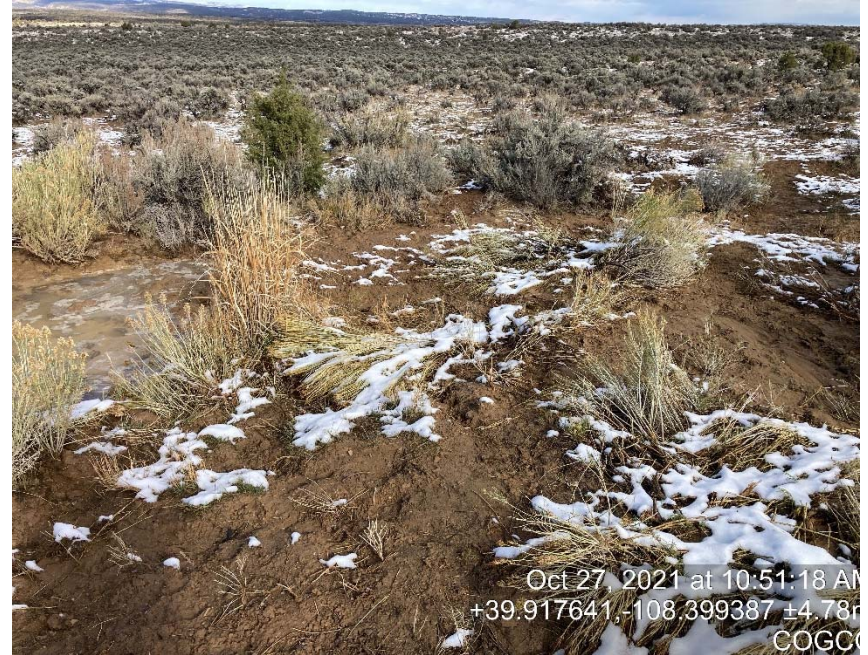
Lack of stabilization/erosion/BMP's failing

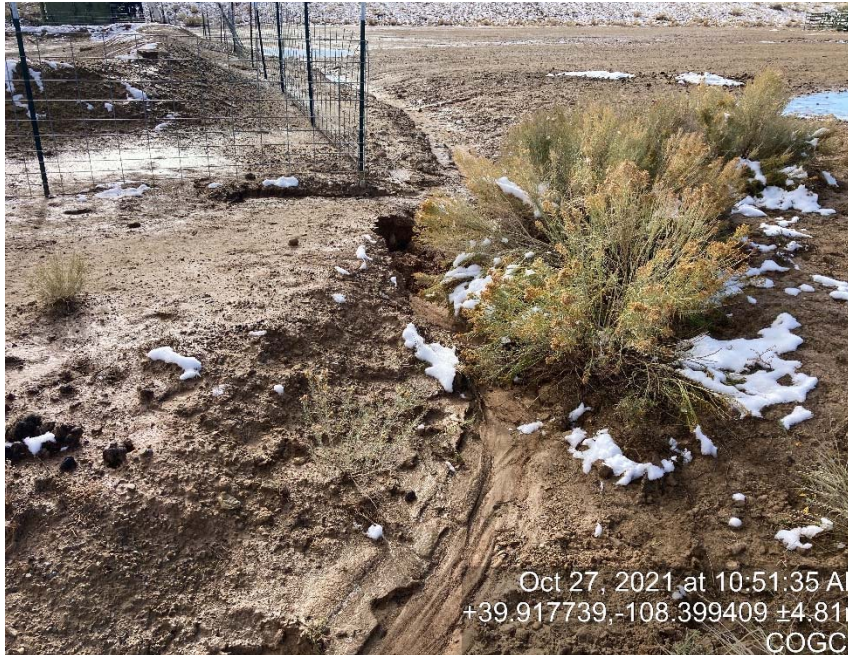
Lack of stabilization/erosion/BMP's failing

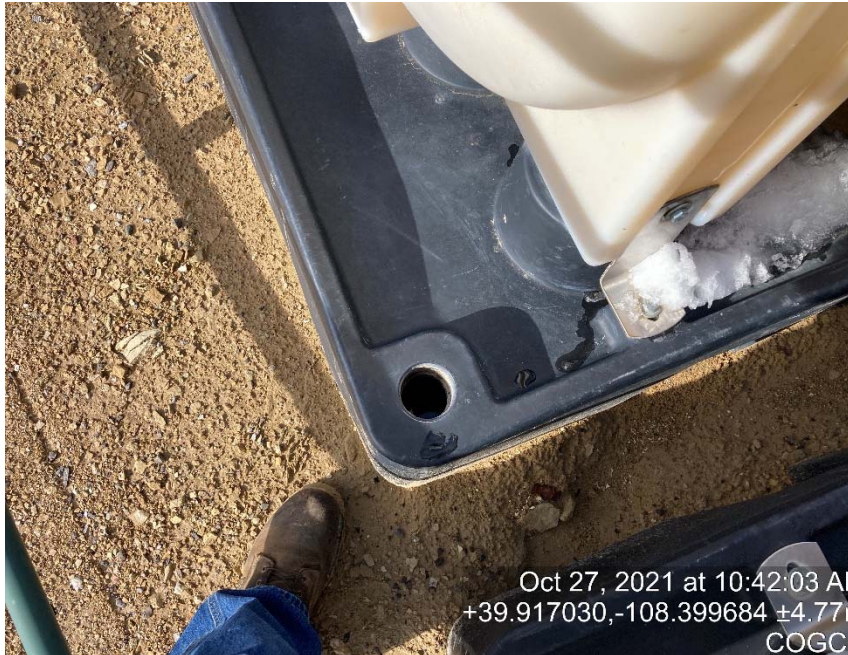
Chemical tank containment is full of fluid

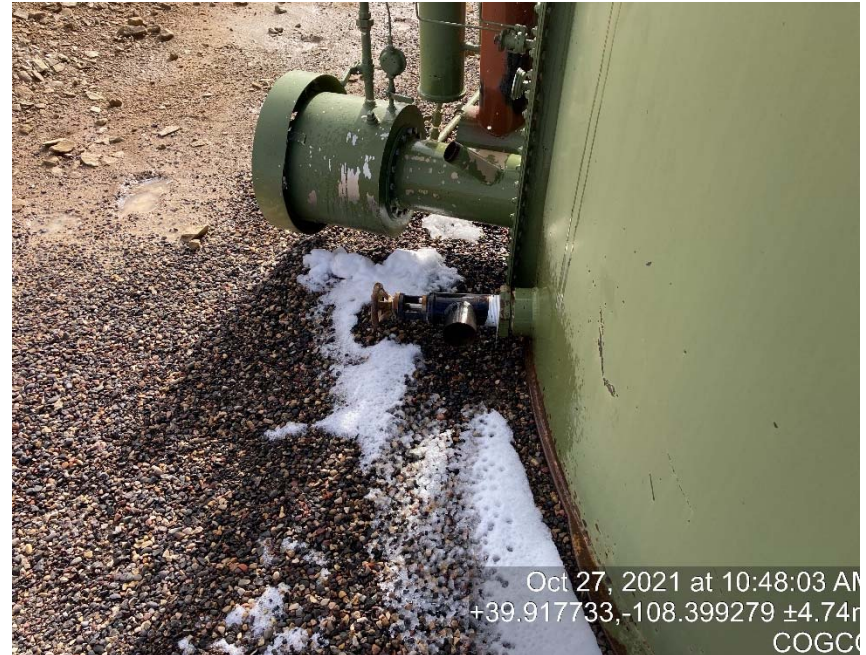
Load out line missing cap/bull plug

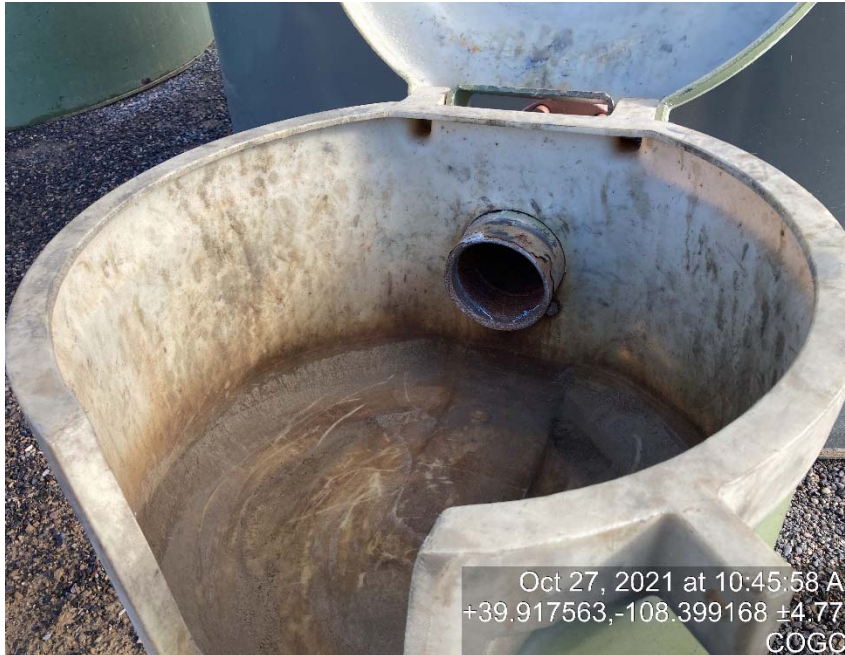
Load out line missing cap/bull plug

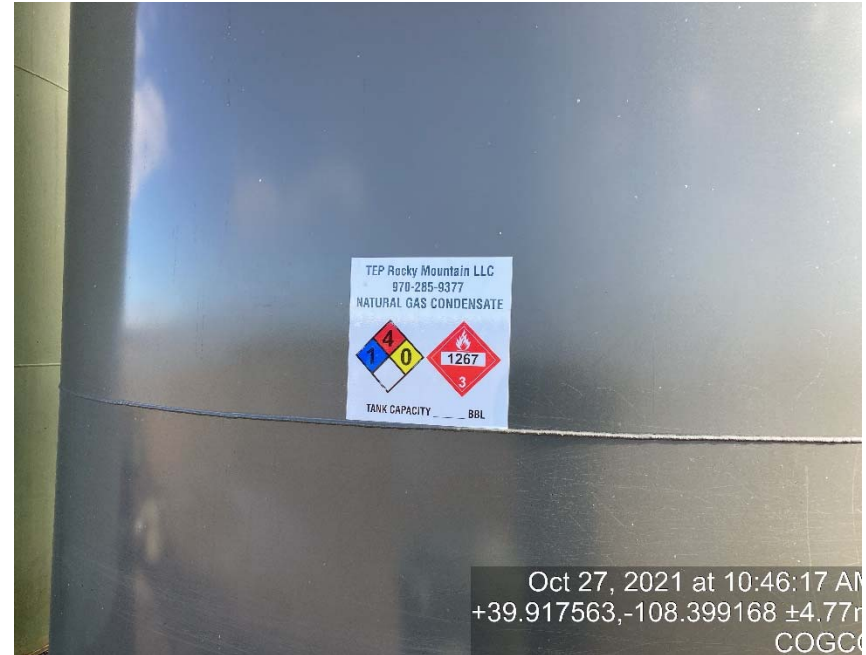
Tank label missing information

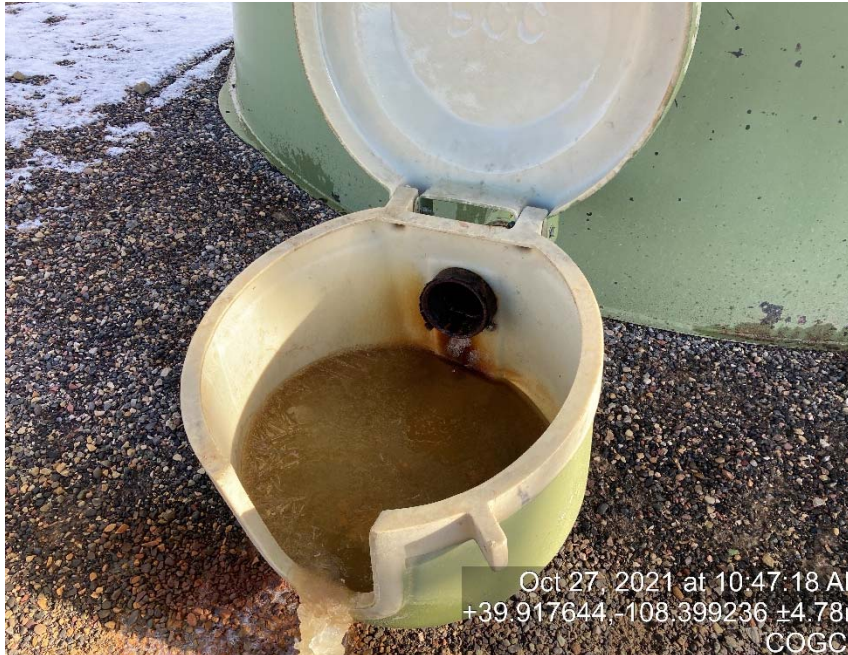
Leaking load out line with out cap/bull plug and staining

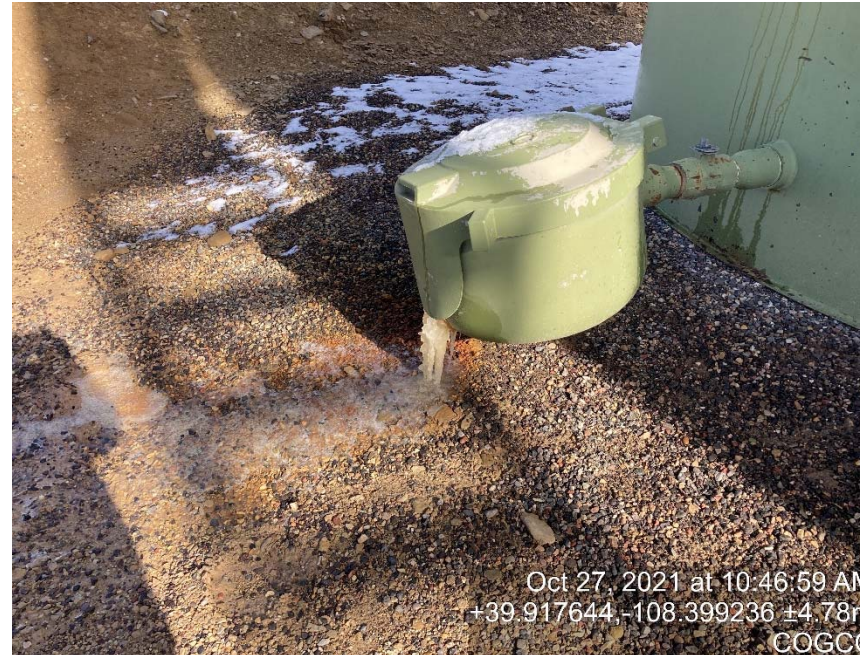
Leaking load out line with out cap/bull plug and staining

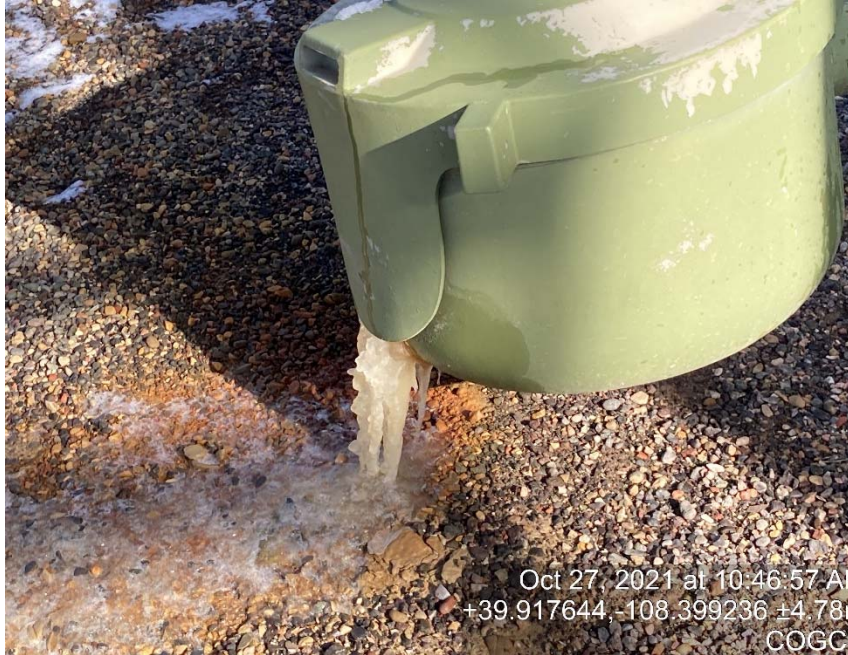
Leaking load out line with out cap/bull plug and staining

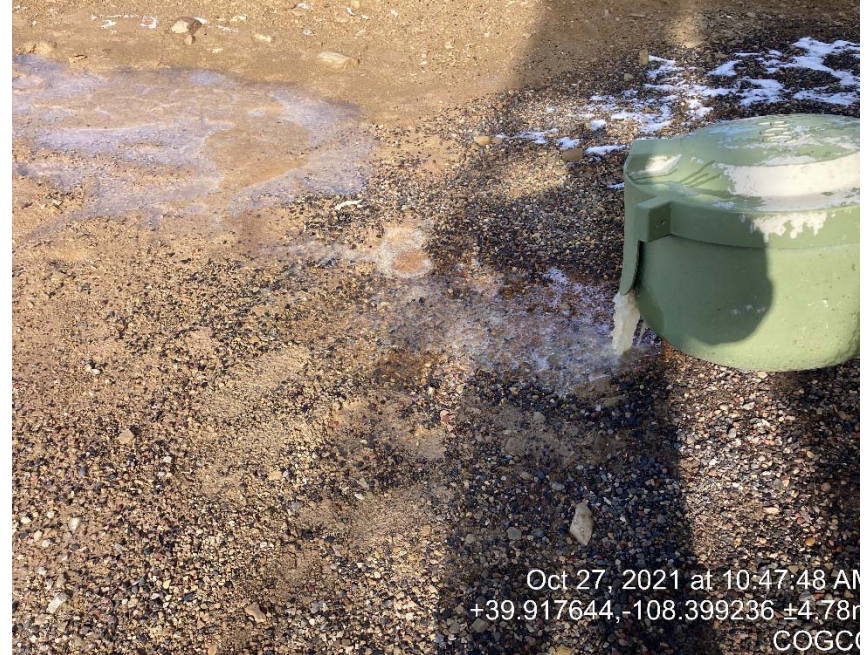
Leaking load out line with out cap/bull plug and staining

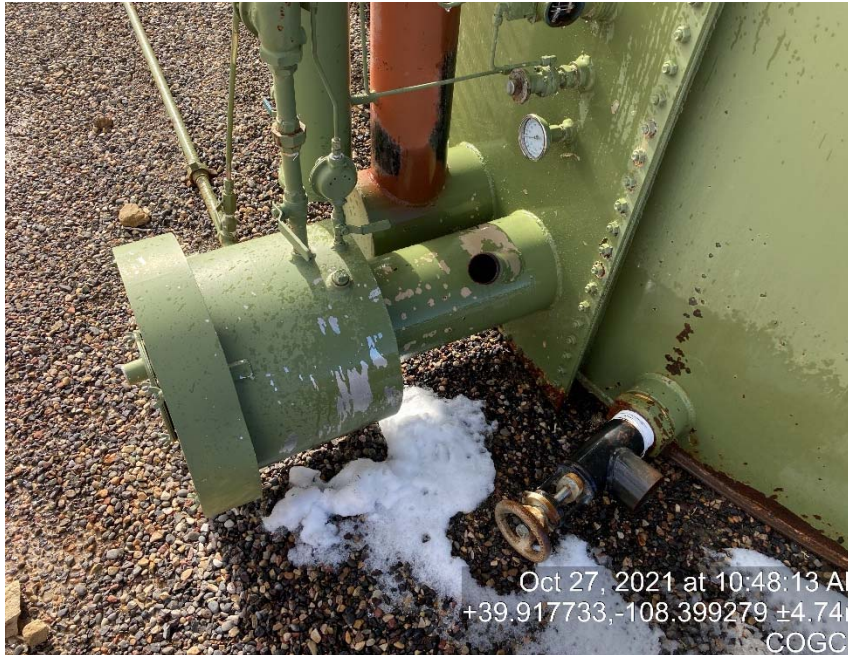
Missing load out cap/bull plug and cap for burner

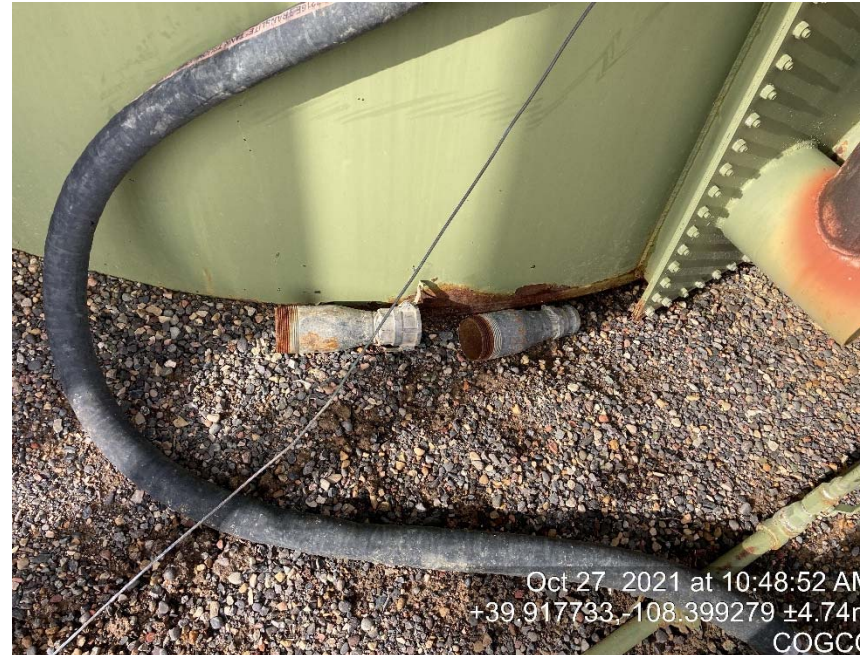
Debris
