Inspection Photos

API: 061-06023

Operator: WESTERN OPERATING COMPANY

Inspection Date: 10/27/2021

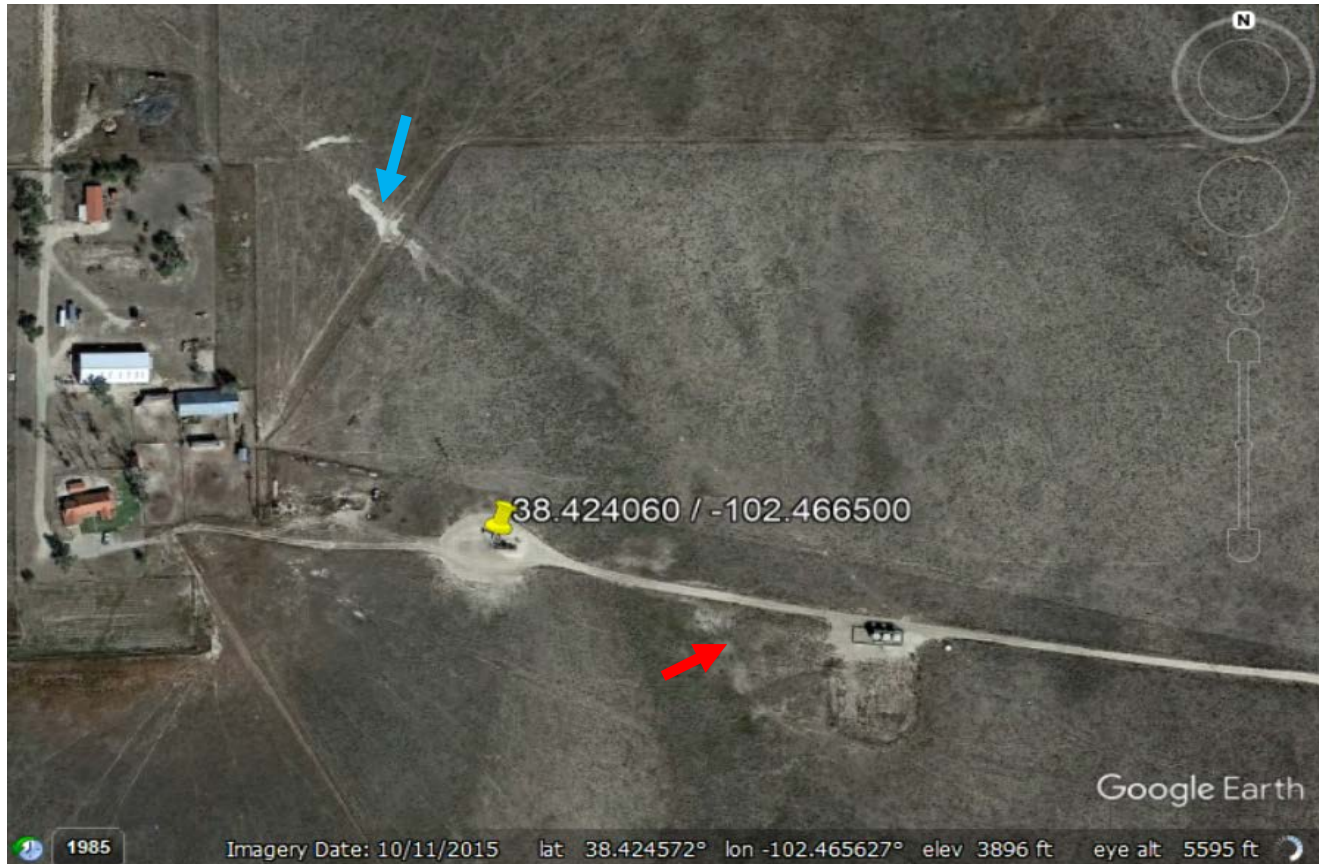
Photo 1. Aerial imagery of the well site and tank battery site. A spill had occurred downhill from the tank battery site shown at red arrow and in the following photos. It appears there was also a spill at the blue arrow north of the well site which was not inspected.

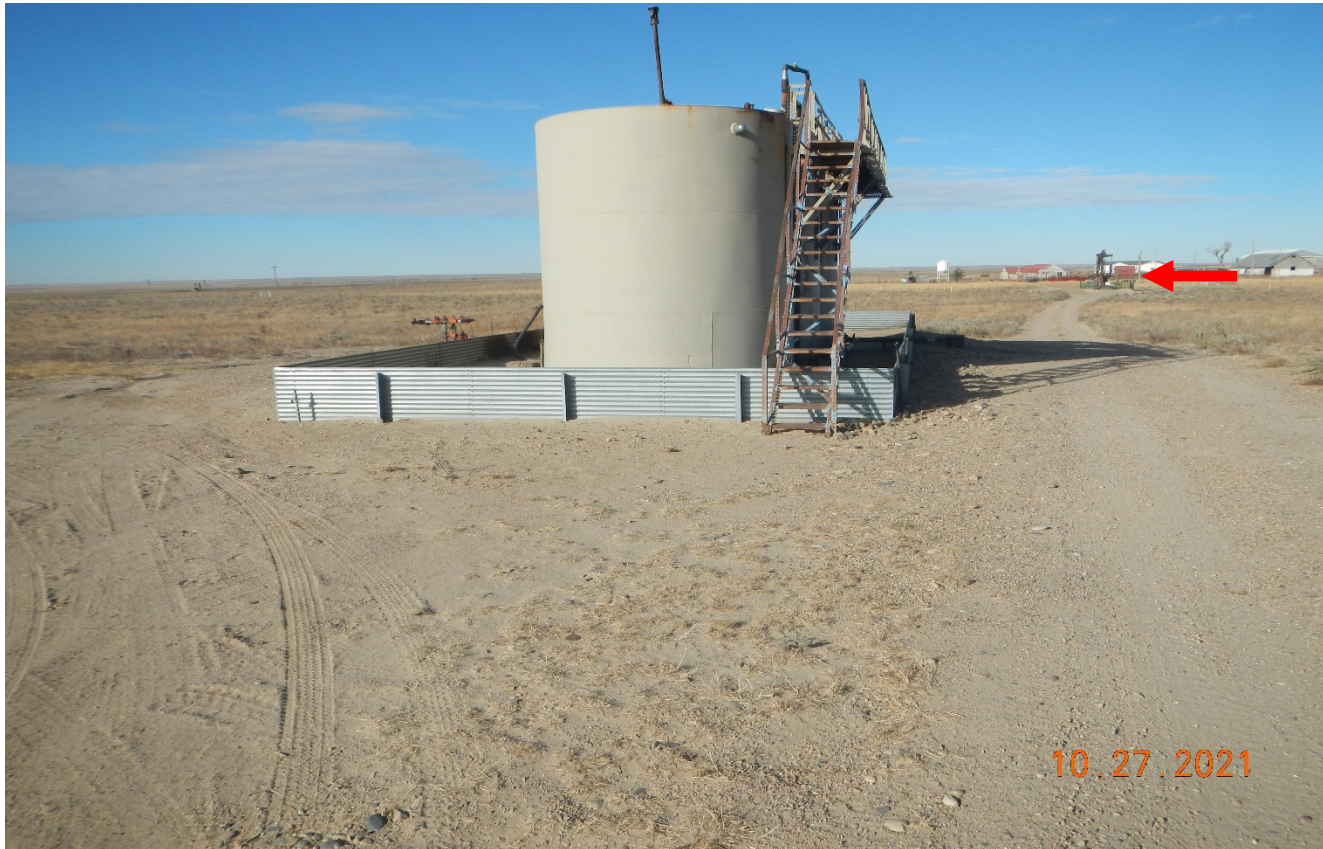
Photo 2. Facing west toward the tank battery. The well site is located at red arrow. The tank battery is not fenced to prevent livestock entry.

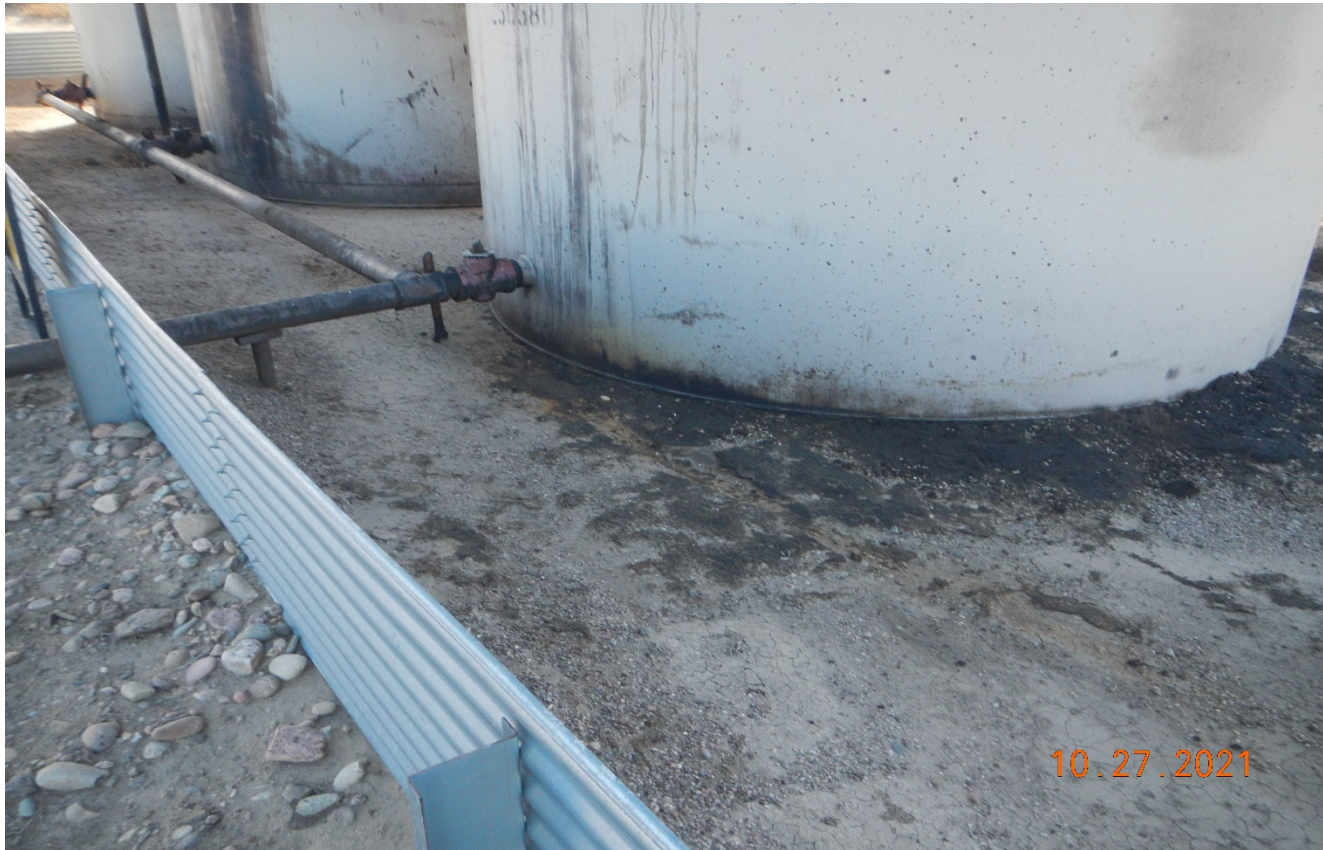
Photo 3. There is oil stained soil around the tanks which need to be cleaned up.

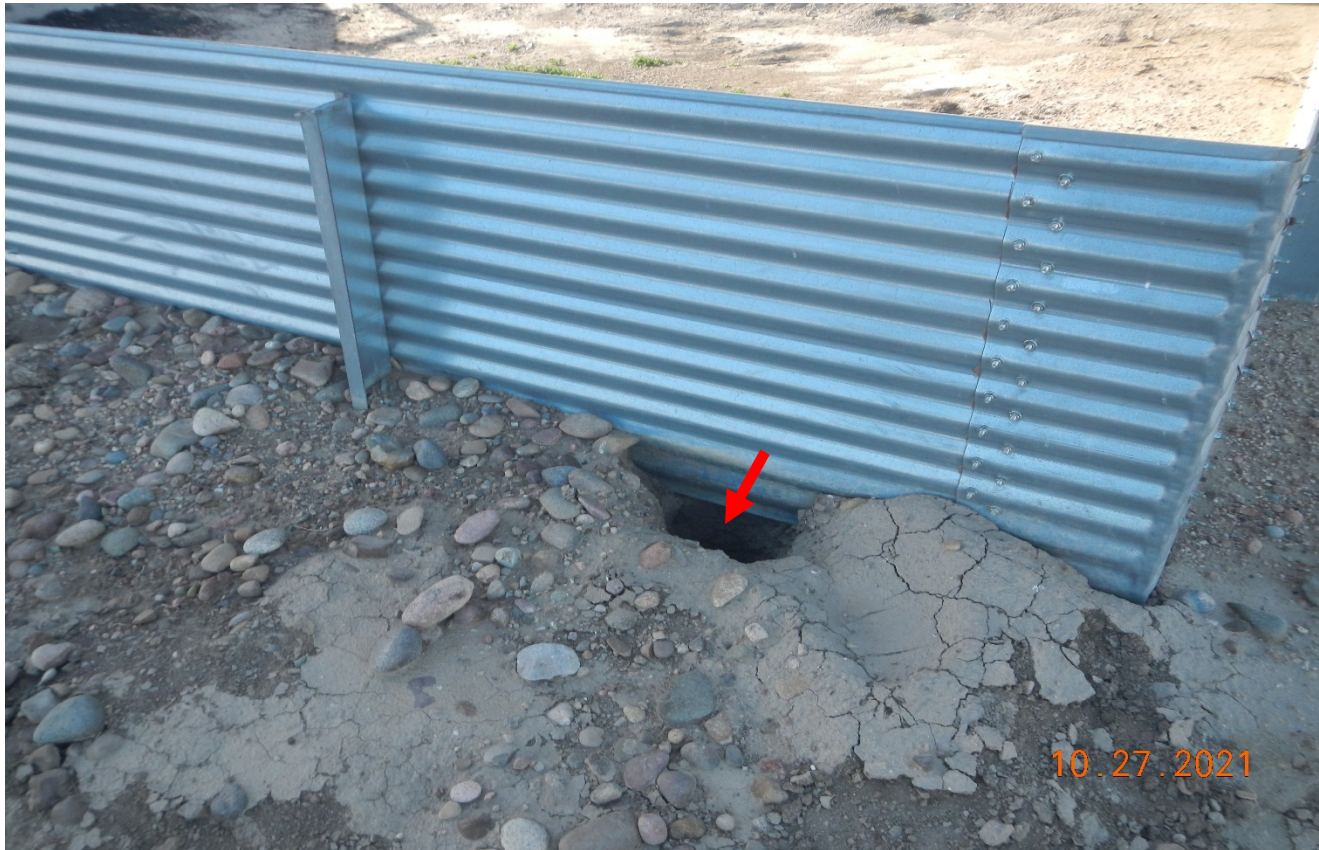
Photo 4. There is a hole at the outside edge compromising the secondary containment of the tank battery.

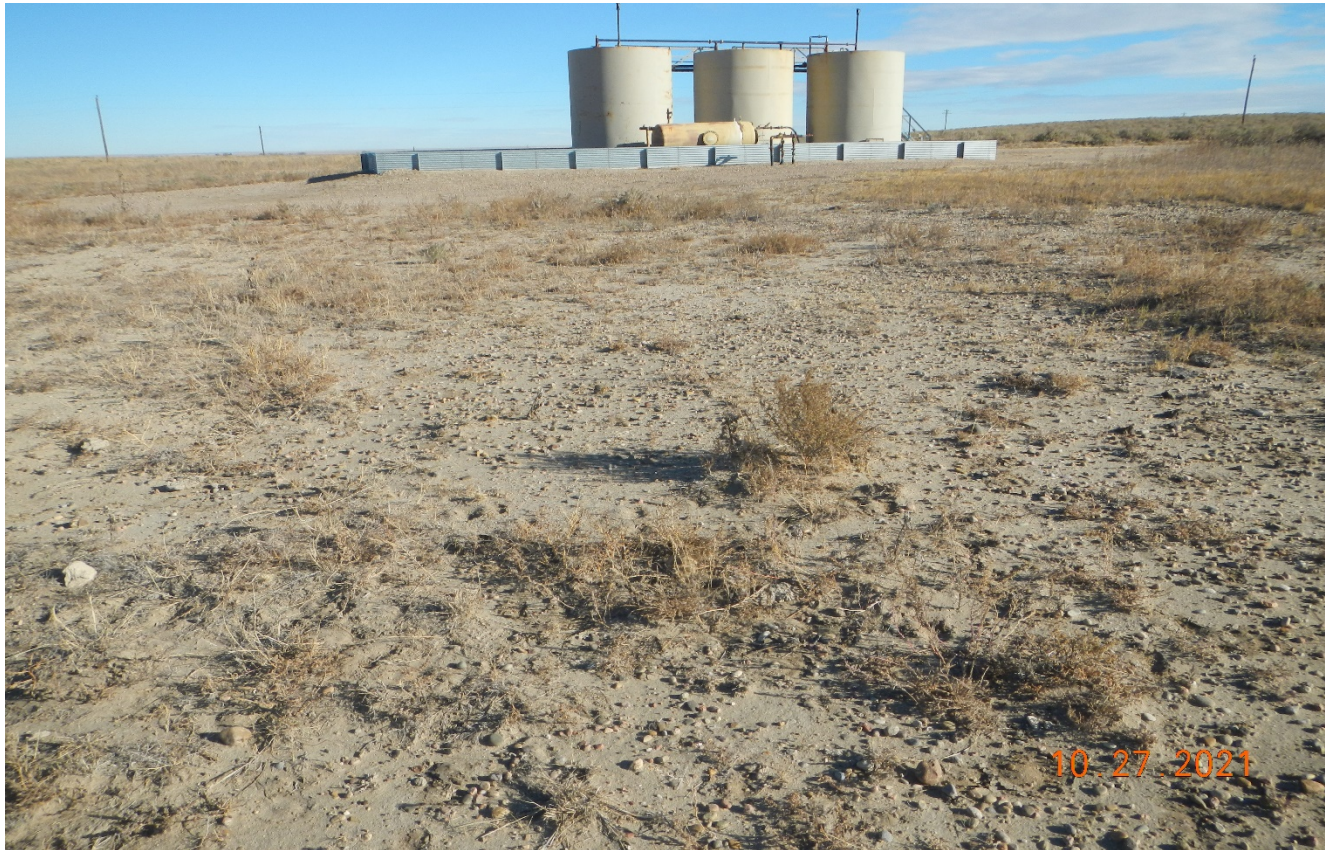
Photo 5. Facing north toward the tank battery. The area of disturbance south of the tank battery is bare of vegetation with compacted soils. This area needs to be reclaimed.

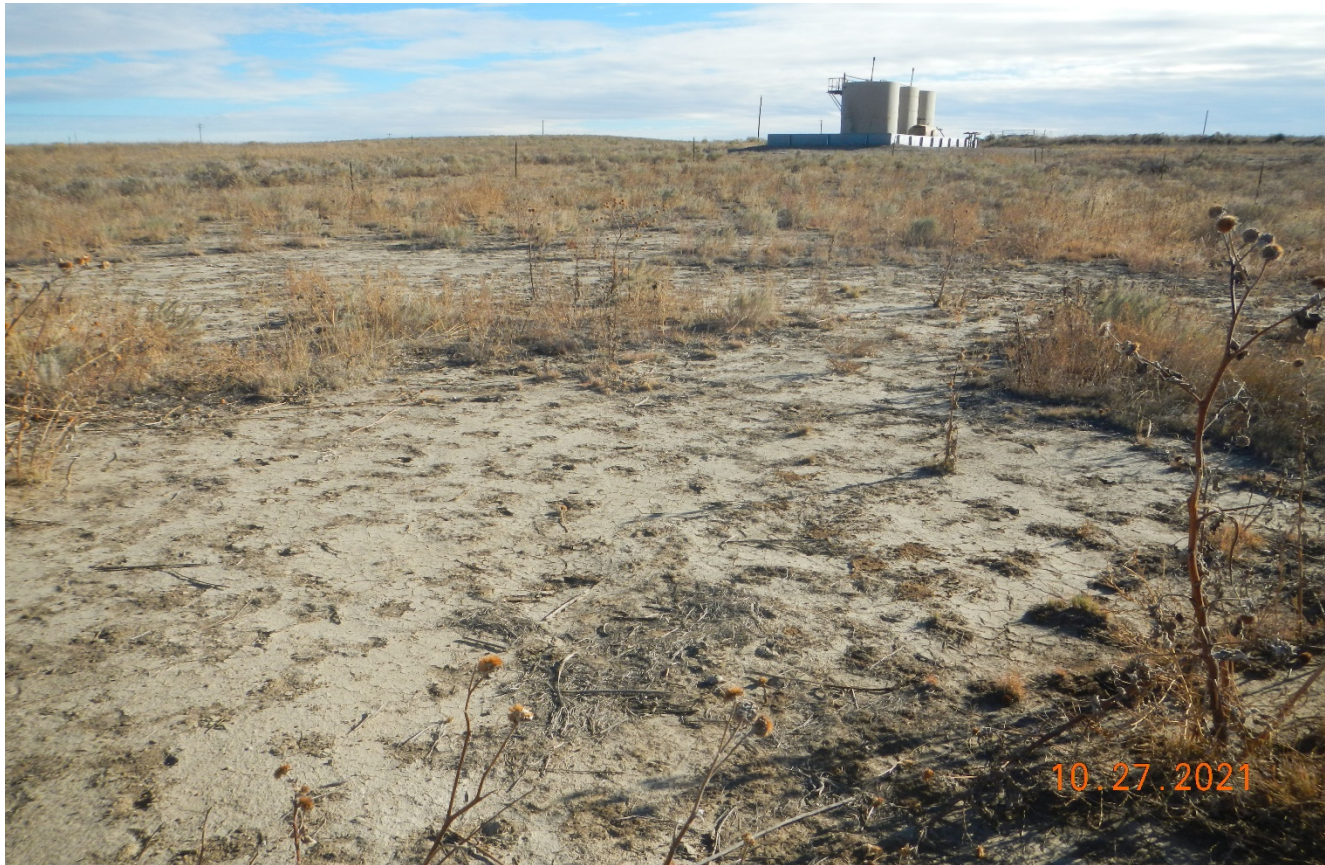
Photo 6. Facing northeast approximately 200' southwest of the tank battery. A former spill had occurred in this area as shown by bare and oil stained soils.

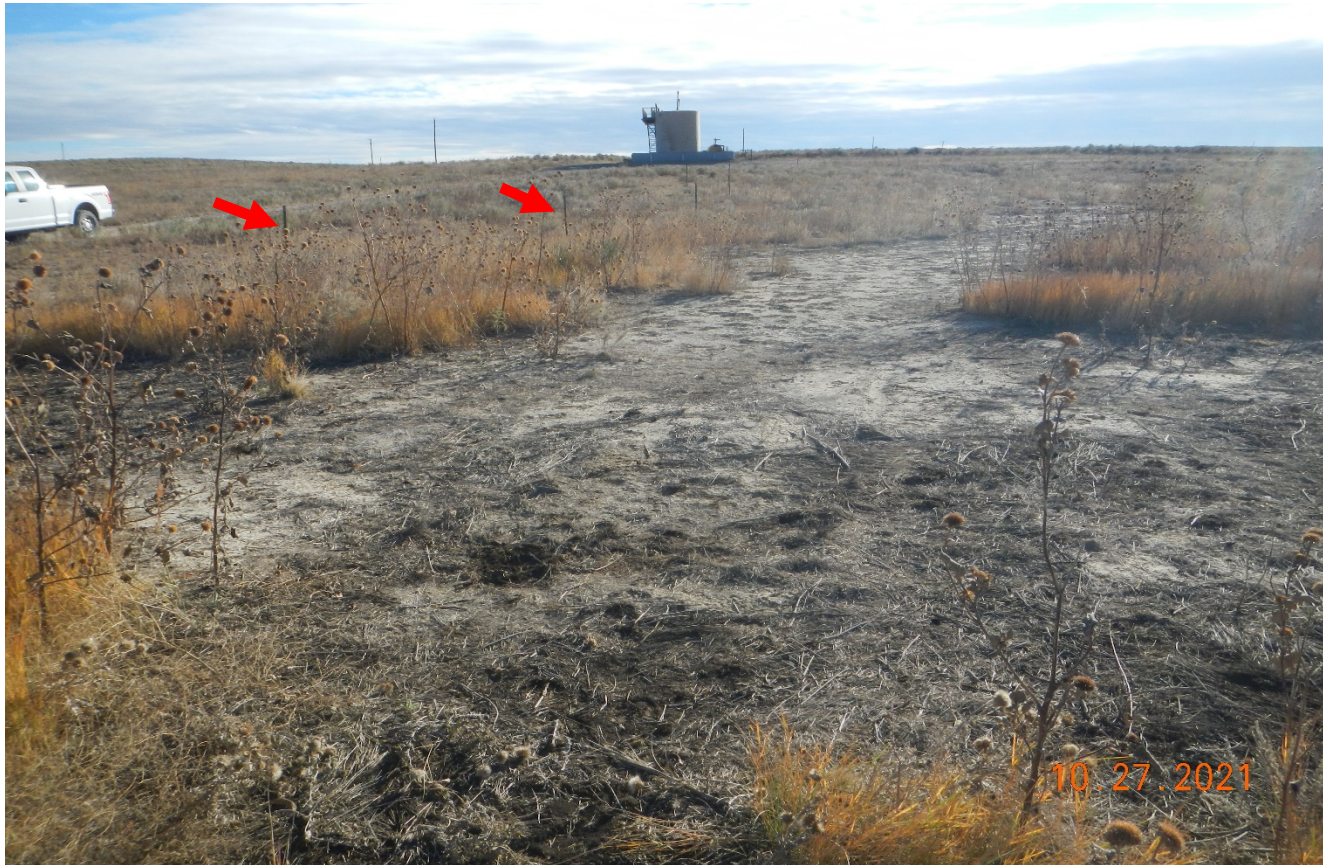
Photo 7. Facing east approximately 275' west of the tank battery. A former spill had occurred in this area as shown by bare and oil stained soils. There are t-posts around this area (red arrows) of the spill indicating it was fenced off.

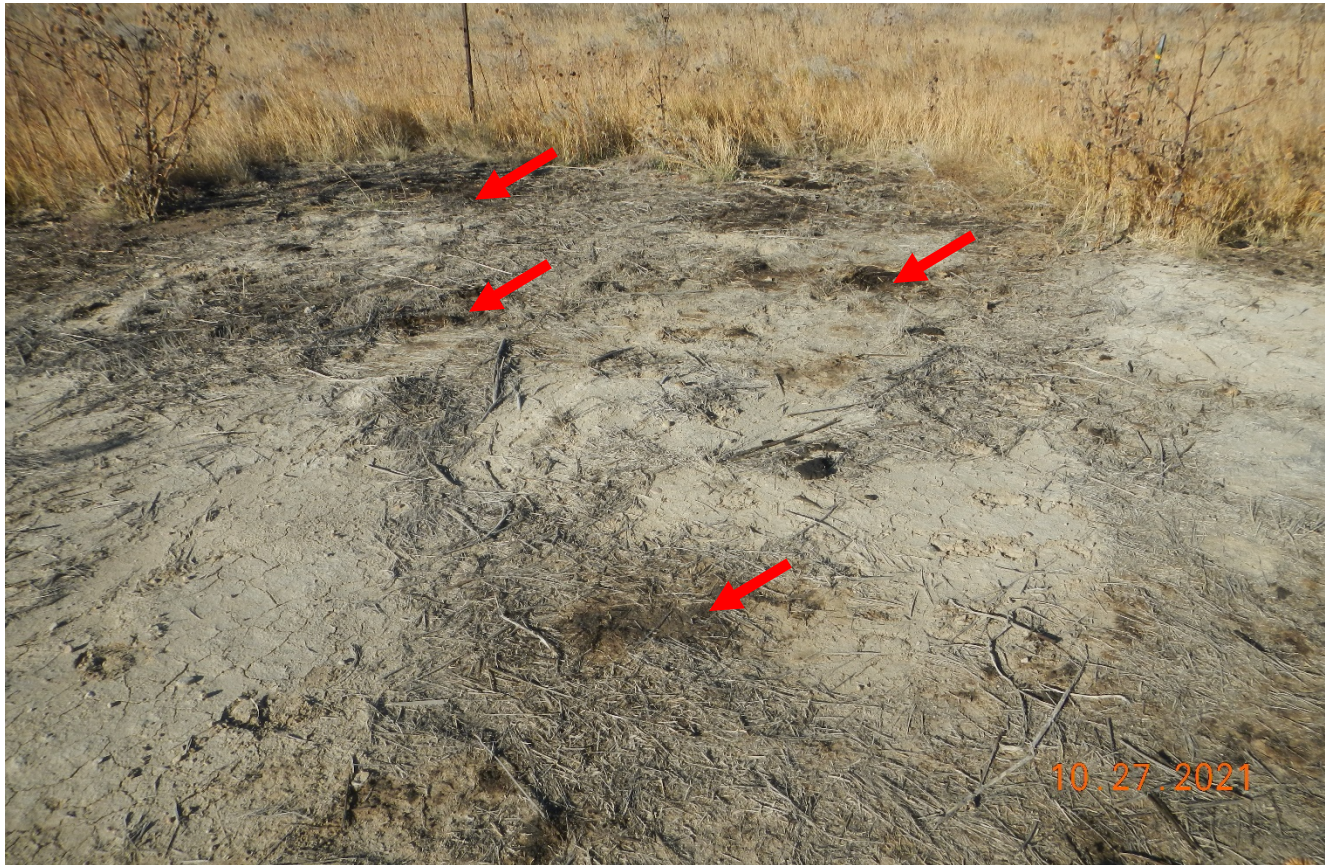
Photo 8. View of bare and oil stained soils. Spots of oil stains are shown at arrows.

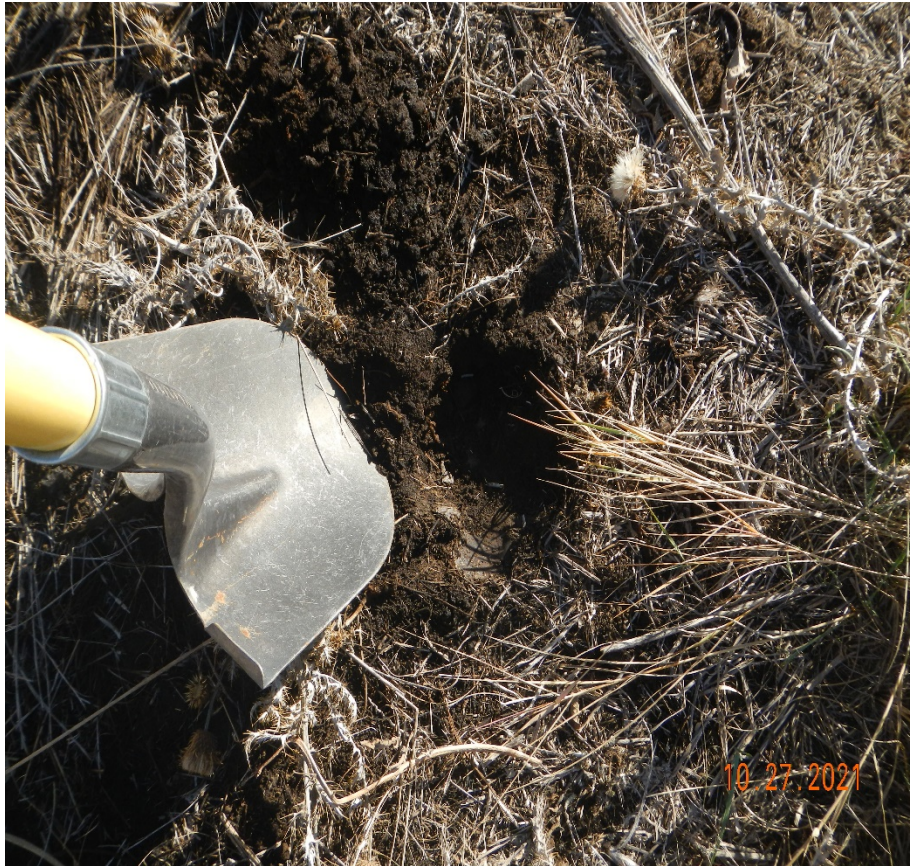
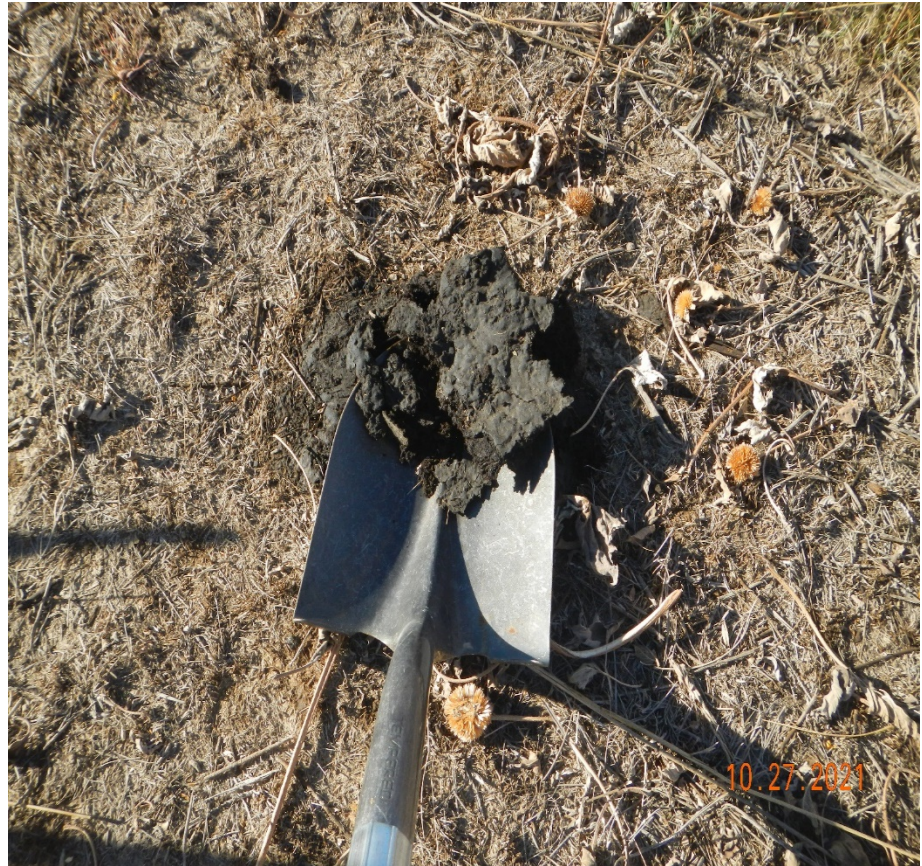
Photo 9&10. The soil at the spill area was dug a few inches down to show oily soils which had strong hydro-carbon odor. The photo on the right shows a conglomerate of oil on the surface.

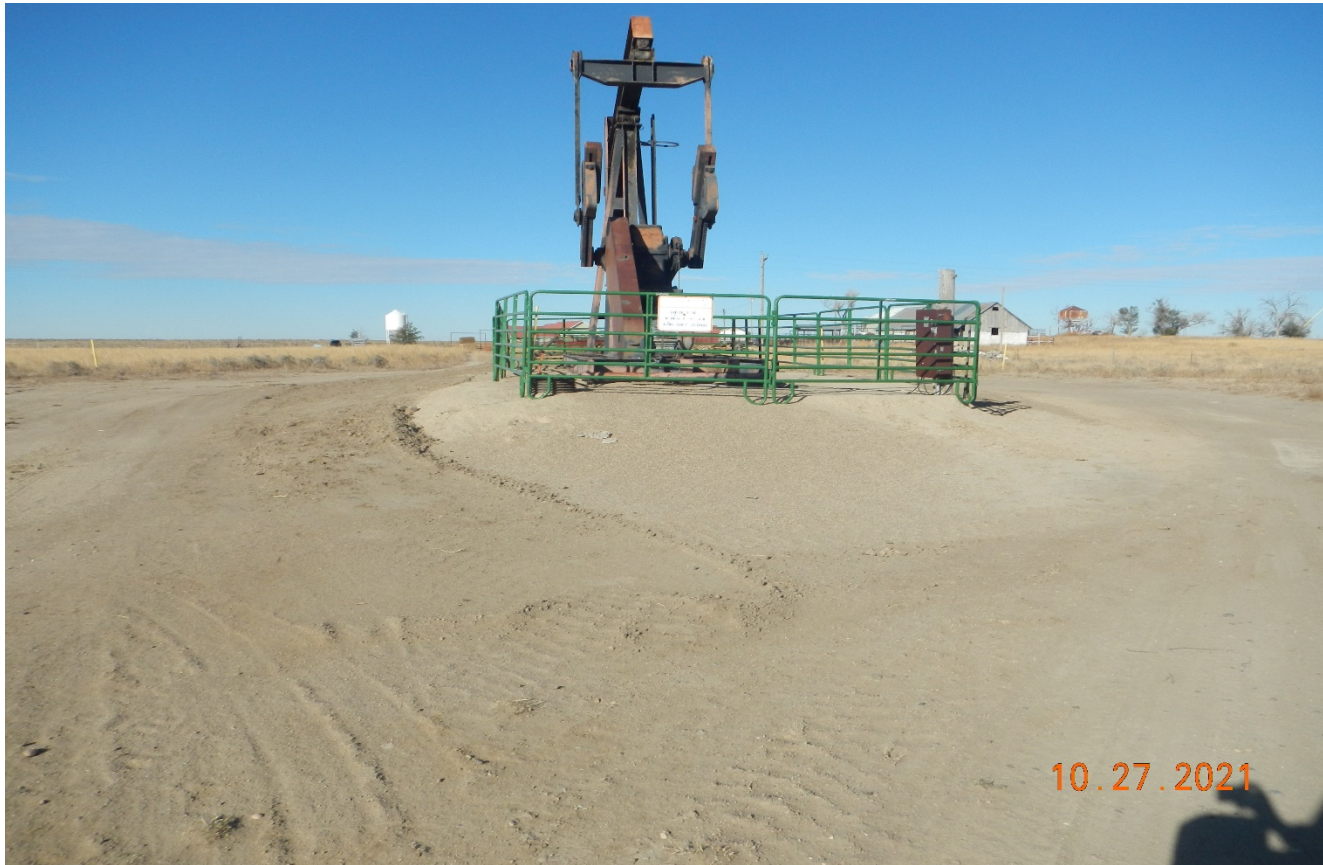
Photo 11. Facing toward the well site which is approximately 500' west of the tank battery.
