Inspection Photos
Operator: Simcoe
API: 067-07849
Date: 10/27/2021

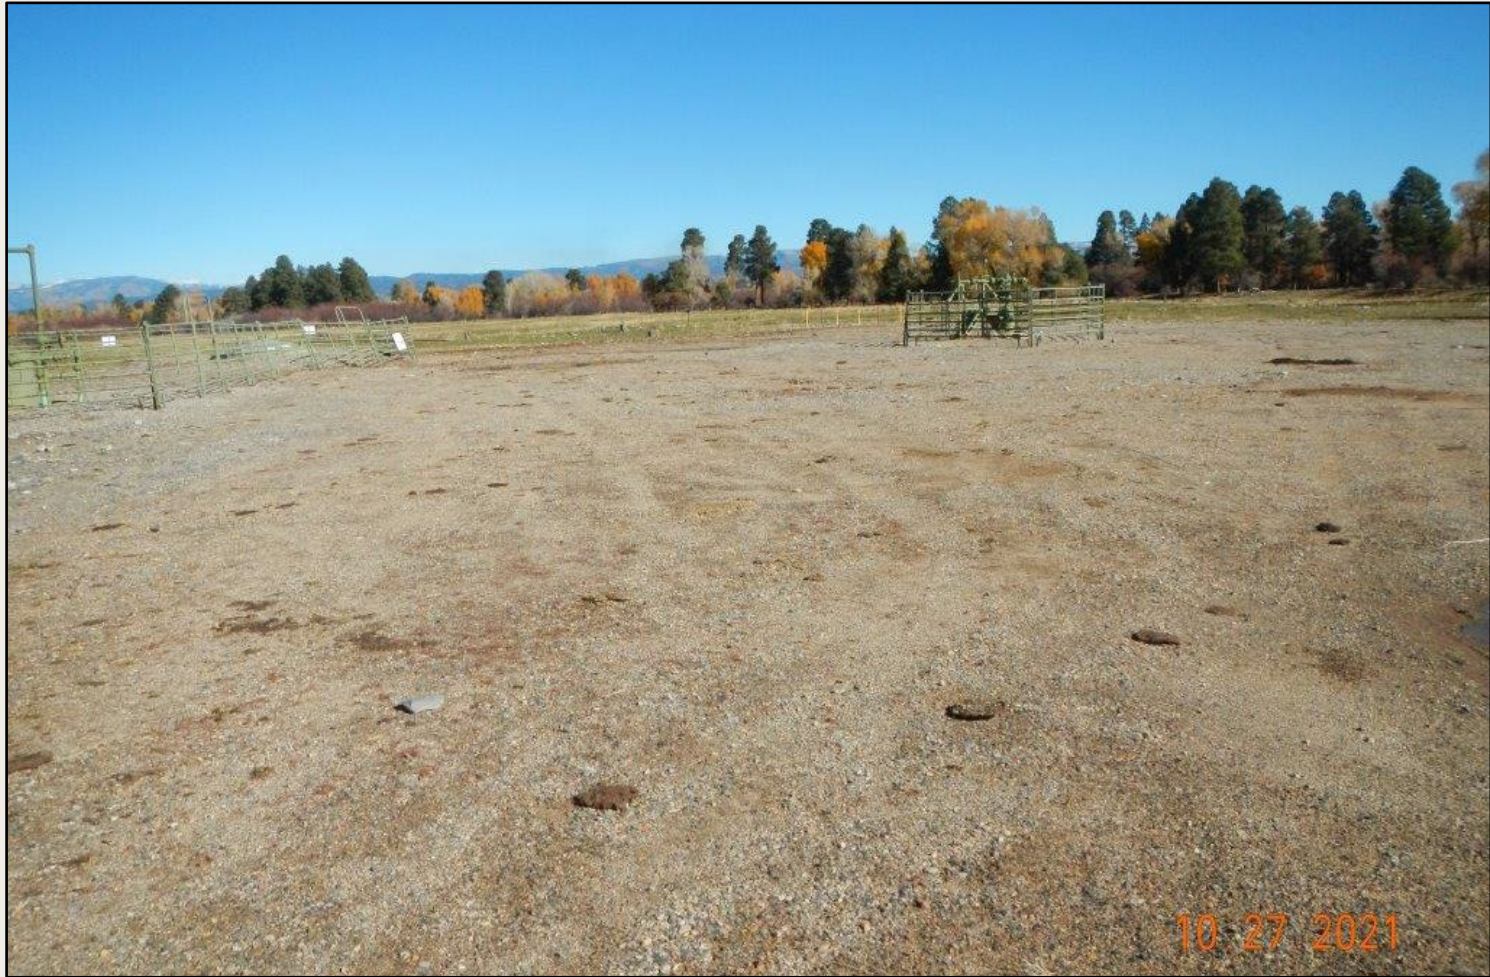
Photo 1. View of the project area from the well pad entrance facing center.

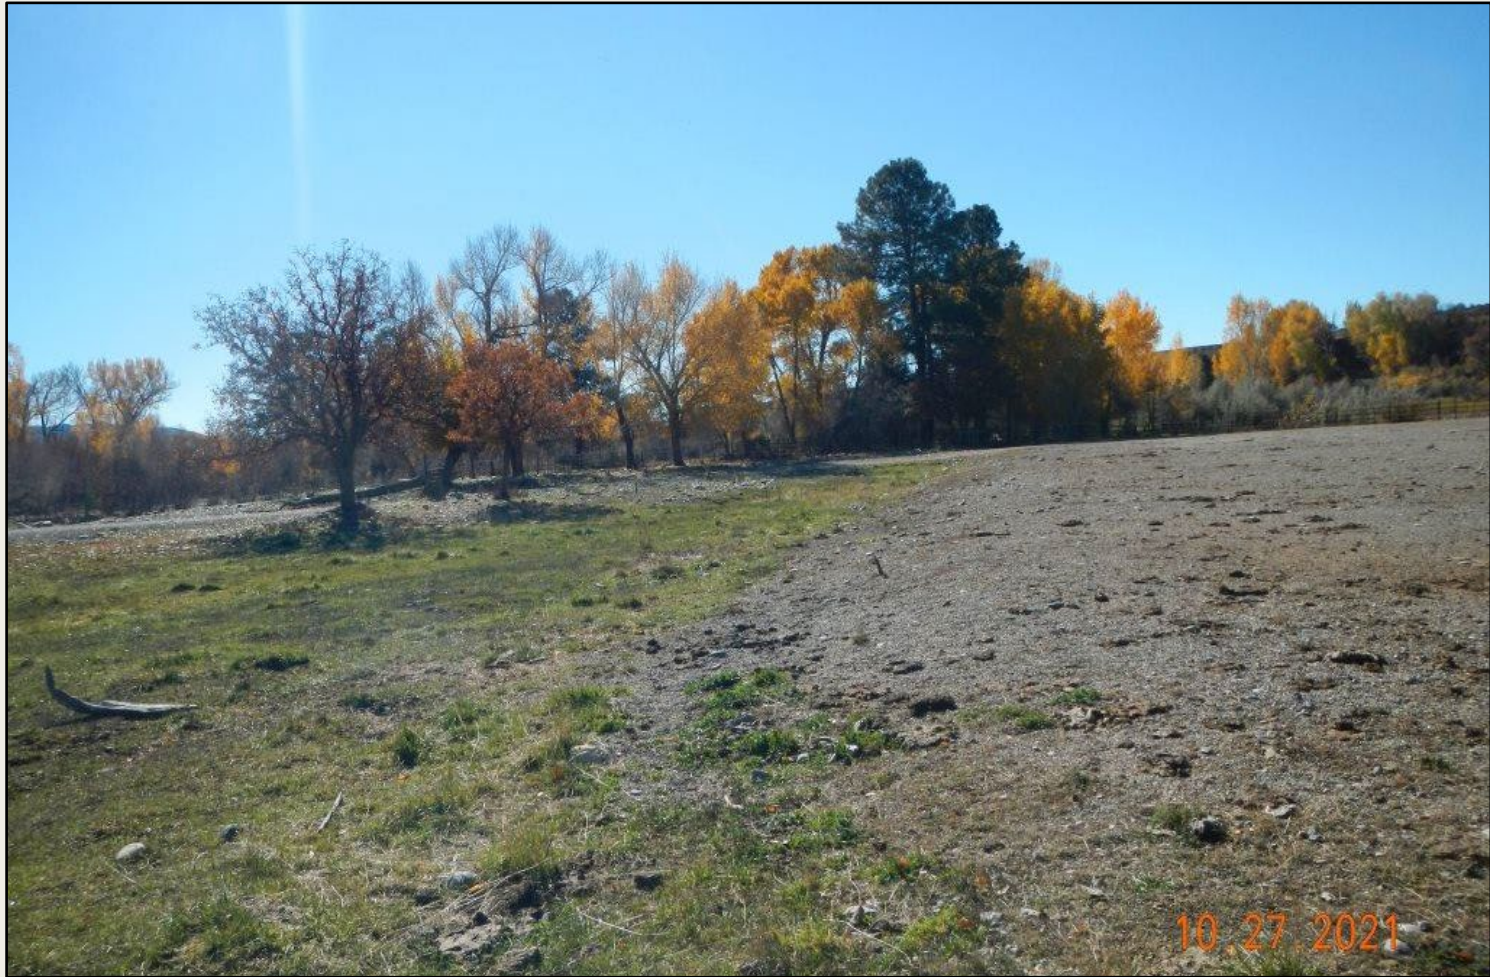
Photo 2. View of the eastern project area from the northeastern corner facing southward. Revegetation is progressing with grasses, largely in a grazed condition.

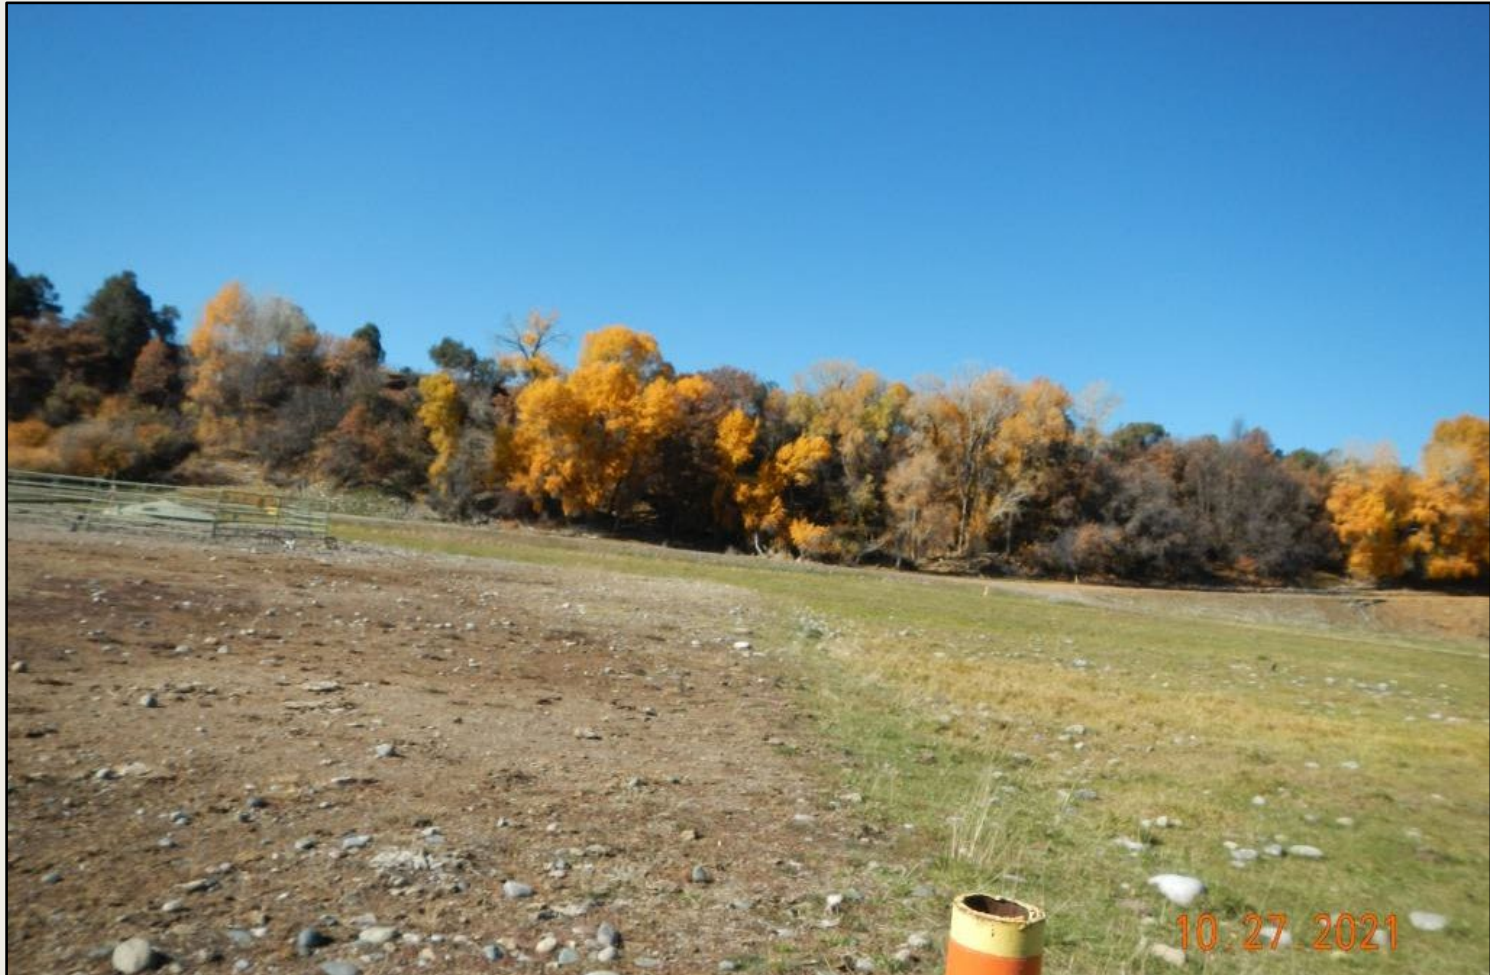
Photo 3. View of the northern project area from the northeastern corner facing westward.

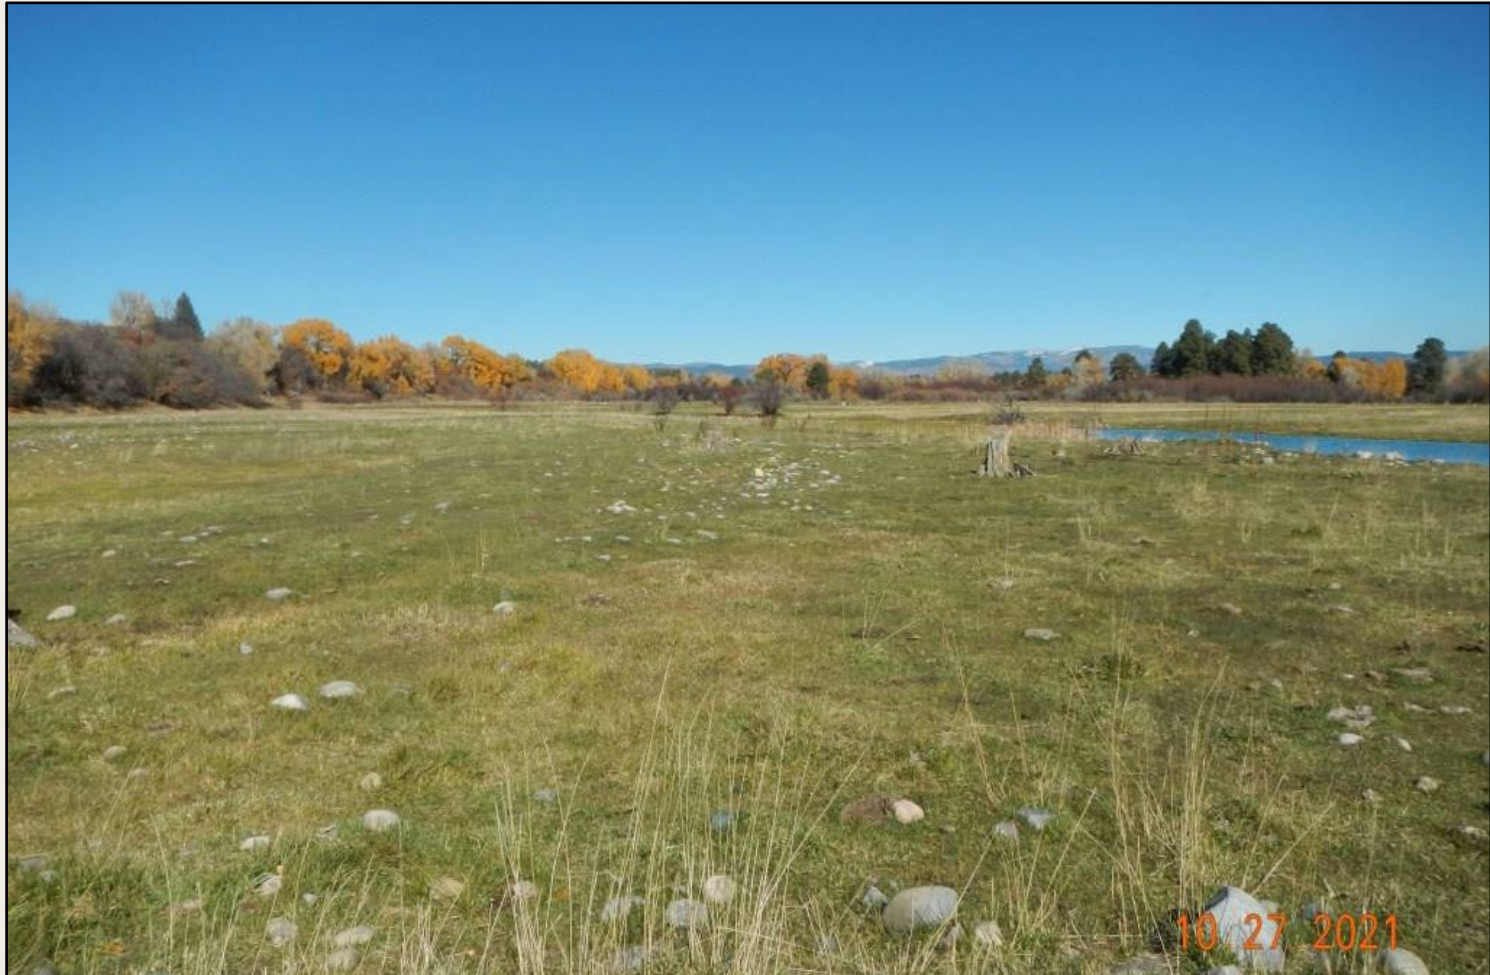
Photo 4. View of the reference area comprised of irrigated grass field with grasses such as meadow brome, orchard grass, perennial rygrass, as well as riparian shrubs and trees such as cottonwoods and willows.
