Inspection Photos

API: 061-05143

Operator: WESTERN OPERATING COMPANY

Inspection Date: 10/27/2021

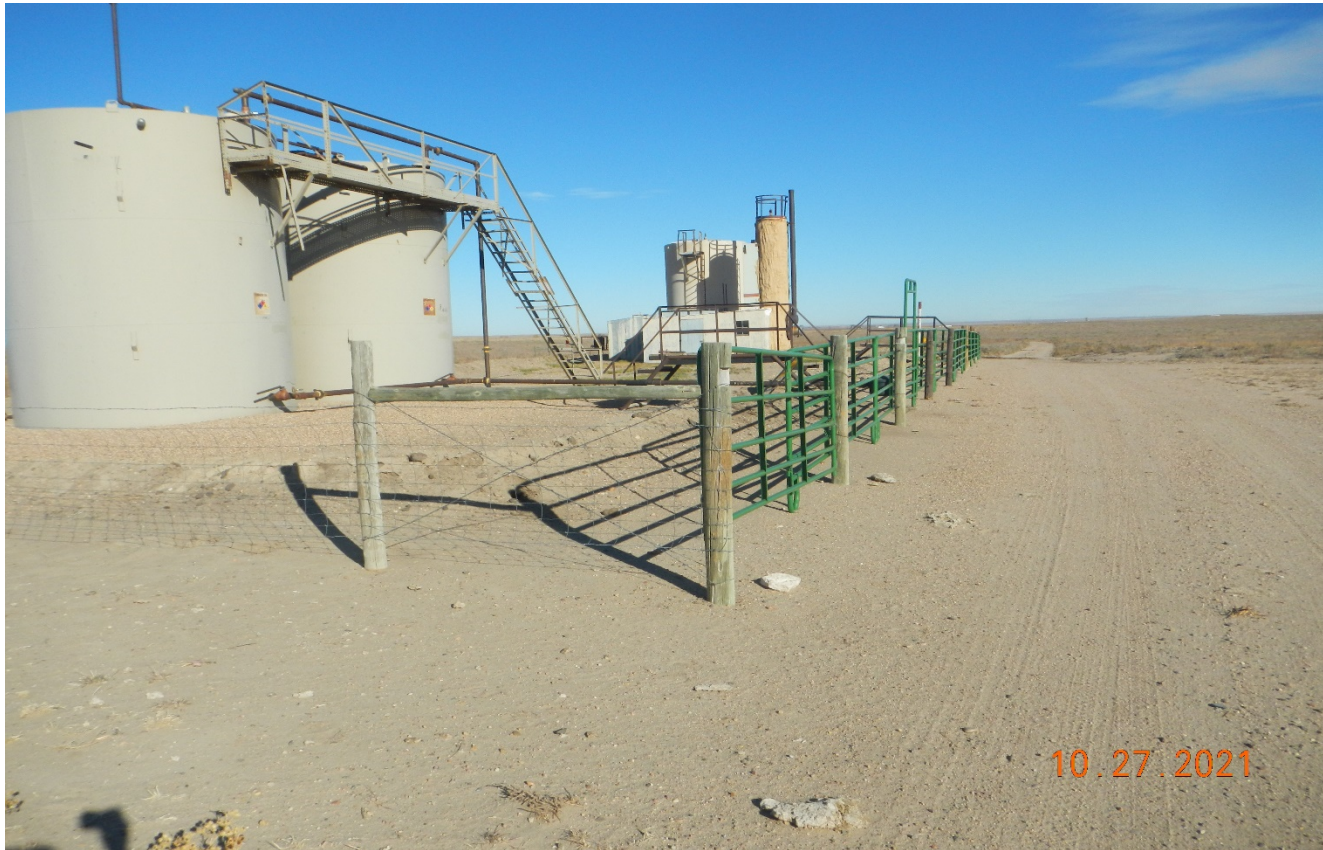
Photo 1. Facing northwest toward the tank battery.

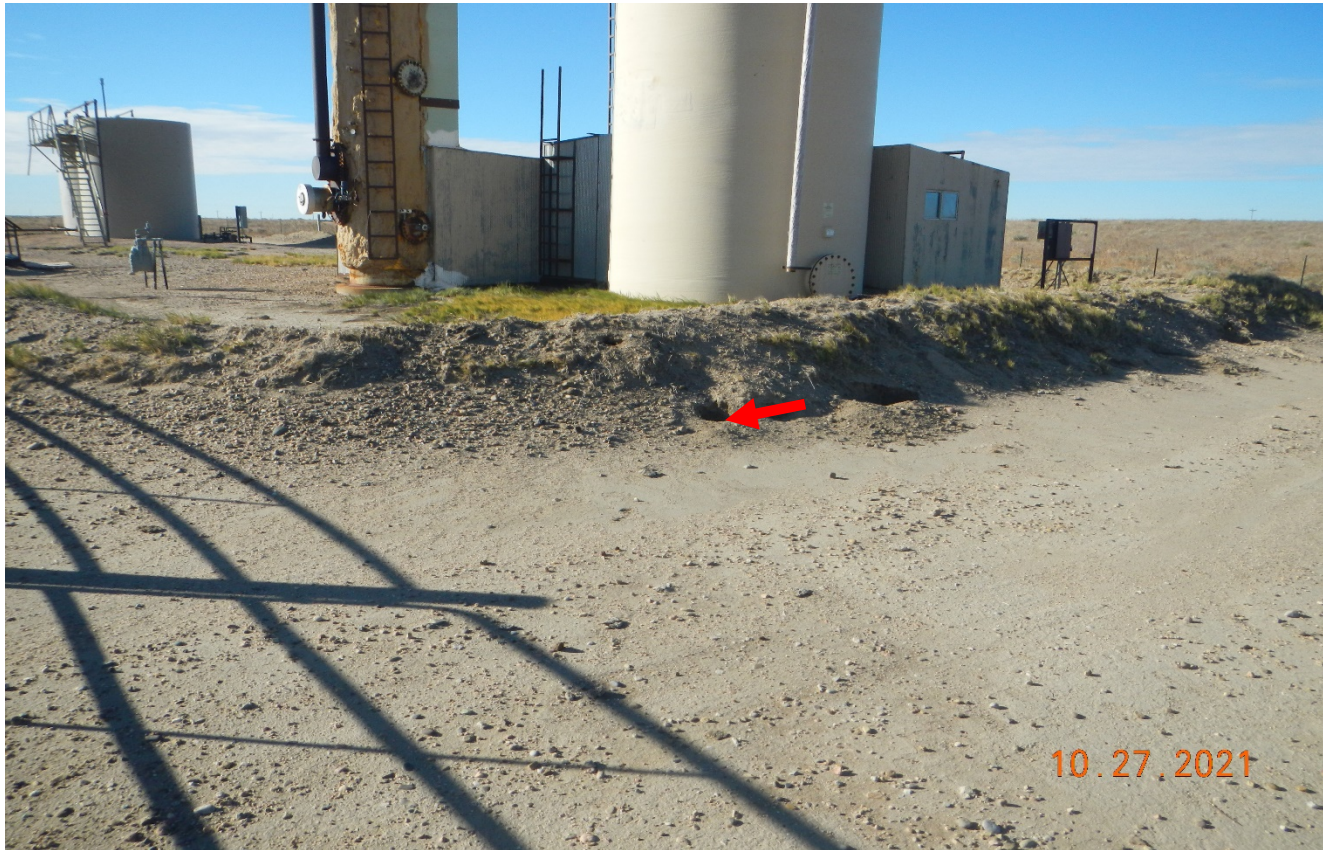
Photo 2. There is animal burrows compromising the berm around the tank battery. The secondary containment is not sufficiently impervious to contain spill. Earthen berms need to be repaired and compacted.

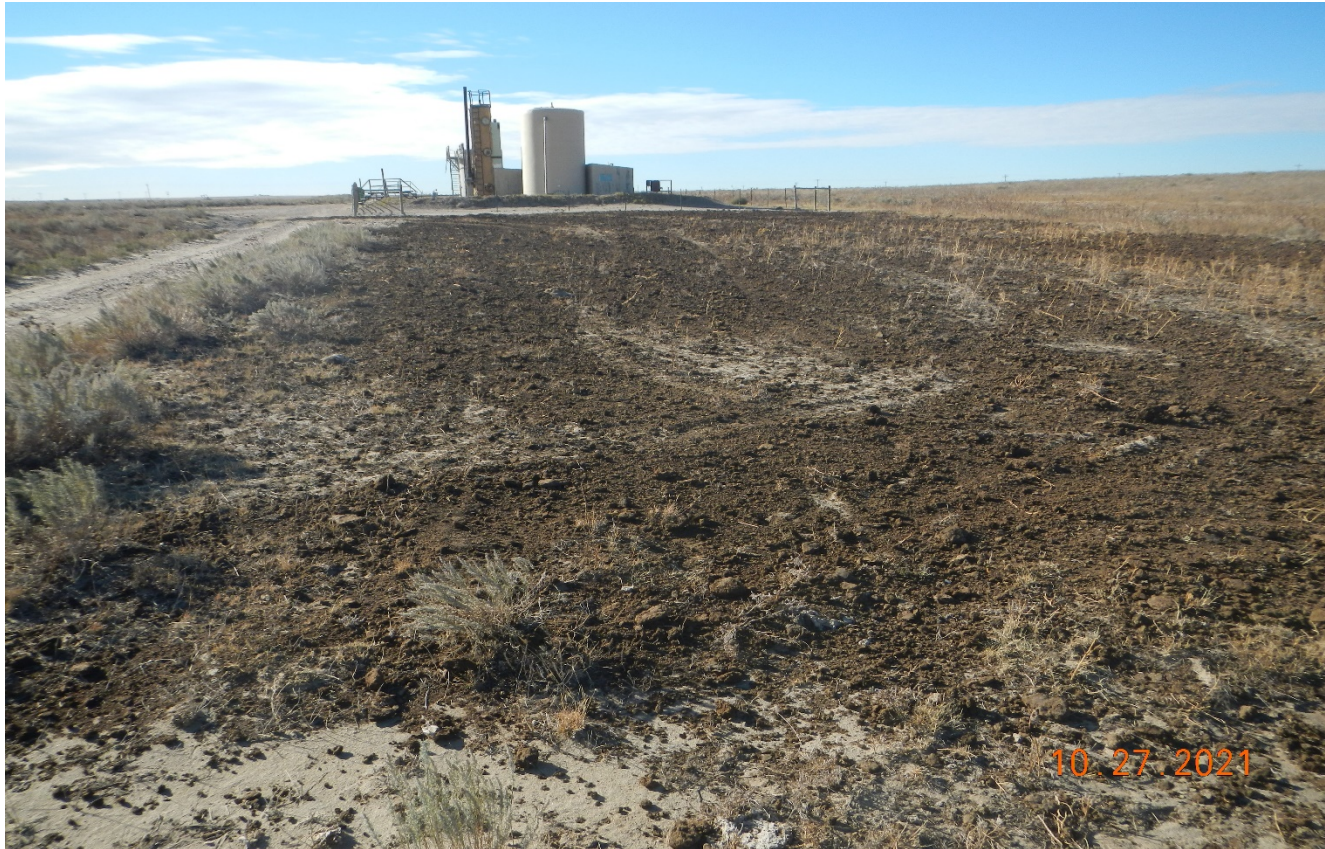
Photo 3. Facing south approximately 180' downhill from the tank battery. A former spill had occurred in this area as shown by bare soils. It appears manure was spread throughout this area. The soils in this area need to be sampled to determine impacted soil properties.

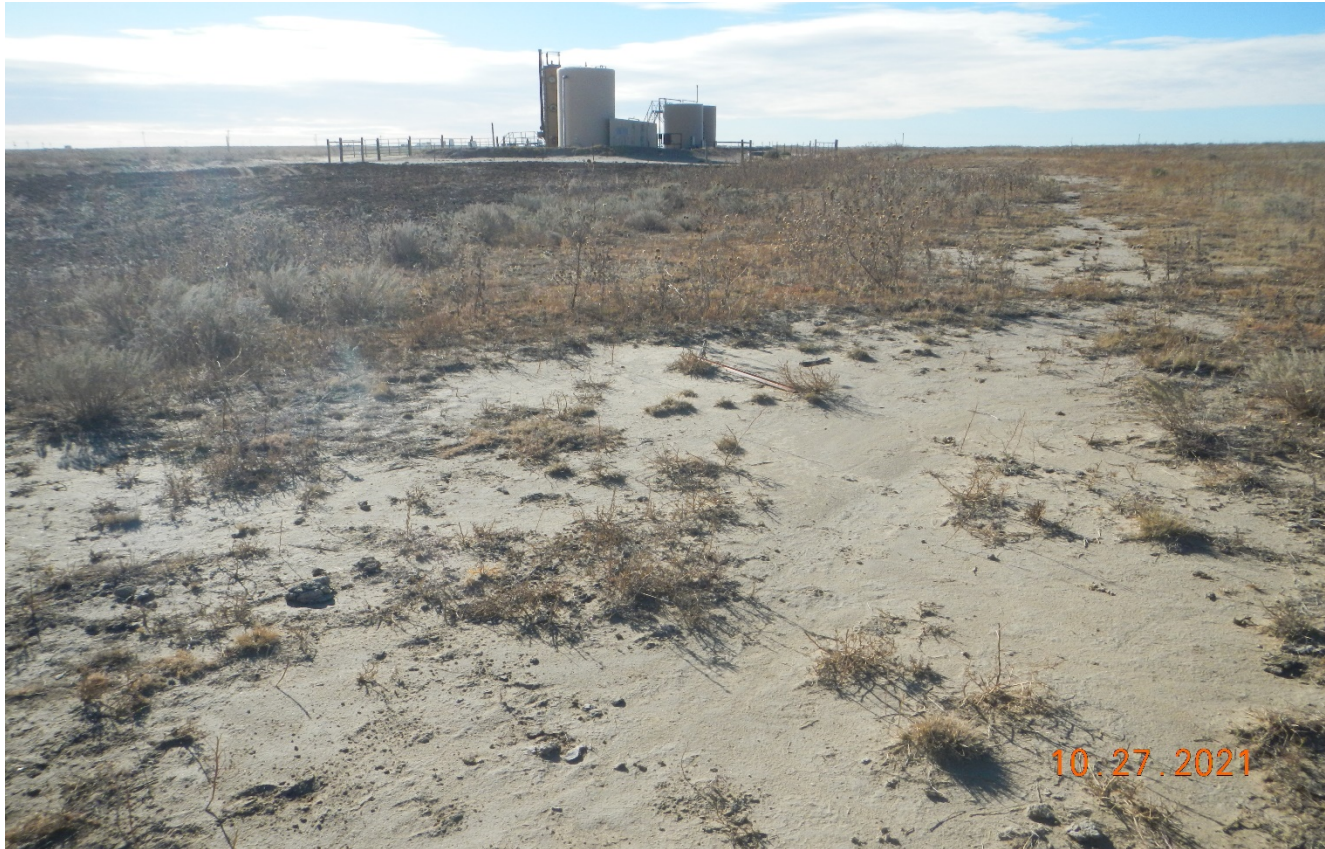
Photo 4. Facing southeast approximately 180' downhill from the tank battery. A former spill had occurred in this area as shown by bare soils. The soils in this area need to be sampled to determine impacted soil properties per 915.b.

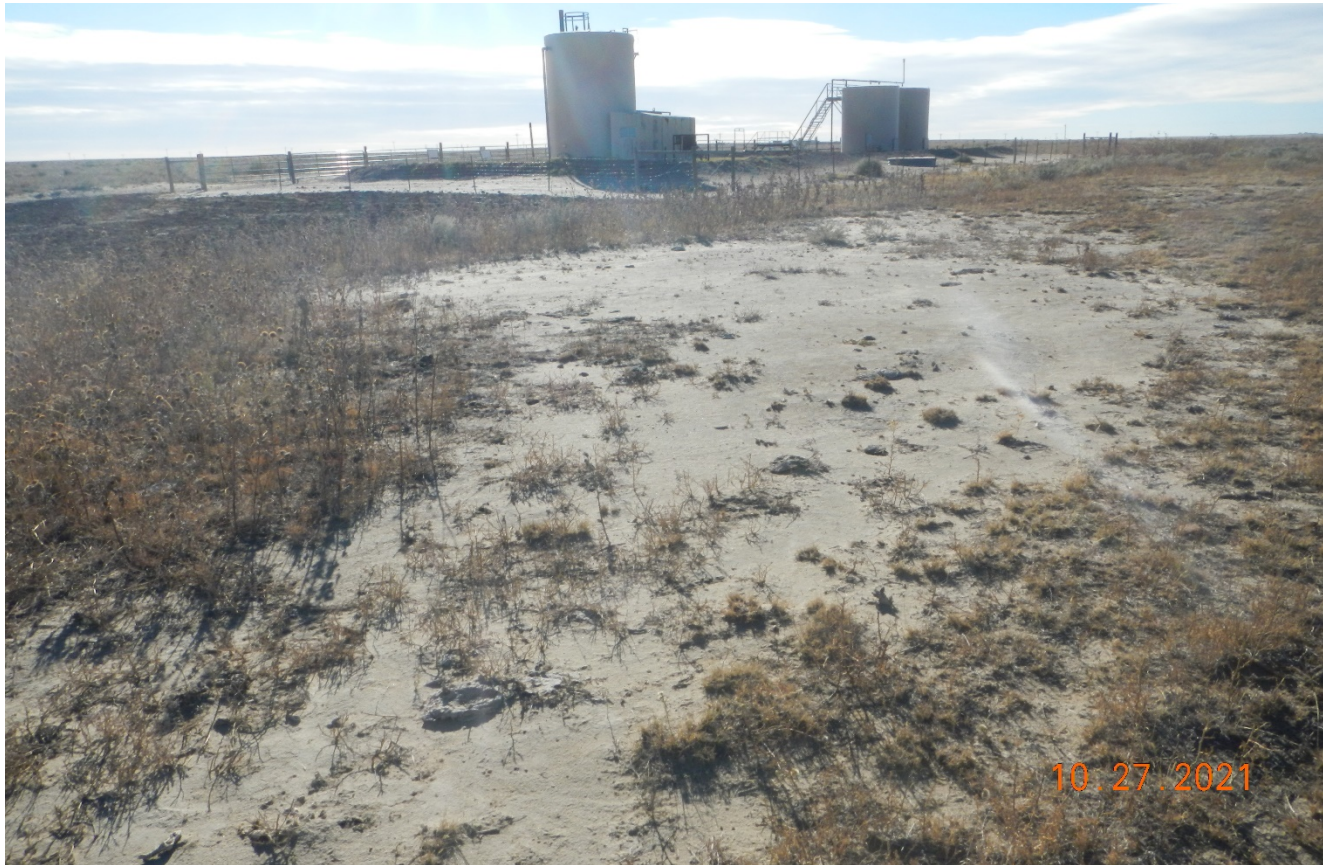
Photo 5. Facing southeast downhill from the tank battery. A former spill had occurred in this area as shown by bare soils. The soils in this area need to be sampled to determine impacted soil properties per 915.b.

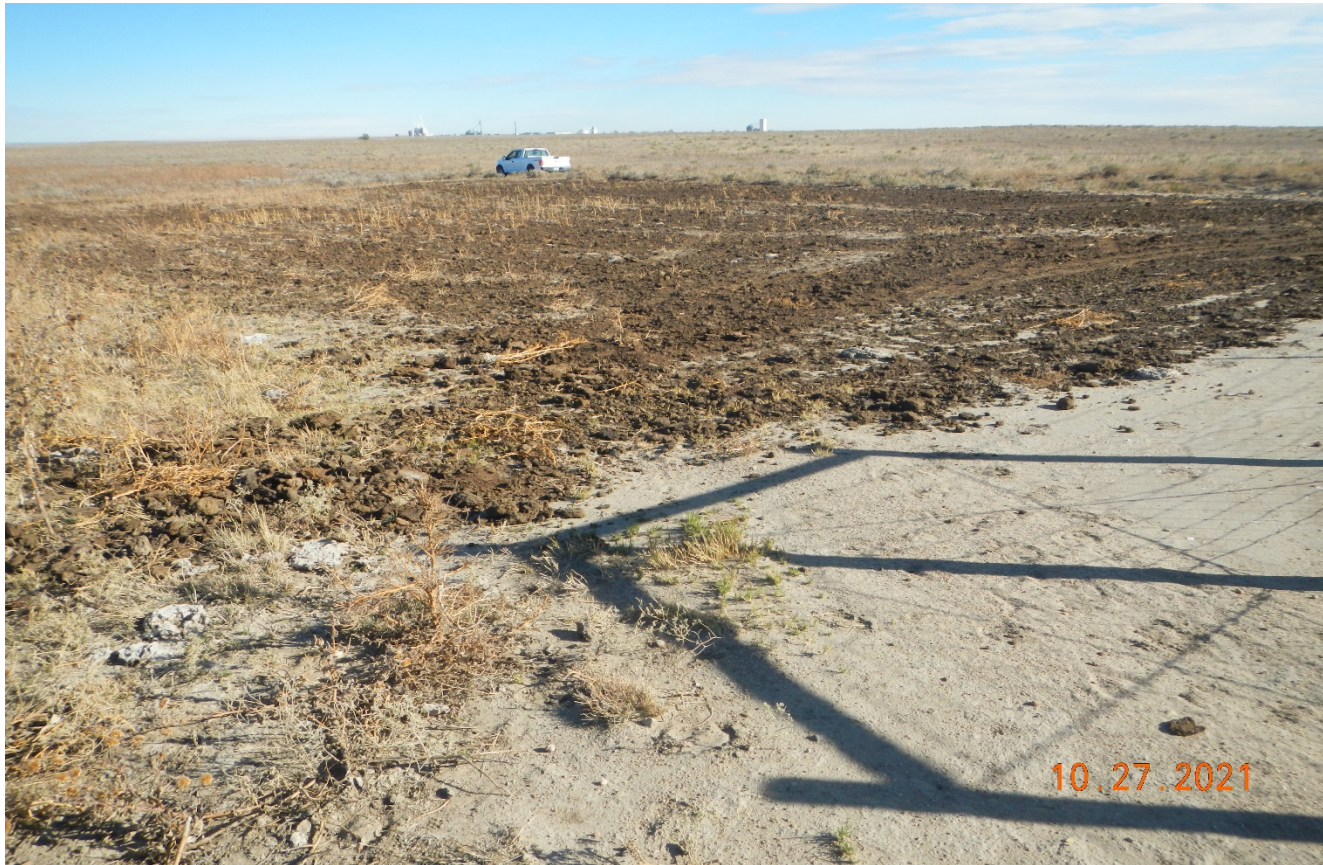
Photo 6. Facing northeast toward the area where manure was spread. The application of uncomposted manure will likely bring in undesirable weeds into this area. This location will need to be monitored for weed management.

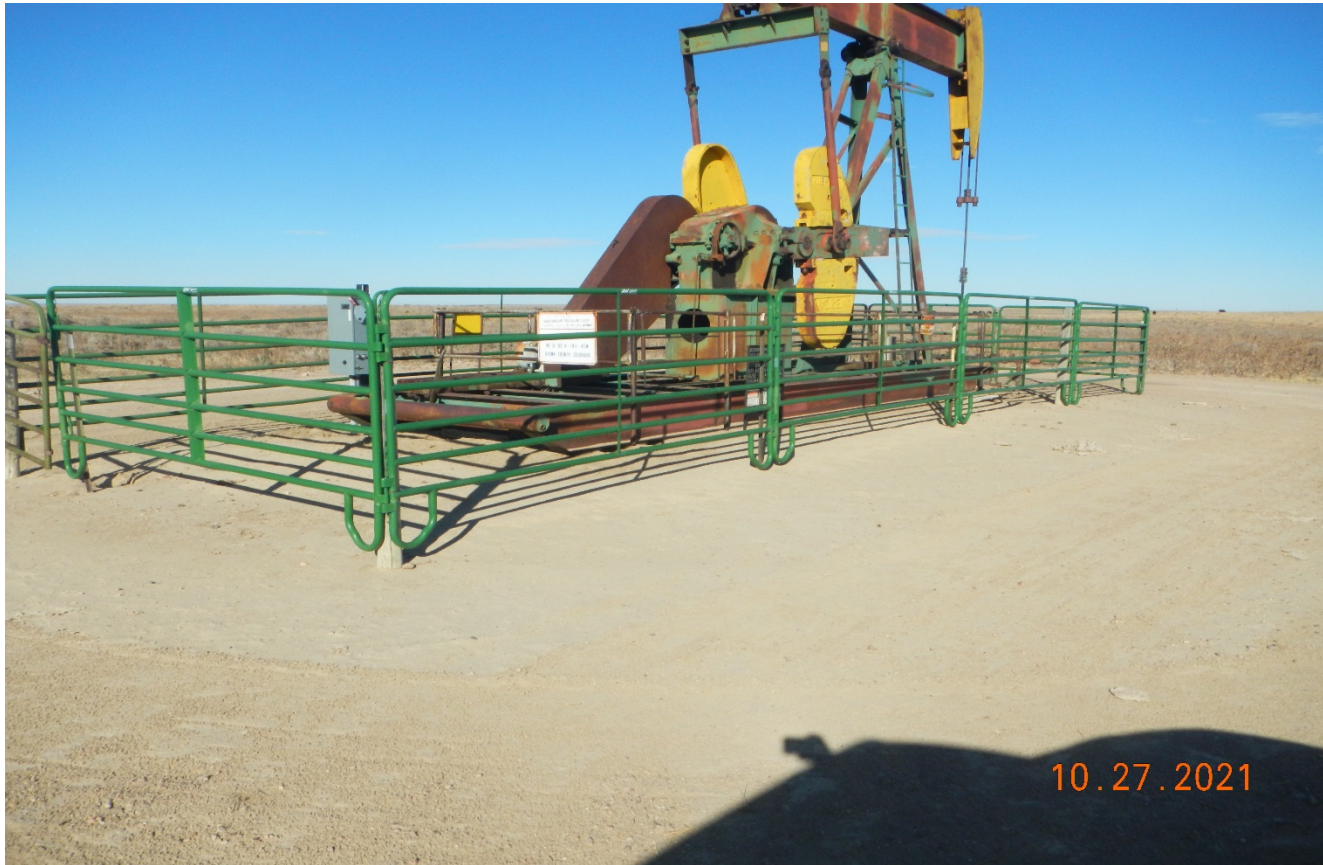
Photo 7. Facing toward the well site which is approximately 800' northwest of the tank battery.
