Inspection Photos
Location Name: Carl A Miller A 4
Location ID: 318365

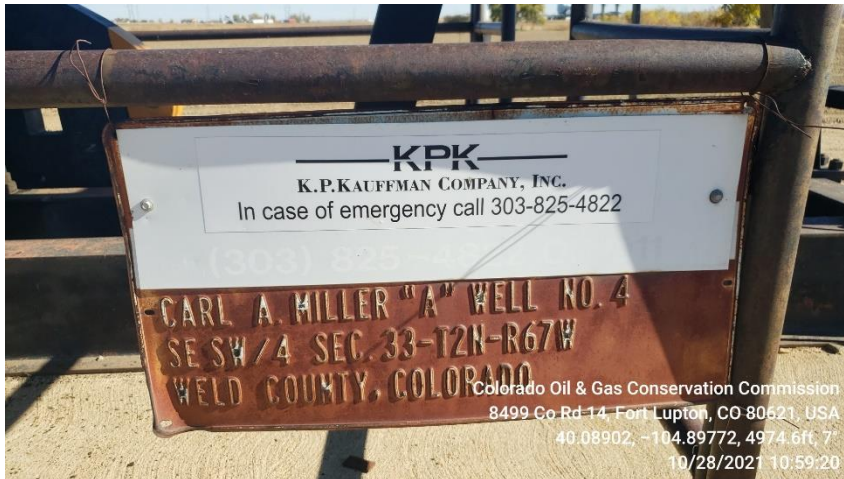
Photo 1 WH sign

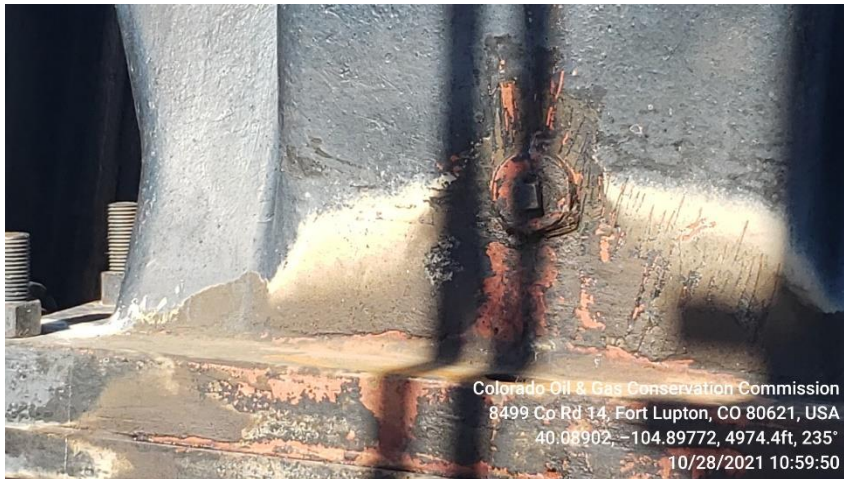
Photo 5 plug has been tightened and leak stopped.

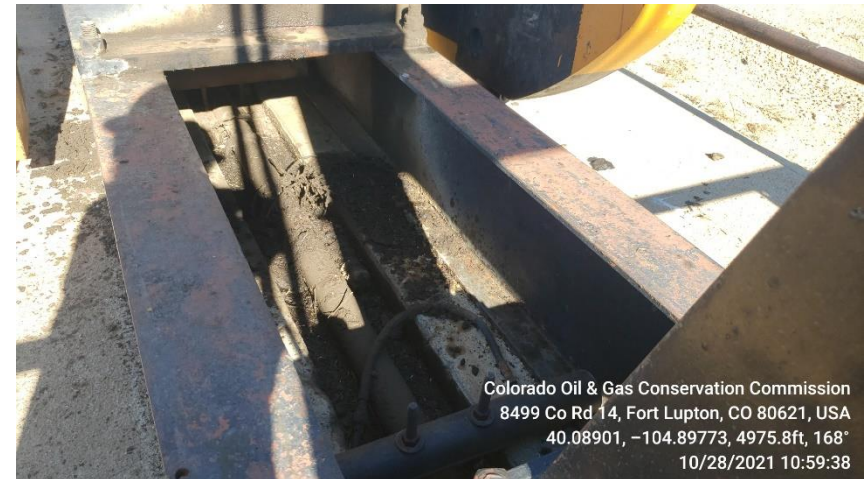
Photo 6 Stained soil between pump jack concrete slabs
