Inspection Photos
Location Name: Marie Gerhardt B2
Location ID: 317863

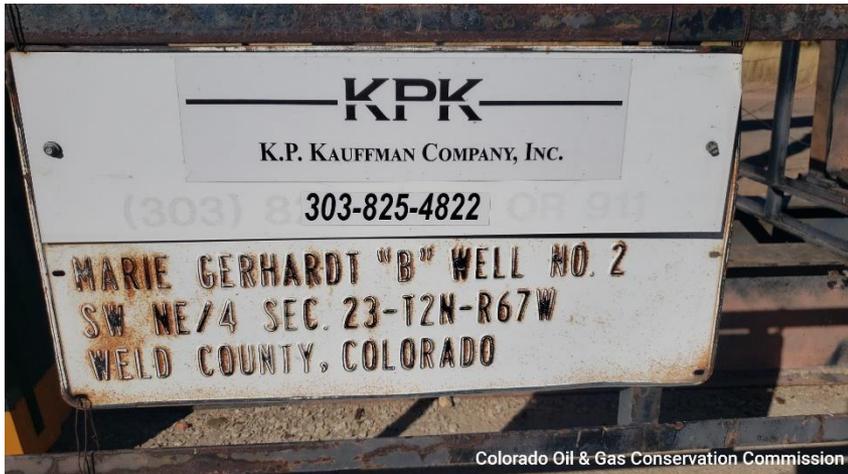
Photo 1 WH sign

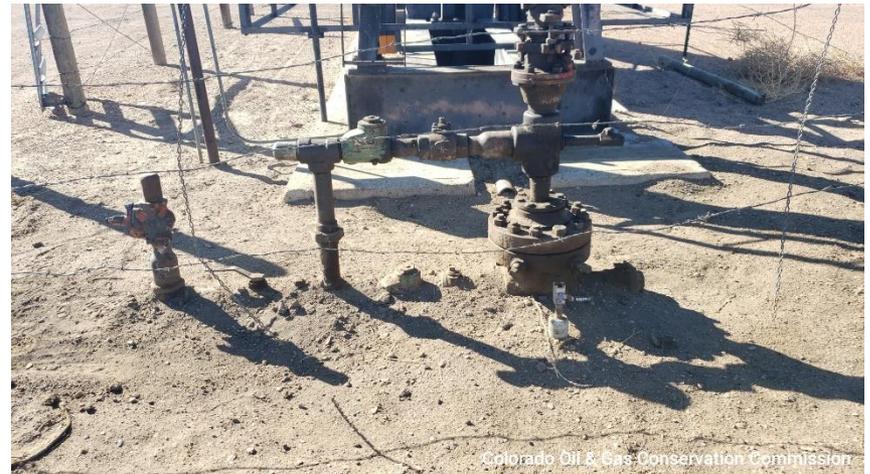
Photo 2 Stained soil and weeds have been removed from around WH

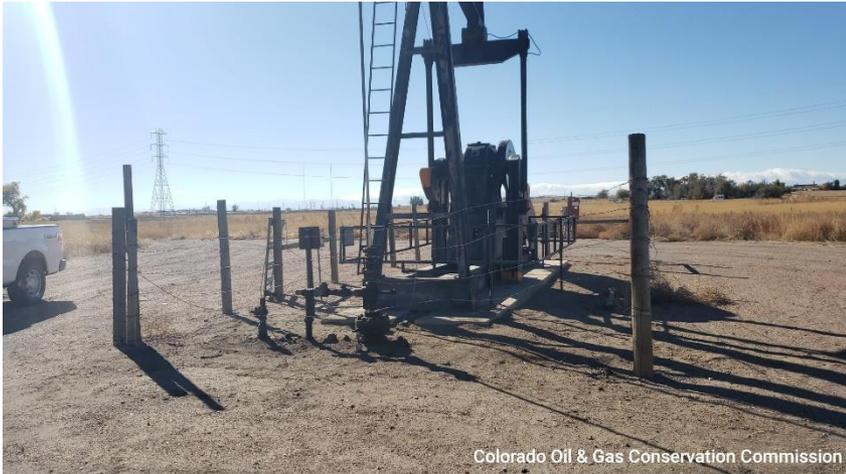
Photo 3 Pump Jack

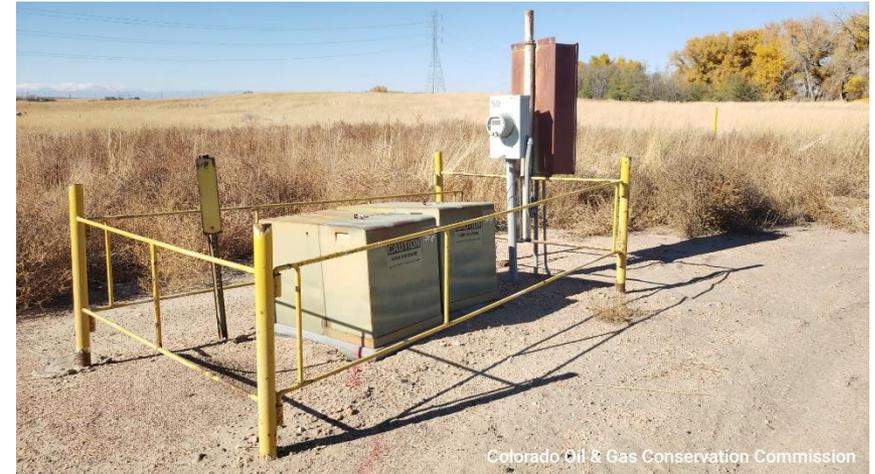
Photo 4 Ancillary equipment

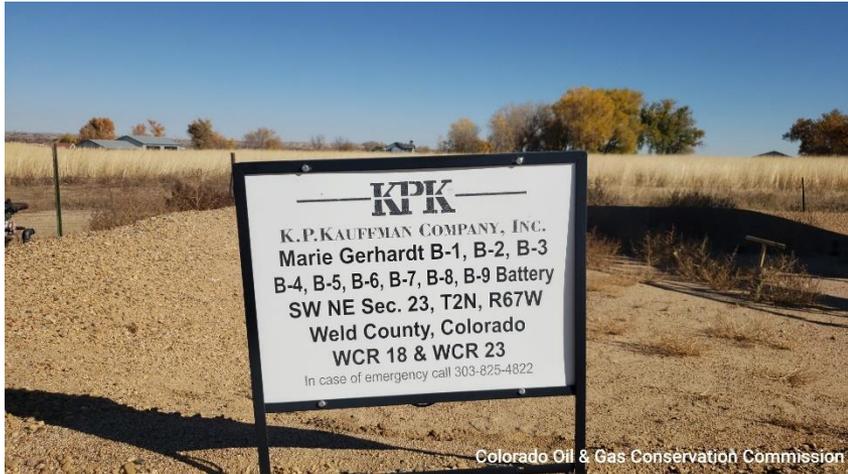
Photo 5 TB sign

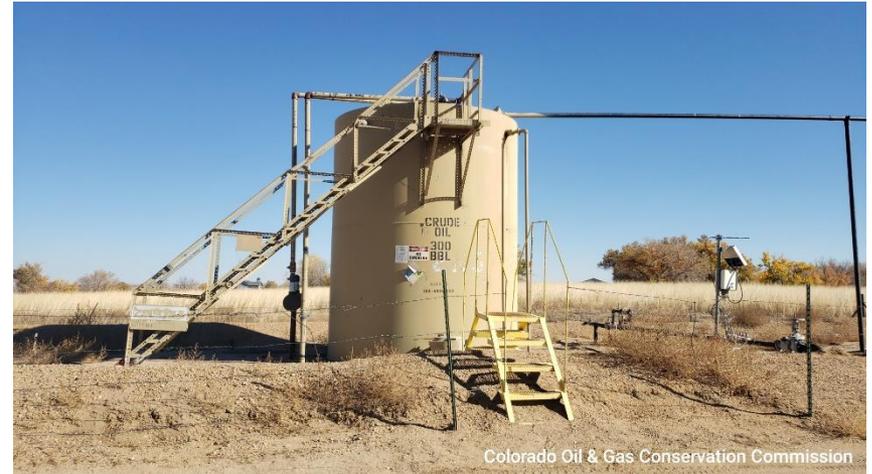
Photo 6 TB

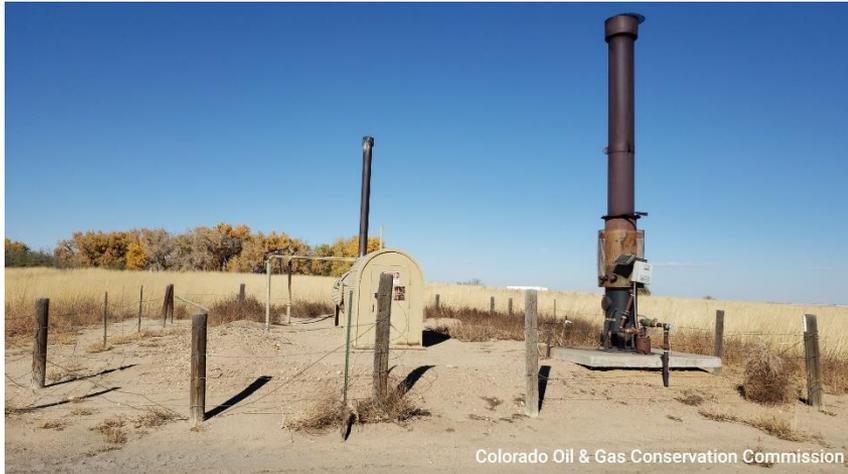
Photo 7 ECD and Horiz. Heated Sep. dead weeds inside fencing

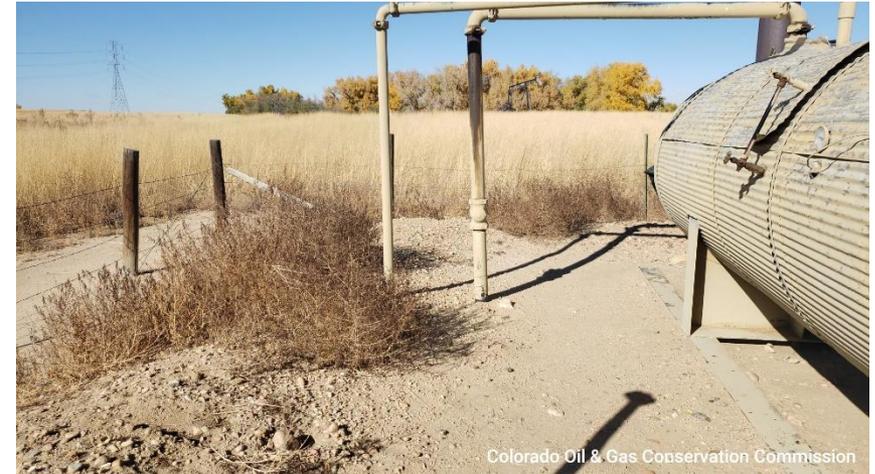
Photo 8 dead weeds inside fencing by Horiz. Heated Sep.

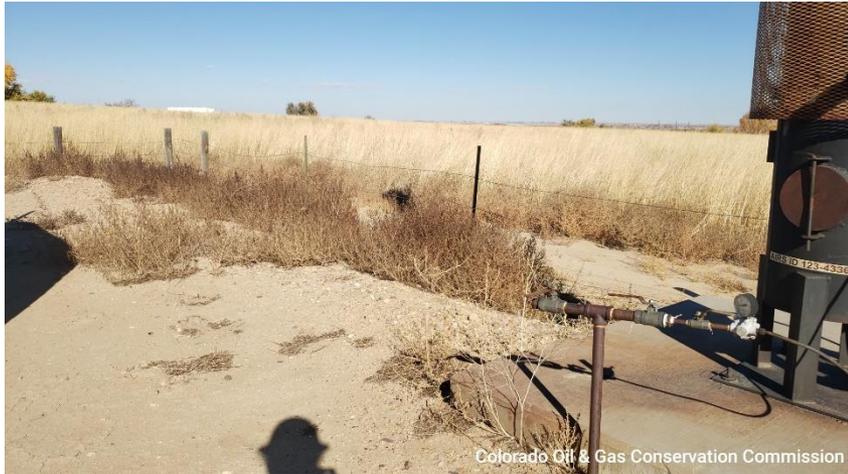
Photo 9 dead weeds inside fencing by ECD

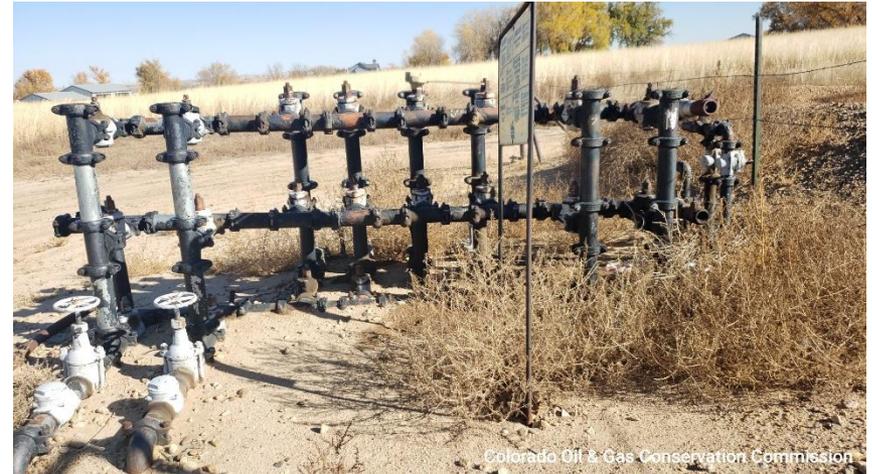
Photo 10 dead weeds by flow line manifold.

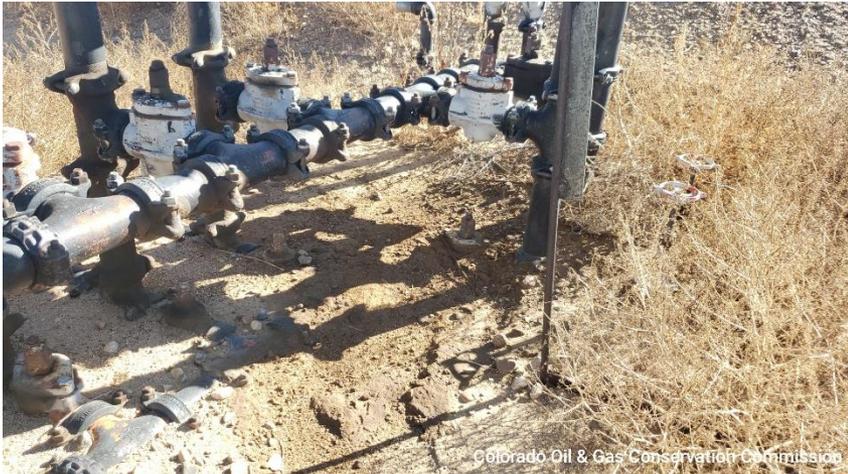
Photo 11 dead weeds and stained soil by flow line manifold

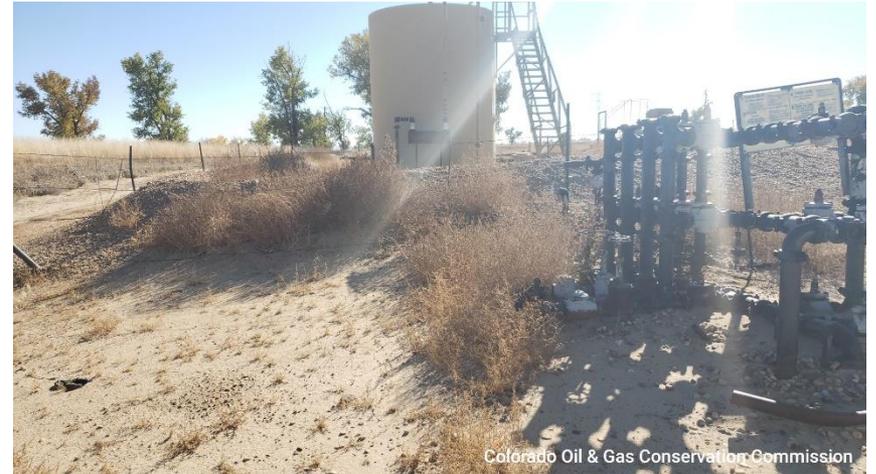
Photo 12 dead weeds by flow line manifold and on TB berm

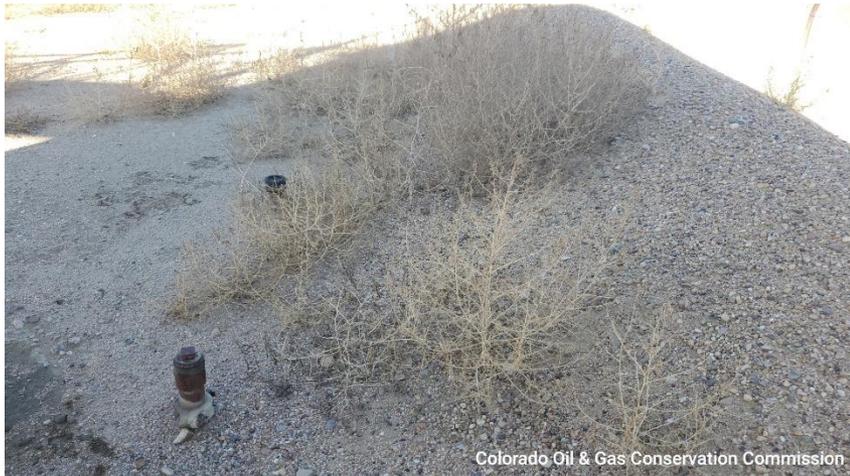
Photo 13 dead weeds inside TB berm

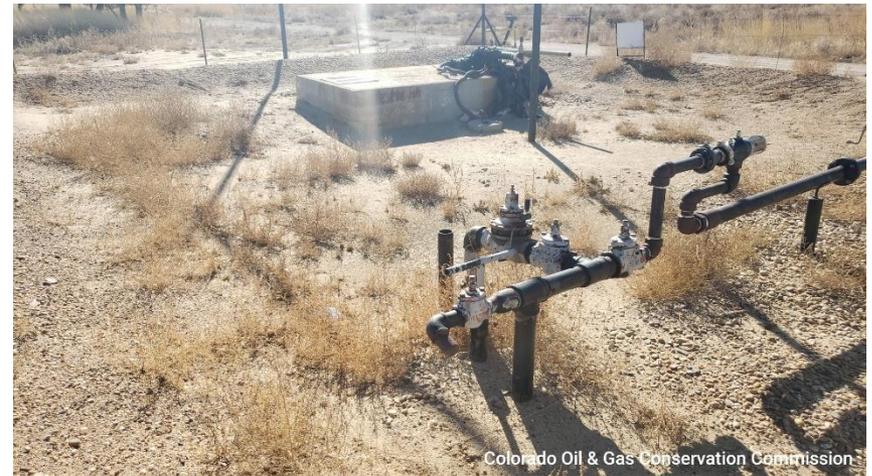
Photo 14 dead weeds by Gas Meter Run inside TB berm

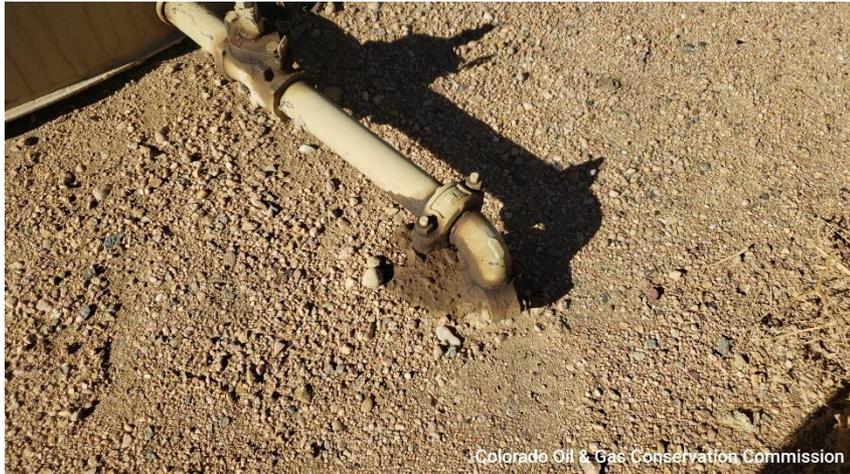
Photo 15 stained soil by Crude tank flow line

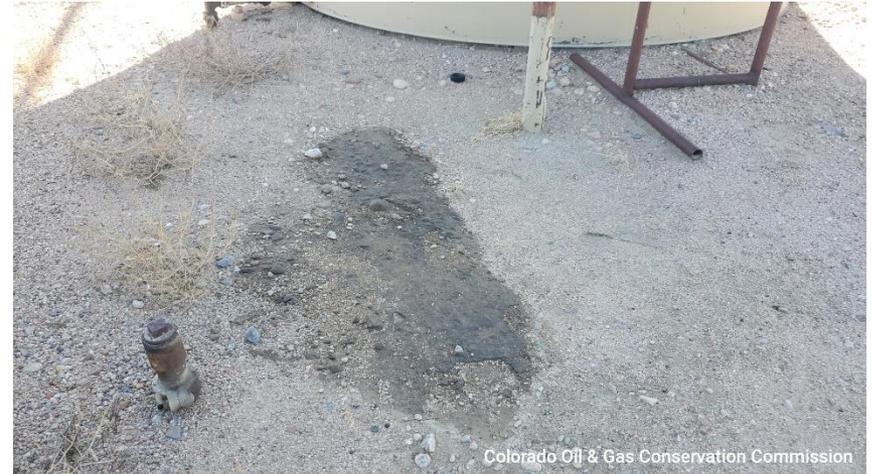
Photo 16 stained soil by Crude tank

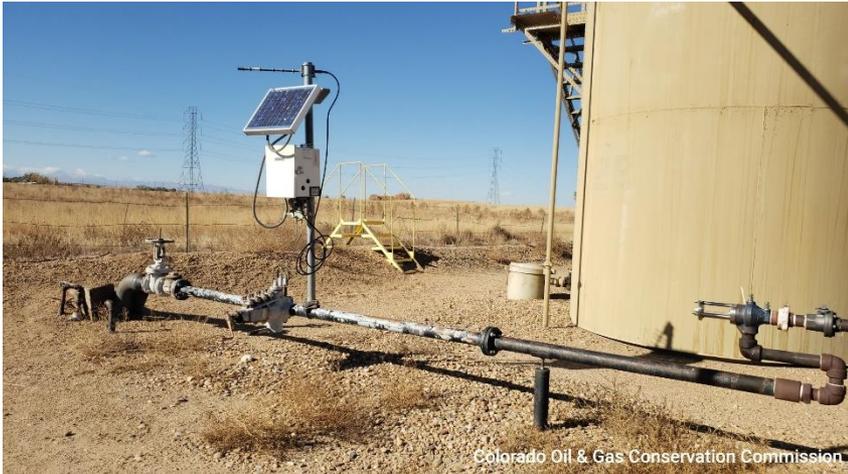
Photo 17 Gas Meter Run

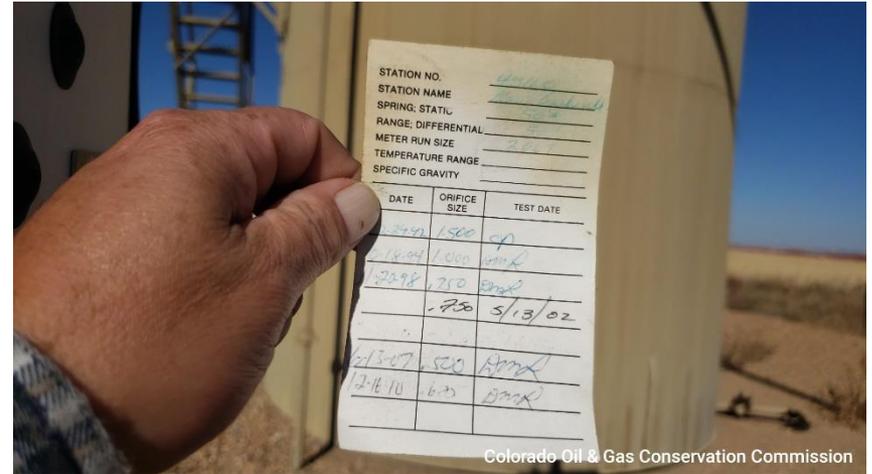
Photo 18 Card in meter box indicates that calibration is not current
