# Final Reclamation Inspection Form

Site: Aloha Mula #16 Jetted  
 Date: 06/22/2021  
 Conditions: 100 F sunny

Inspector: Brian Podobnik

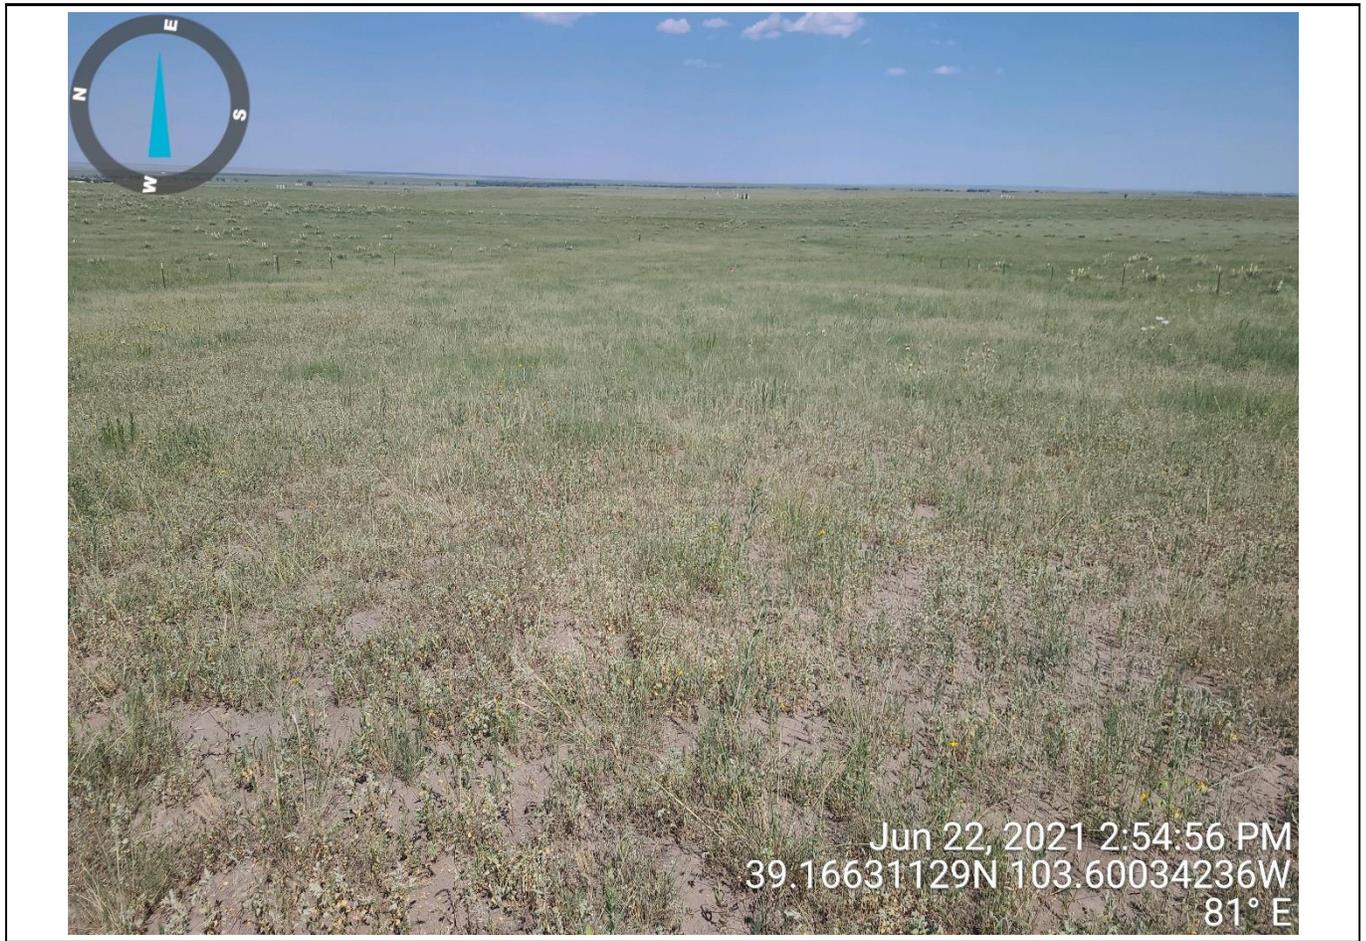
**Photograph 5:** Overview photograph.

Other Comments/Observations: Site was recently mowed. Site appears to have reached 70% uniform vegetation cover.
