# Inspection Photos

API: 043-06219

Operator: AUSCO PETROLEUM INC

Inspection Date: 10/27/2021

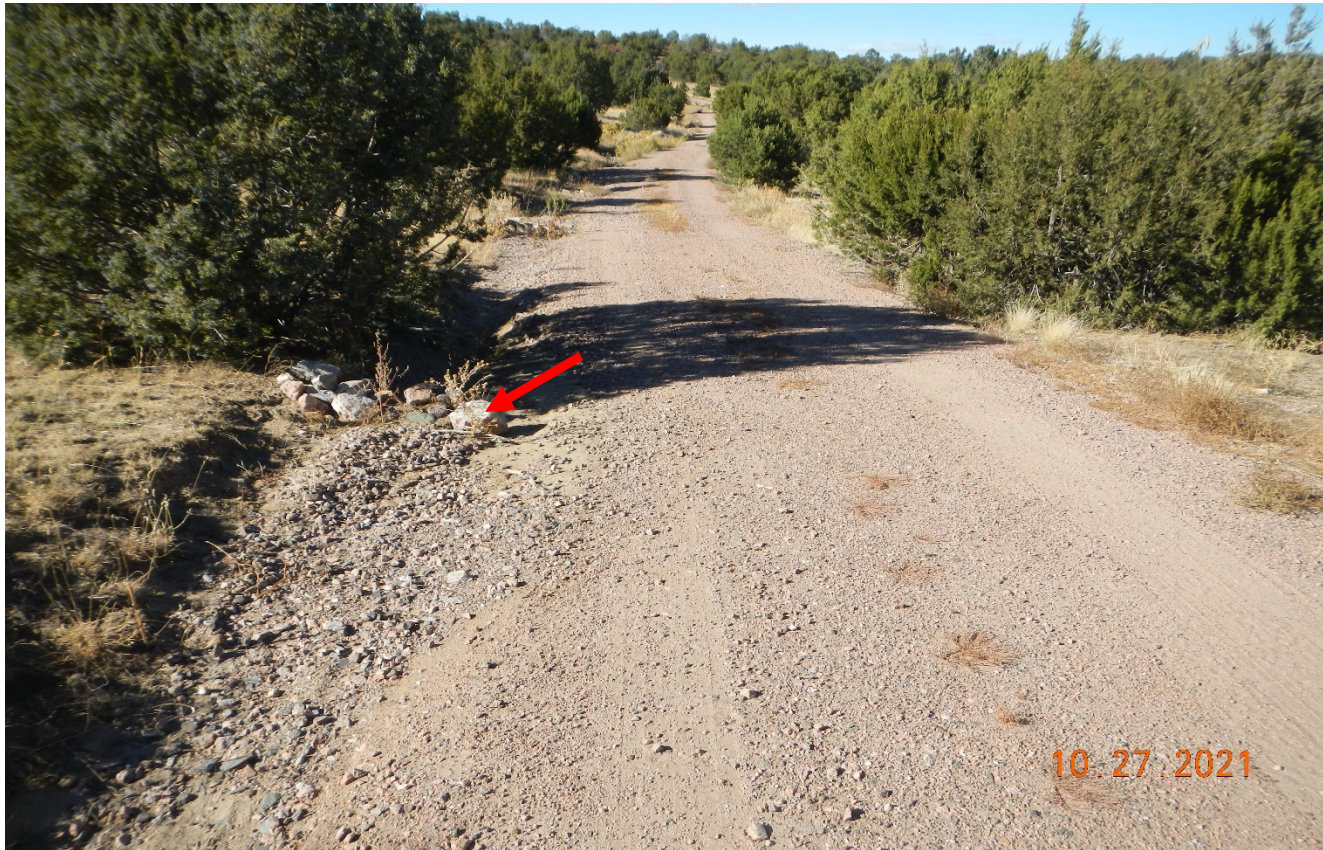
**Photo 1.** Facing northwest along the access road. The check dams along the road have filled in with sediment and need to be maintained.

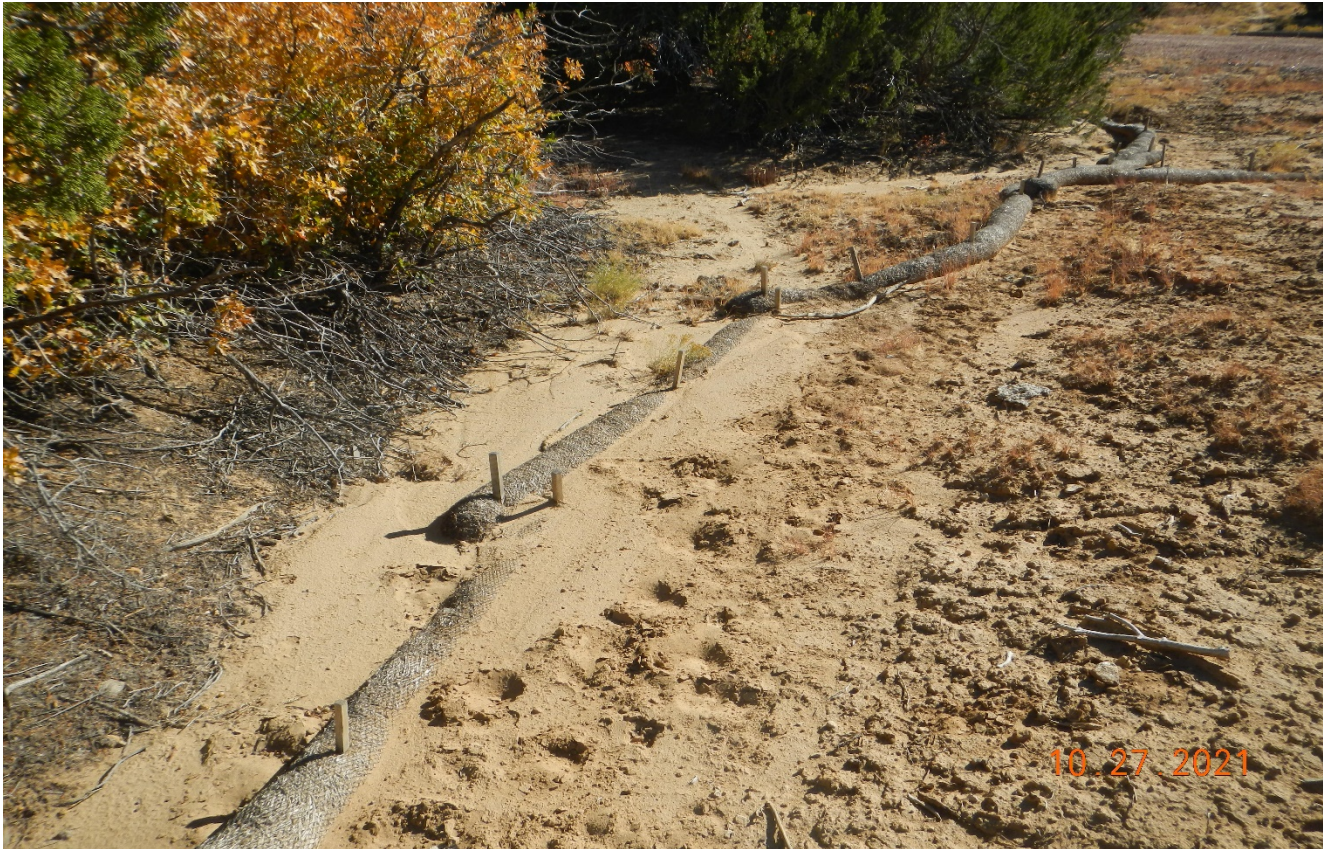
**Photo 2.** There are wattles along the access road that are filled in with sediment and not maintained.

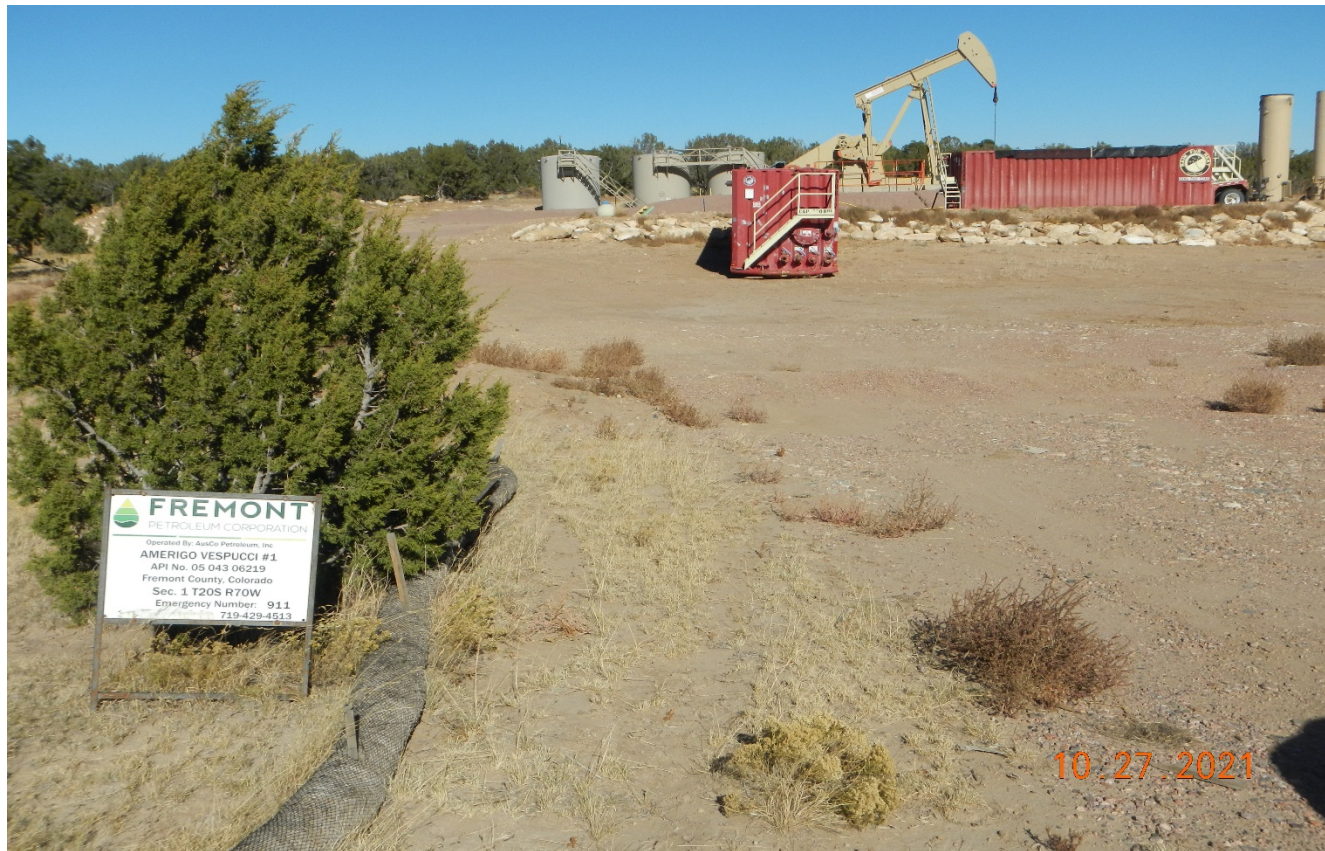
**Photo 3.** Facing northeast toward the location. Unused equipment has not been removed and interim reclamation has not been performed.

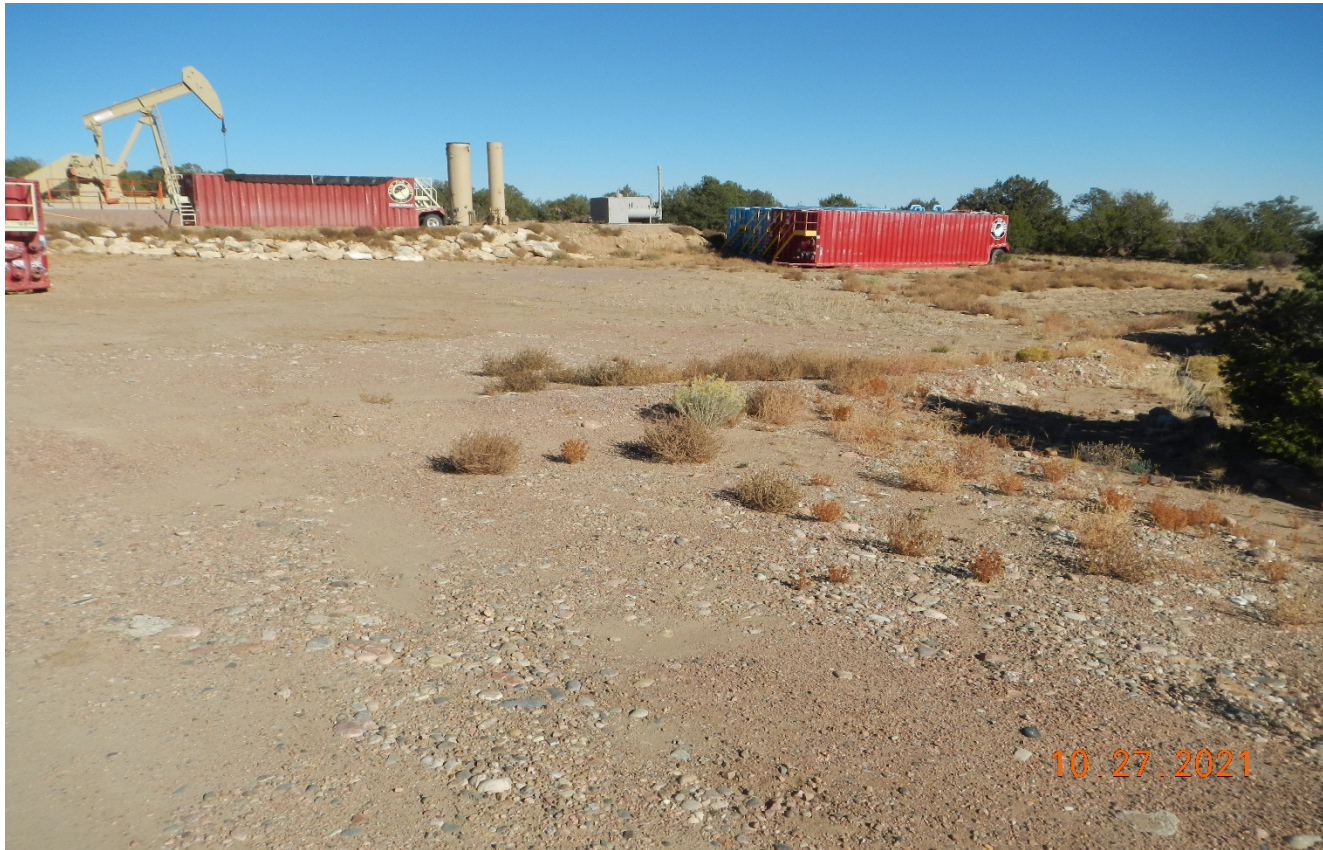
**Photo 4.** Facing northeast at the location. There are 5 frac tanks staged that remain at east side of the location. The tanks have not been removed since previous inspection. Previous corrective actions have not been performed.

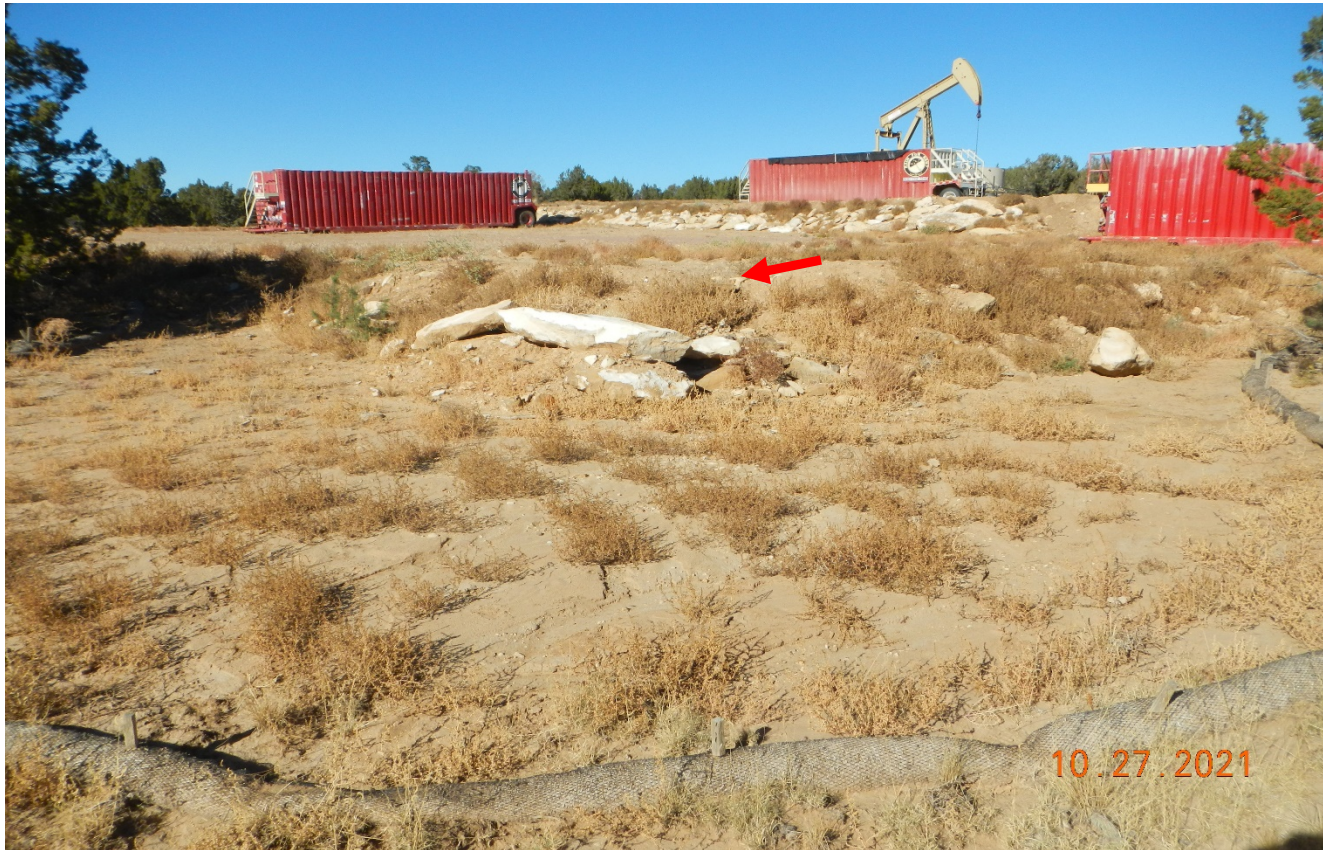
**Photo 5.** Facing north at the south corner of the location. There is erosion occurring from the disturbed pad site which is filling in the perimeter wattles. Previous corrective action has not been performed.

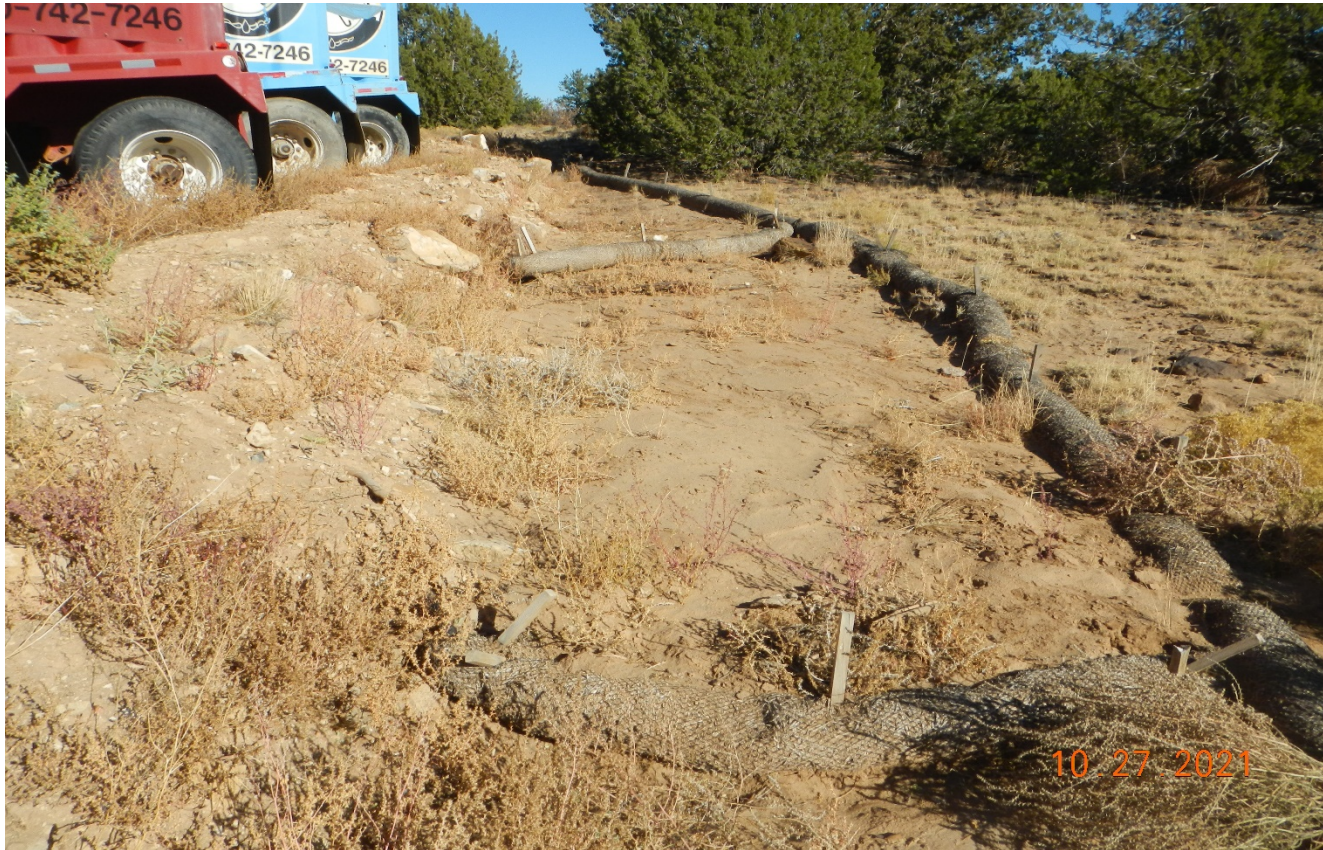
**Photo 6.** Facing southwest behind the frac tanks. The wattles have filled in with sediment. Previous corrective action has not been performed.

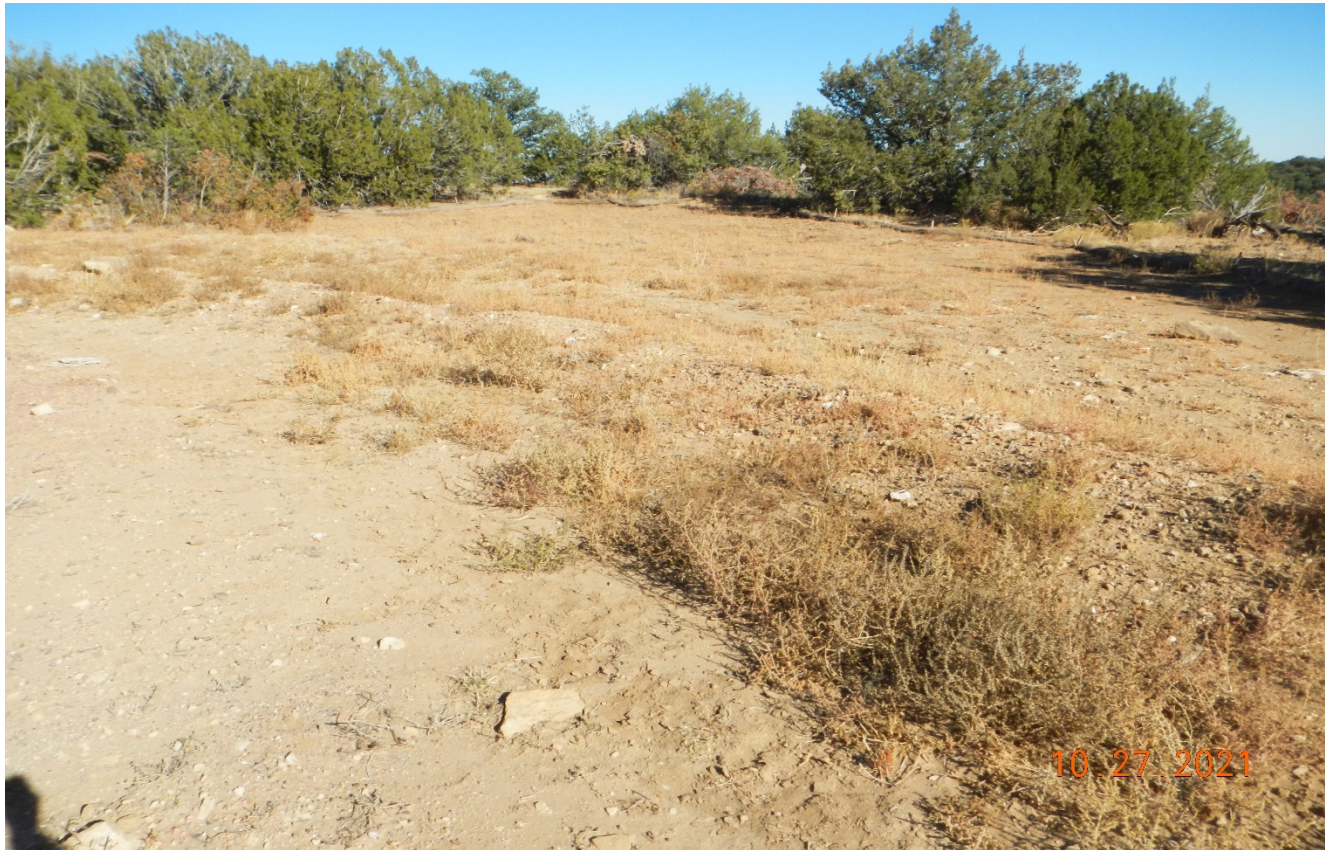
**Photo 7.** Facing northeast at the location. Disturbed areas around the location have not been reclaimed and stabilized. There are undesirable weeds that have grown throughout disturbed areas.

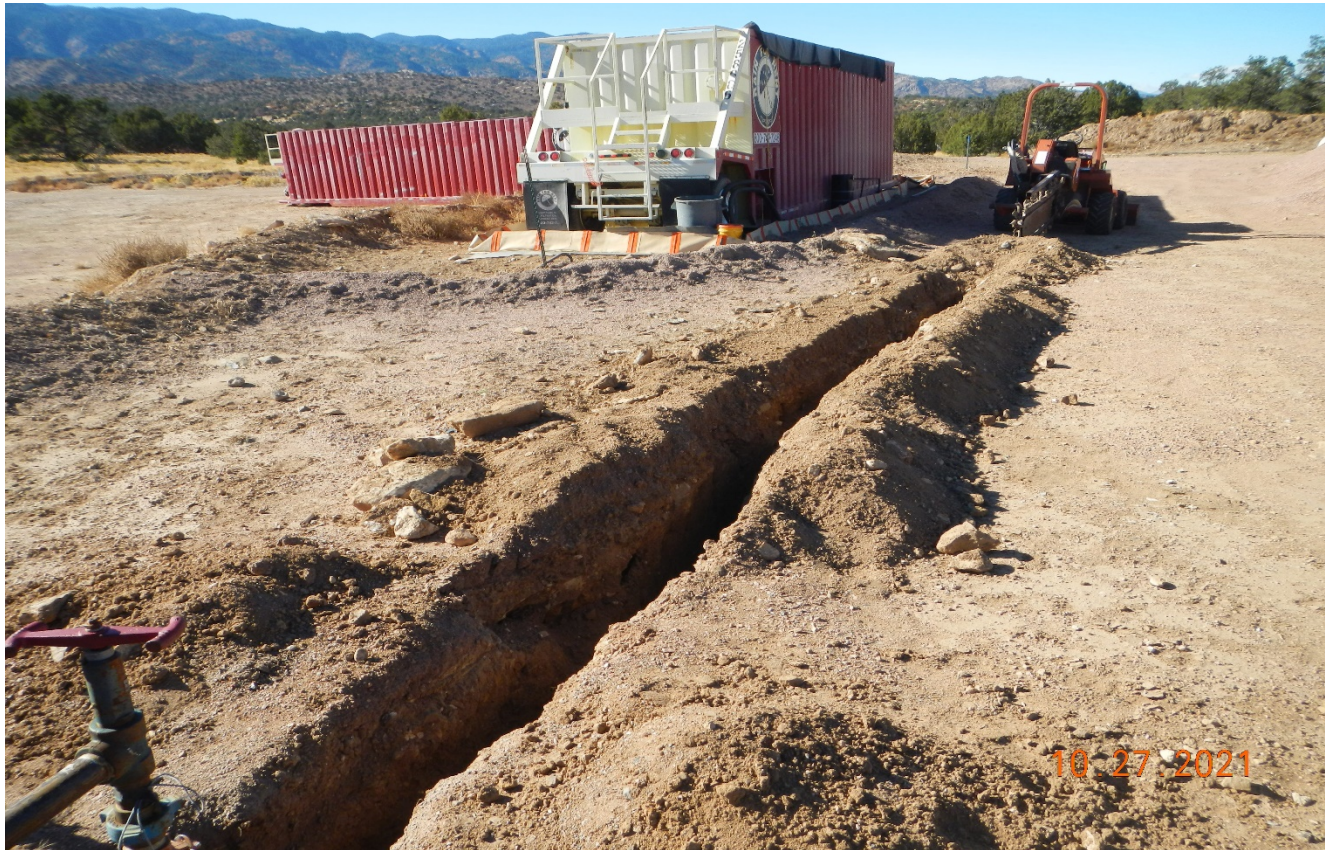
**Photo 9.** There is an open trench at the location that has been excavated.

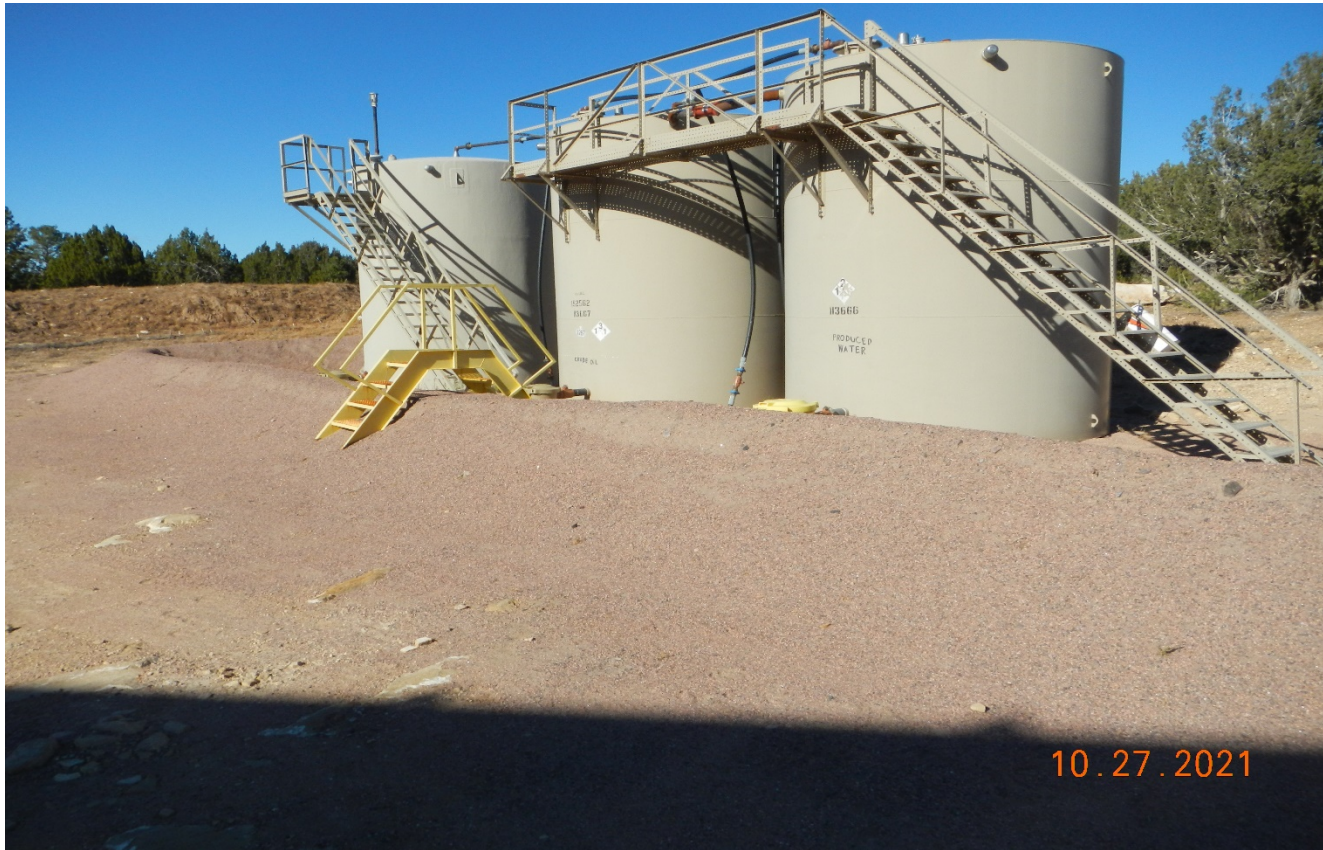
**Photo 10.** The tanks at north side of the location are not properly labeled.

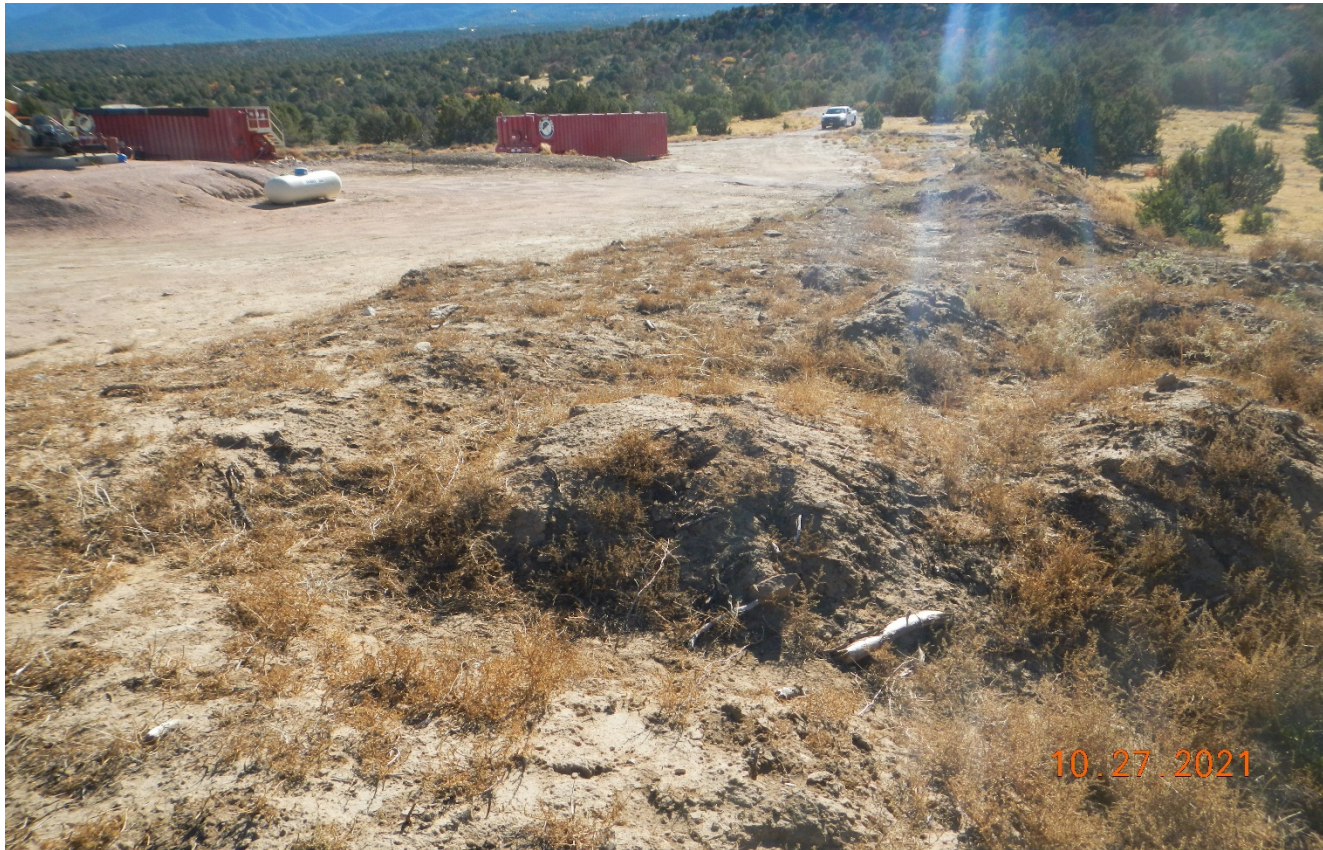
**Photo 12.** Facing toward the topsoil pile. The topsoil piles are not stabilized and protected. Topsoil piles have not been replaced for interim reclamation. There are undesirable weeds throughout the stockpiles.

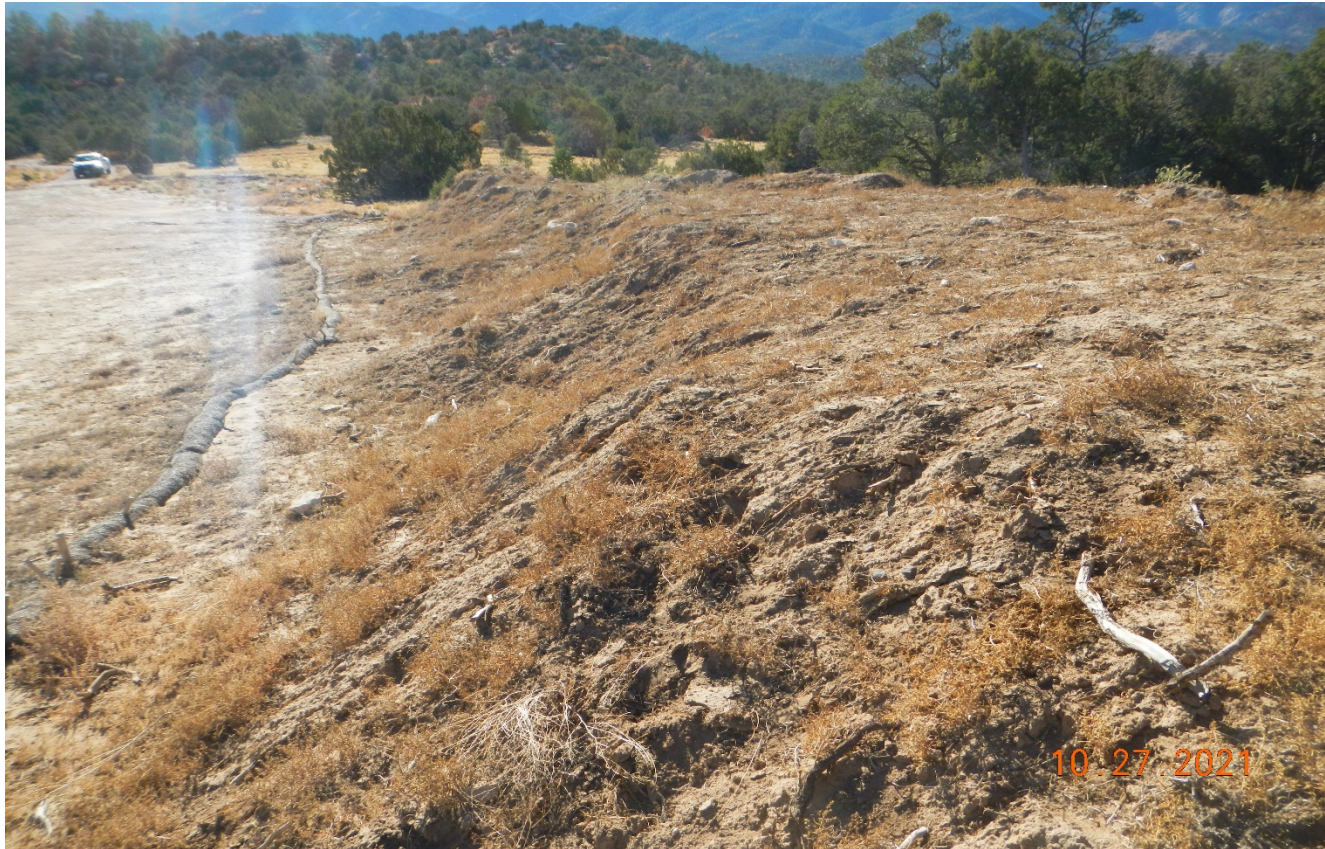
**Photo 13.** Facing southeast toward the topsoil pile which are not maintained and protected from degradation and weed infestation. Previous corrective action has not been performed. The BMP's around the stockpile are not maintained.

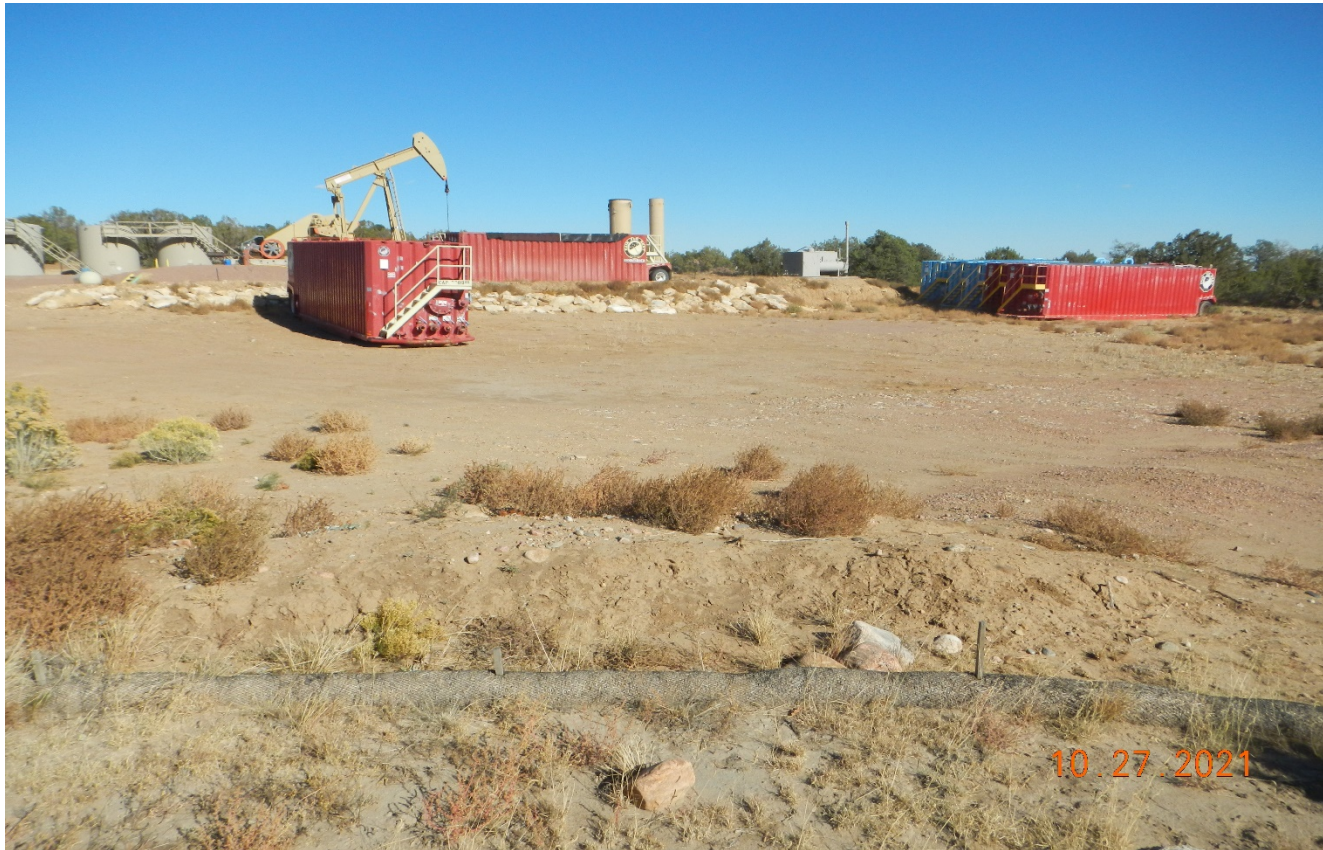
**Photo 14.** Facing northeast toward the location. The unused tanks need to be removed. Unused areas of the location need to be recontoured and reclaimed. Previous corrective actions have not been performed.
