# Inspection Photos

API: 05-017-07453

Operator: RESOURCE DEVELOPMENT

Inspection Date: 10/26/2021

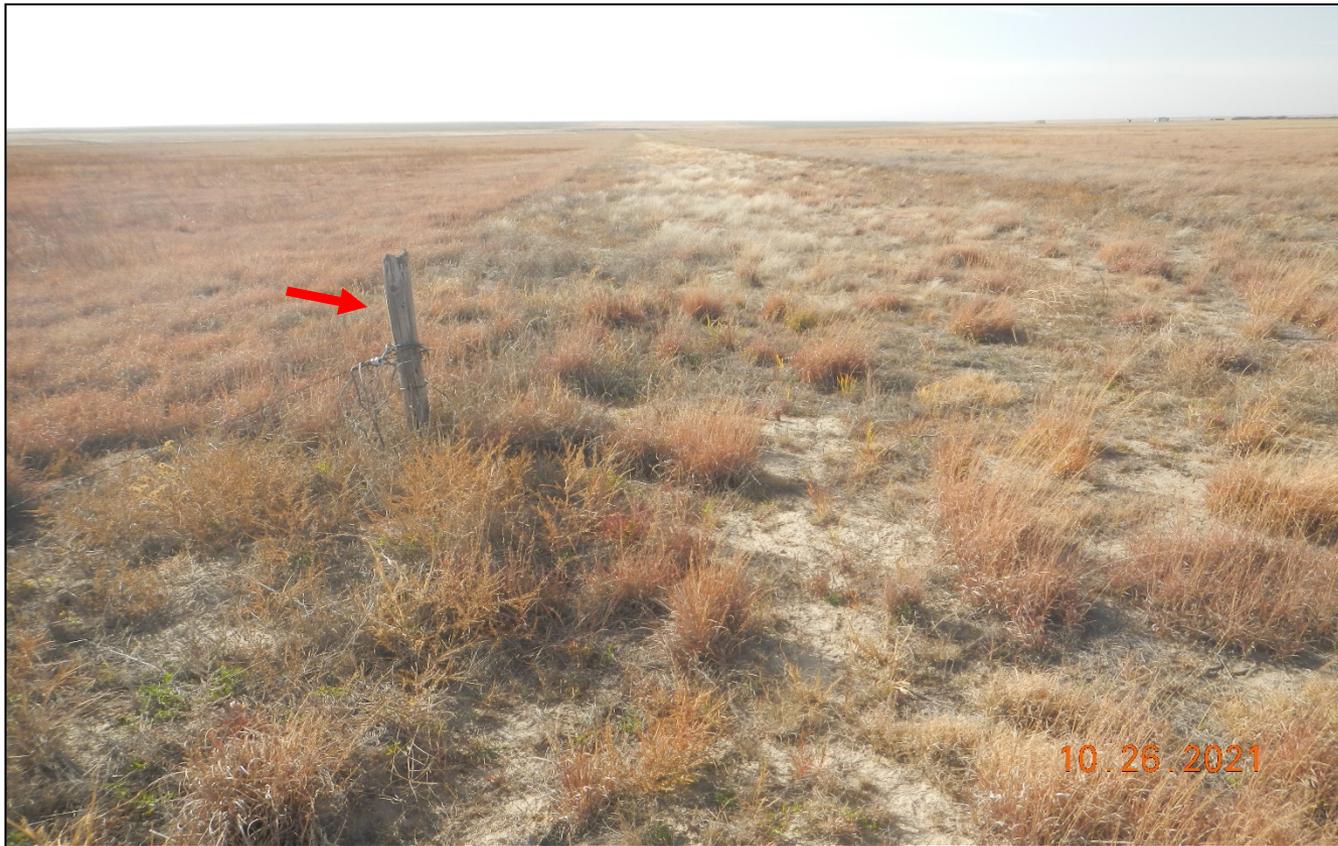
**Photo 1.** Facing west at the beginning of the access road. The wood posts still remain.

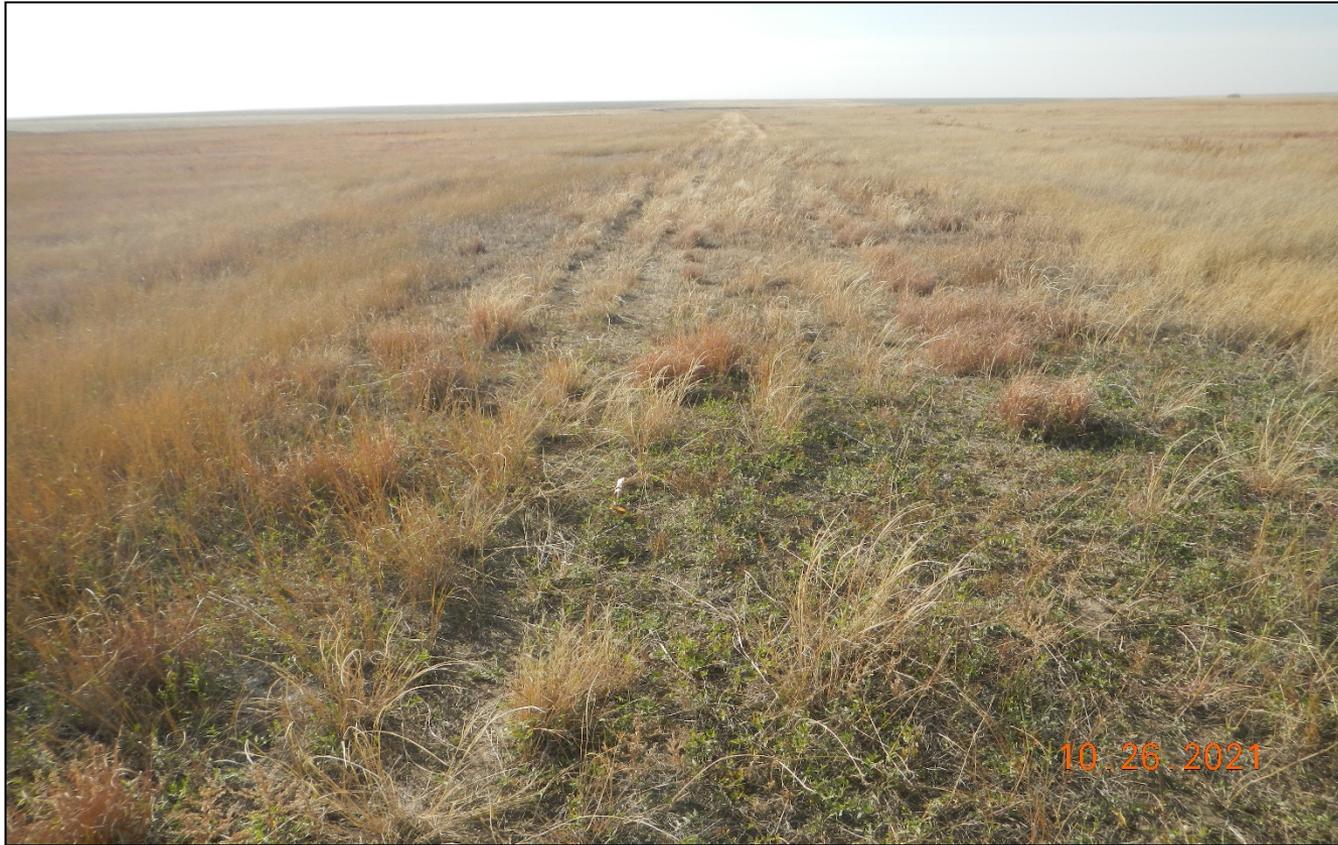
**Photo 2.** Facing west along the former access road.

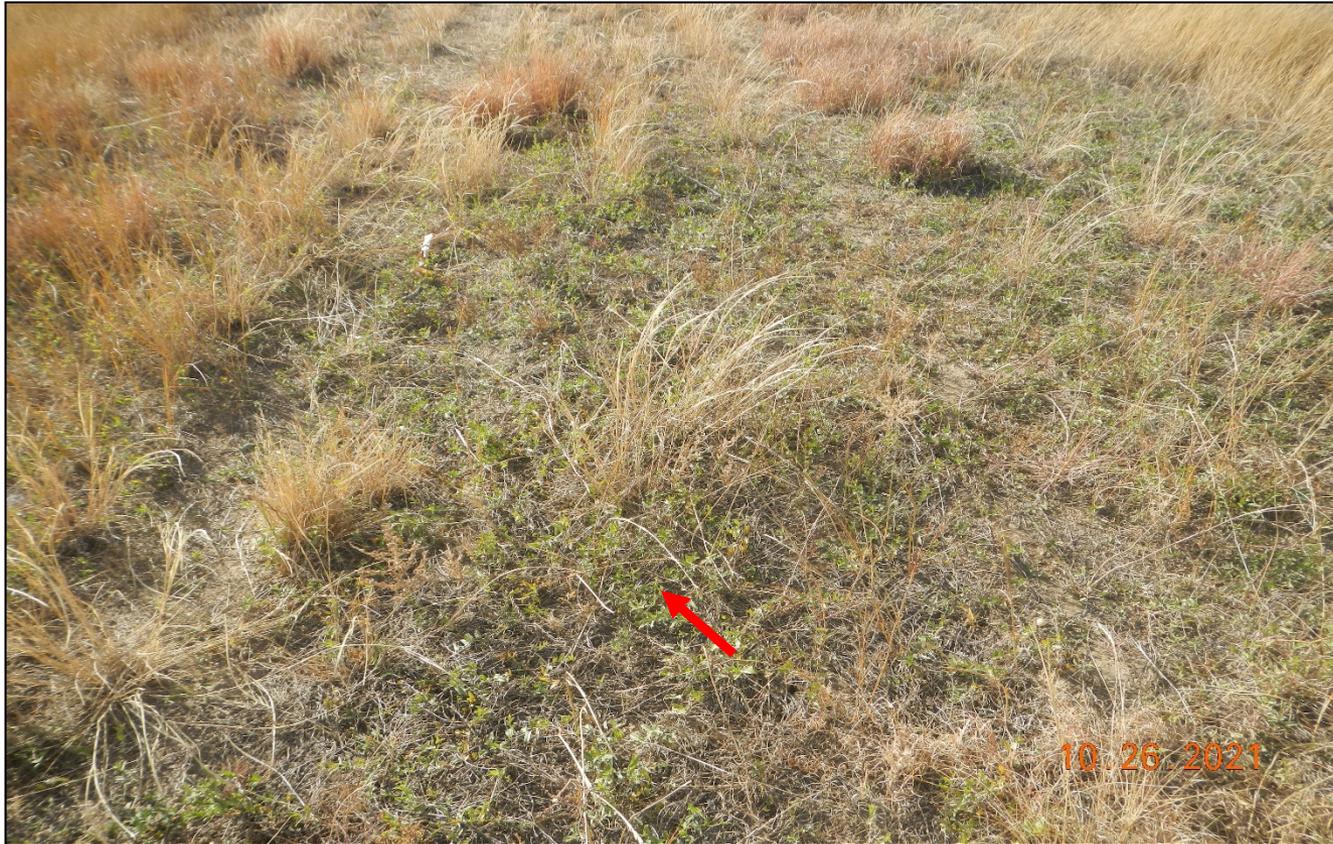
**Photo 3.** View of vegetation along the road. There is areas with Field bindweed which is a noxious weed that needs to be controlled. Arrow points to the green colored bindweed.

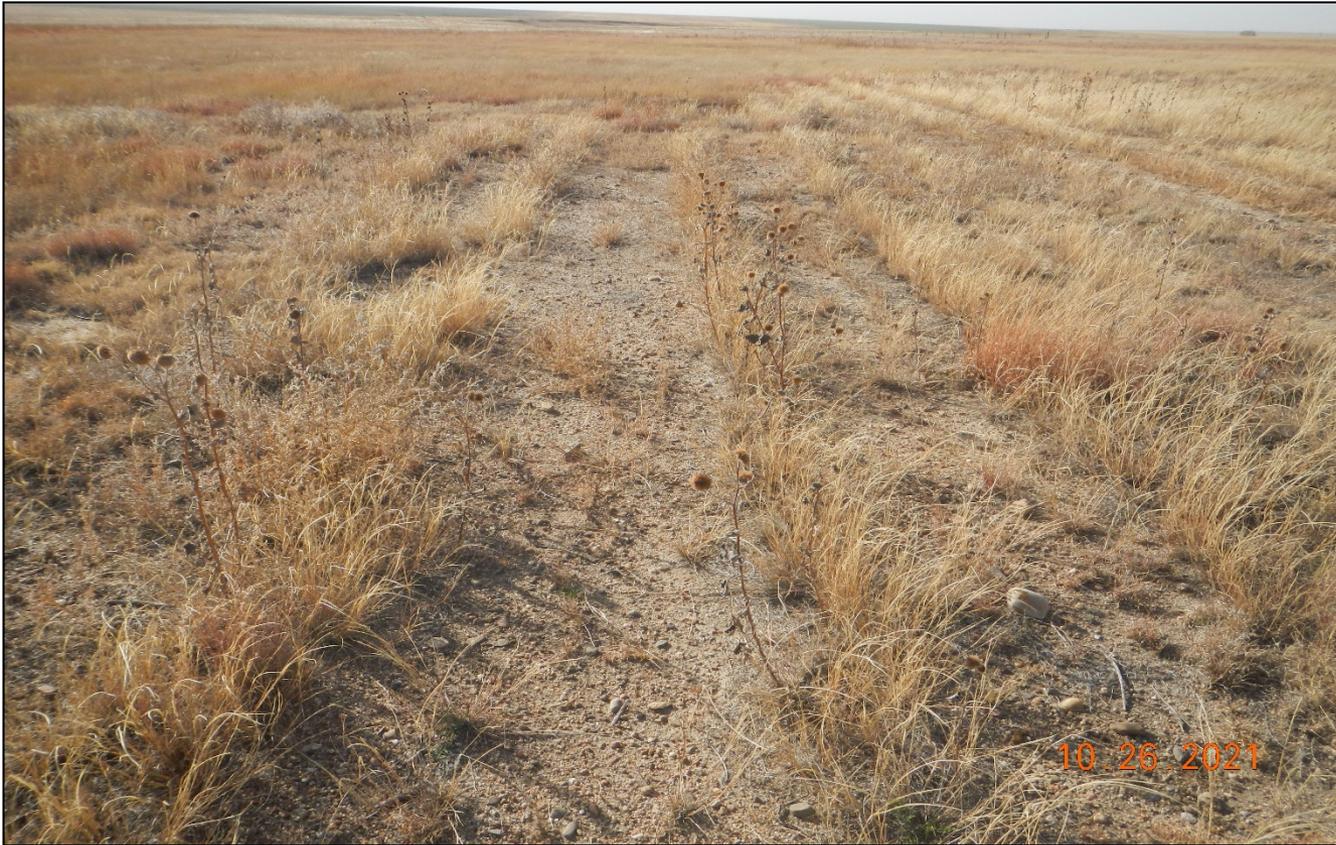
**Photo 4.** Facing west toward the location. Vegetation has not adequately established and bare areas have compacted soils. It appears the soils were not cross ripped as required. This area needs to be decompacted and reclaimed.

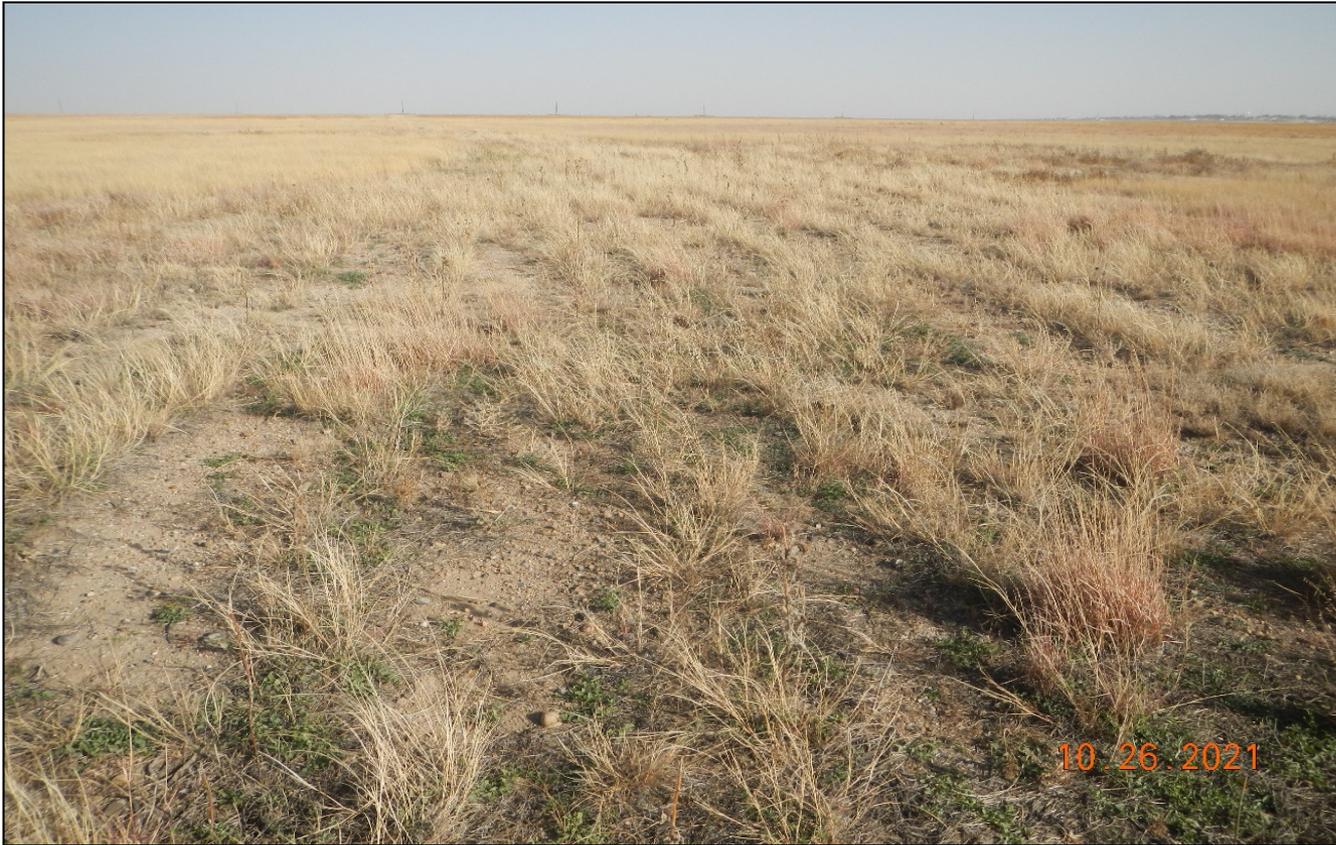
**Photo 5.** West side of the location facing east. There are rows of compacted soil where vegetation is sparse. This area has not adequately re-established to 80% reference area levels.

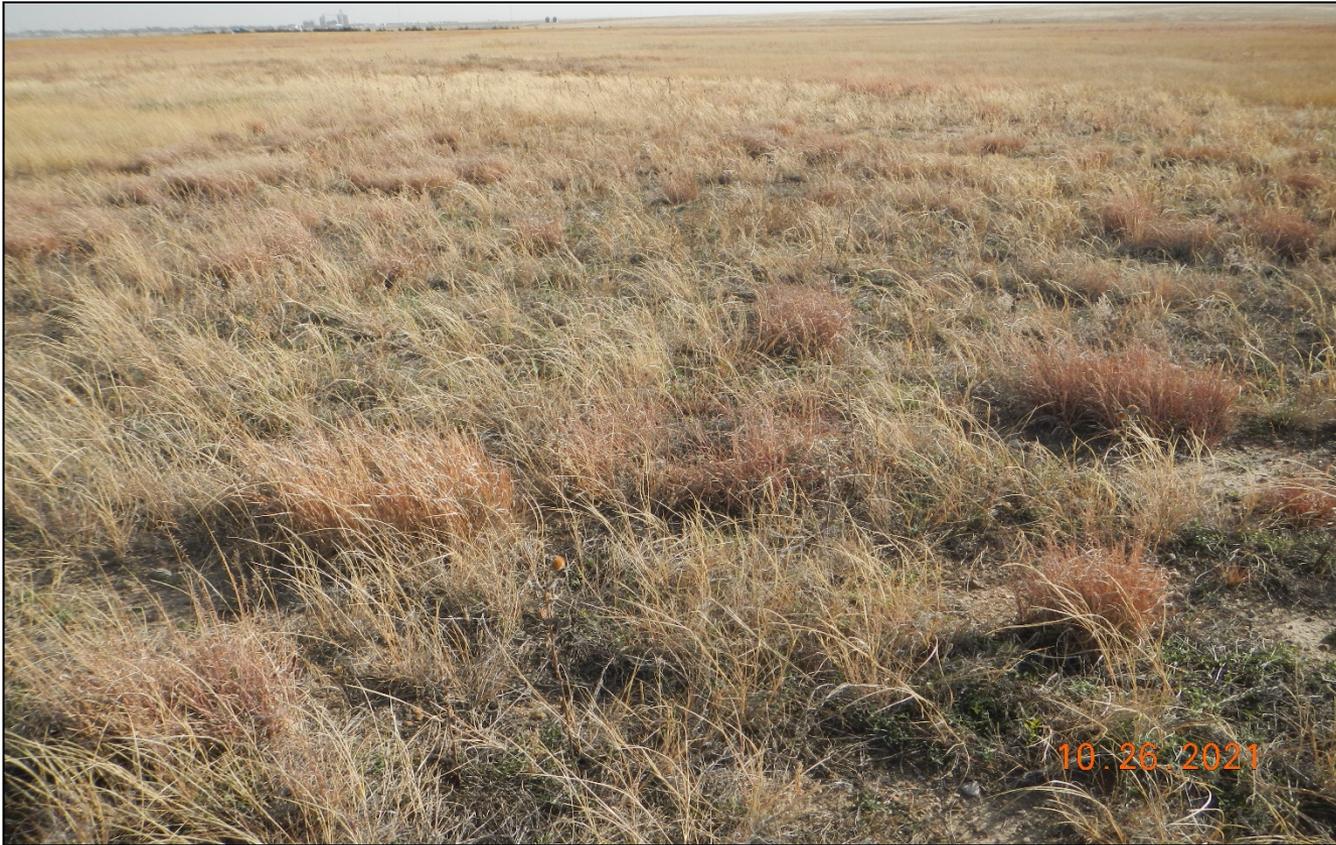
**Photo 6.** Facing south at the location. The perennial vegetation has progressed more in areas of the location.

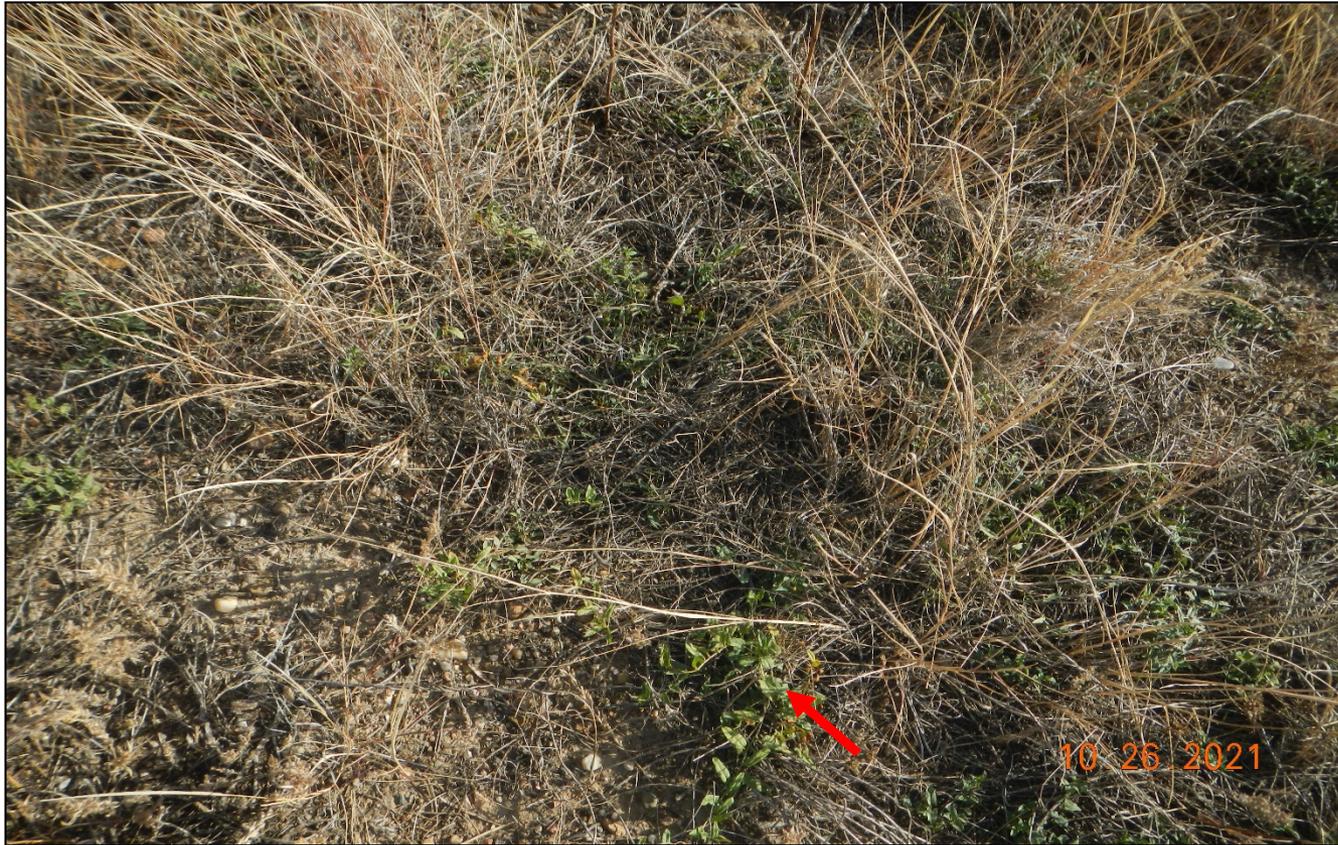
**Photo 7.** View of vegetation at the location. There is areas with Field bindweed which is a noxious weed that needs to be controlled. Arrow points to the green colored bindweed.

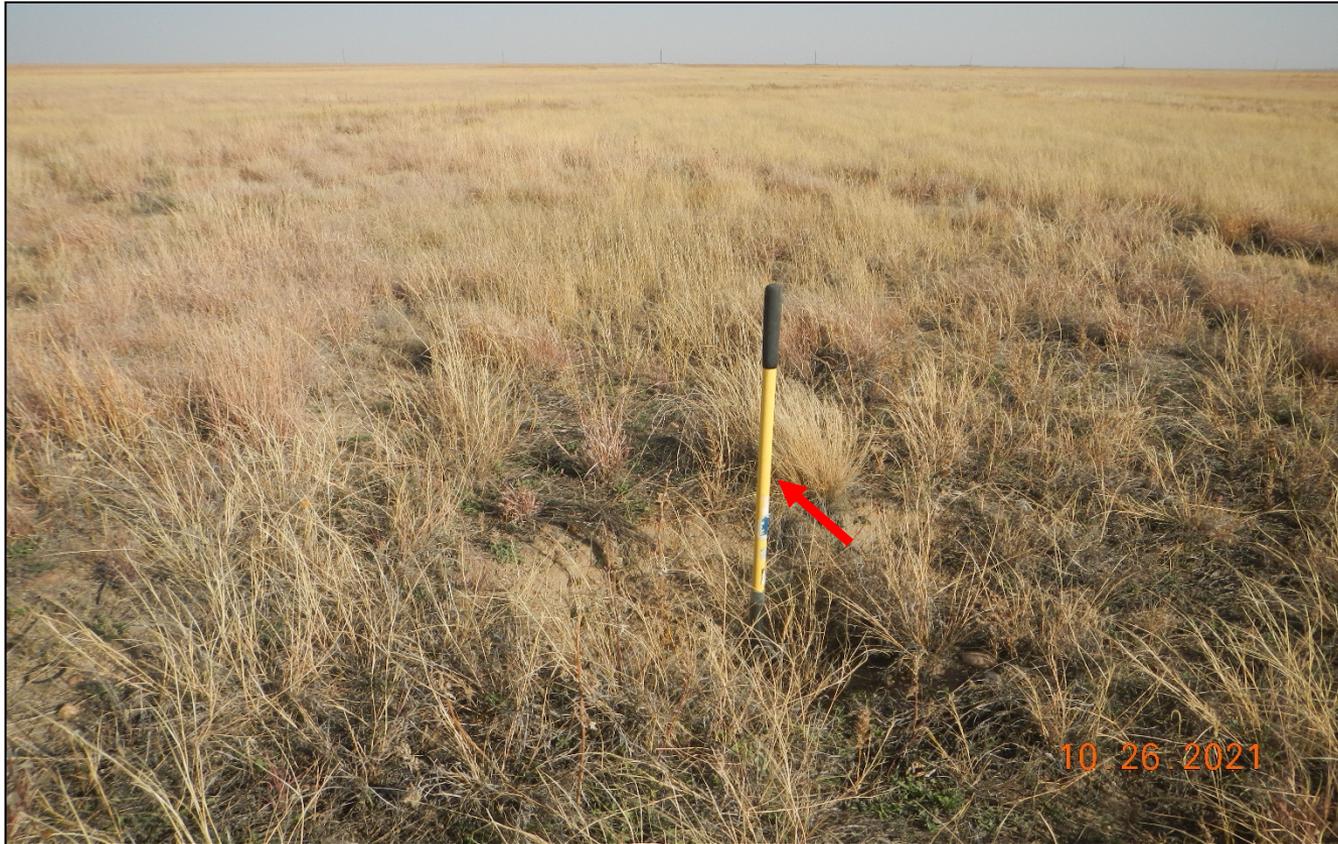
**Photo 8.** There is an area of subsidence at the location which is approximately 1-2ft. deep. Red arrow points to 5 ft. shovel placed in the area.  
Approx. Lat/Long:38.85031,-102.39605.

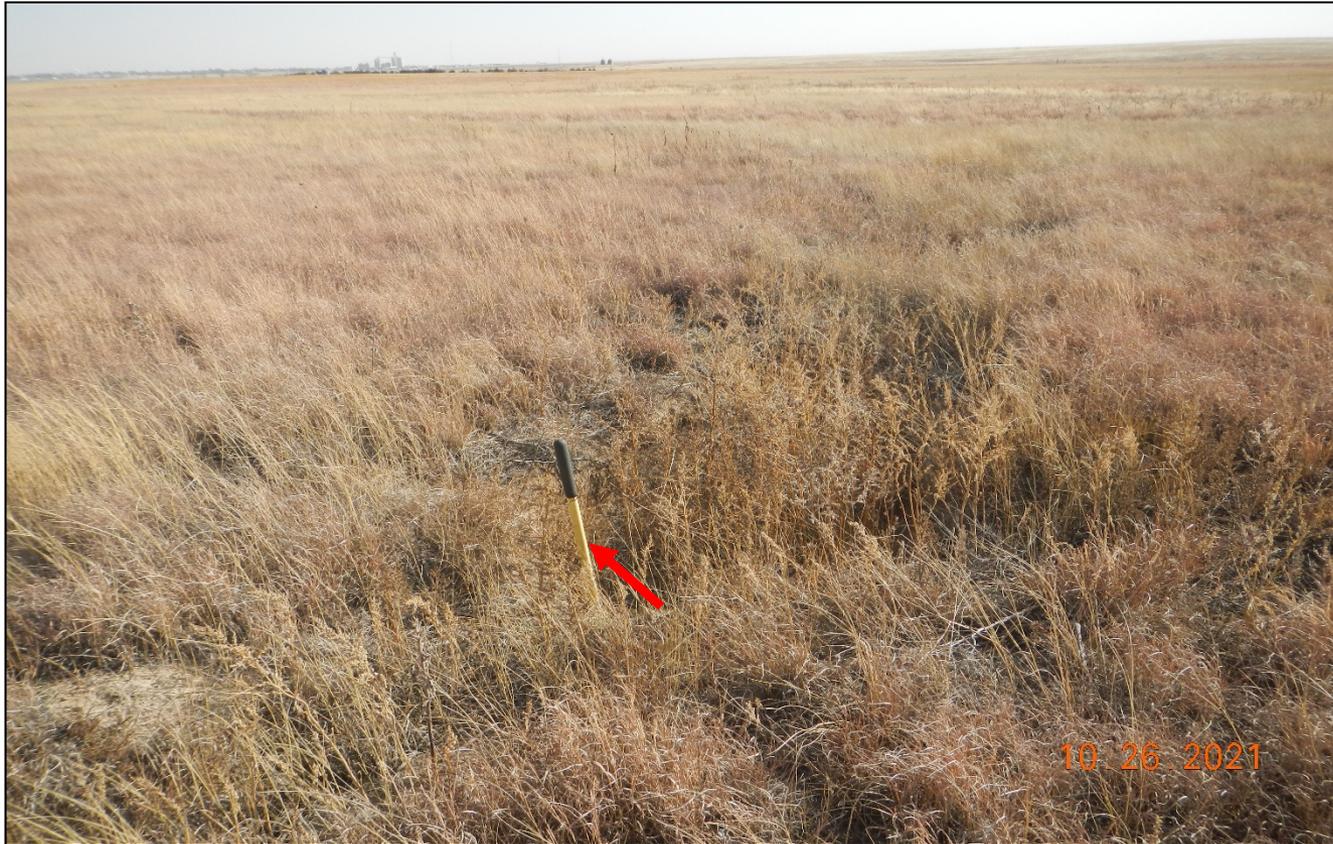
**Photo 9.** There is another area of subsidence at the north side of the location which is approximately 3-4ft. deep. Red arrow points to 5 ft. shovel placed in the area. Approx. Lat/Long:38.85052,-102.39459.

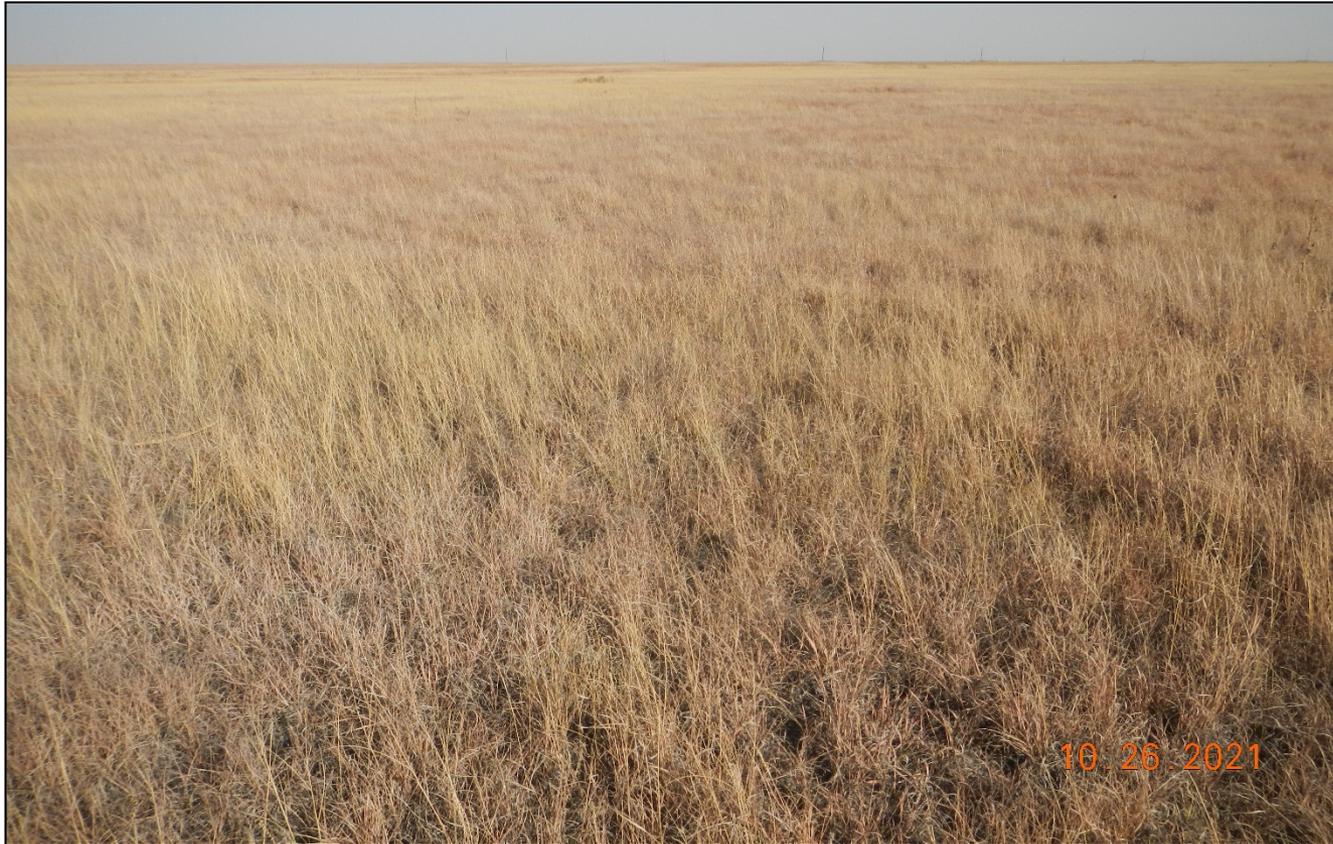
**Photo 10.** Facing north toward the undisturbed reference area which is mostly composed of Sideoats grama, Blue grama, and Sand dropseed.
