Inspection Photos
Operator: Simcoe
API: 067-06544
Date: 10/27/2021

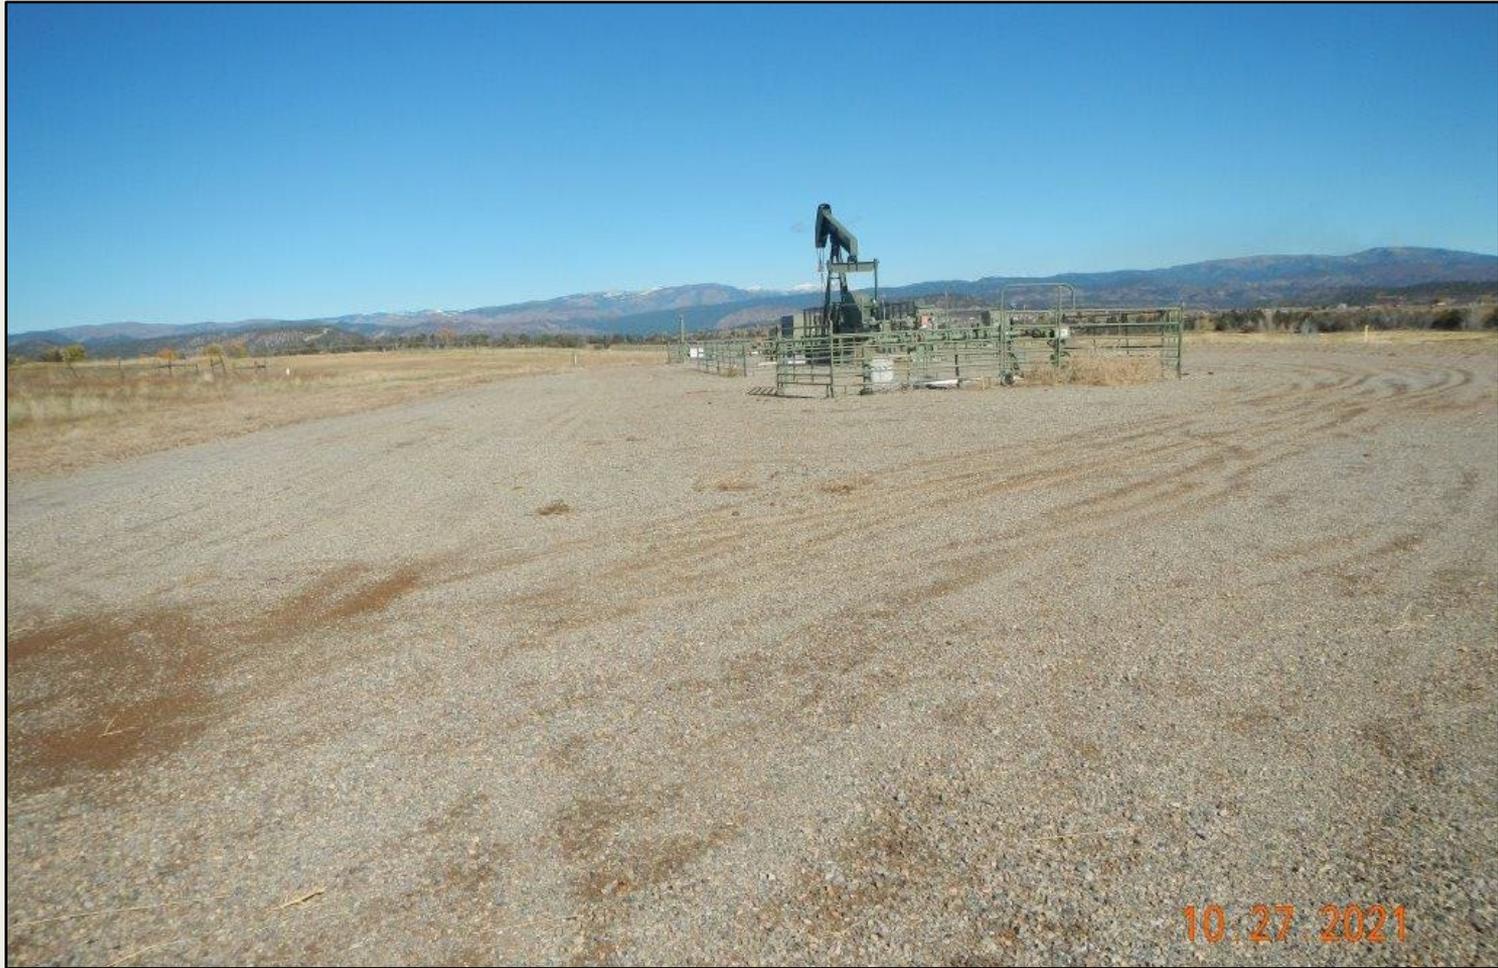
Photo 1. View of the project area from the well pad entrance facing center.

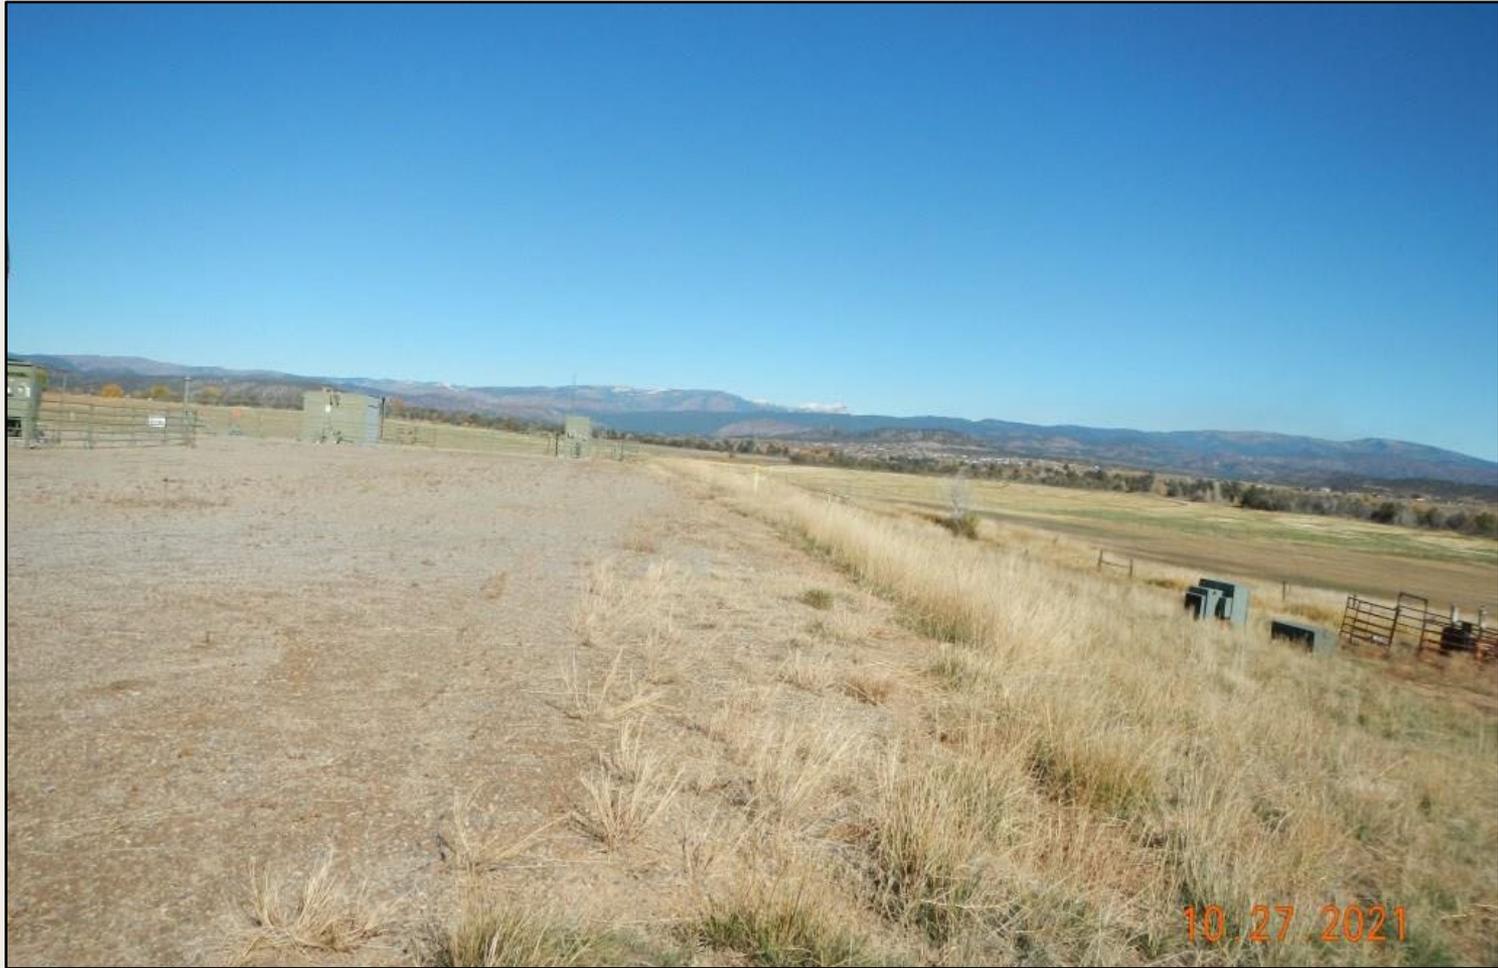
Photo 2. View of the eastern project area from the southeastern corner facing northward. Revegetation is progressing with grasses such as western wheatgrass, sand dropseed, and intermediate wheatgrass.

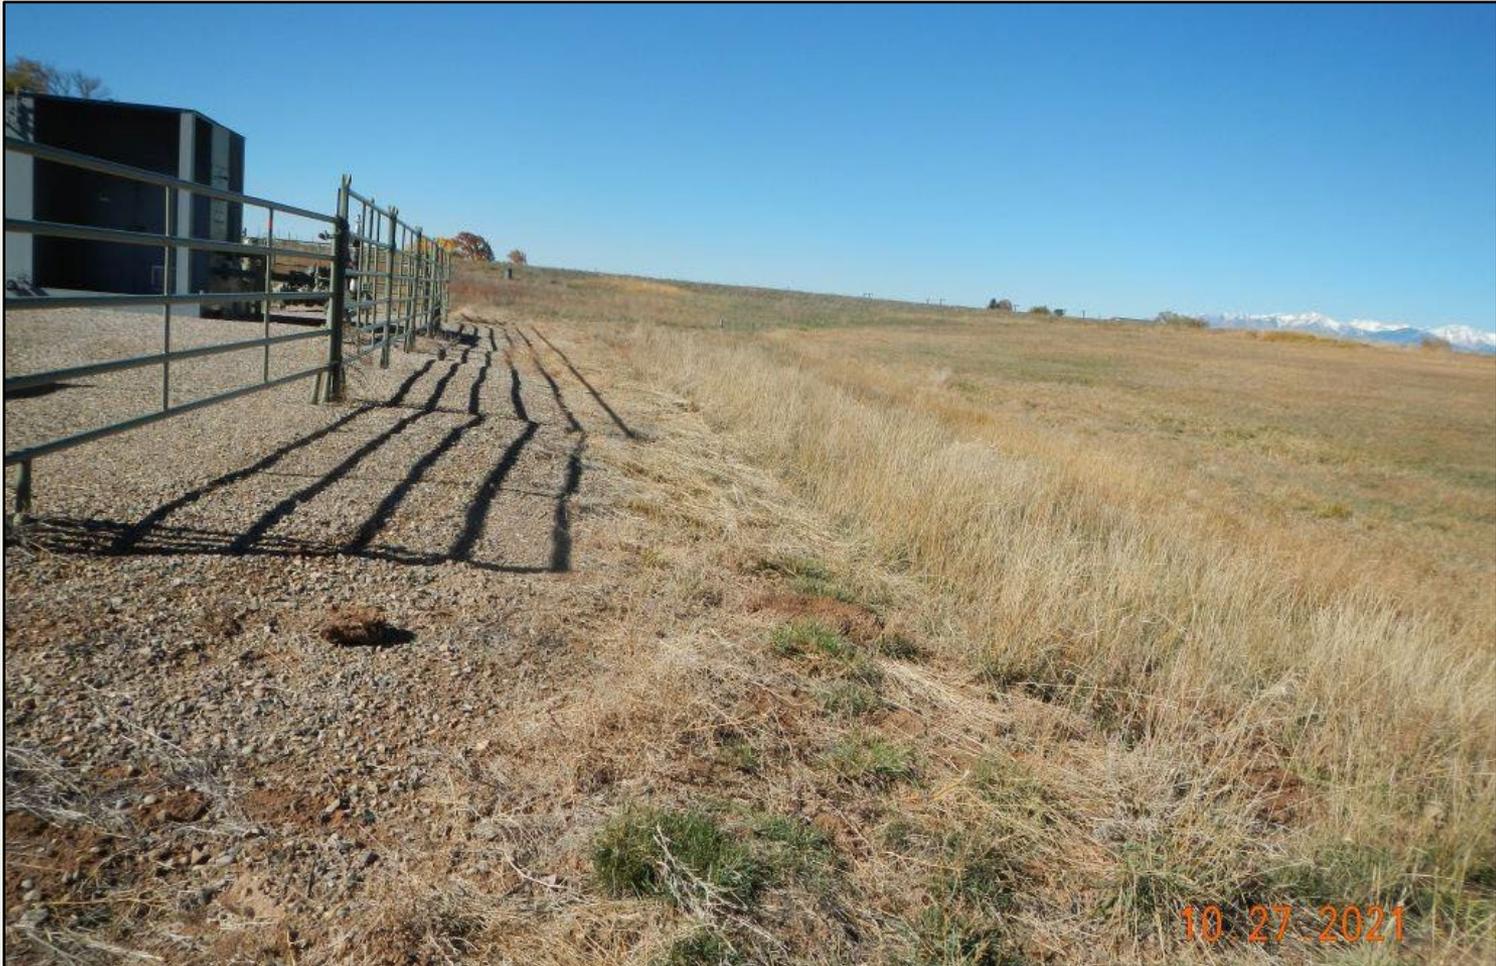
Photo 3. View of the northern project area from the northeastern corner facing westward.

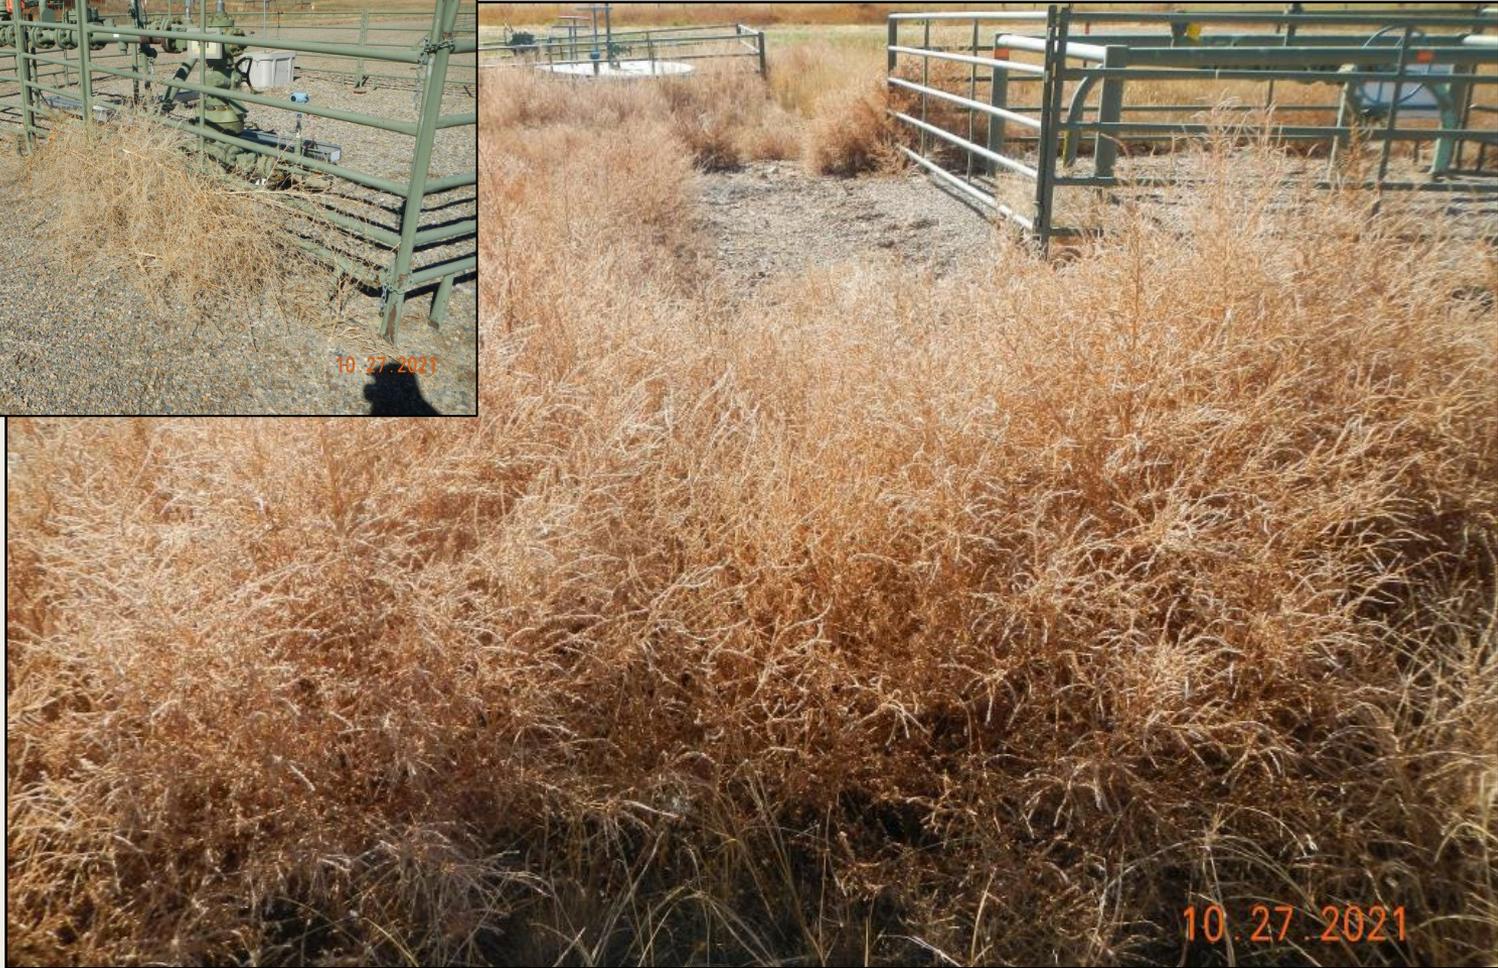
Photo 4. View of kochia debris round project facilities, needing removal.

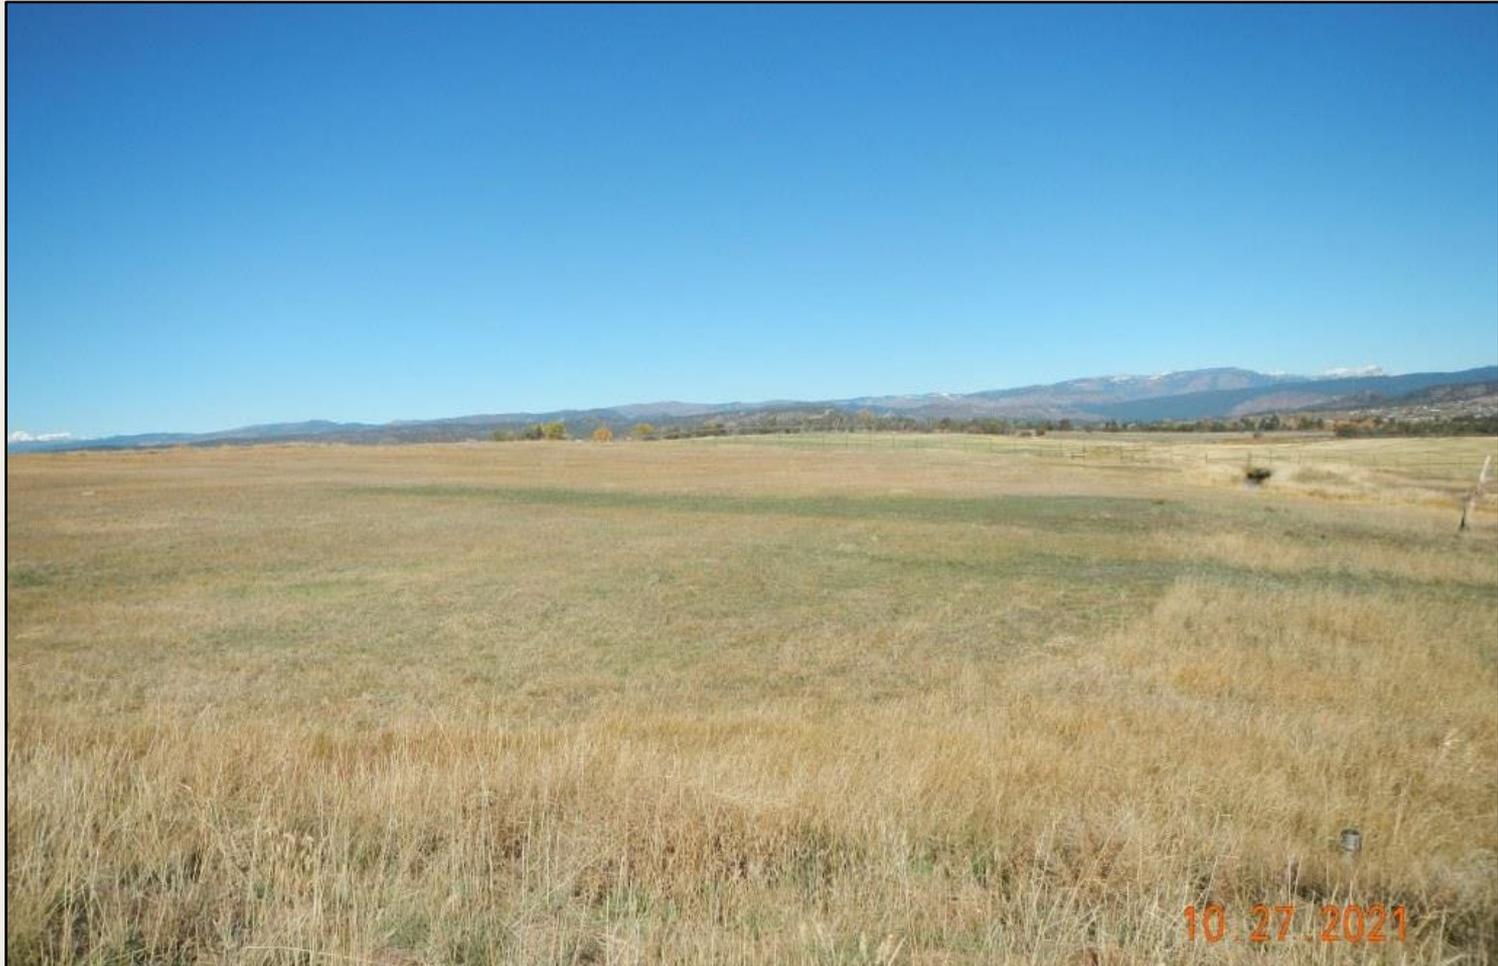
Photo 5. View of the reference area comprised of irrigated grass field with smooth brome, orchard grass, and mixed wheatgrasses.
