Inspection Photos

11/01/2021

Operator: NONSUCH NATURAL GAS INC

Location ID: 453726

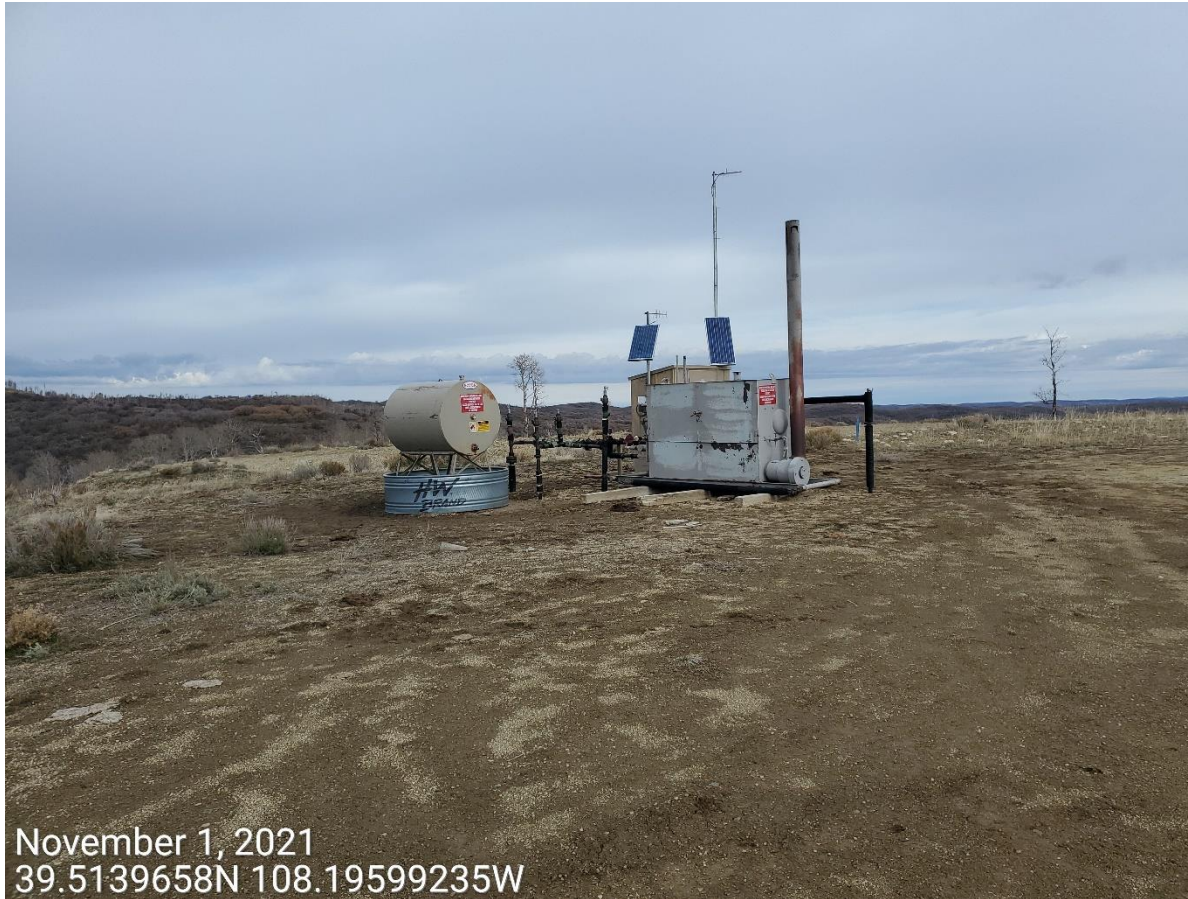
Photo 1: Photo shows Nonsuch equipment on the Location. Previous inspections required Operator to submit a Form 4 w/ records identifying equipment's (Methanol tank, separator, meter shed) current status and use for production on the Location by 10/2/2020; Operator failed to submit a Form 4 with records. Inspection #696202916 required Operator to comply with Rule 606.a and remove equipment not necessary for use on the Location. To date, records have not been submitted and equipment has not been removed.

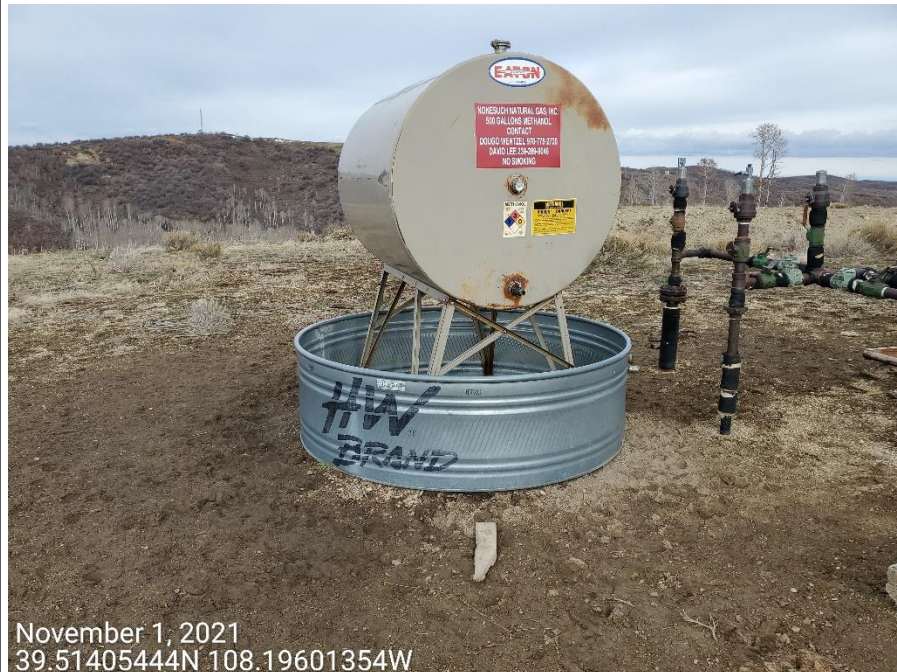
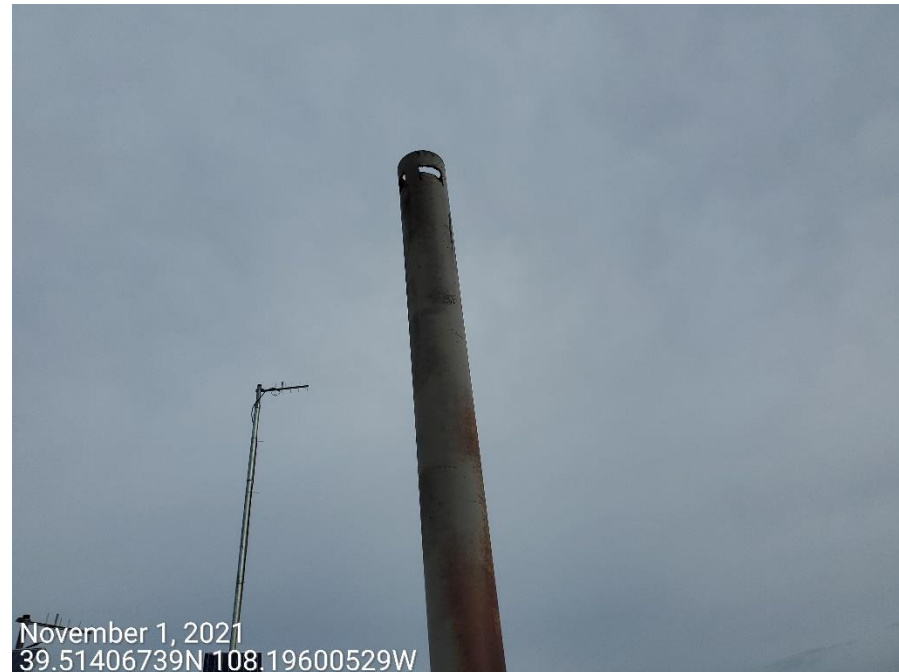
Photo 2: Previous inspections observed that protection equipment to prevent wildlife access to the secondary containment BMPO at the 500 gallon methanol tank, and the separator stack was missing or insufficient. Photos show wildlife protection equipment remains missing or insufficient.

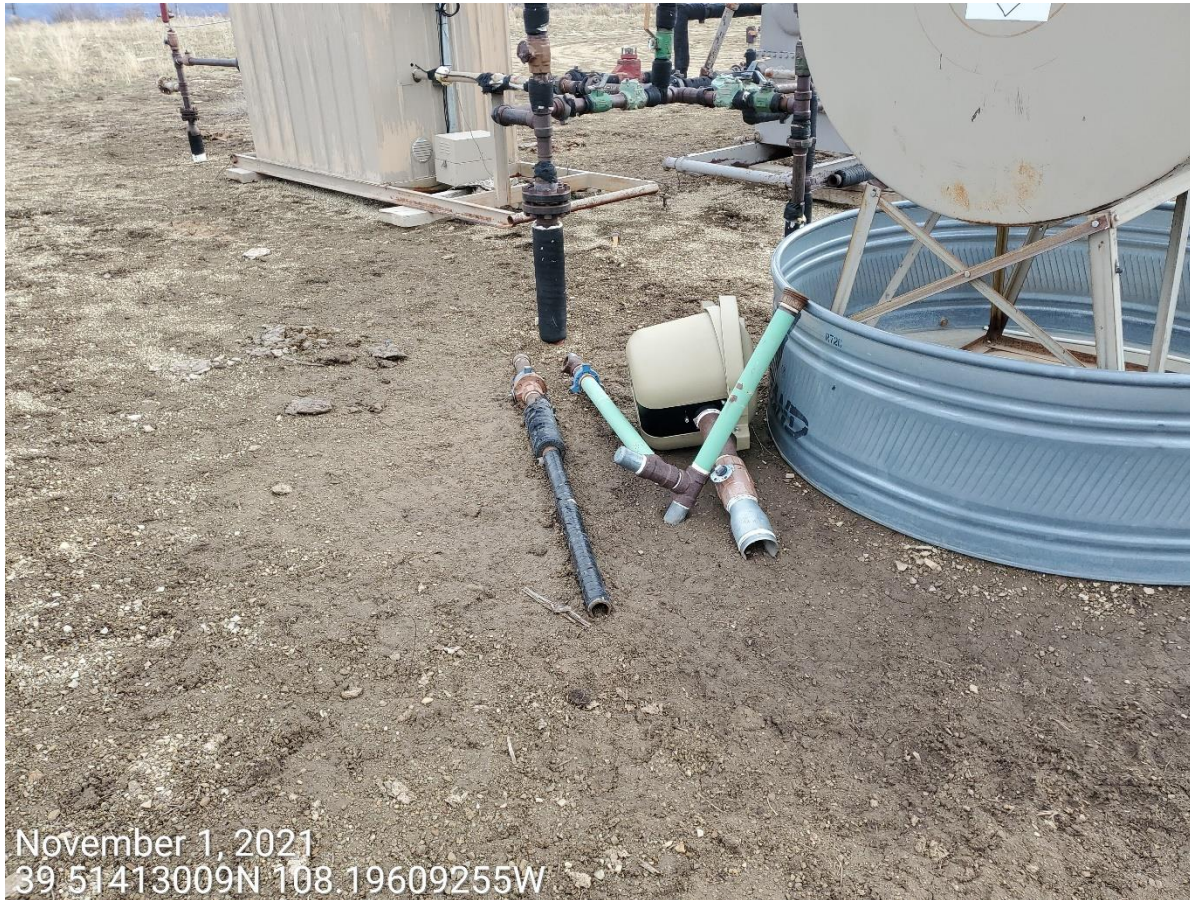
Photo 3: Photo shows unused equipment remains improperly stored on the Location.

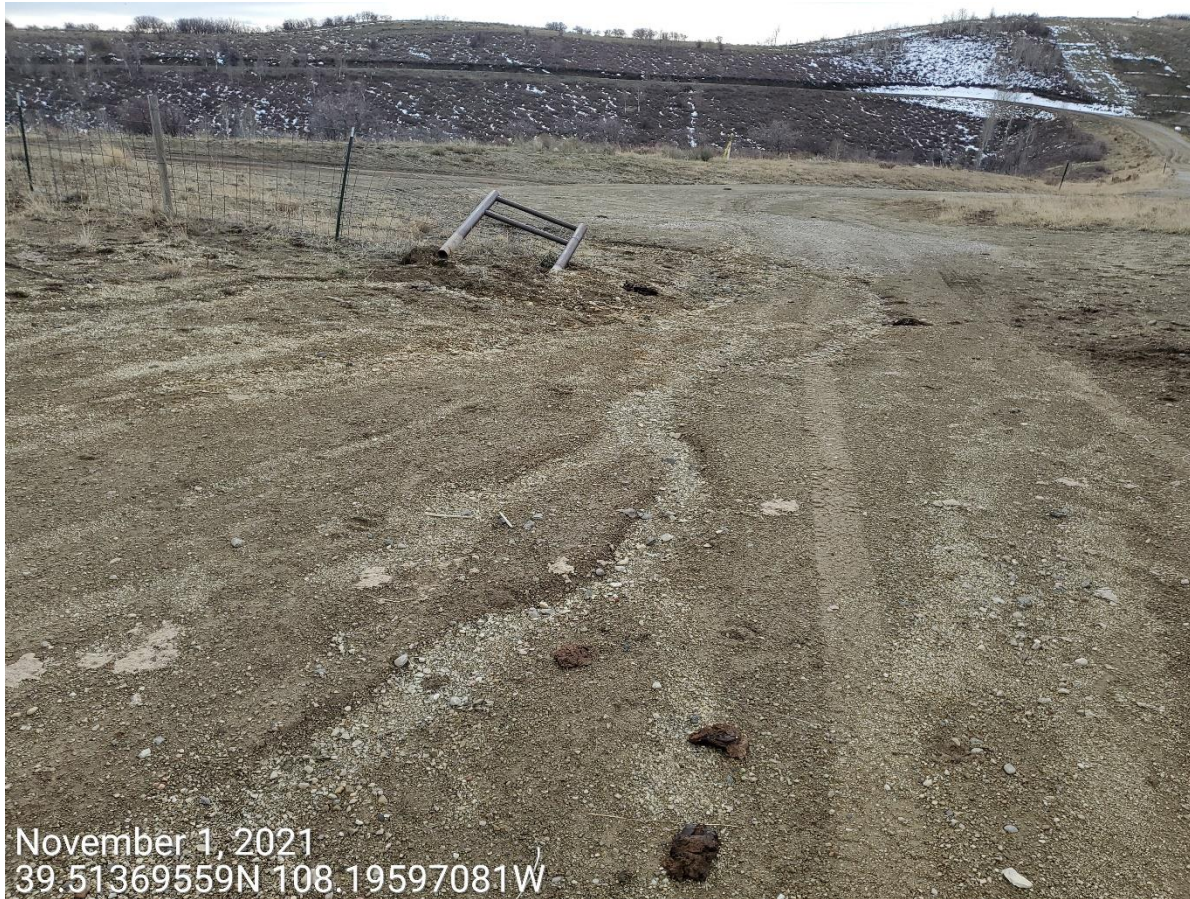
Photo 4: Photo taken from the east end of the Location, facing east. Photo shows stormwater runoff from the Location has resulted in erosion degradation at the Location entrance, and the access road; required stormwater and erosion control measures pursuant to Rule 1002.f remain missing or insufficient.

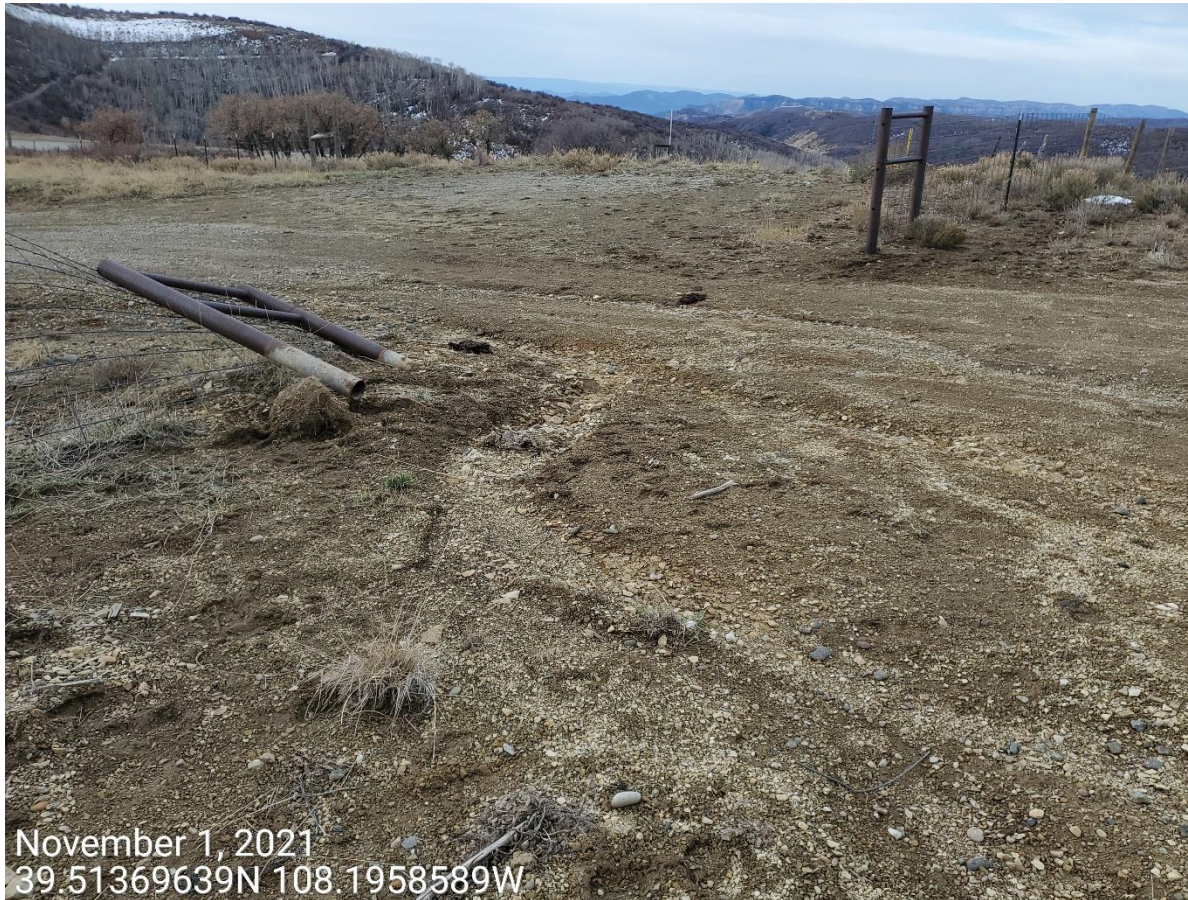
Photo 5: Photo taken from the east end of the Location, facing south. Photo shows stormwater runoff from the Location has resulted in erosion degradation at the Location entrance, and the access road; required stormwater and erosion control measures pursuant to Rule 1002.f remain missing or insufficient.

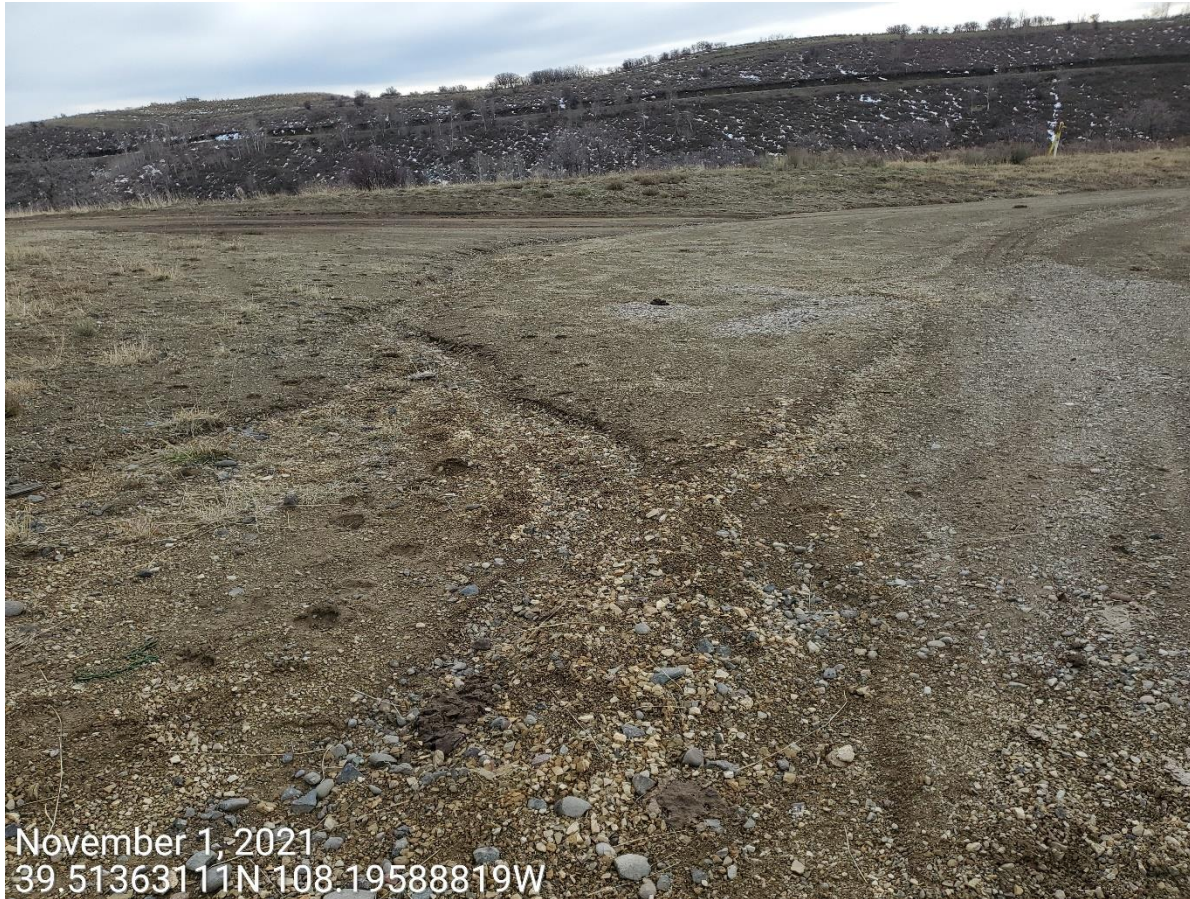
Photo 6: Photo taken from the access road, facing east. Photo shows stormwater runoff from the Location has resulted in erosion degradation at the Location entrance, and the access road; required stormwater and erosion control measures pursuant to Rule 1002.f remain missing or insufficient.

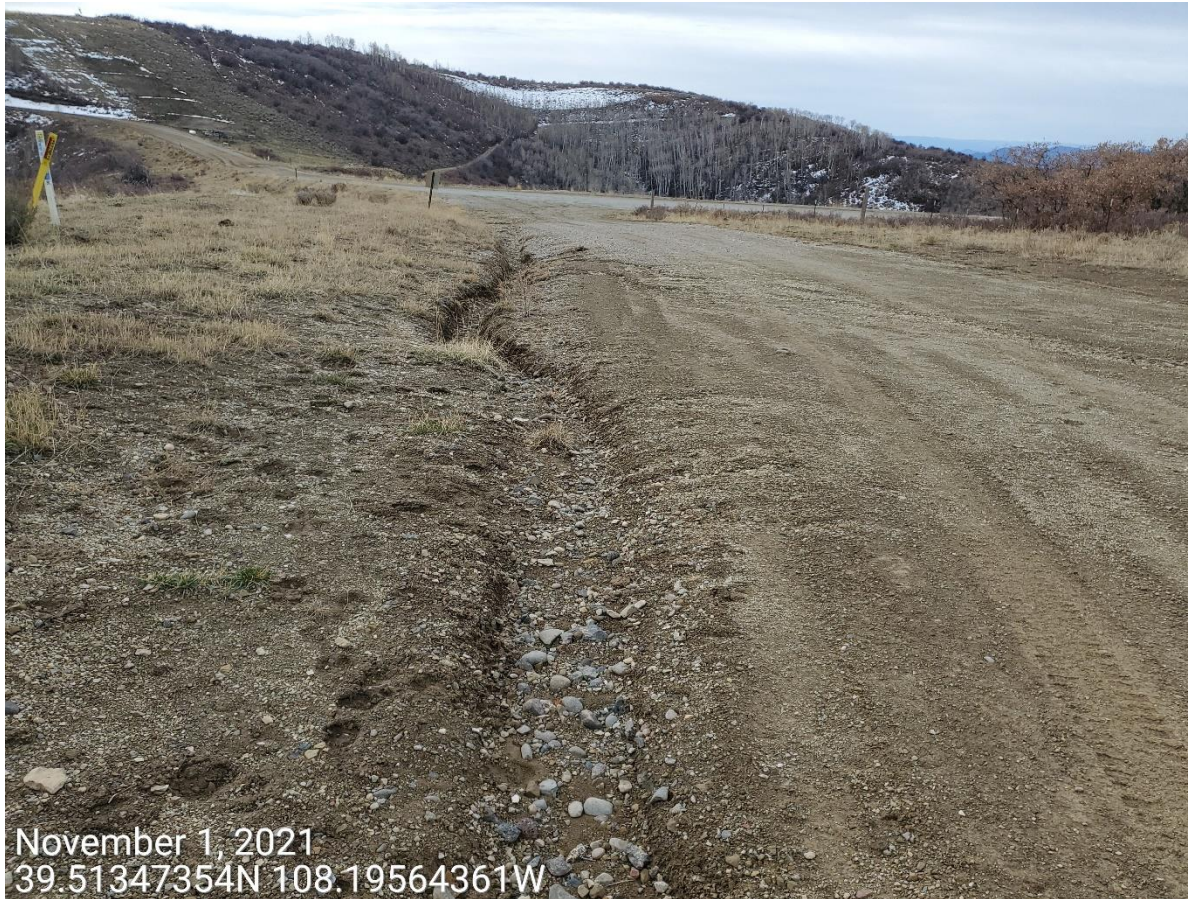
Photo 7: Photo taken from the access road, facing south. Photo shows stormwater runoff from the Location has resulted in erosion degradation at the Location entrance, and the access road; required stormwater and erosion control measures pursuant to Rule 1002.f remain missing or insufficient.

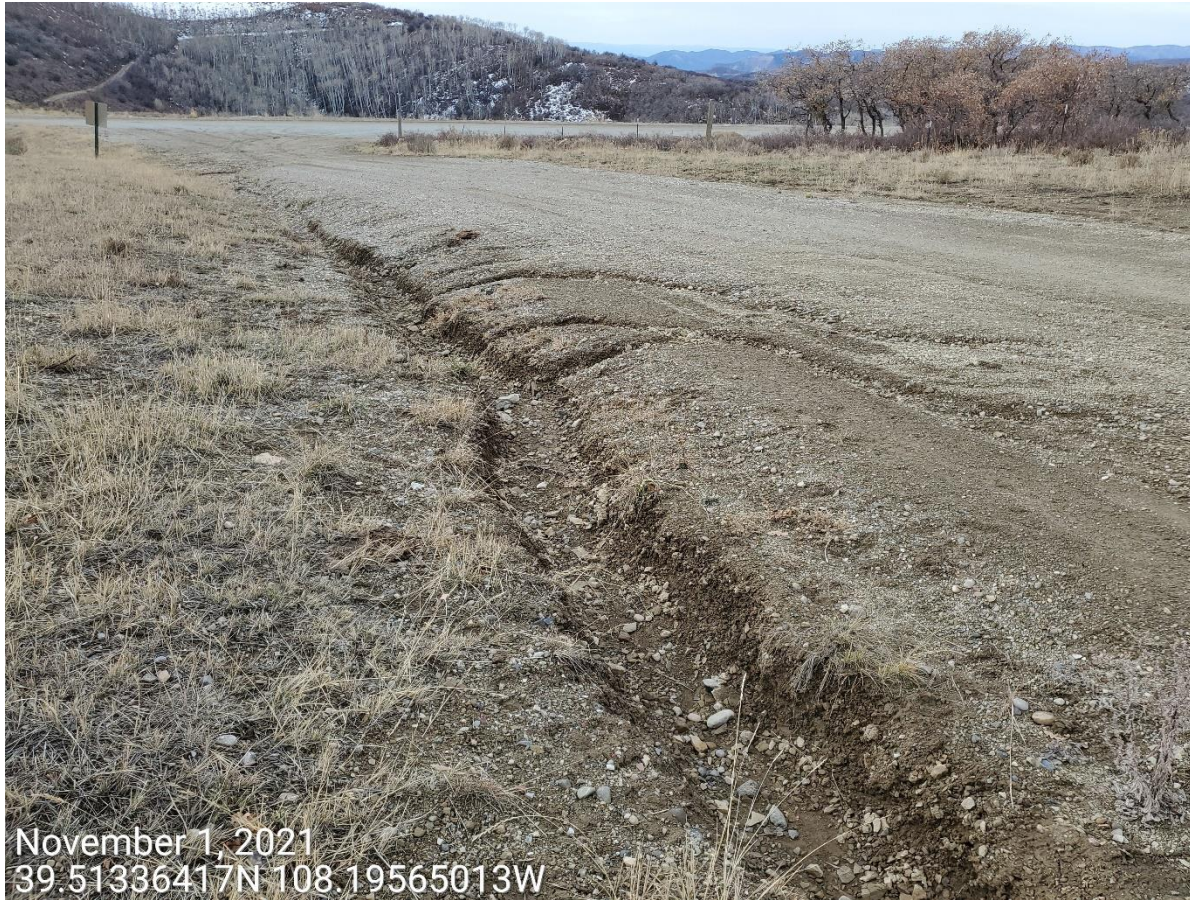
Photo 8: Photo taken from the access road, facing south. Photo shows stormwater runoff from the Location has resulted in erosion degradation at the Location entrance, and the access road; required stormwater and erosion control measures pursuant to Rule 1002.f remain missing or insufficient.

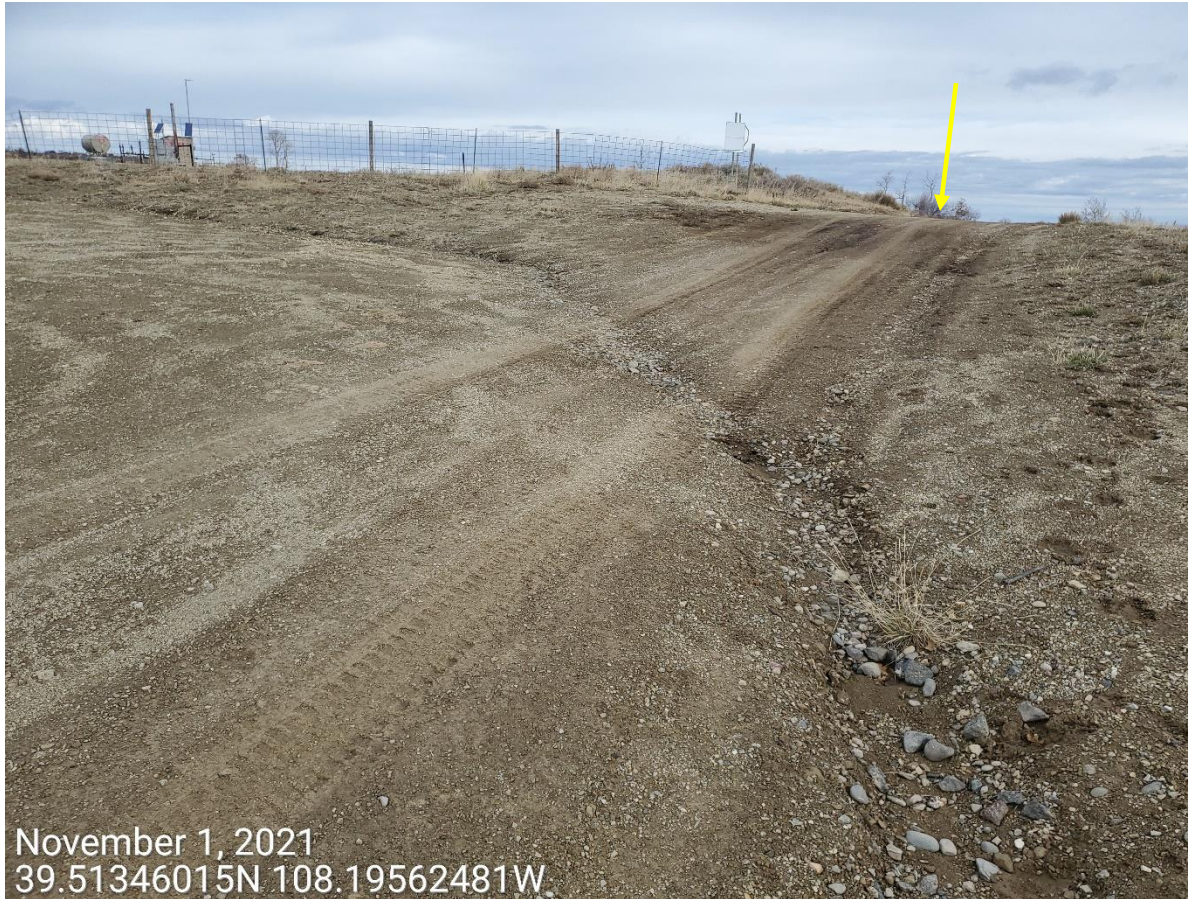
Photo 9: Photo taken from access road east of the Location, facing north. Photo shows “fork” in access road, with the left fork leading the Location, and the right fork leading to addition O&G Locations. Photos shows that the Nonsuch Location is the source of the stormwater runoff causing the erosion degradation along the access road; hill on access road (arrow) prevents stormwater runoff traveling south.
