# Inspection Photos

API: 061-06027

Operator: WESTERN OPERATING COMPANY

Inspection Date: 10/27/2021

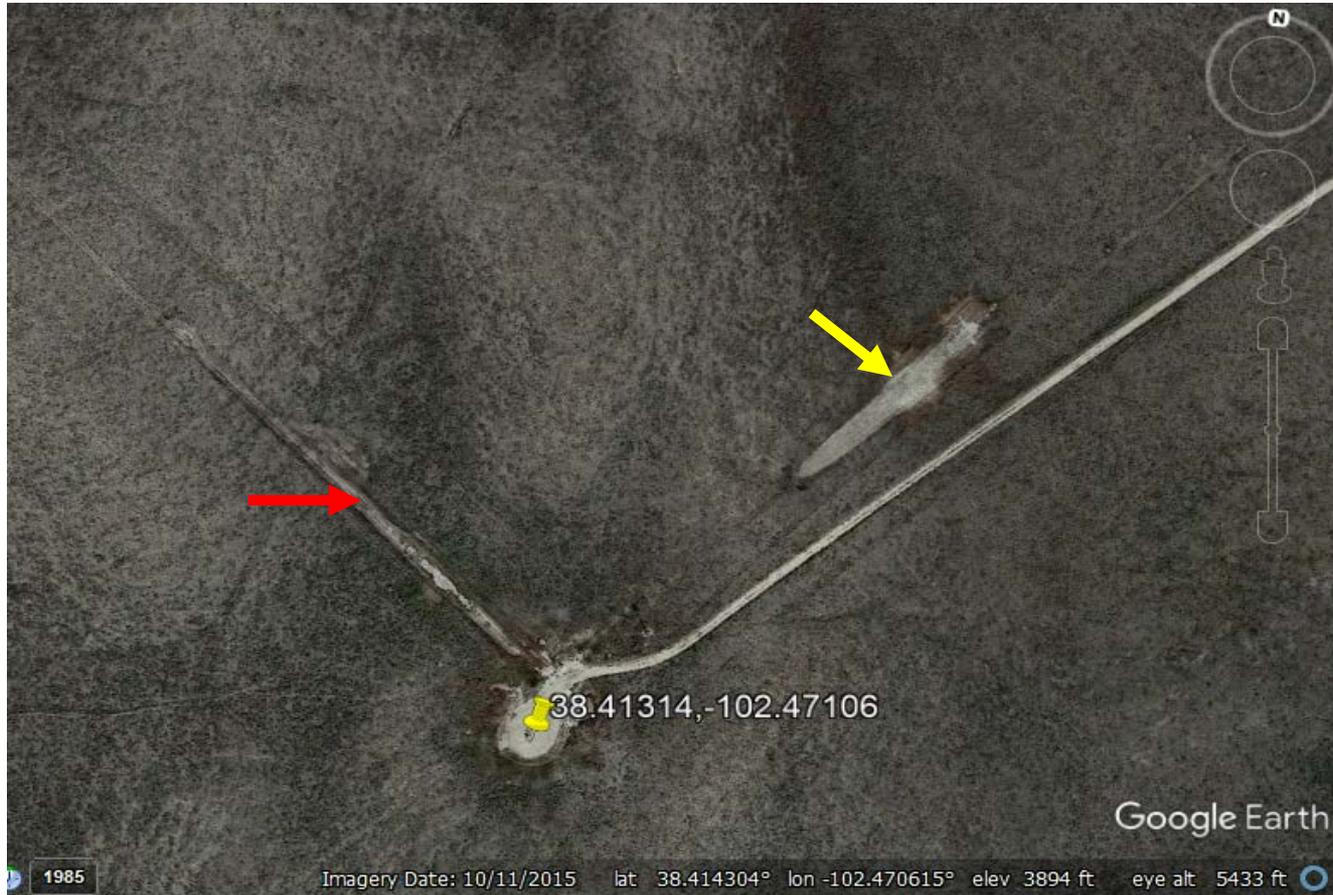
**Photo 1.** Aerial imagery shows the impacted spill area at yellow arrow and red arrow. There is undesirable weed and bare soil within these area that have not been reclaimed.

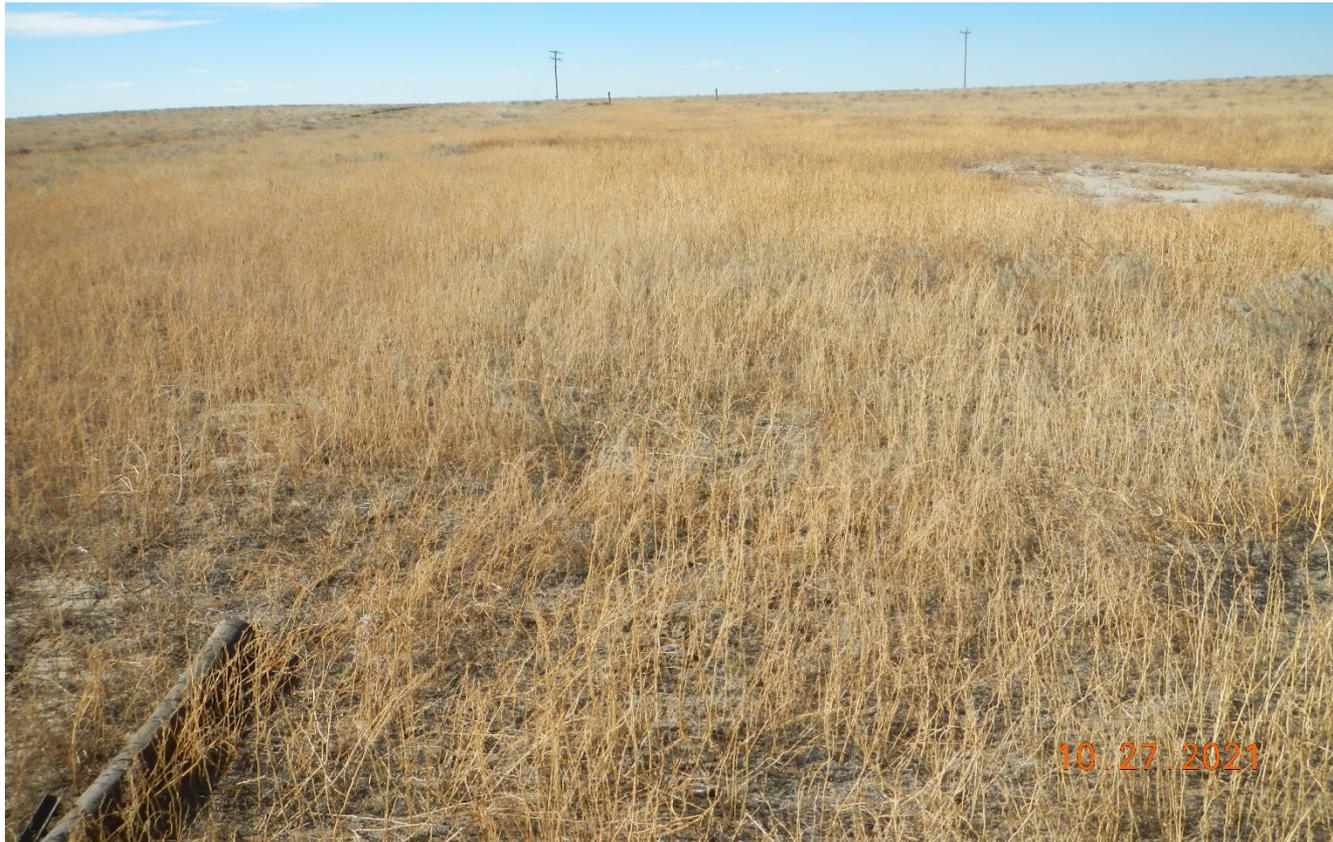
**Photo 2.** Facing southwest at the former spill area near the access road shown by yellow arrow in the previous photo. This area consists of only undesirable weeds.

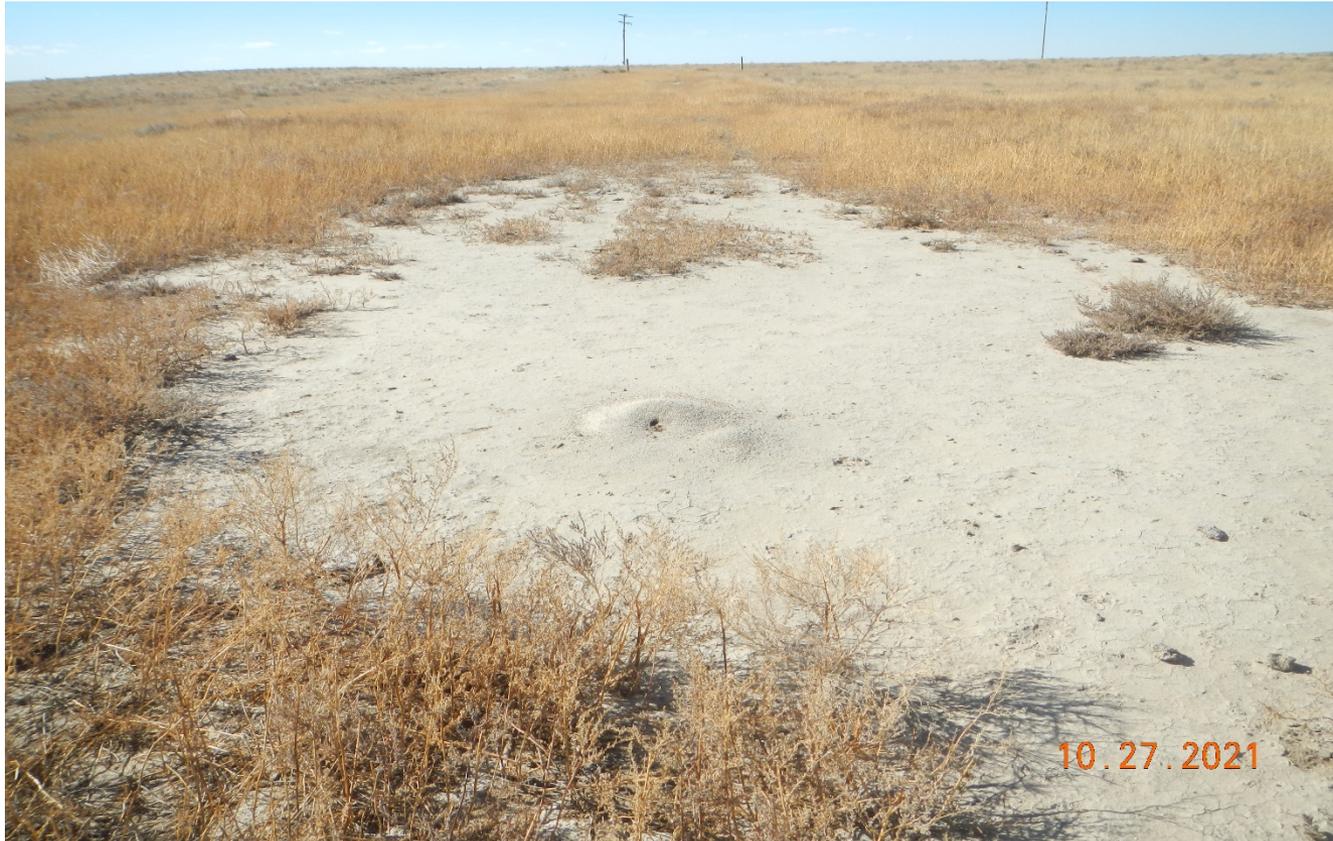
**Photo 3.** Facing southwest at the former spill area. There is no vegetation growth along this area approx. 100'x60'.

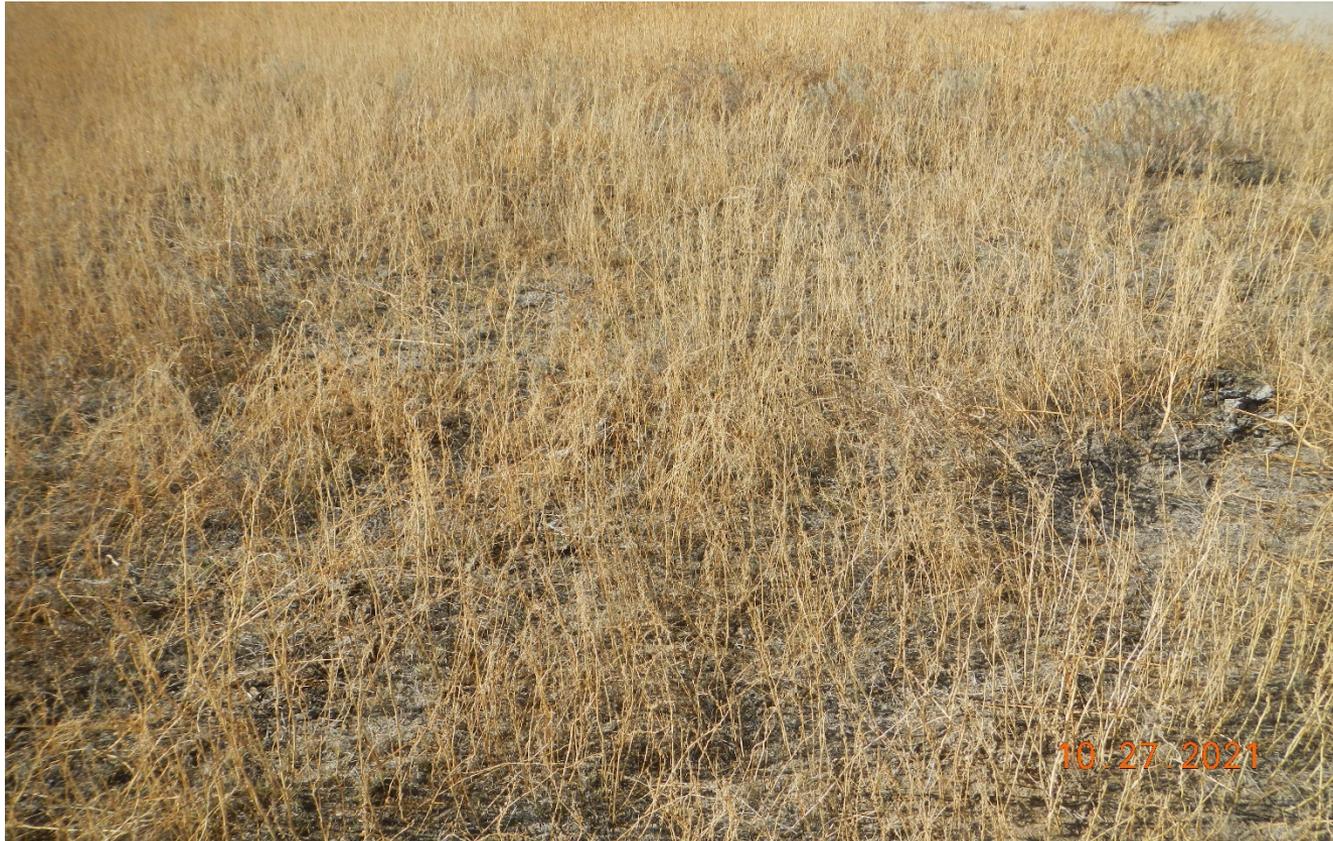
**Photo 4.** View of groundcover shows only undesirable weed growth (Kochia sp.) which is capable of growing in impacted soils. No perennial desirable vegetation was observed in this area.

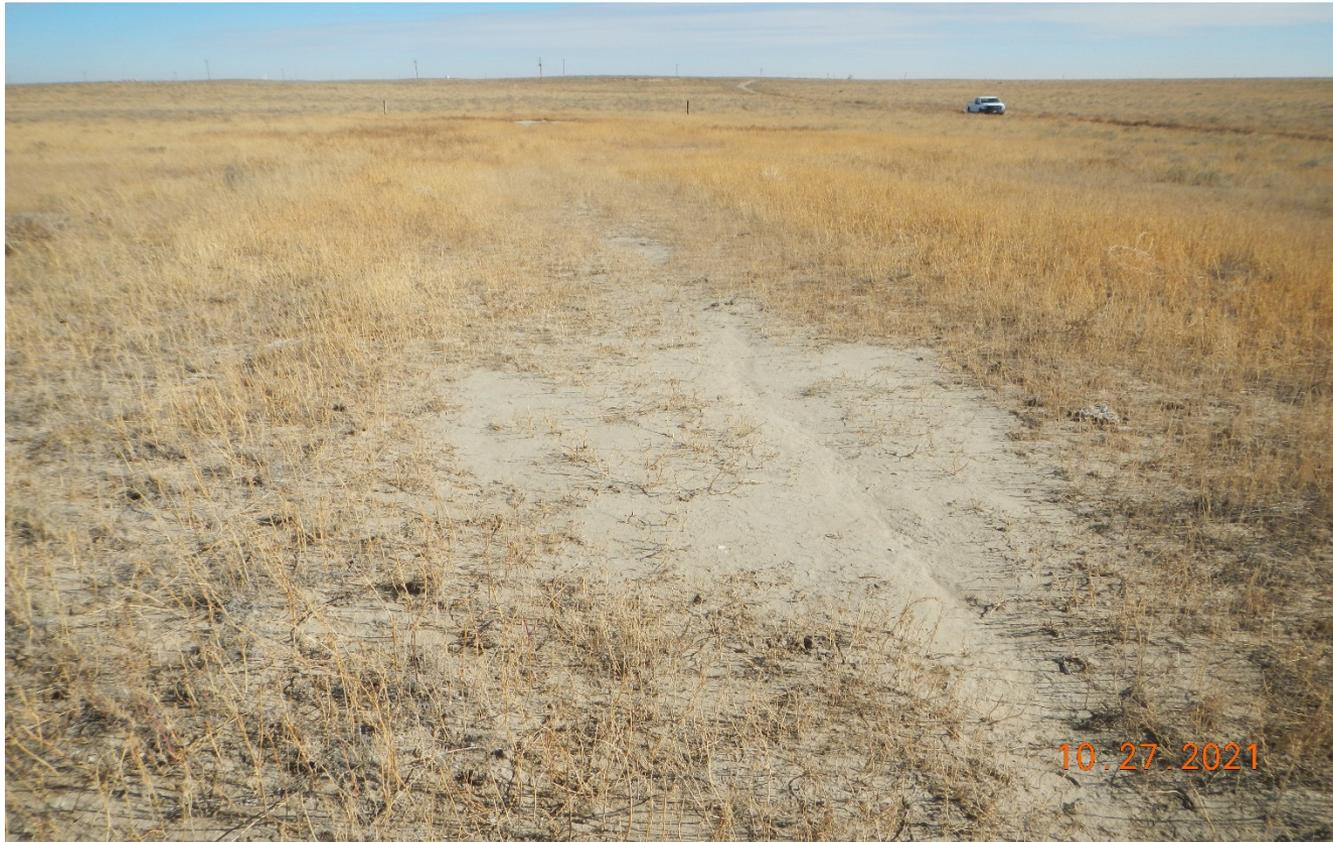
**Photo 5.** Facing northeast at the former spill area near the access road. This area consists of only undesirable weeds.

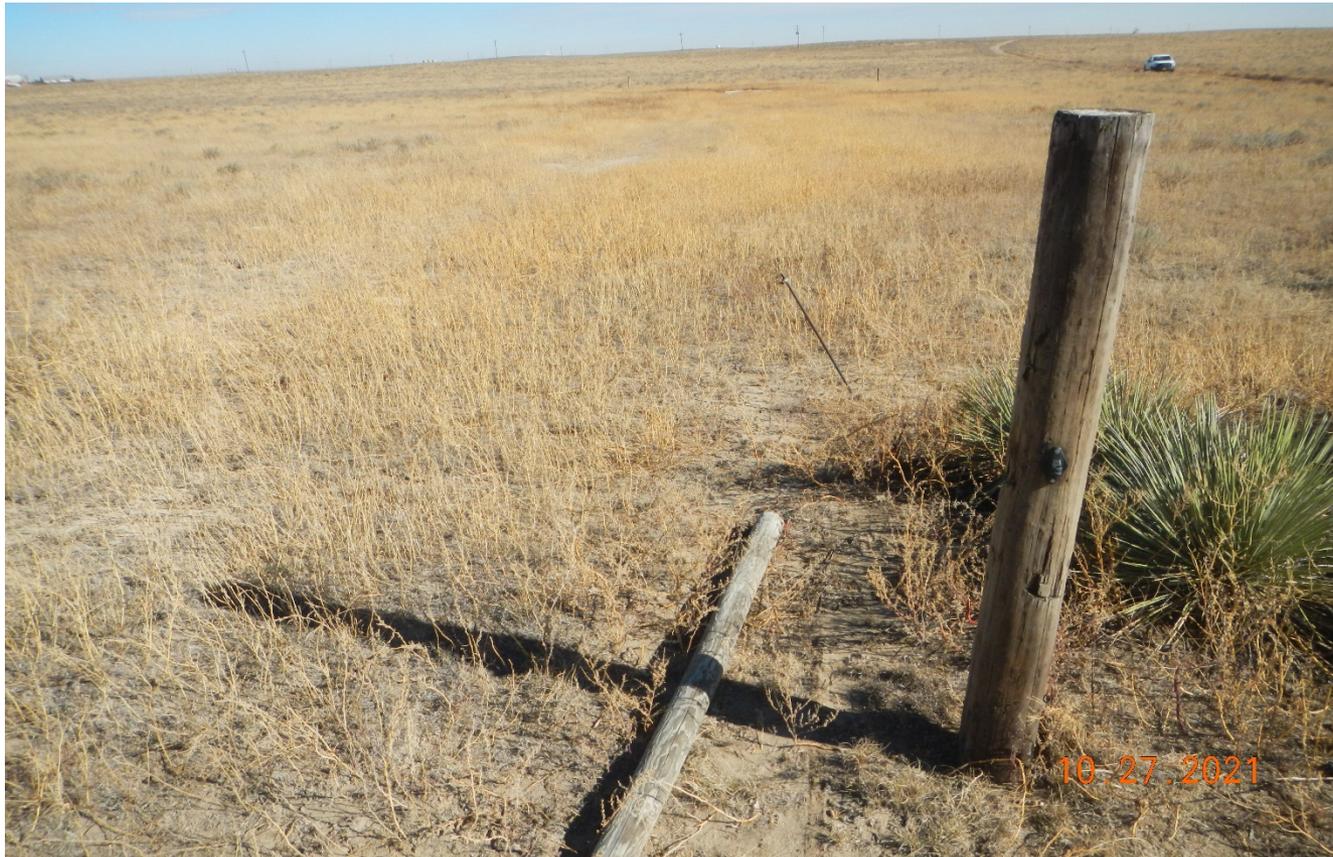
**Photo 6.** There are four posts that remain around the impacted area indicating this area was previously fenced.

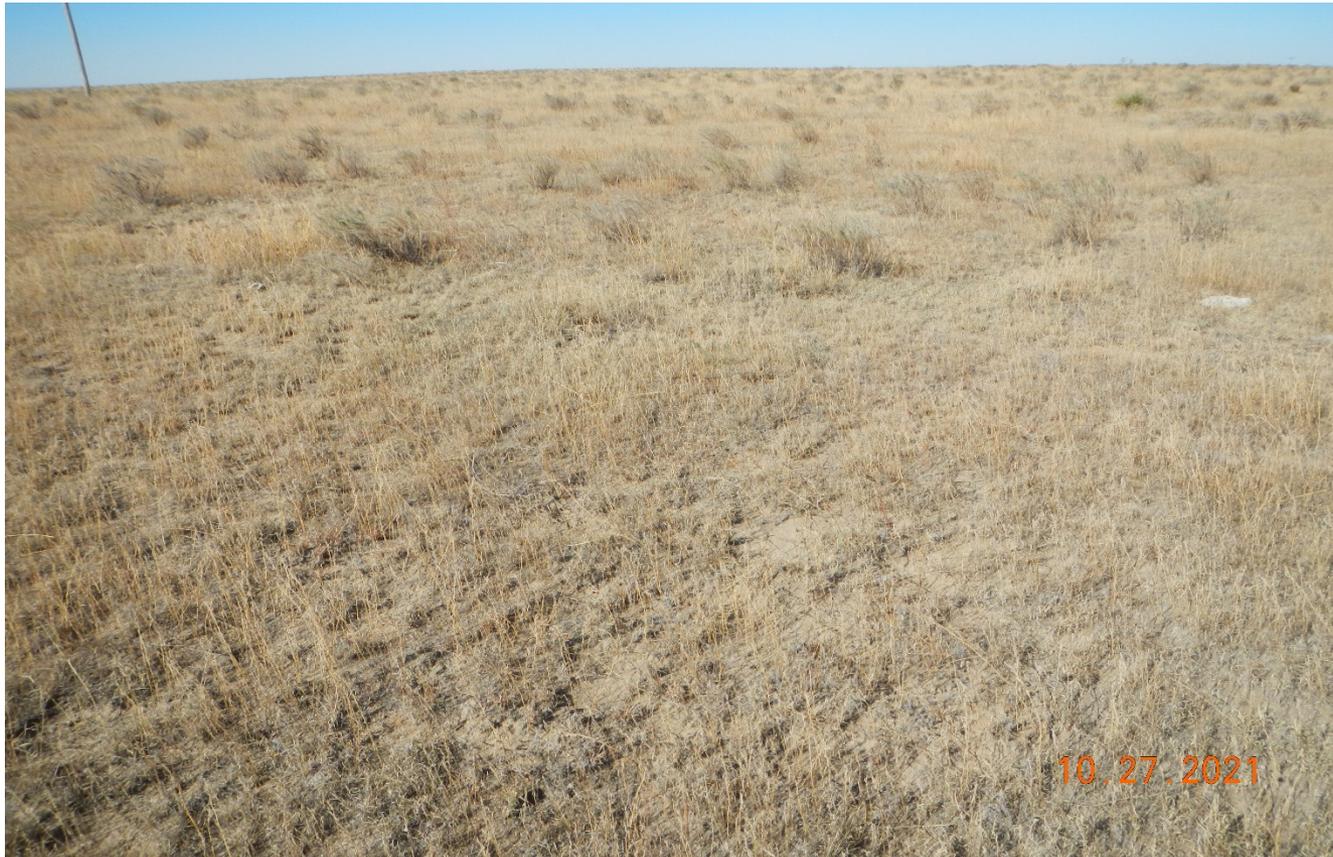
**Photo 7.** Facing north toward the surrounding undisturbed pasture which consists of native Blue grama grass prairie.

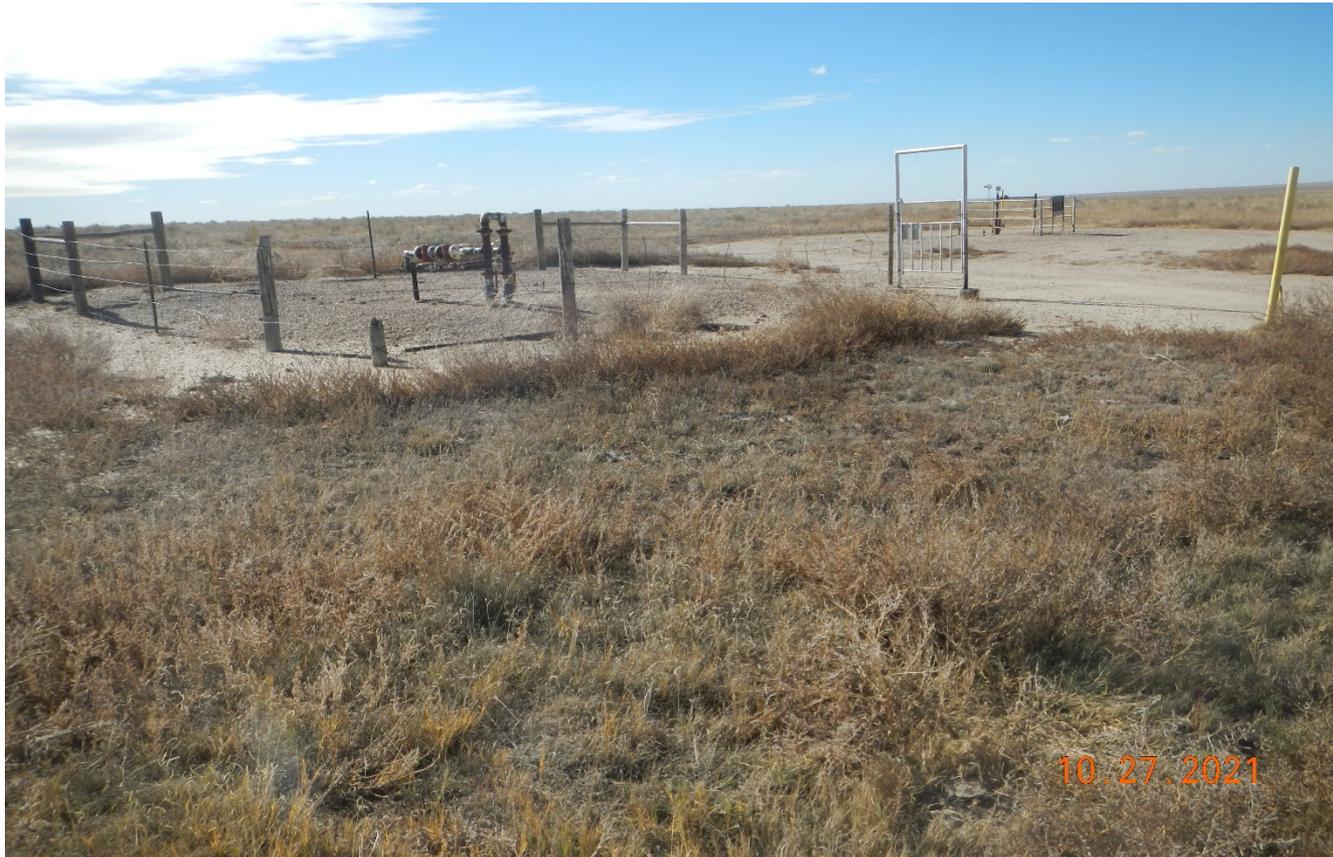
**Photo 8.** Facing southwest toward the well site.

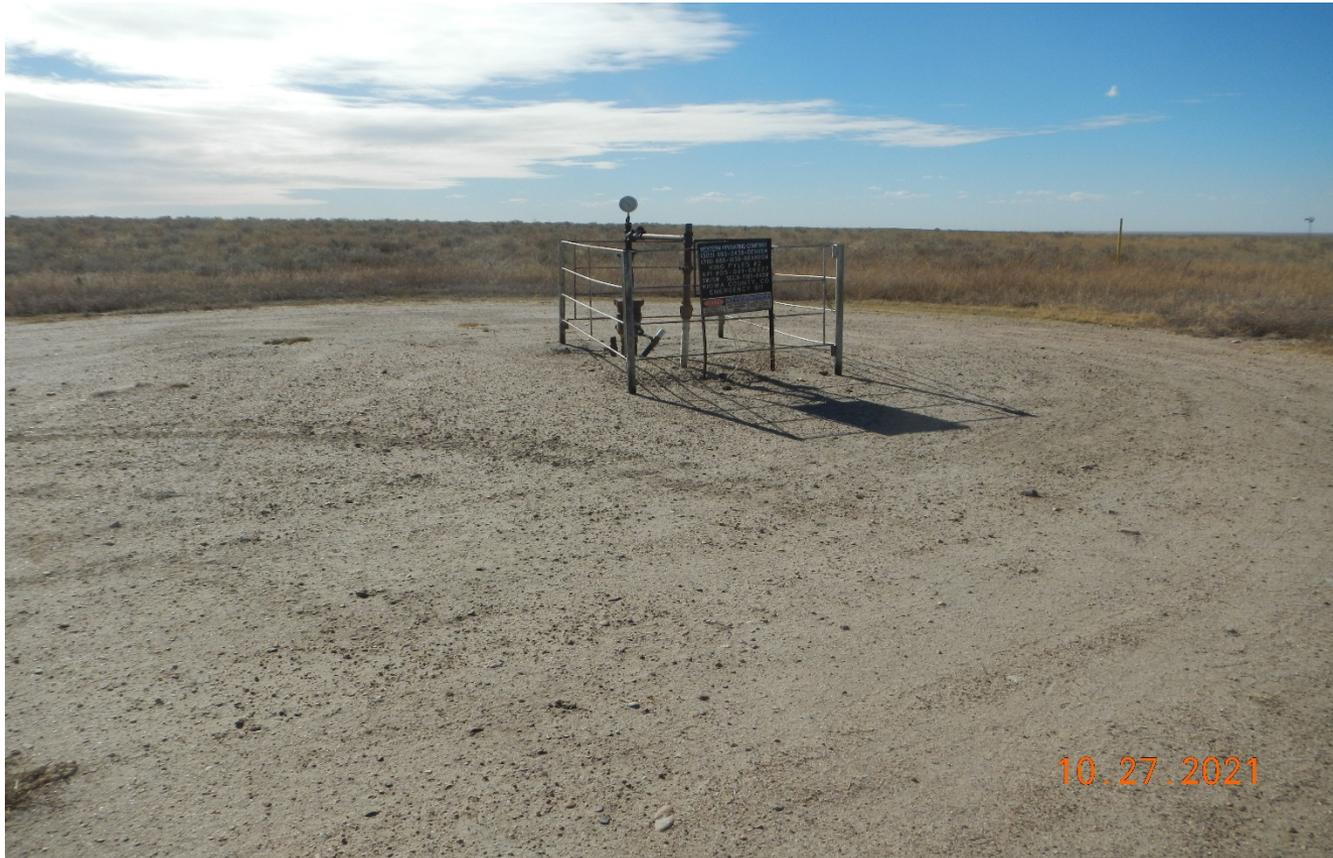
**Photo 9.** Facing southwest toward the well site.

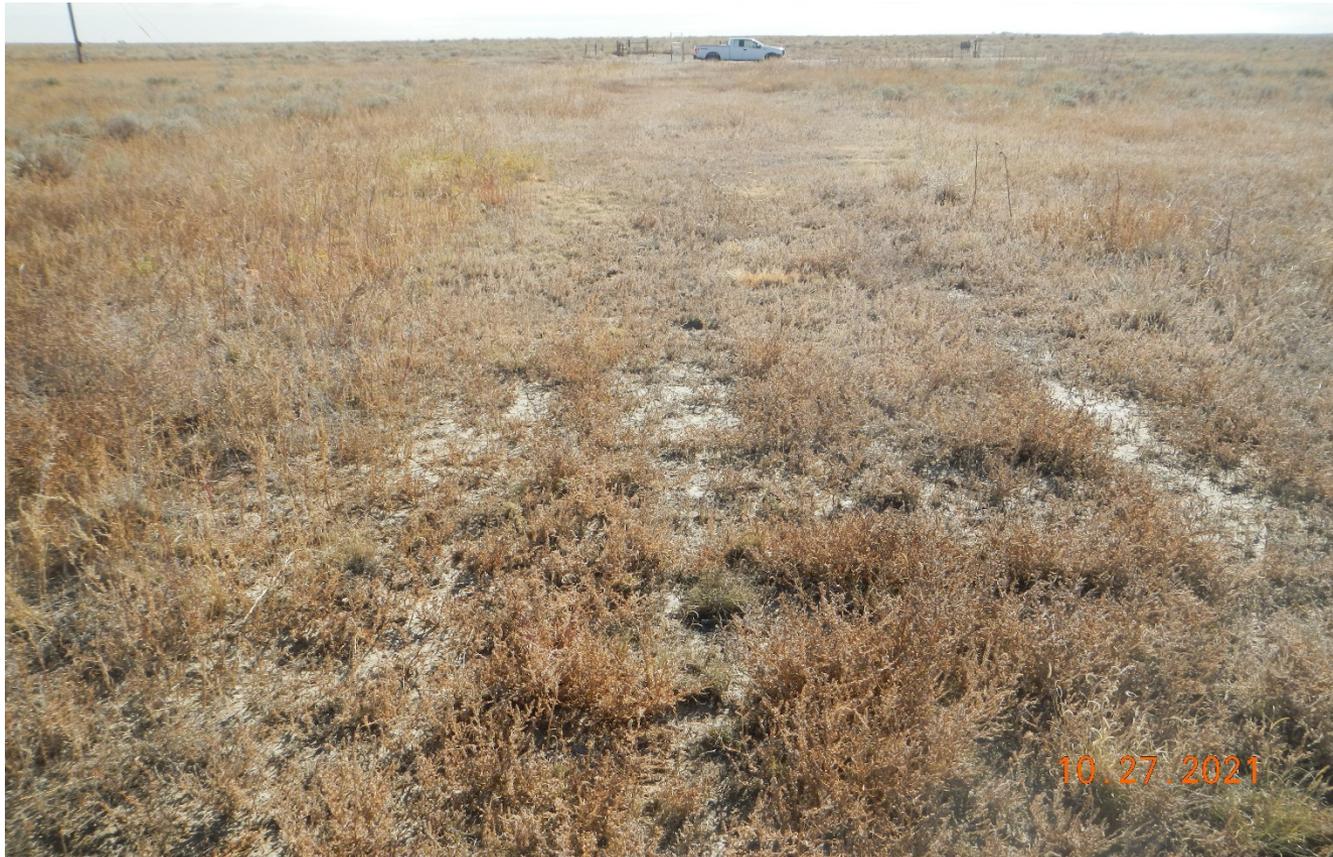
**Photo 10.** Approximately 400' northwest of the well site is another impacted area shown by red arrow in aerial photo 1. This area consists of only undesirable weeds.
