TEP
RMV 5-21
Location # 323888

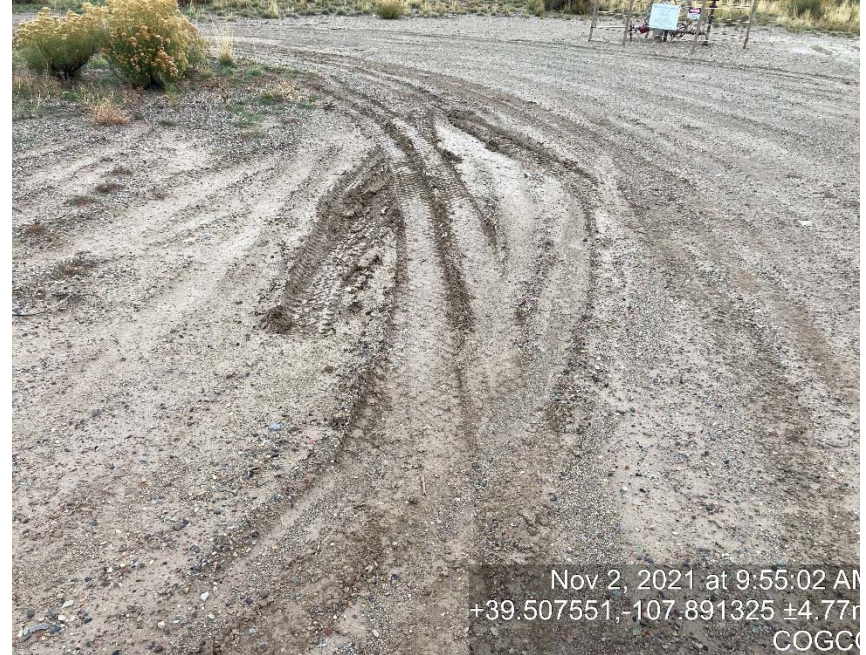
Lack of stabilization/compaction

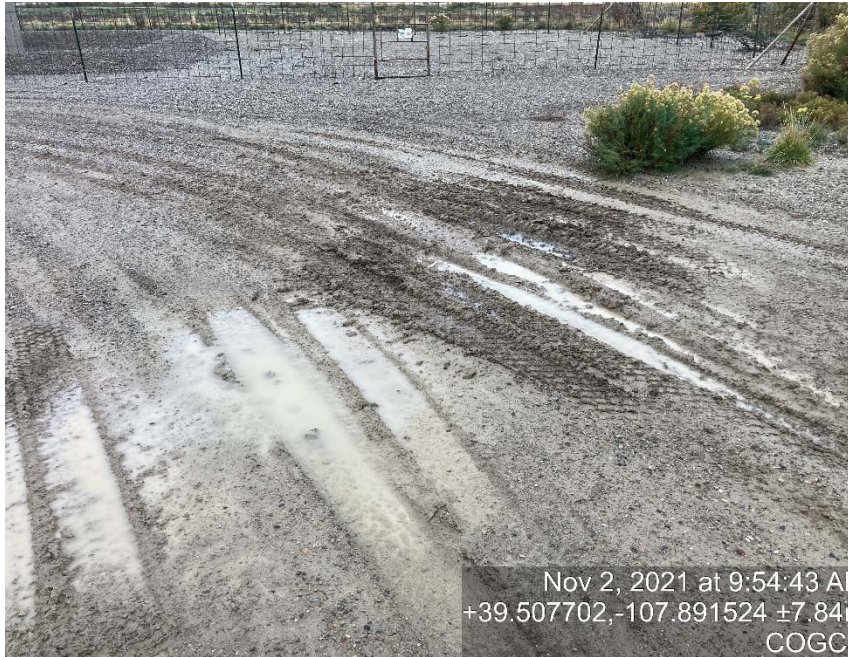
Lack of stabilization/compaction

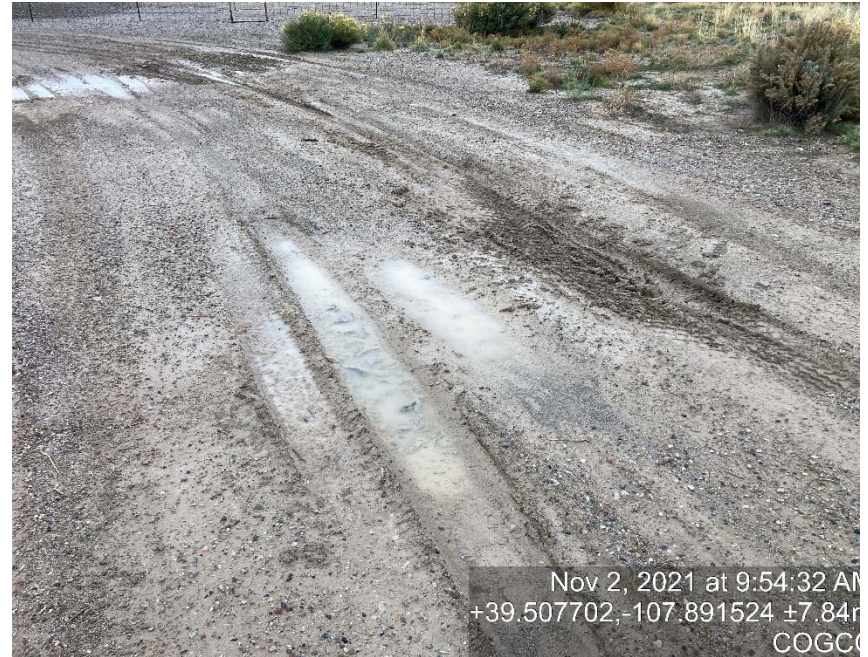
Lack of stabilization/compaction

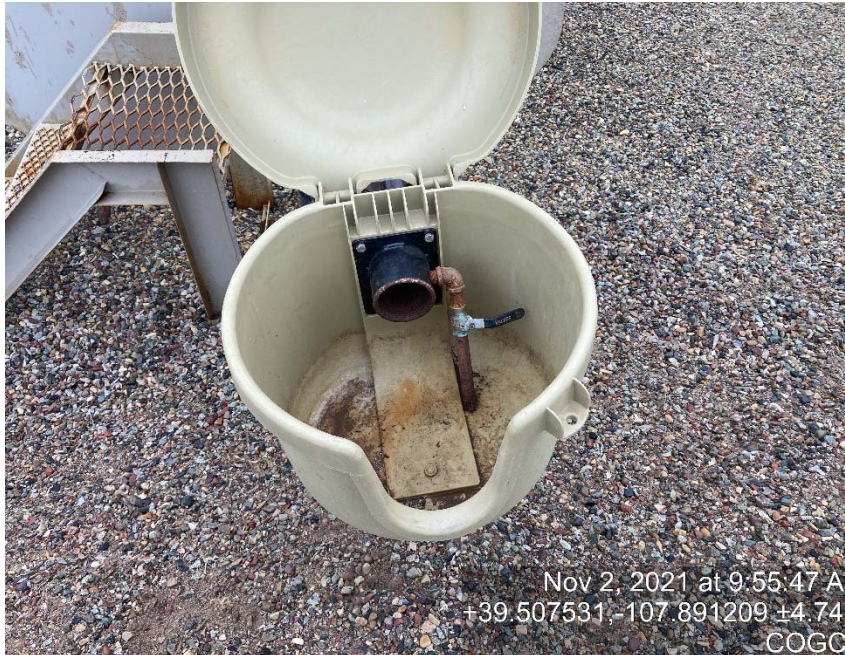
Load out line missing cap/bull plug

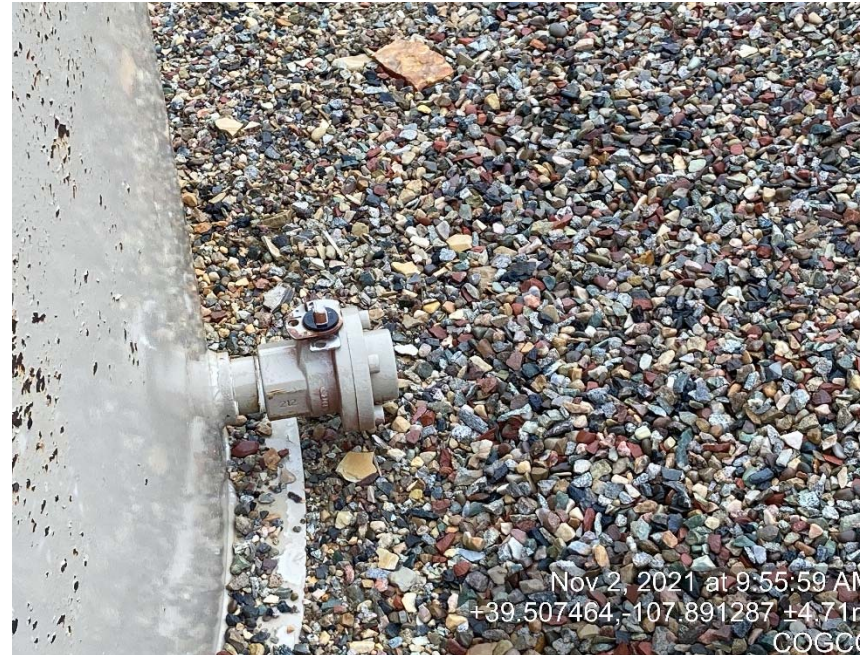
Load out line missing cap/bull plug
