# TEP RWF 513-10 Location # 335655

**COLORADO**  
Oil & Gas Conservation  
Commission  
Department of Natural Resources

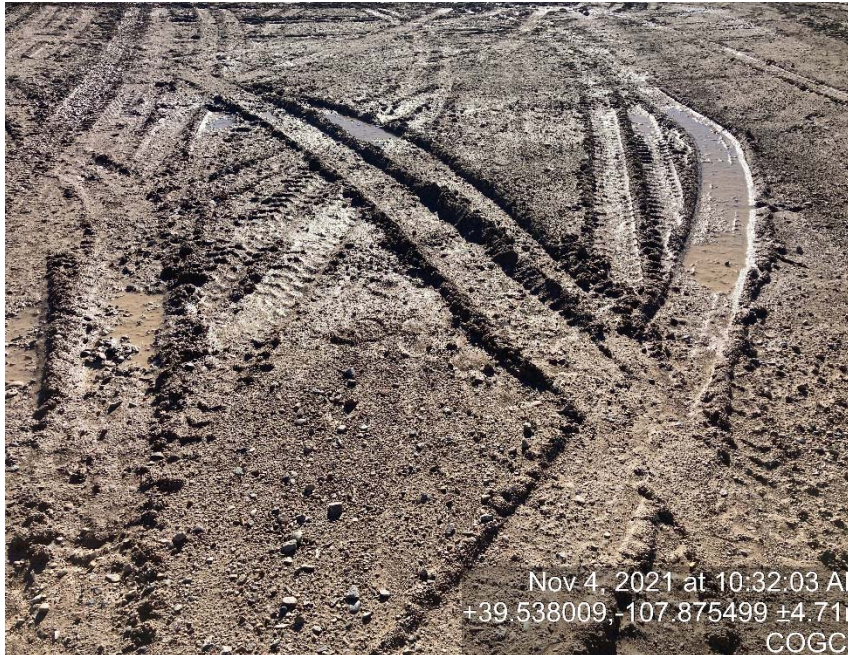
**Lack of stabilization/compaction**

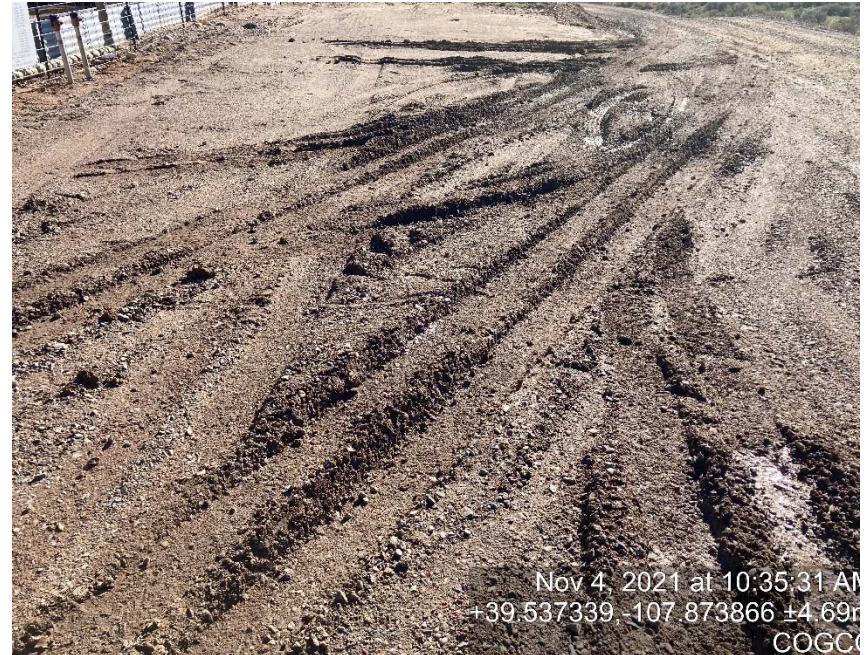
**Lack of stabilization/compaction**

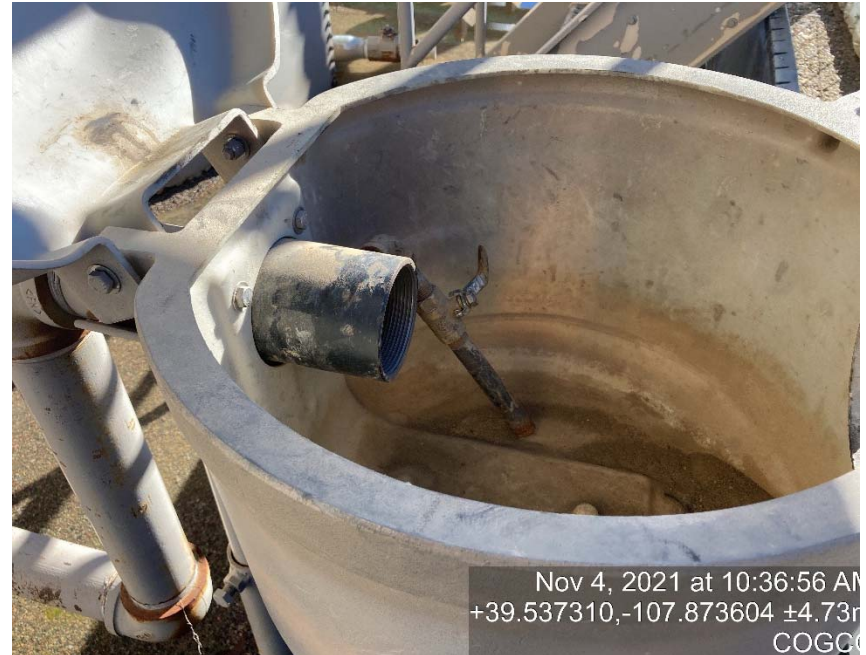
**Load out line missing cap/bull plug**

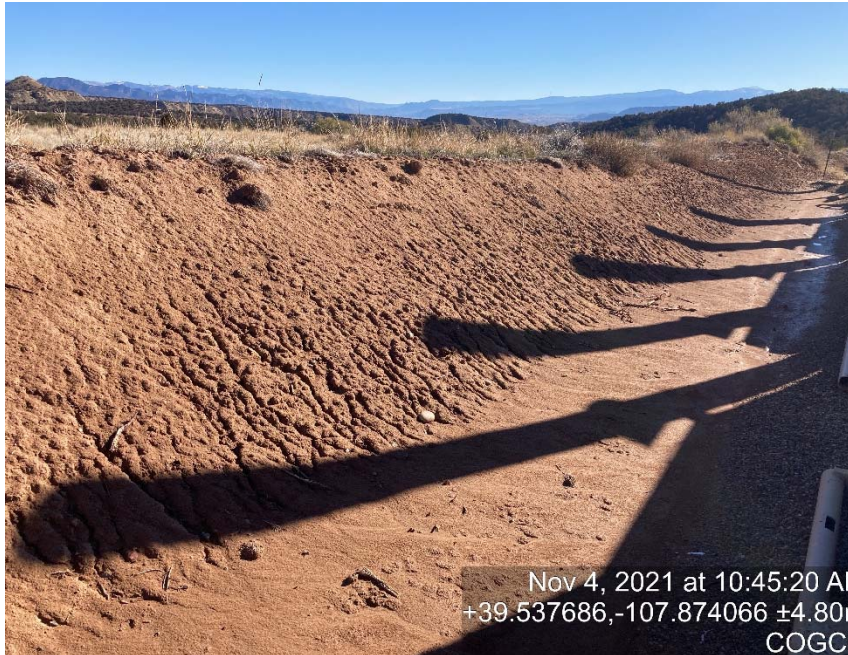
**Lack of stabilization/erosion**

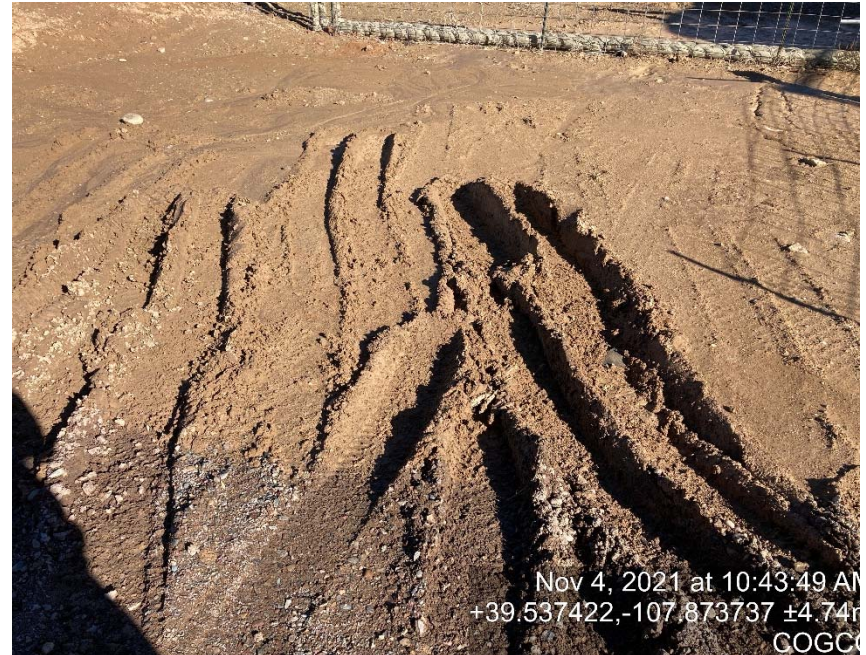
**Lack of stabilization/compaction**

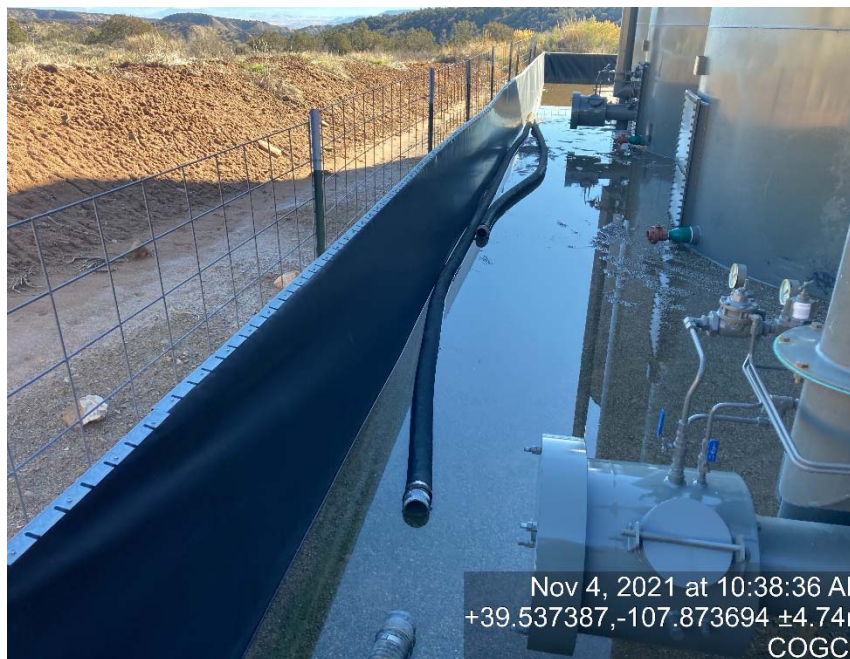
Debris

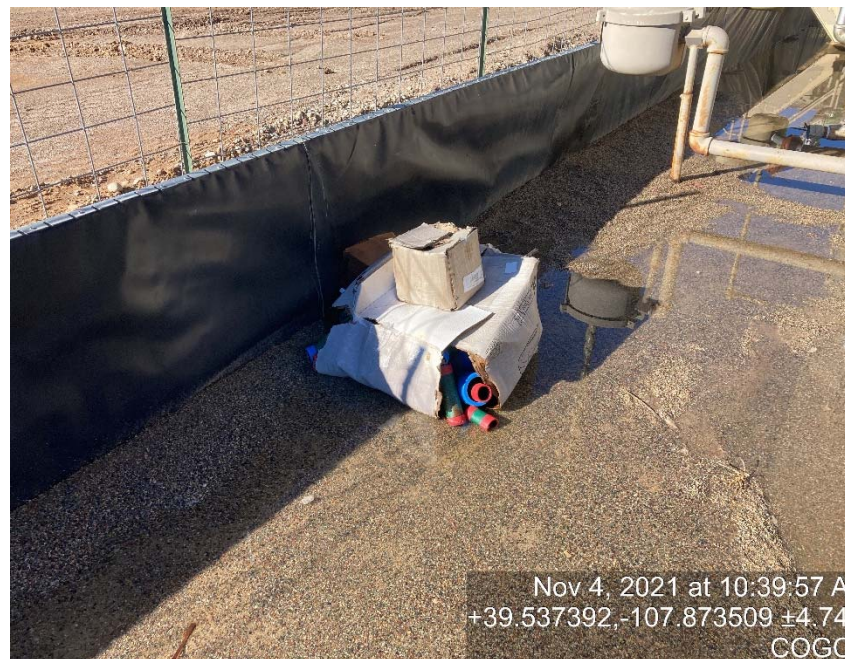
Debris
