Inspection Photos

API: 071-06491

Operator: EVERGREEN NATURAL RESOURCES

Inspection Date: 11/3/2021

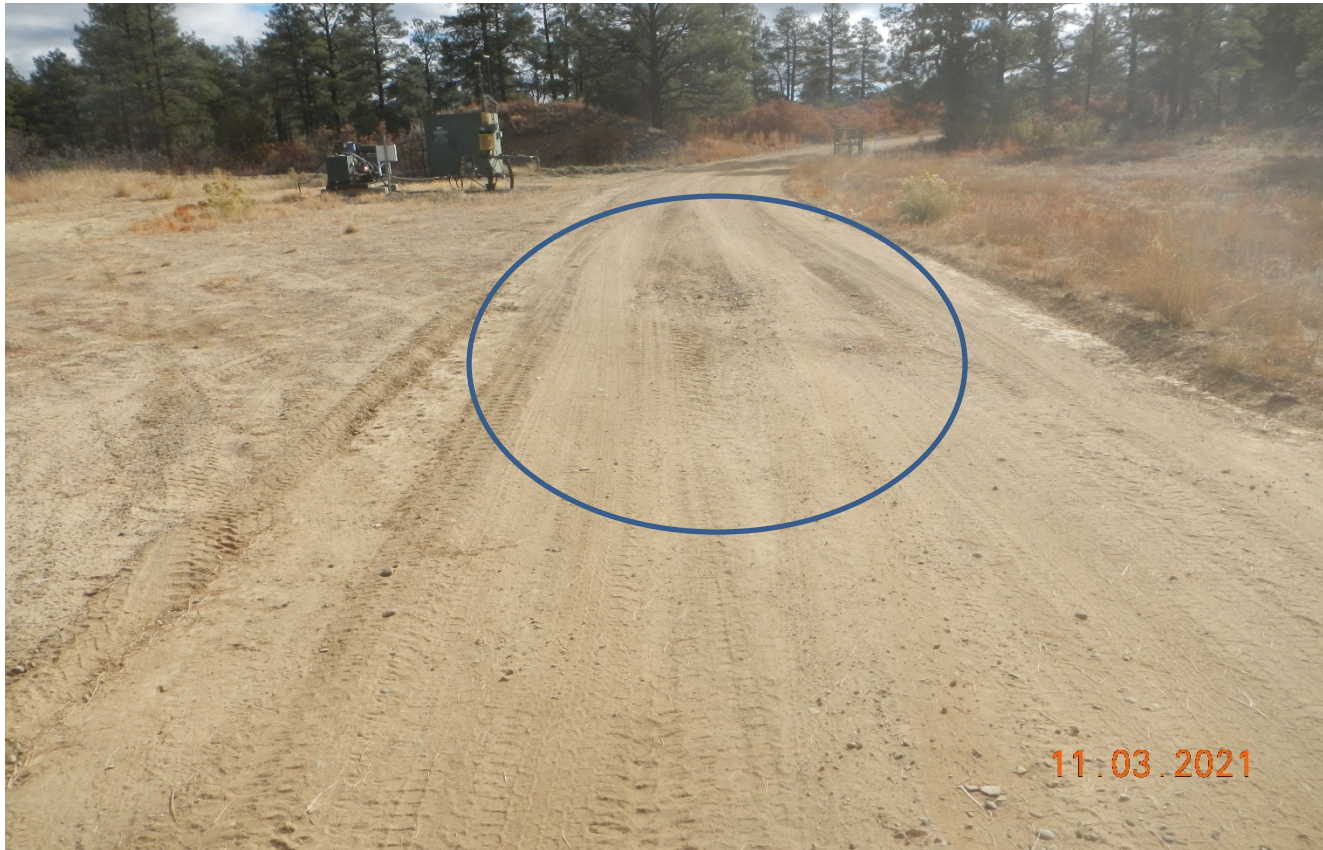
Photo 1. Facing southeast toward at the [LEFT FIELD #31-29](#) well site. The access road was bladed however the area of water pooling circled has not been repaired to divert water. This area of the road should be crowned to divert water from the road.

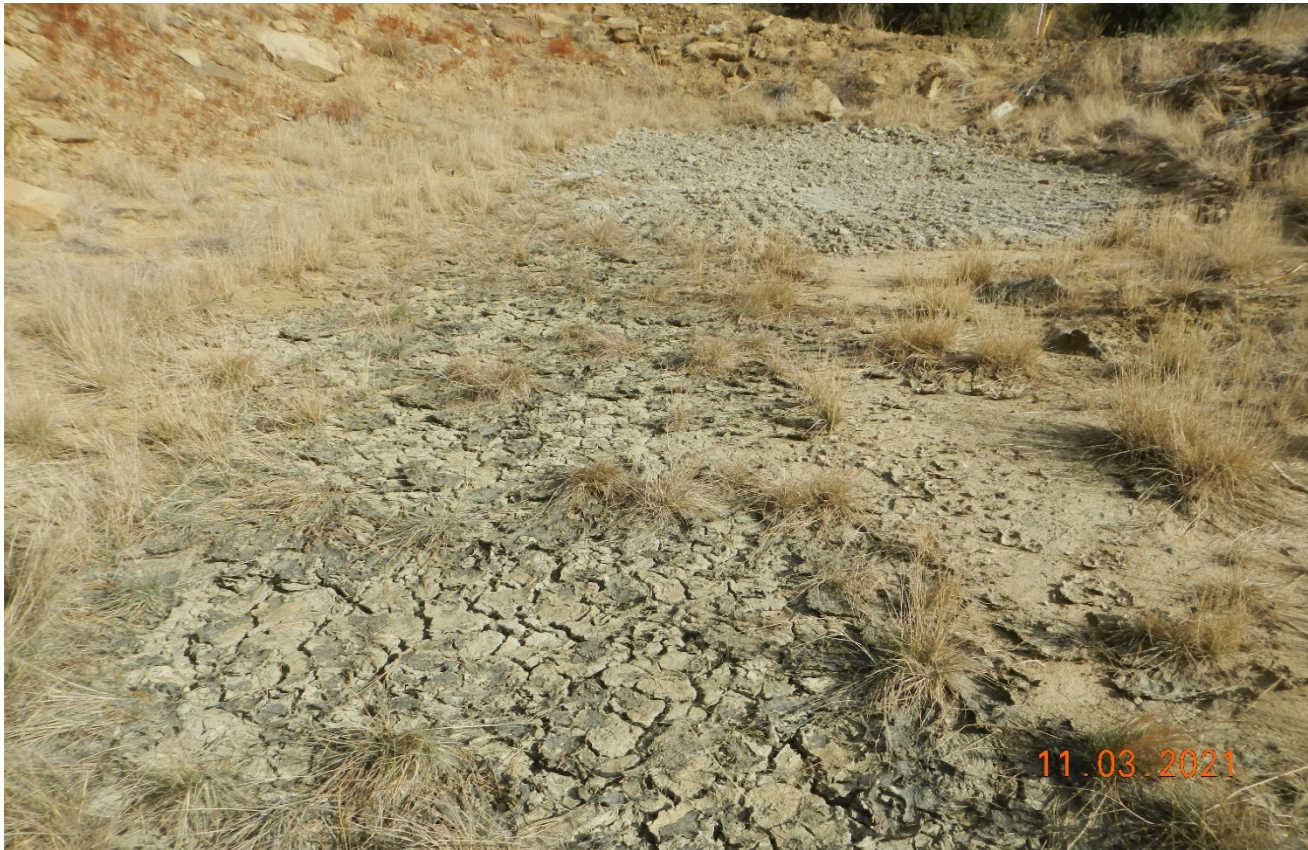
Photo 2. Facing toward the pit. The pit was scrapped but there is still gray soil that remains.

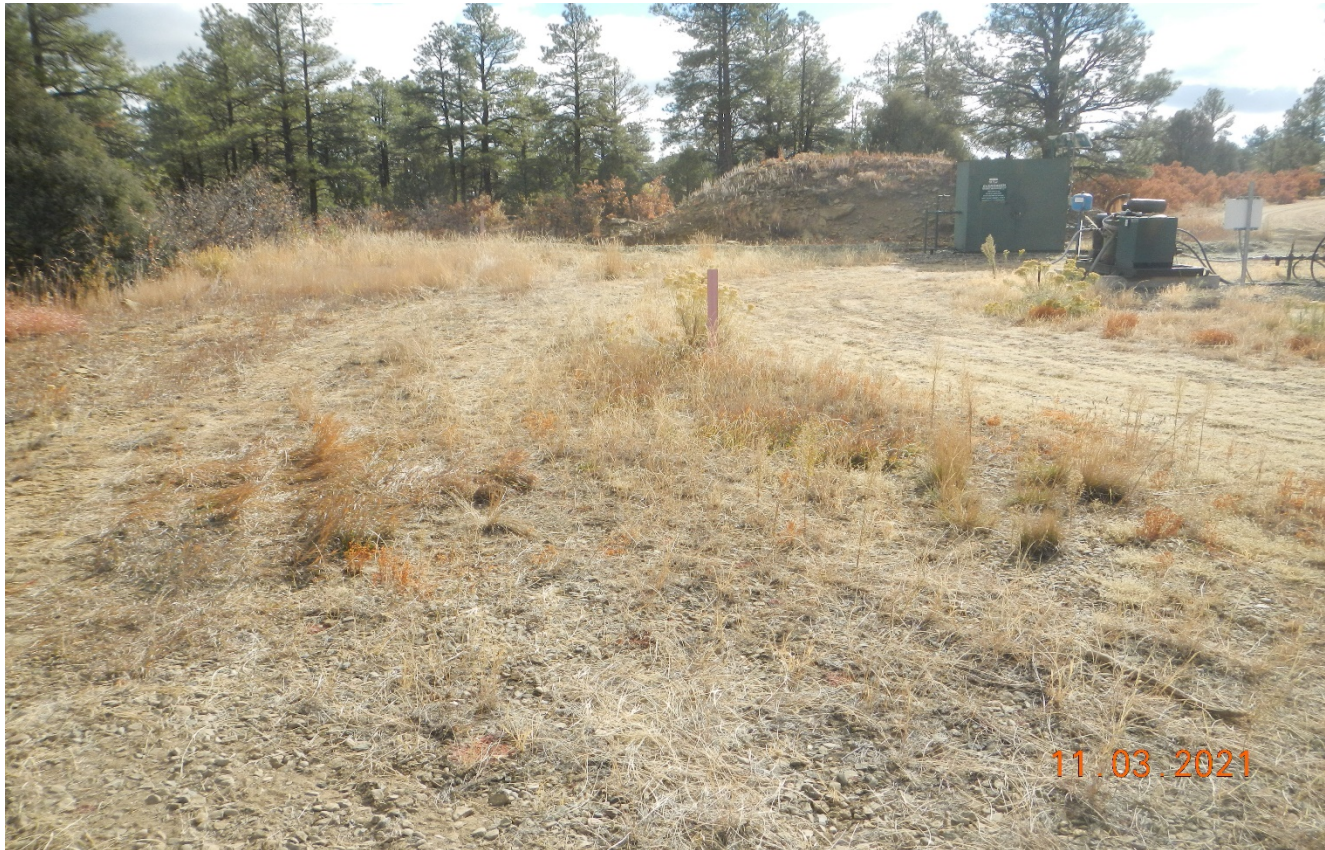
Photo 3. Facing southeast toward the LEFT FIELD #31-29 TR well site.

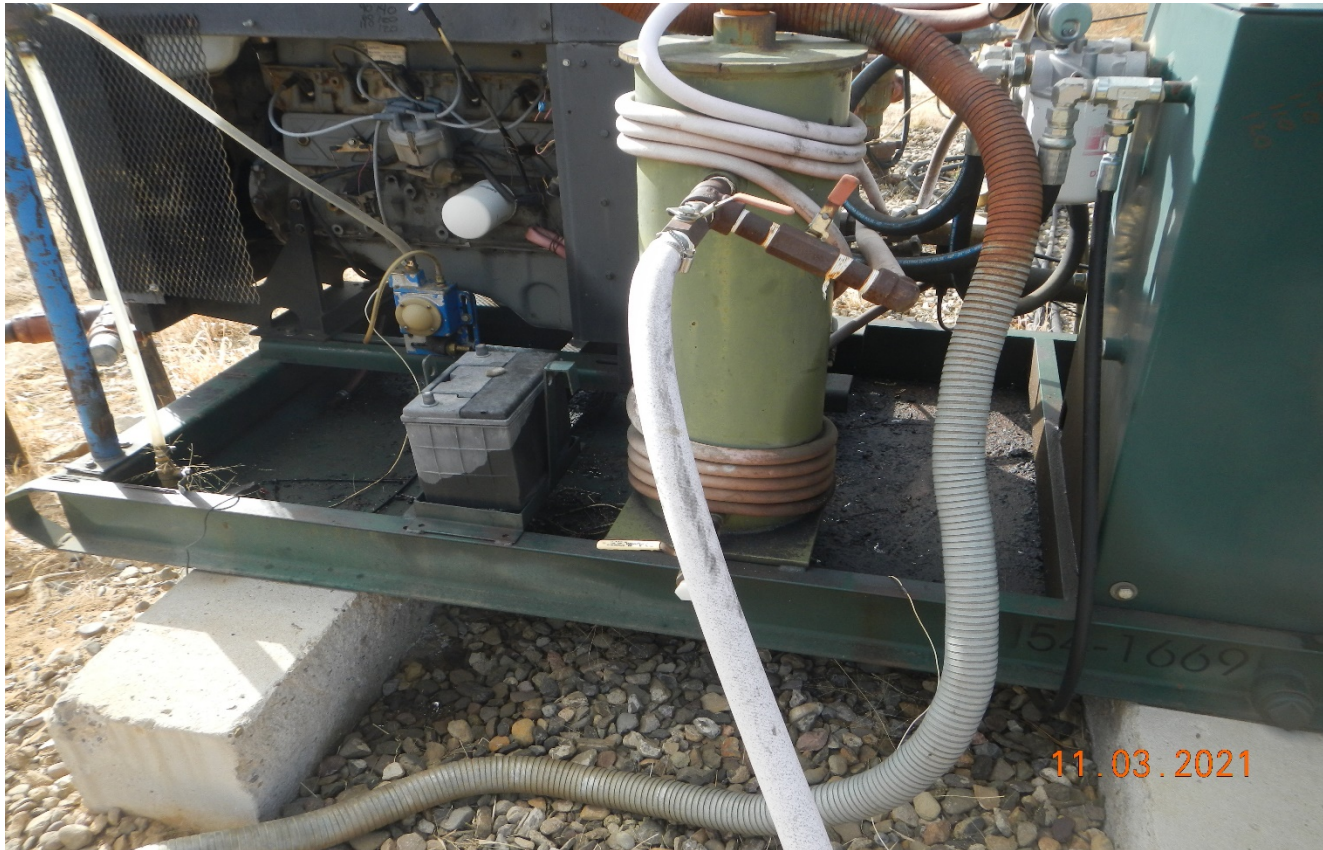
Photo 4. The oily rags were removed from the engine skid.

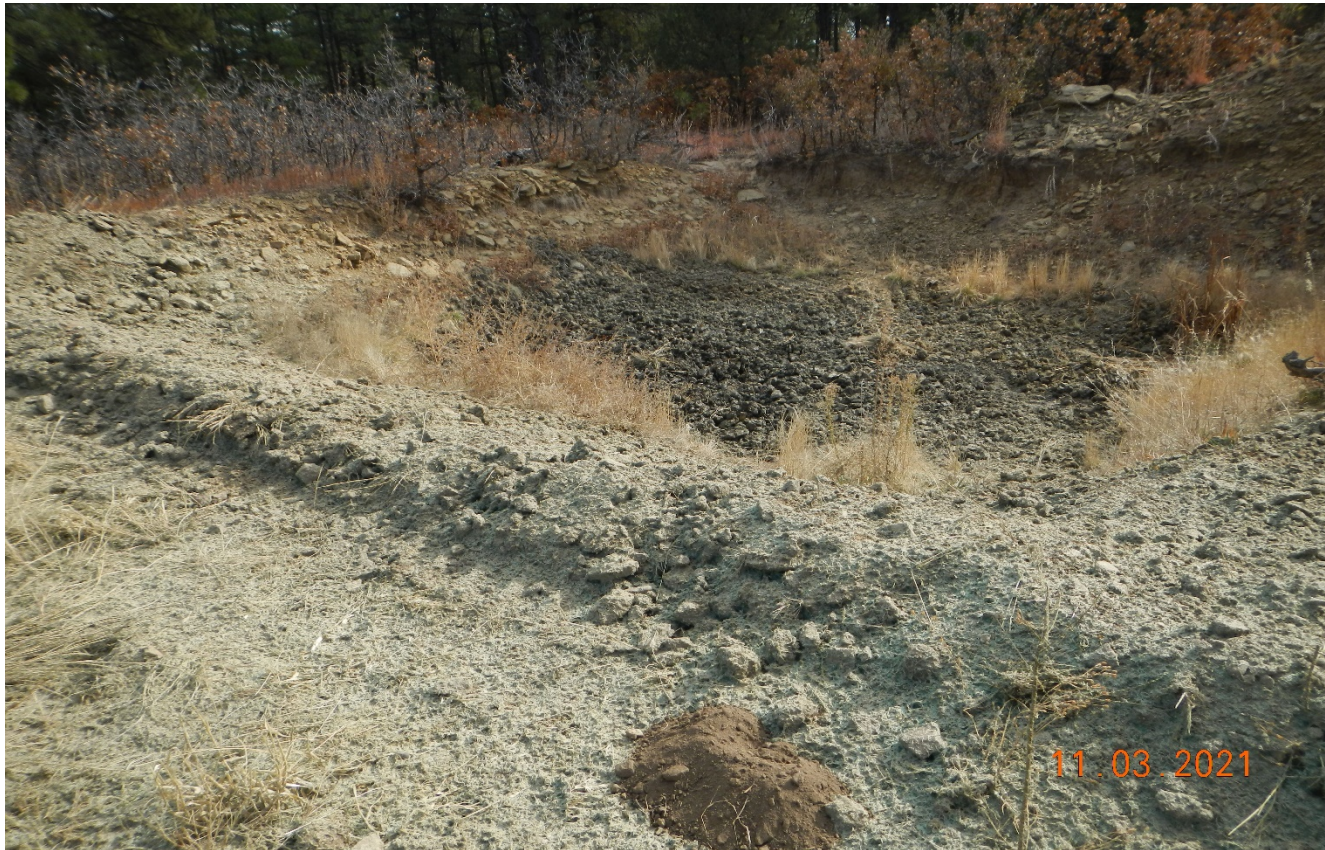
Photo 5. Facing toward the pit. The pit was scrapped out.

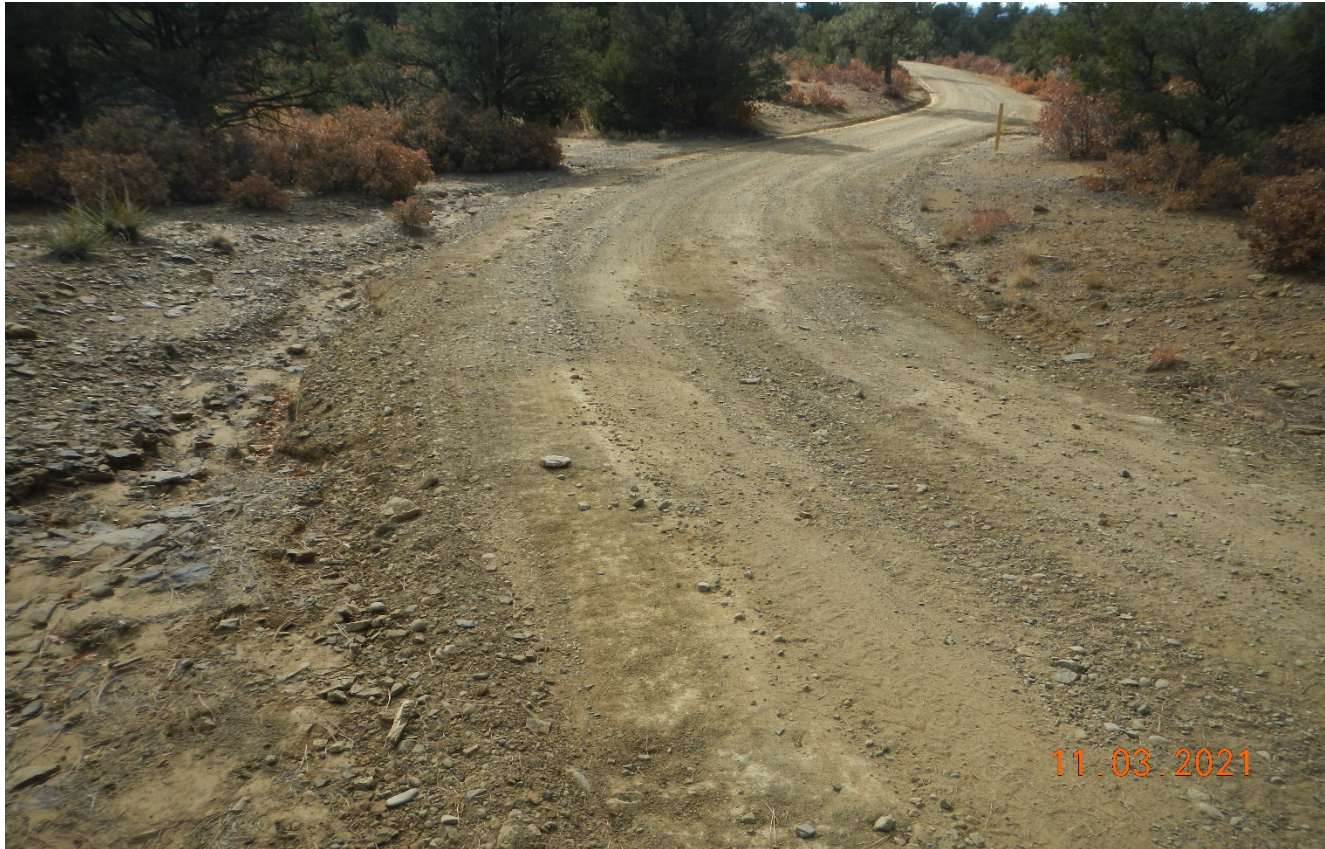
Photo 6. Facing south along the access road. The road was graded however there is insufficient stabilization.

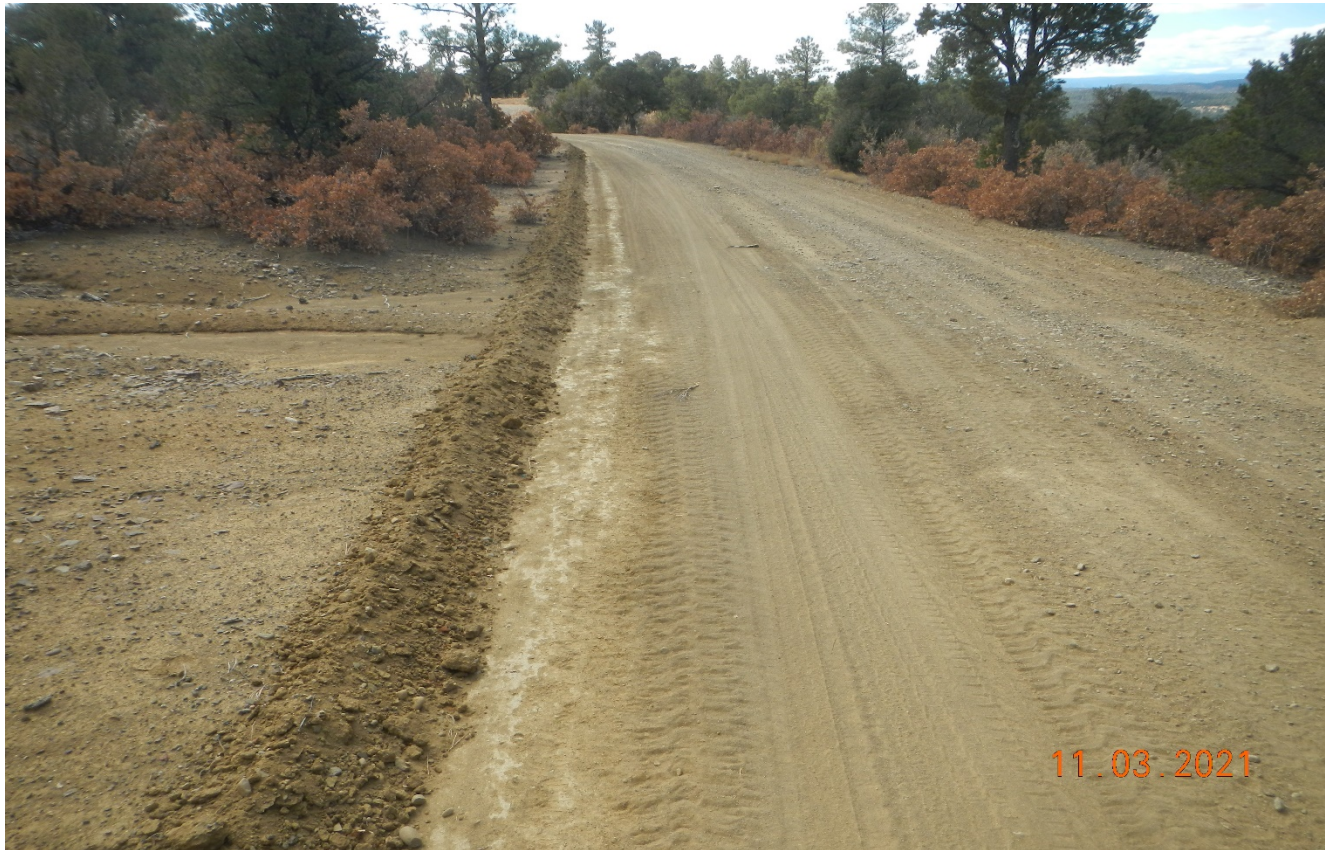
Photo 7. Facing south along the access road. The road was graded however there is insufficient stabilization. Loose graded soils are susceptible to erosion.

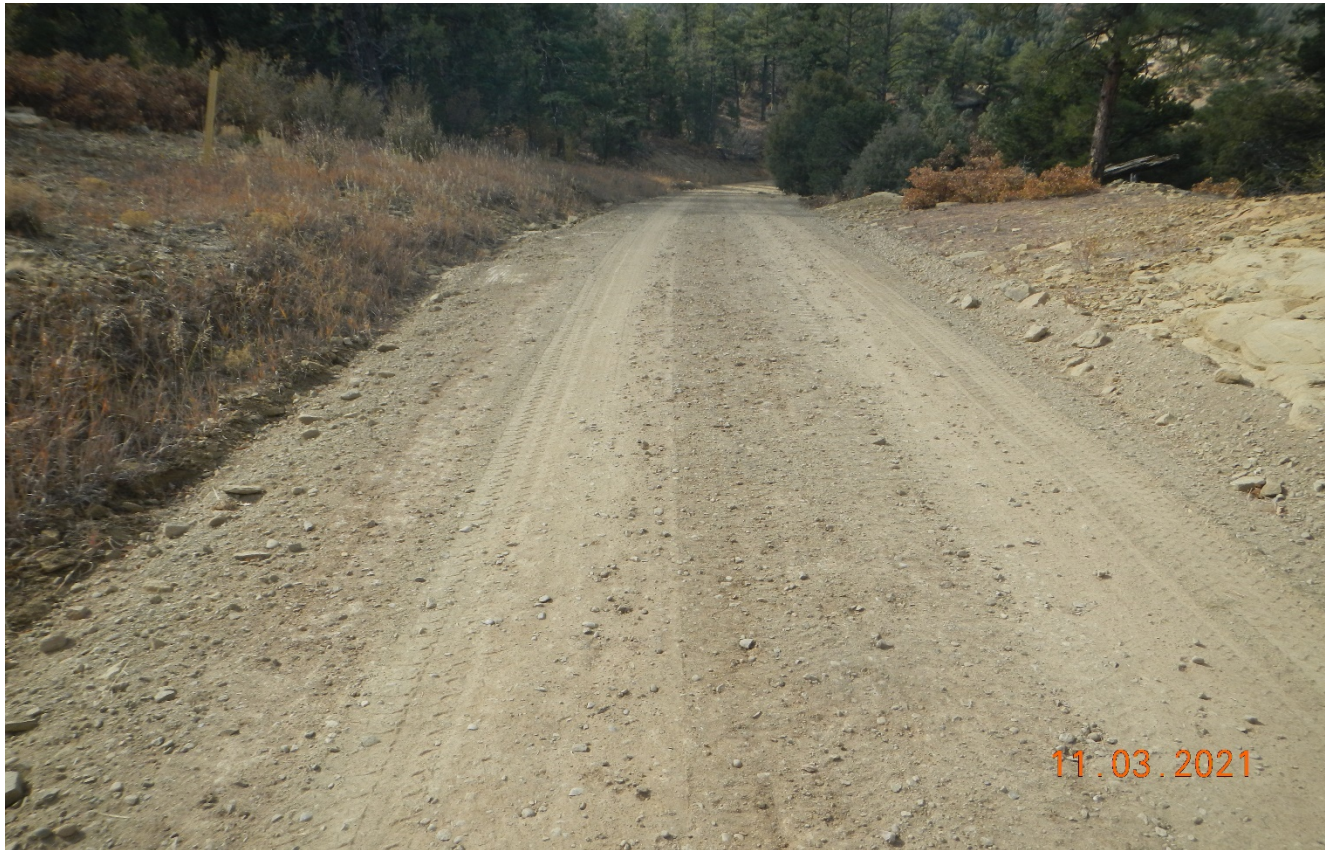
Photo 8. Facing southwest at steep road traveling down from the top of the ridge. The road was graded however loose soils are susceptible to erosion.

Photo 13. View of the aerial map between the two red arrows is the road shown in photos 8 thru 10. This road is steep and not stabilized as shown in the photos. This section of the road is not necessary for production of the well and needs to be recontoured and reclaimed.

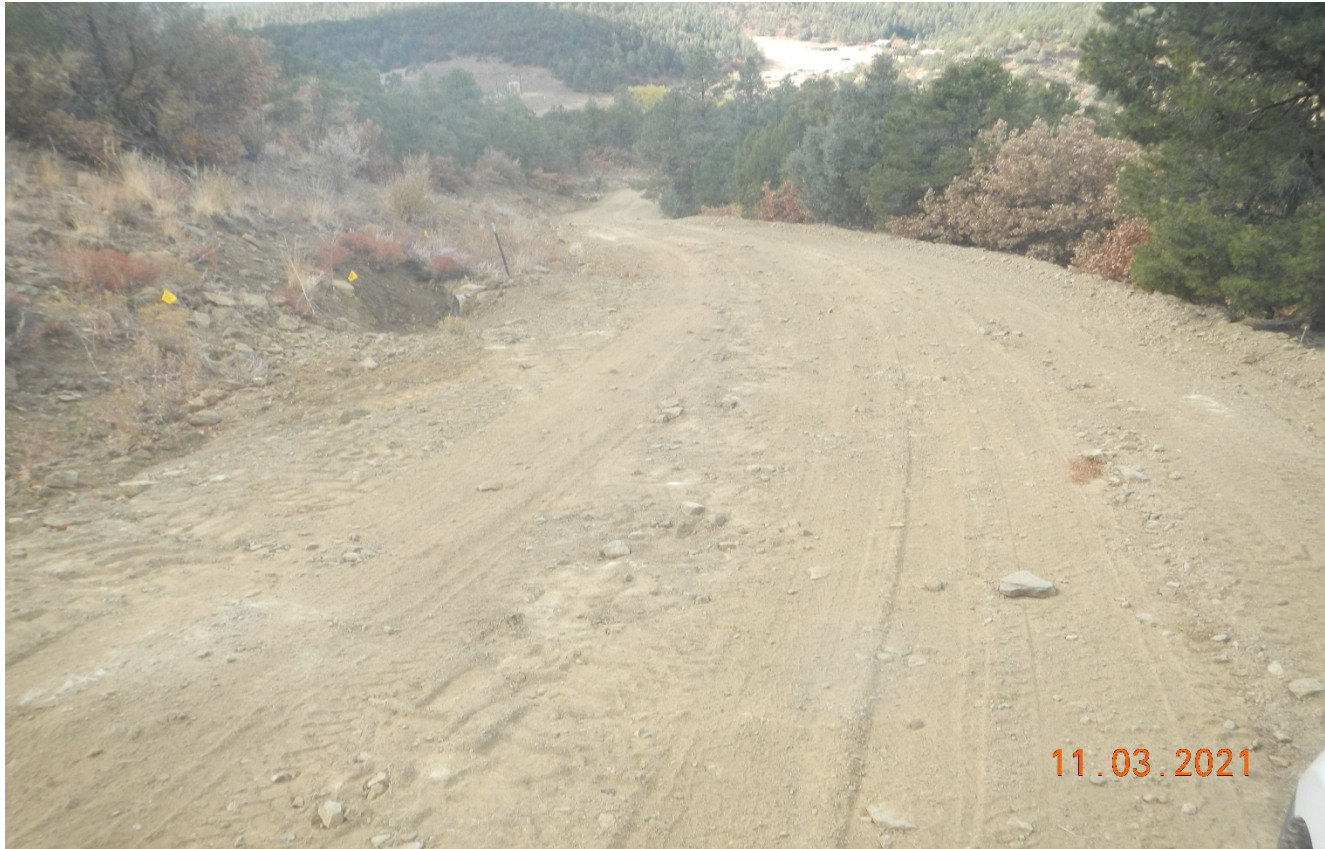
Photo 9. Facing southwest further down the hill side. The road was graded however loose soils are susceptible to erosion.

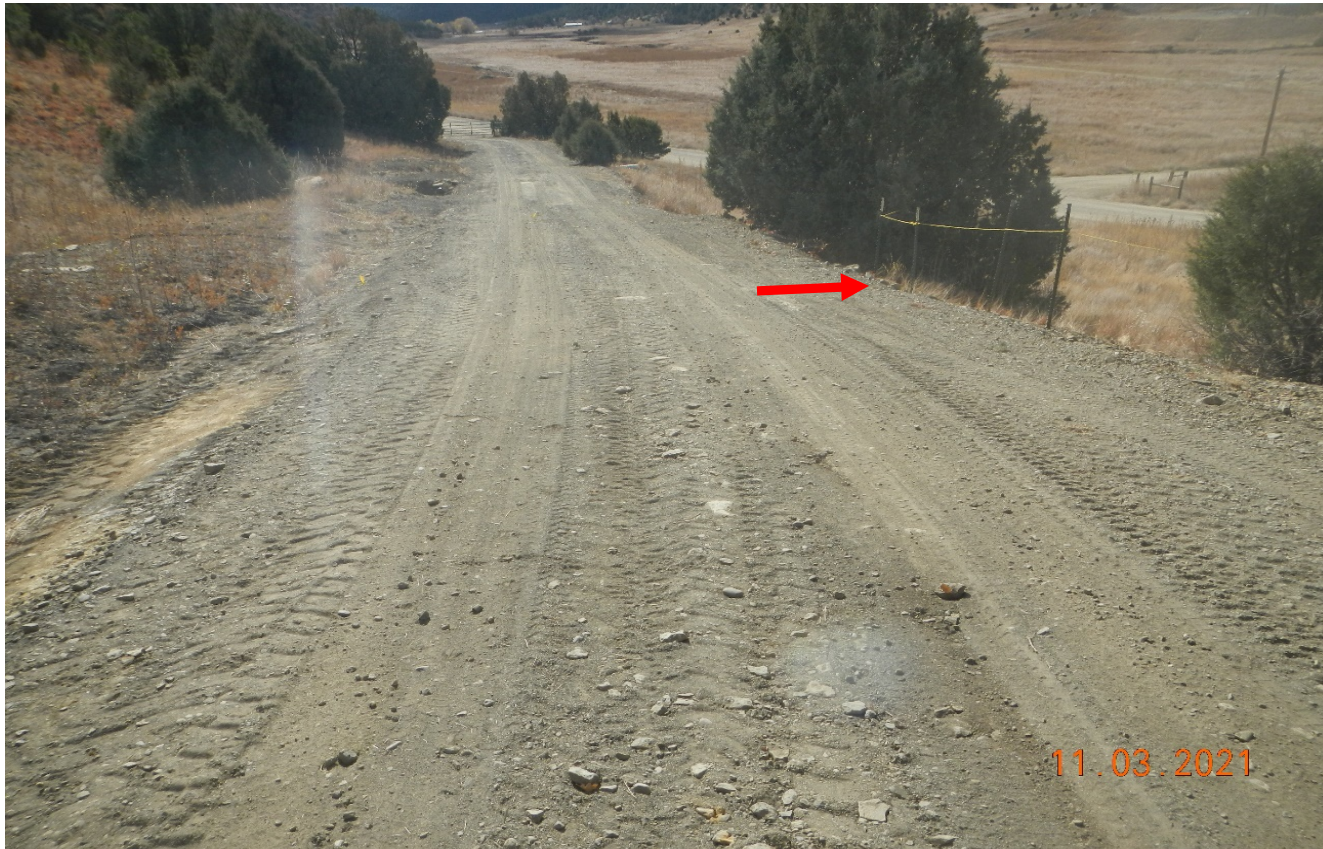
Photo 10. Facing south down the access road near county road 51. Red arrow points to where vehicle had driven off the designated road. This area down to the gate has not been restricted to prevent access by fence installation per landowner request.

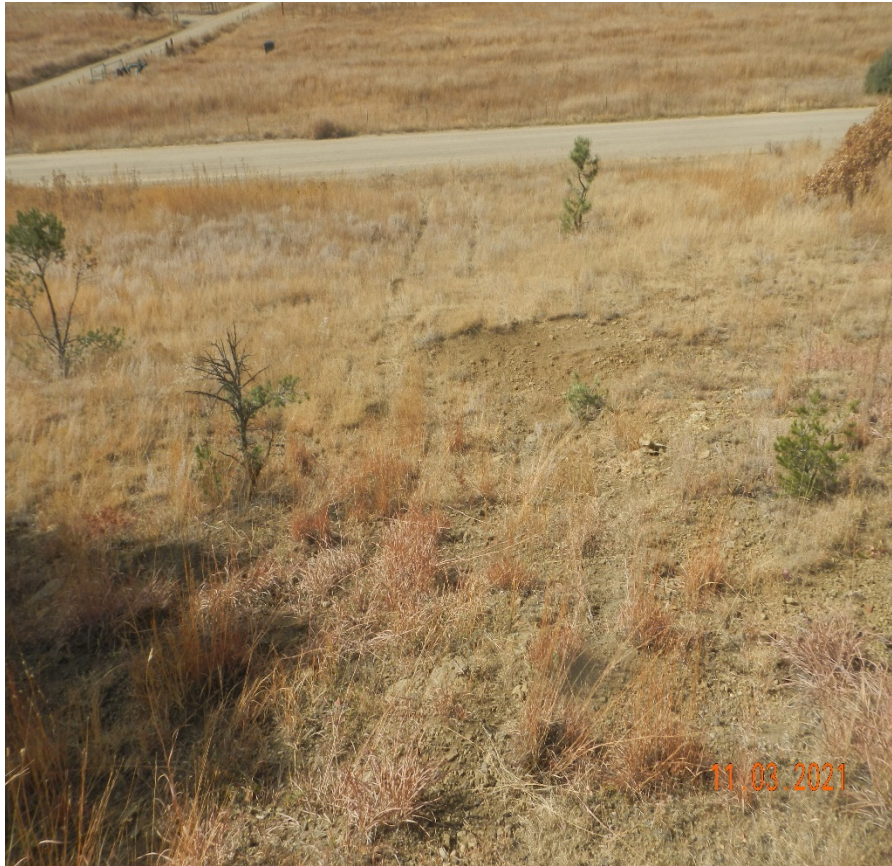
Photo 11. Facing down toward County Road where vehicle tracks across the grass are visible.

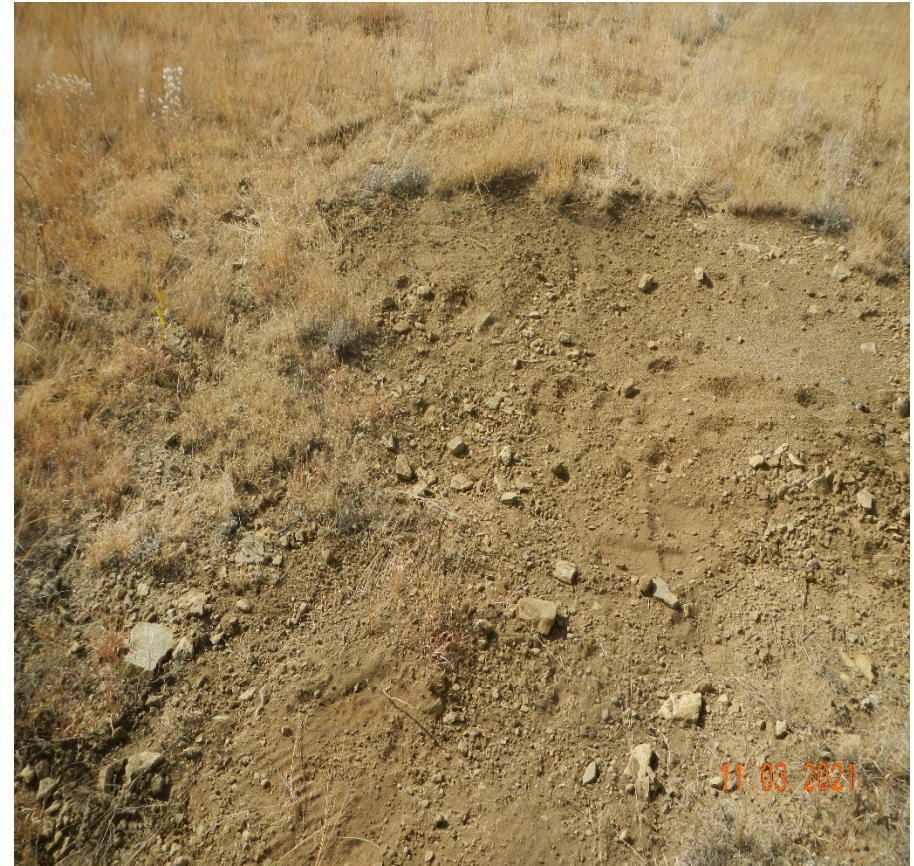
Photo 12. The areas where vehicle tracks and ruts were made have been raked out.
