**Buchner 2-2H Photographs**  
**Inspection Doc # 696303726**  
**Loc ID 431634**  
**API No. 123-36703**

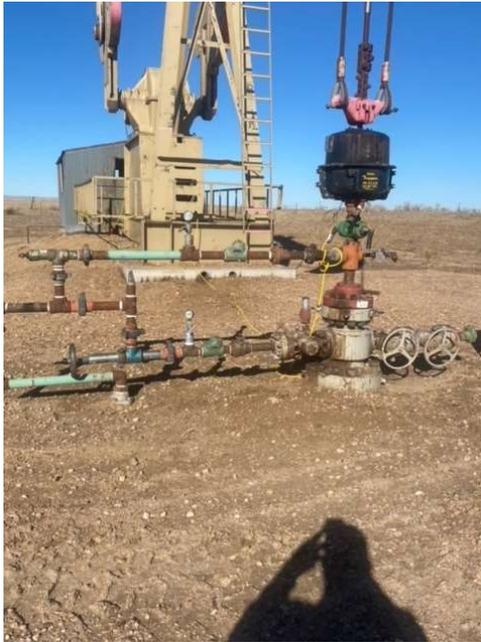
Stained soil at wellhead removed

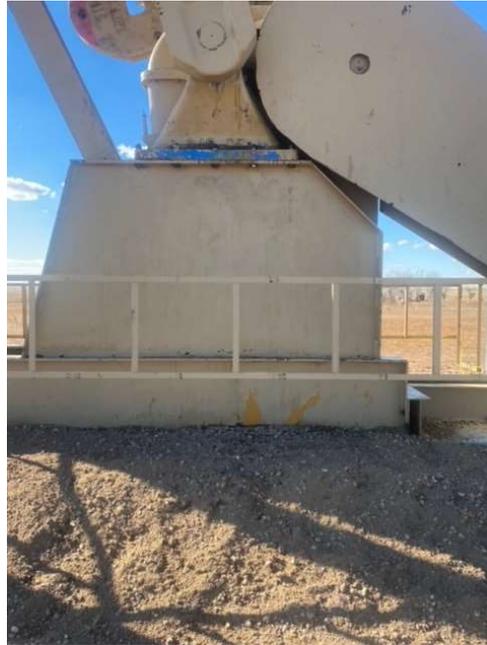
Stained soil east of gearbox removed

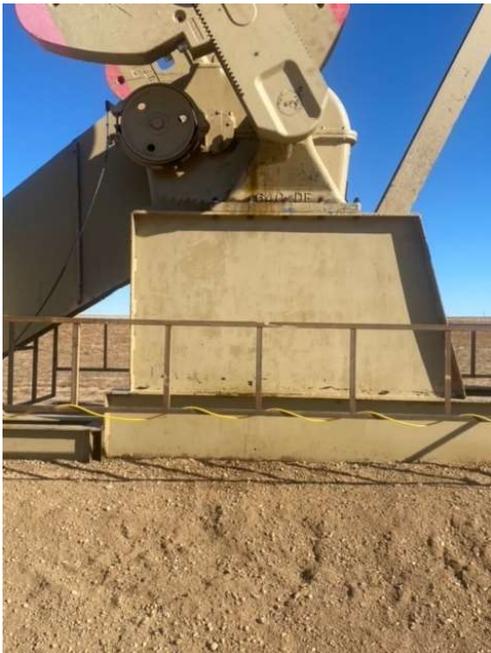
Stained soil west of gearbox removed

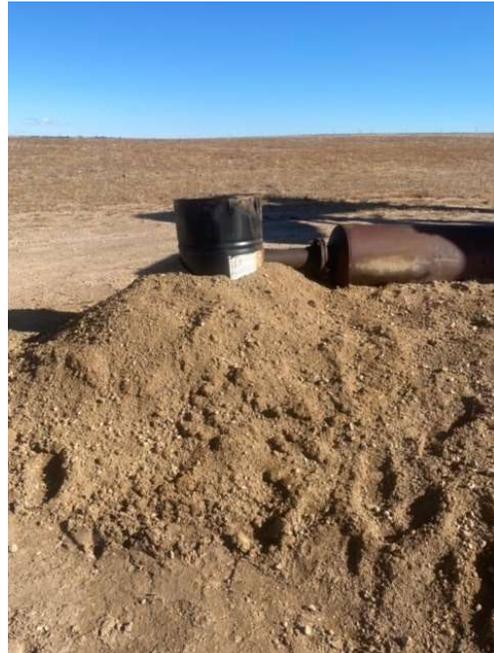
Stained soil at exhaust removed

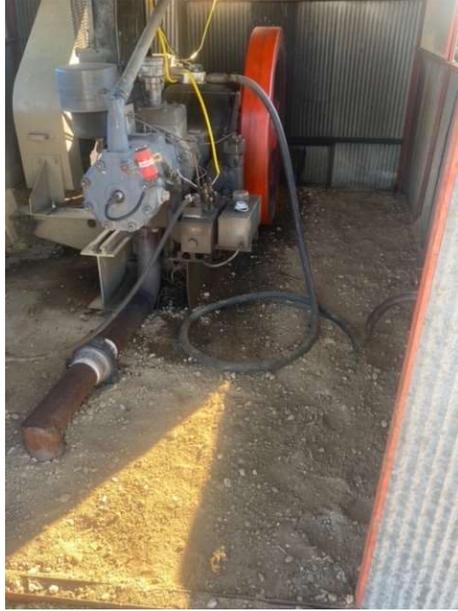
Stained soil at gas engine removed
