# Inspection Photos

11/05/2021

Operator: TEP ROCKY MOUNTAIN LLC #96850

Location ID: 480732

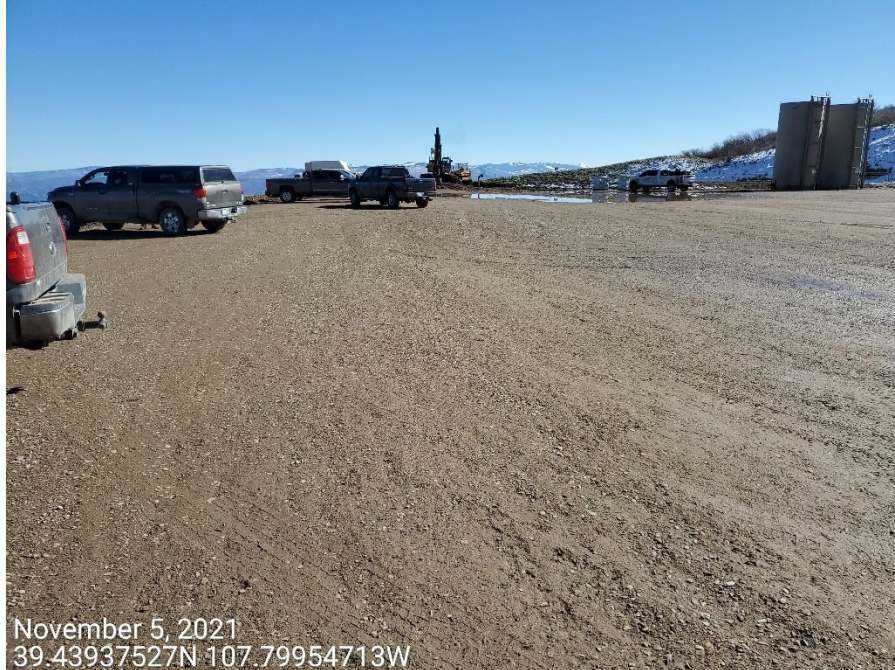
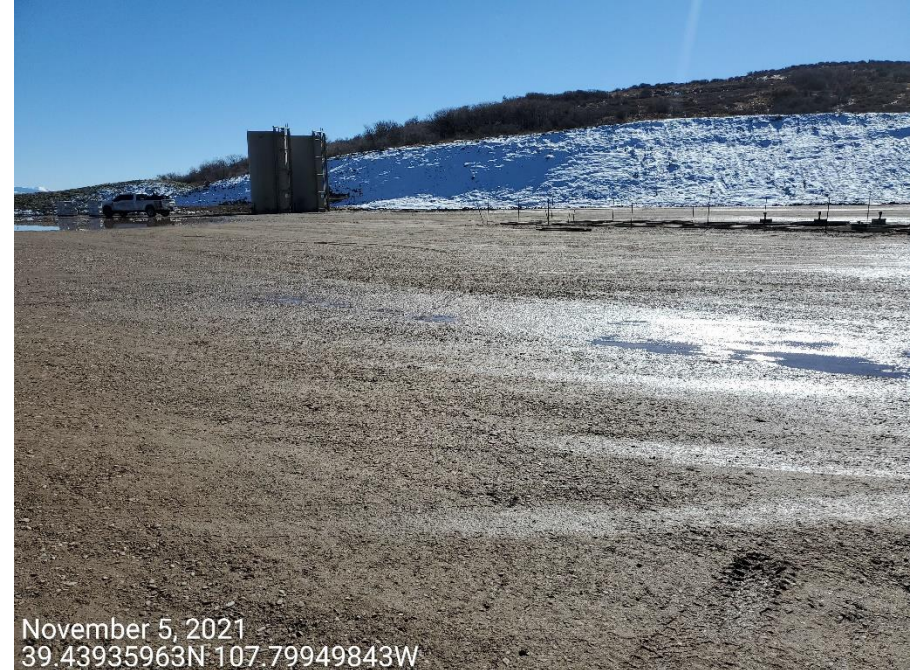
**Photo 1:** Photos 1-2 taken from the north end of the working pad areas. Photos provide an overview from east, southeast, southwest to west.

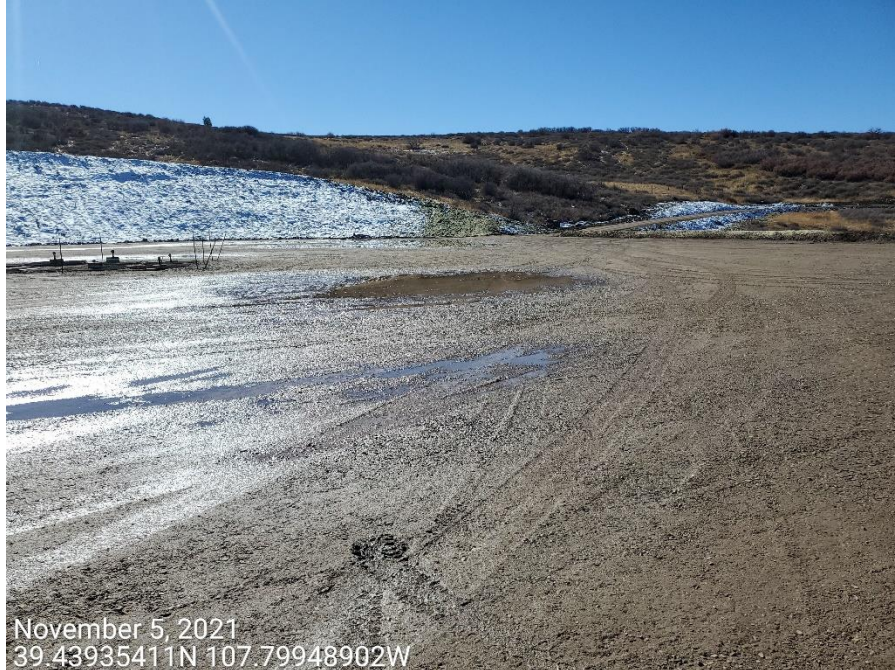
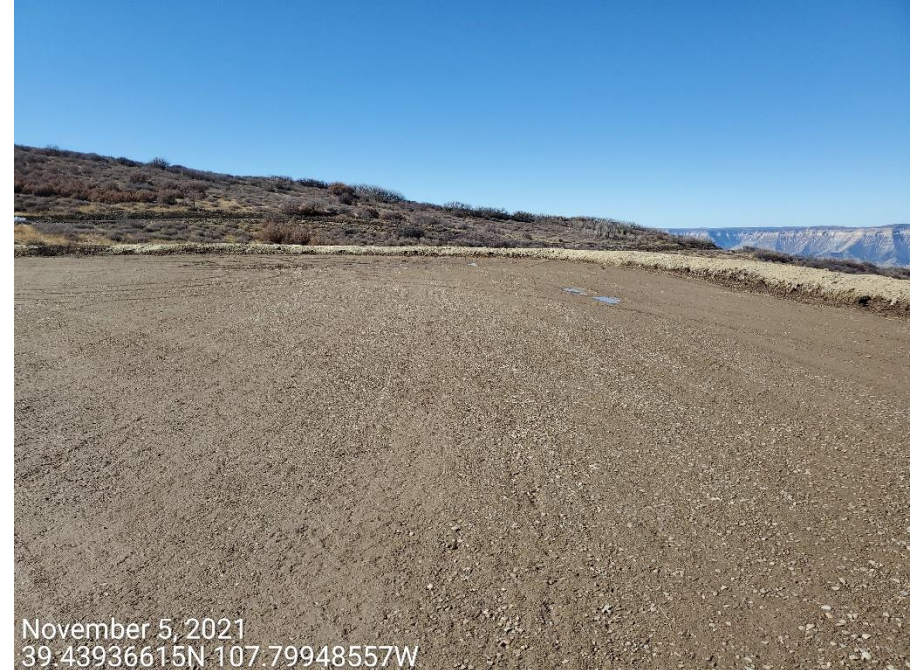
**Photo 2:** See comments under photo 1.

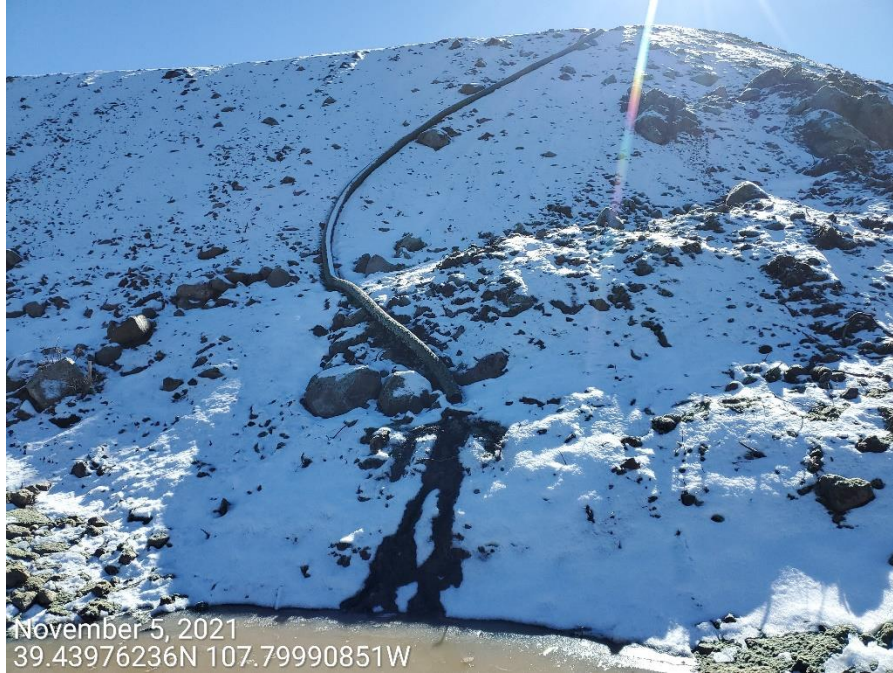
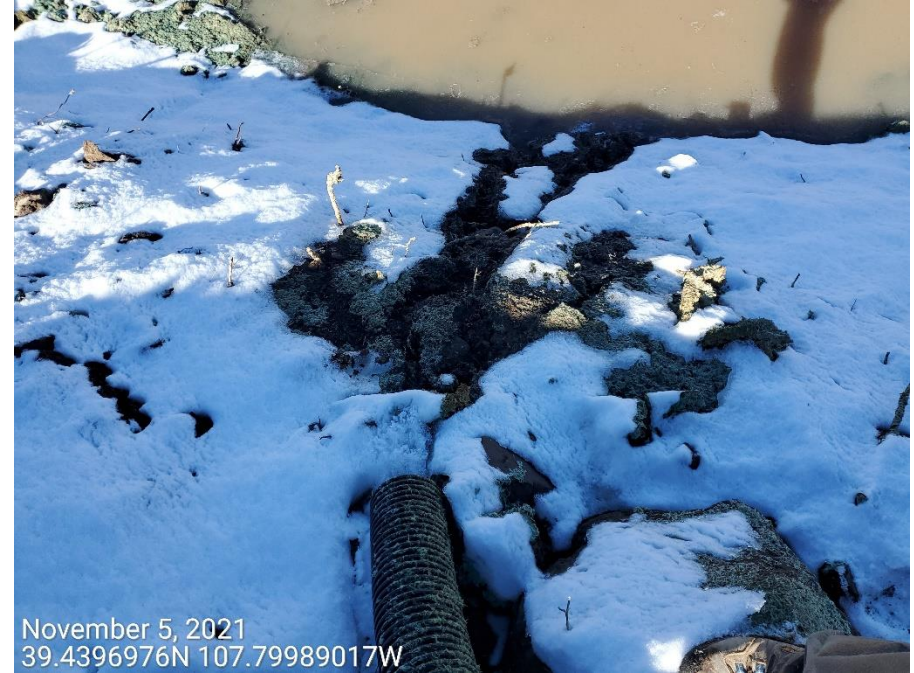
**Photo 3:** Photos taken from the northwest end of the Location. Photo shows example of slopes drains that have been installed along the northern perimeter of the working pad area and fill slopes. Photo shows slope drains have not been installed in accordance with good engineering practices; slope drains constructed with flexible pipe that has not been properly anchored/secured to the ground. Slope drains have not been constructed with a stabilized/armored outlet. Photo also shows slope drain on the northwest corner discharges onto the fill slope above the sediment trap; inadequate armoring/protection has resulted in erosion degradation at the outlet.

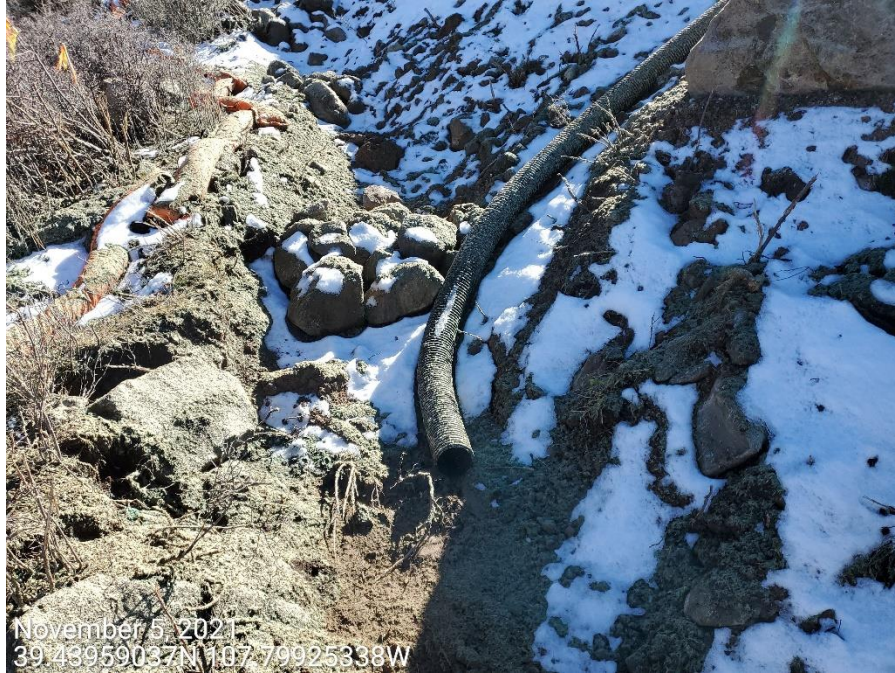
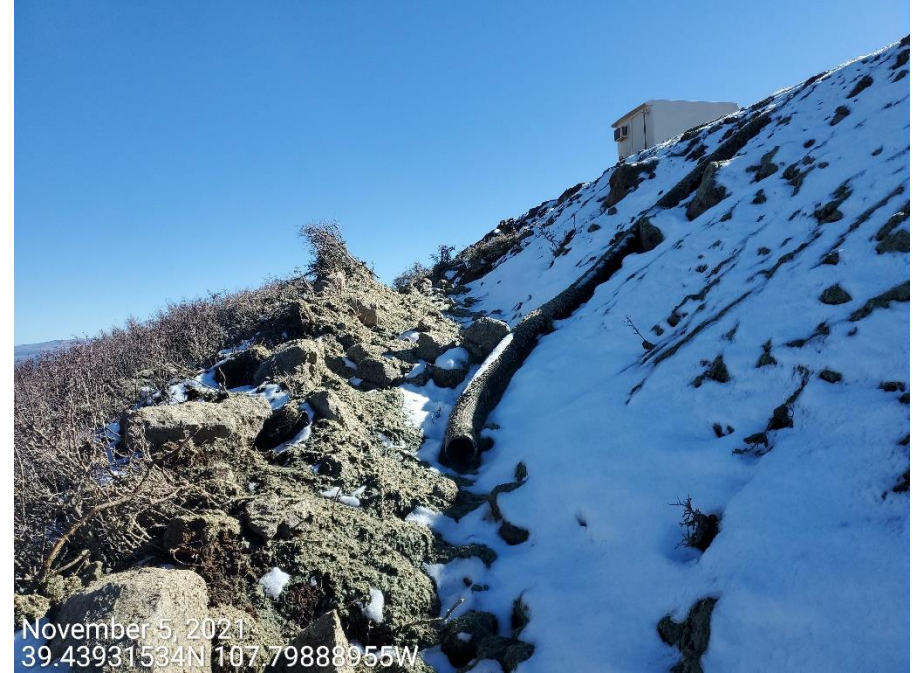
**Photo 4.** Photo shows example of slopes drains that have been installed along the northern perimeter of the working pad area and fill slopes. Slope drains have not been installed in accordance with good engineering practices; slope drains constructed with flexible pipe that has not been properly anchored/secured to the ground. Slope drains have not been constructed with a stabilized/armored outlet

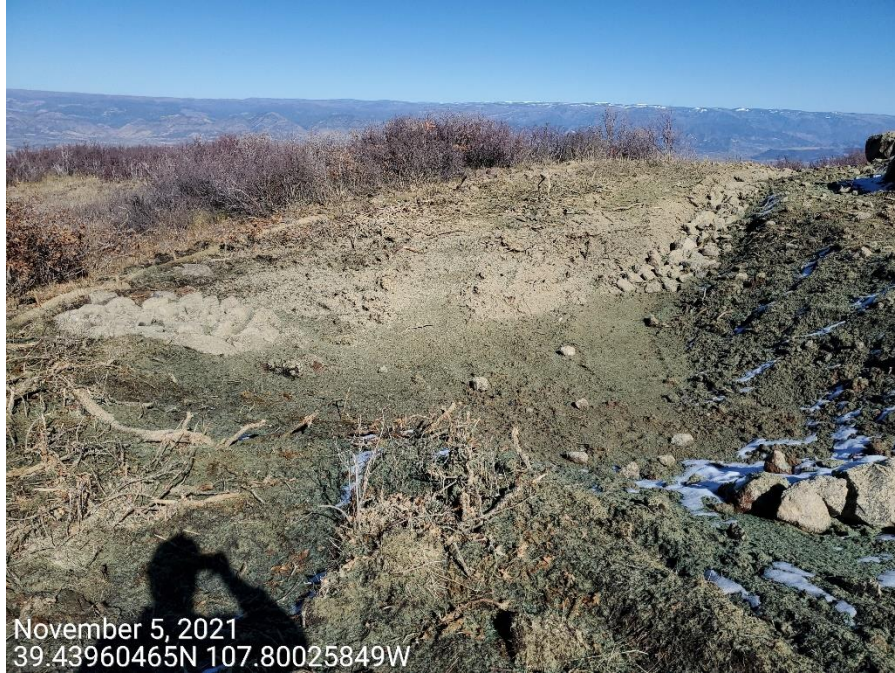
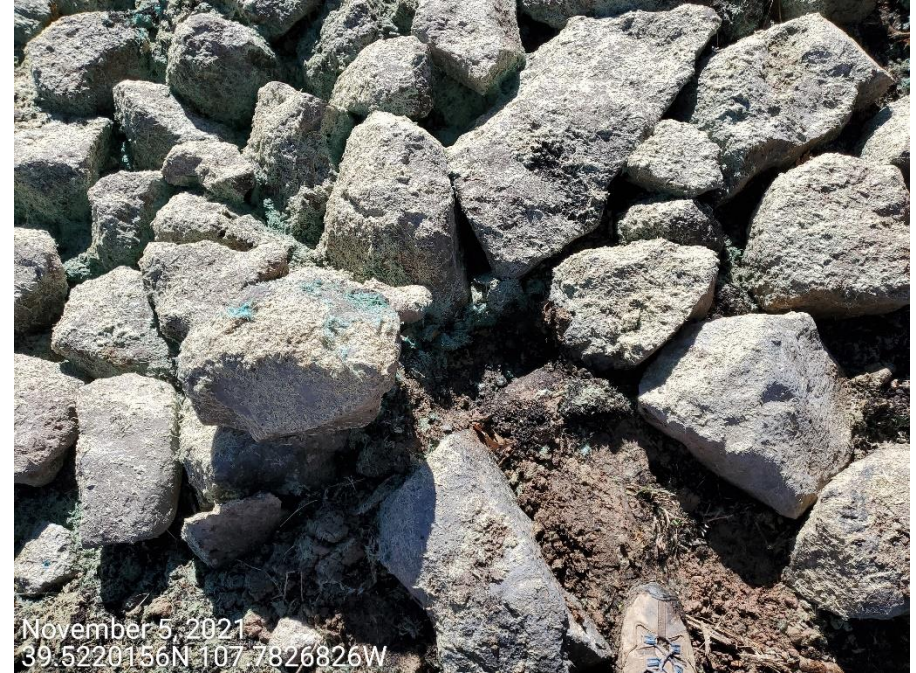
**Photo 5:** Photos 5-6 show the two sediment traps constructed on the northwest end of the Location. Traps do not appear appropriate in size to manage runoff from the drainage area of the Location and upslope, undisturbed areas, and have not installed per good engineering requirements; outlets have not been installed with a geotextile lining beneath riprap material per good engineering practices.

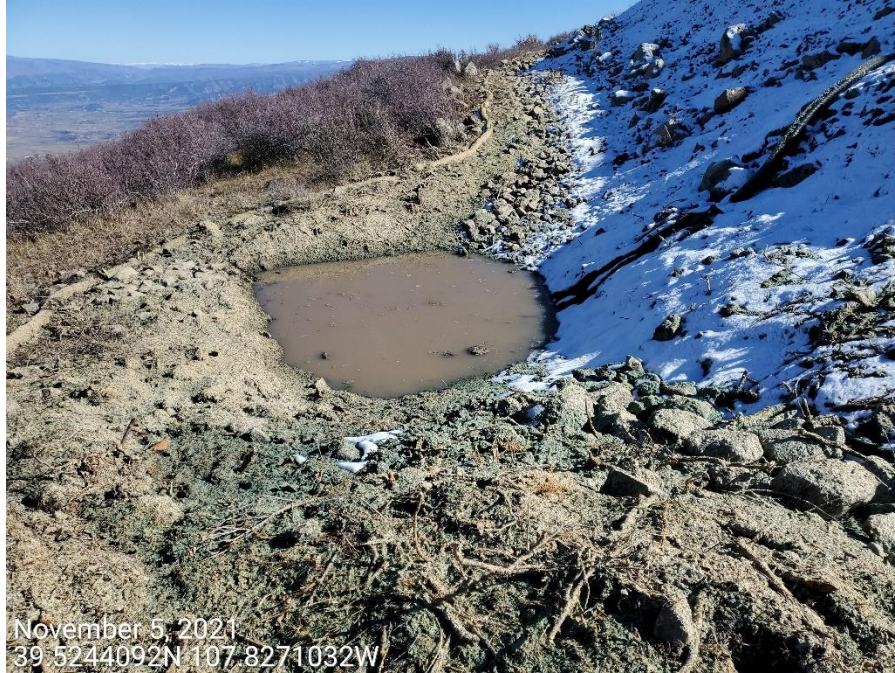
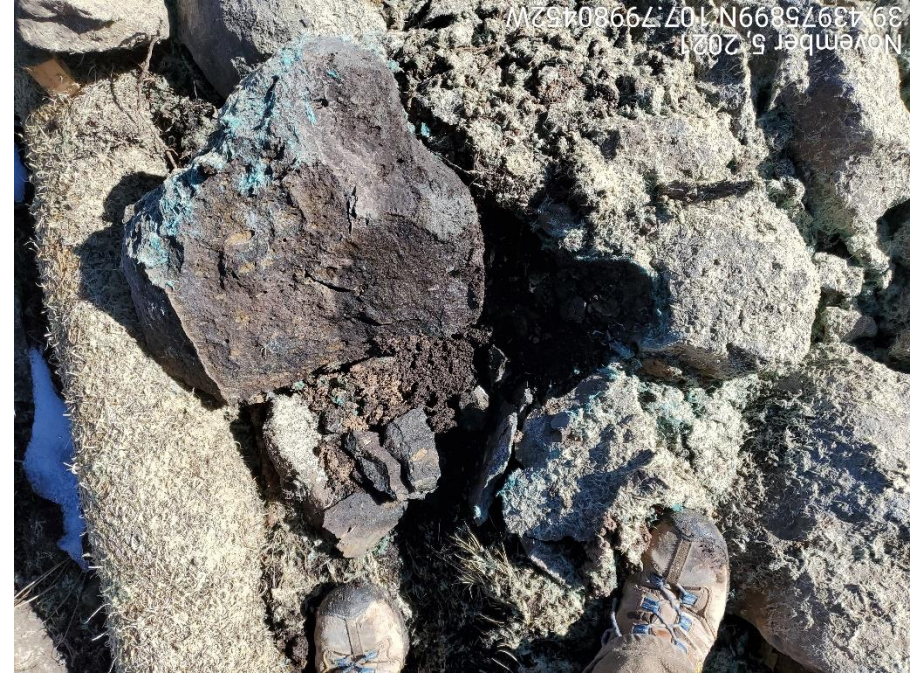
**Photo 6:** See comments under photo 5.

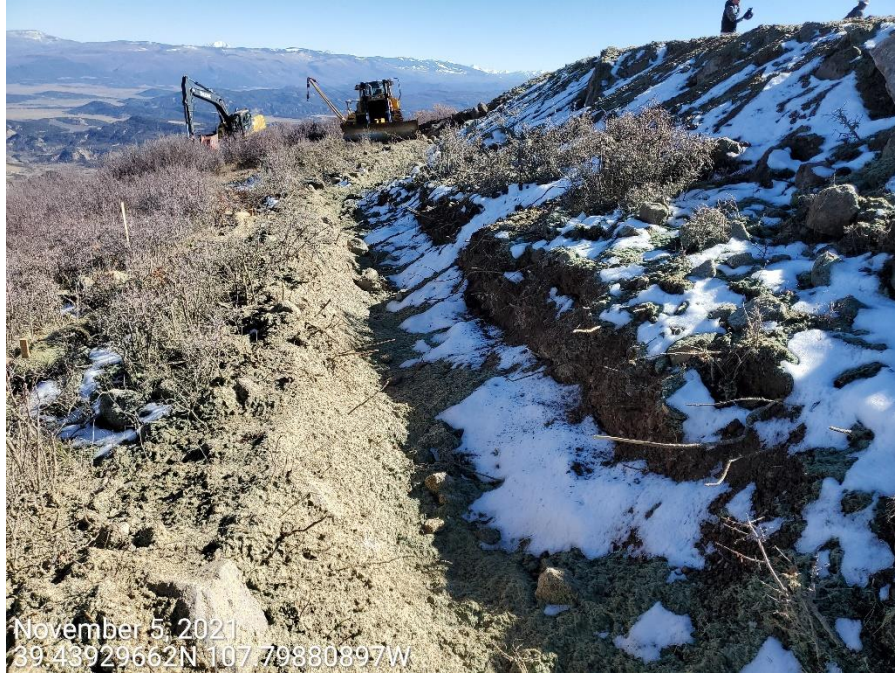
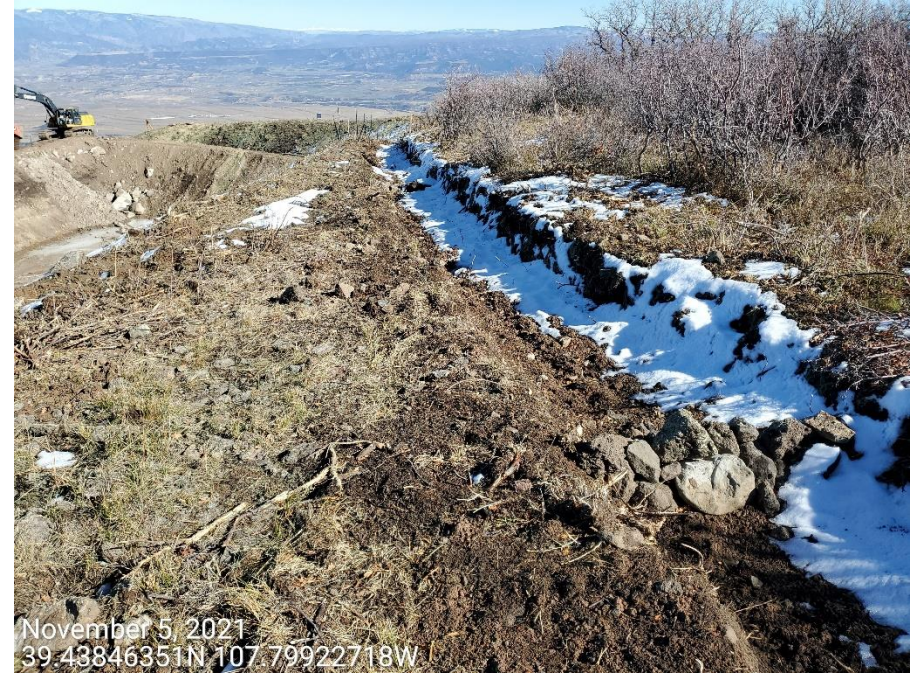
**Photo 7:** Photos provide examples of the perimeter stormwater diversion ditch on the Location; ditch has not been constructed in accordance with good engineering practices; BMPs improperly constructed with vertical slopes; soils within the control measure are unconsolidated and are a pollutant source.

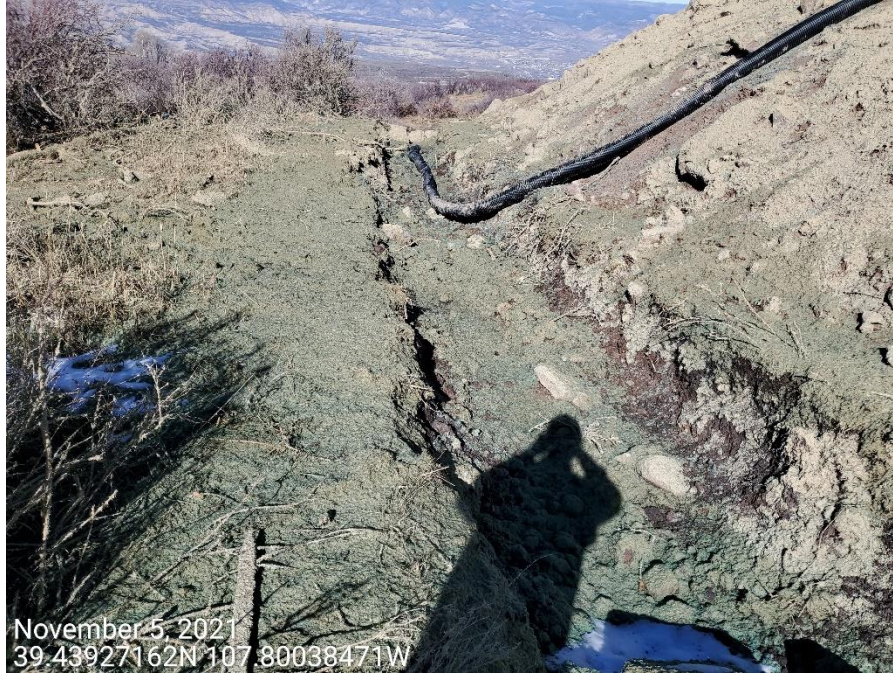
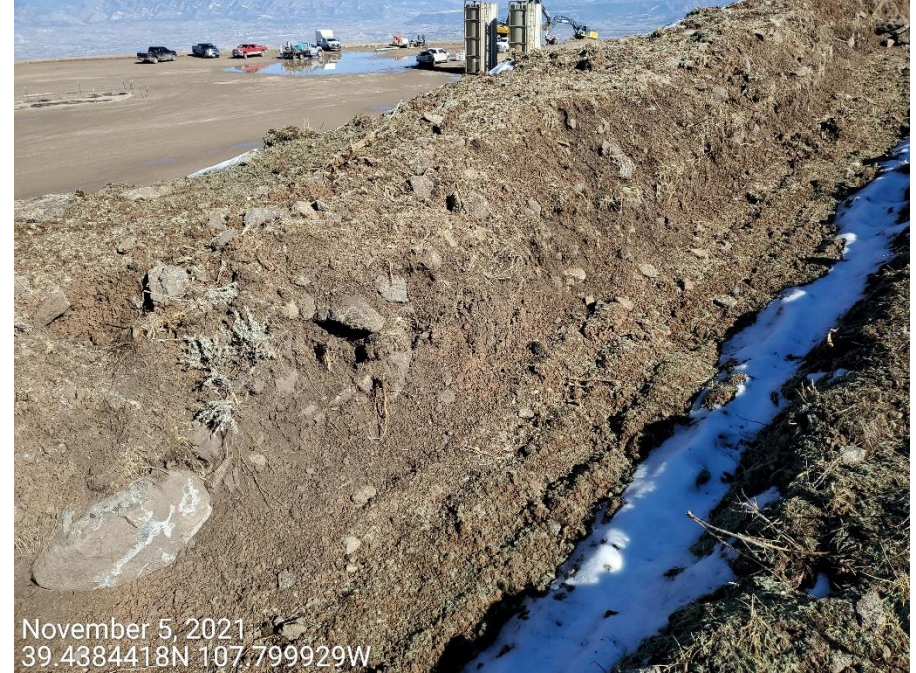
**Photo 8:** Photos provide examples of the perimeter stormwater diversion ditch on the Location; ditch has not been constructed in accordance with good engineering practices; BMPs improperly constructed with vertical slopes; soils within the control measure are unconsolidated and are a pollutant source.

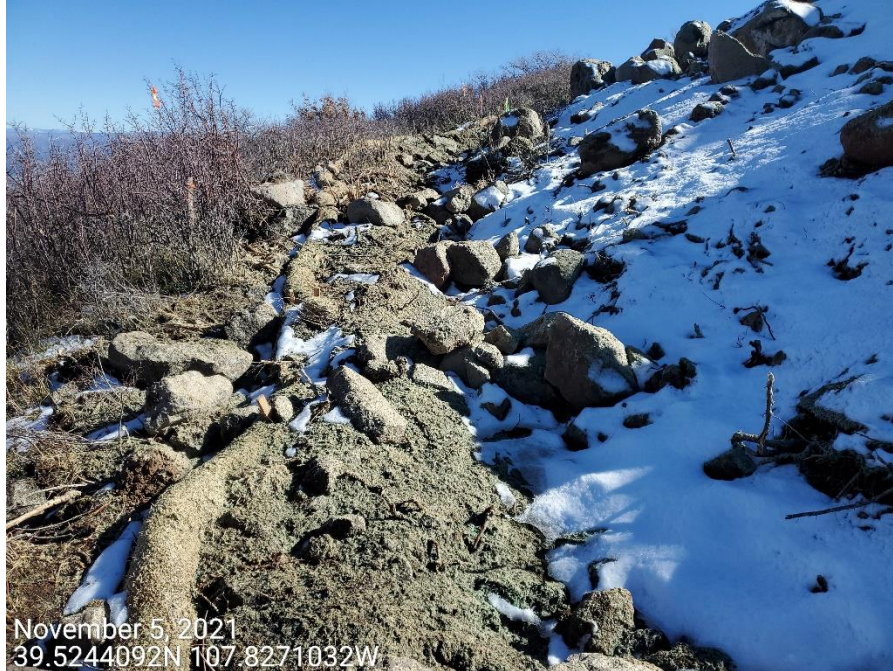
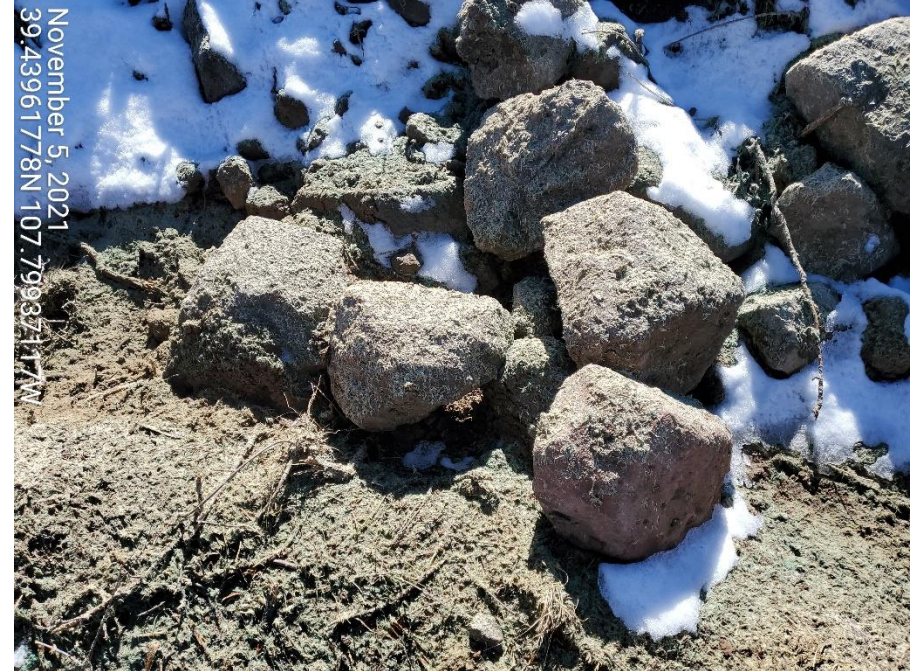
**Photo 9:** Photo provide example velocity checks within the stormwater diversion ditch that have not been installed in accordance with good engineering practices, with inappropriate sized material; large voids can be observed within a majority of the checks and will not interrupt stormwater velocity; stormwater runoff will accelerate around the rock material, resulting in erosion within the ditch and increased sediment loads.

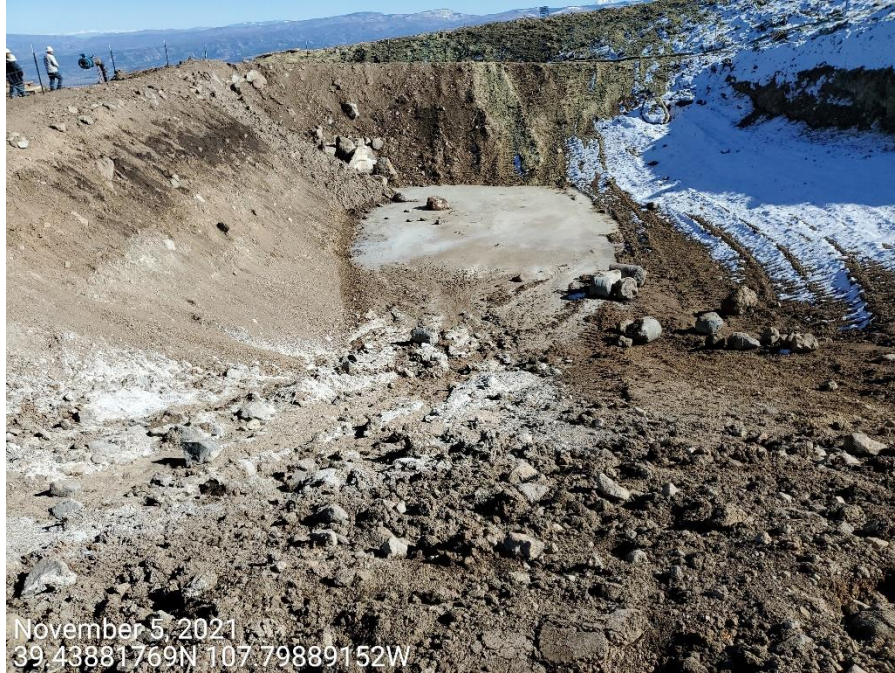
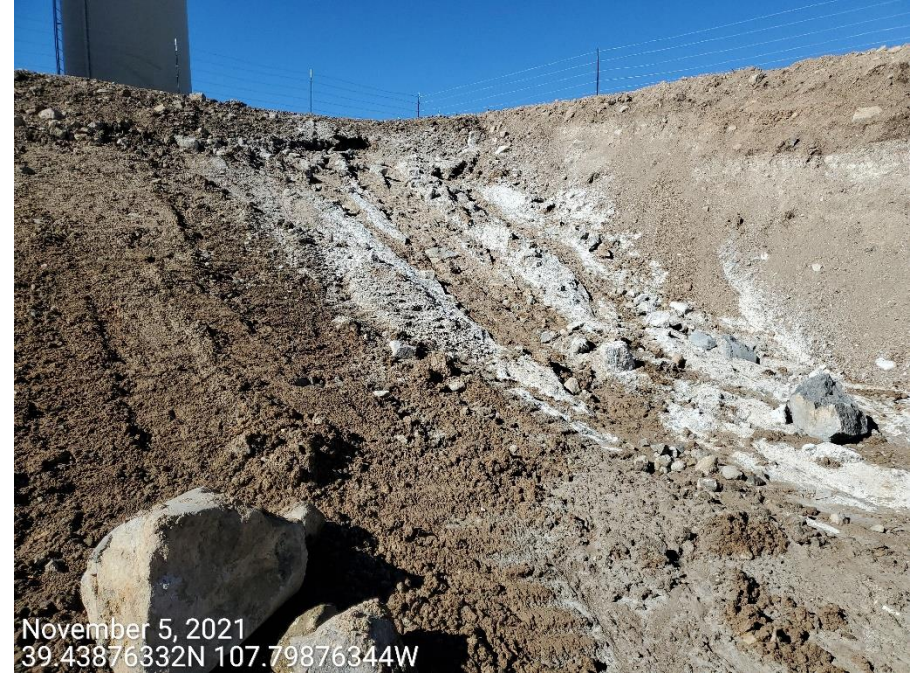
**Photo 10:** Photos 10-12 taken from the cuttings trench/pit on the east end of the Location. Photo shows concrete/cement waste/debris observed within the cuttings trench. Operator appears to have “washed out” into the trench post conductor installs and cementing operations. Concrete/cement waste/debris requires removal and proper disposal in accordance with Rule 606, and

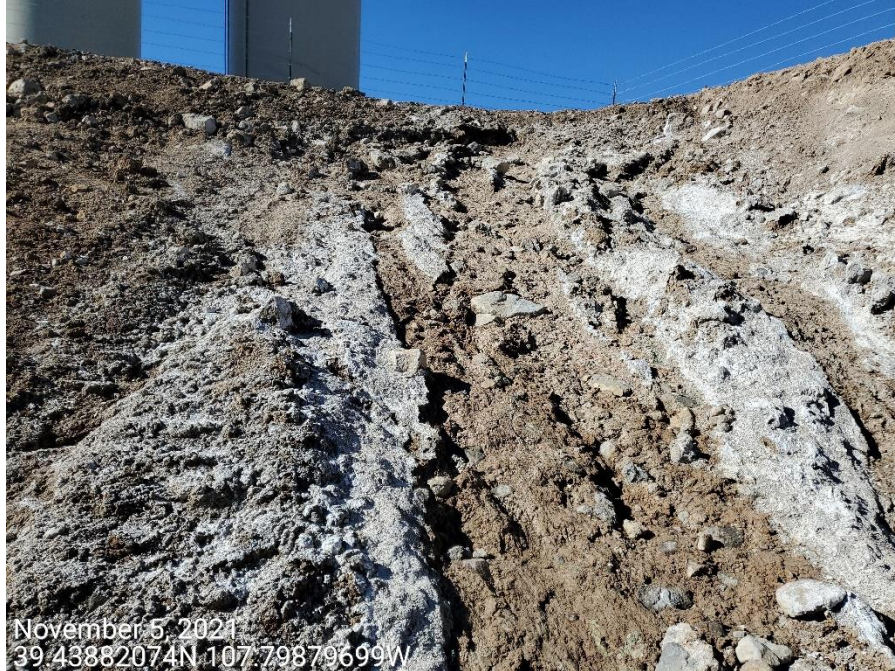
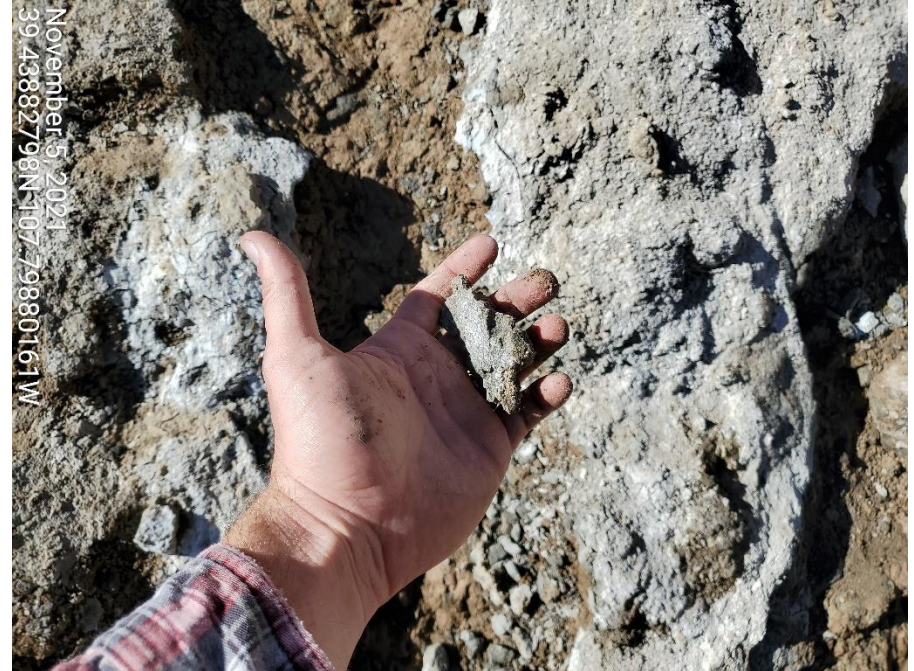
**Photo 11:** See comment under photo 10.

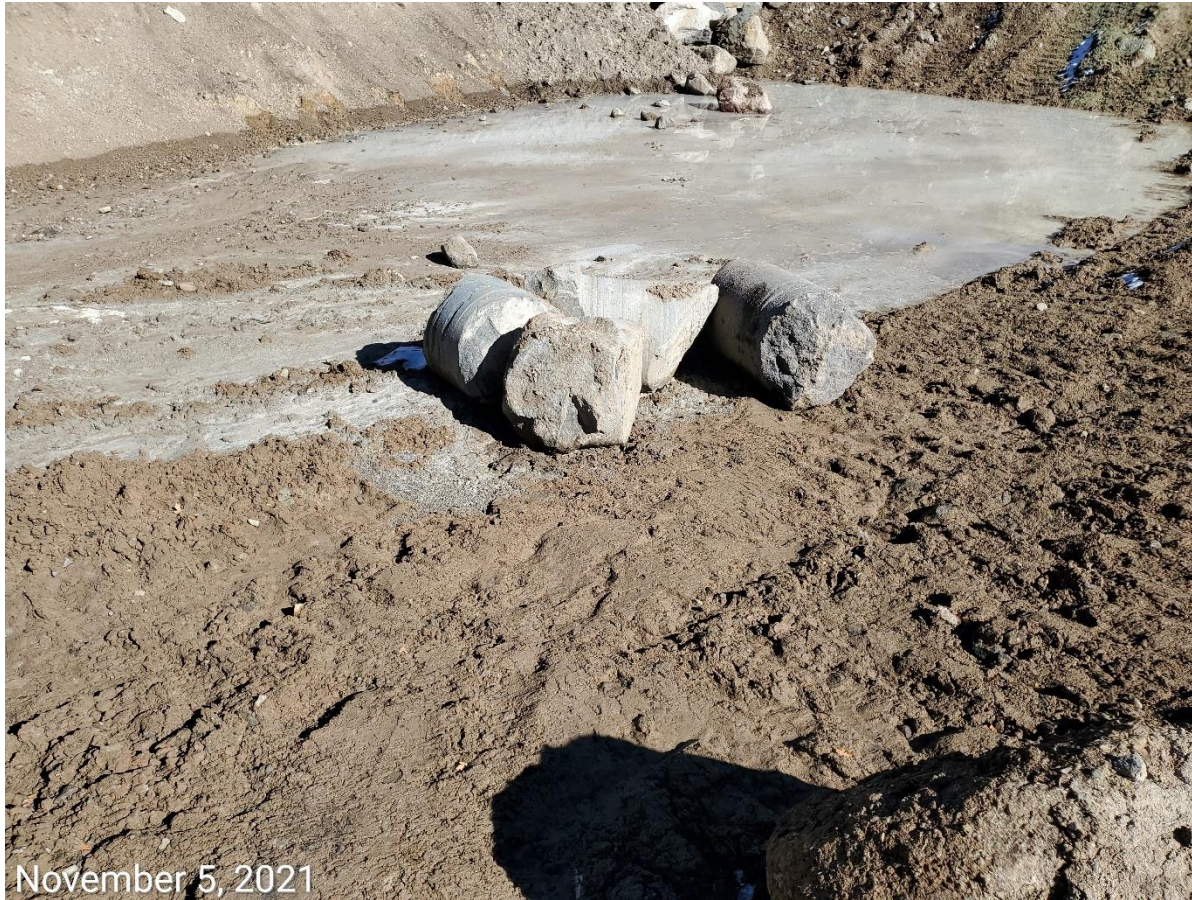
**Photo 12:** See comment under photo 10.

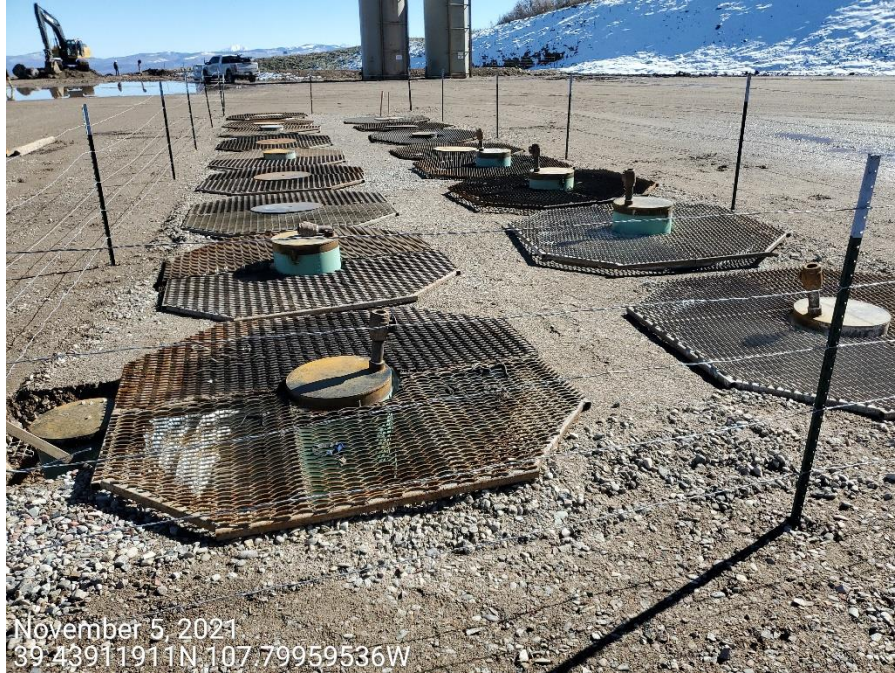
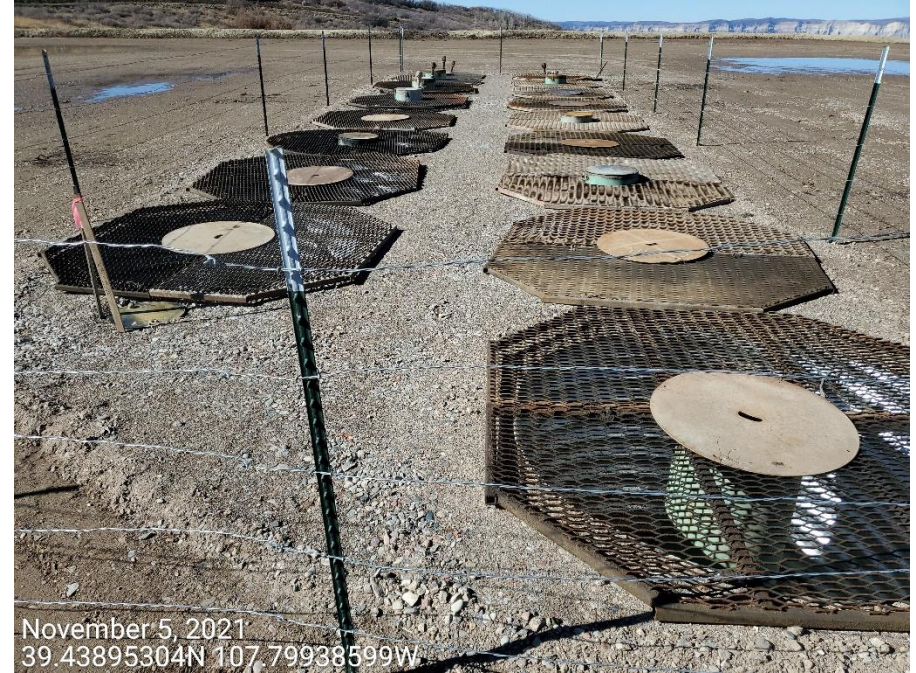
**Photo 13:** Photos show the well conductors on the Location.
