Today's Date:	10/21/2021					
Well Name:	HUBER/SPC -FEDERAL 2-13	Location:	Sec: 13	Twn: 035N	Rng: 008W	UL: K
API Number:	05.067.07683	Footage:				
Operator:	Hilcorp Energy Company	Area/Run/MSO:	01	0100	Charlie Ruybal	
Meter #:			Pipeline:			
INC Number:	693903770	Agency:	COGCC	Inspector:	Catherine Roy	
Type of INC:	Written	Photos Required:	Yes	Due Date:	7/1/2021	
Issue of Concern:	<p>Comment: Unused equipment remains within the project area. Flowline markers observed. Well pad and access road are not recontoured and reclaimed. Thousands of musk thistles and Canada thistles observed within the eastern project area.</p> <p>-All equipment needs to be removed. This includes any inactive flowlines or risers not abandoned that serviced the well.</p> <p>-Weeds need to be controlled.</p> <p>-Well pad and access road need to be reclaimed to COGCC reclamation standards per 1000 series reclamation rules.</p>

1-970-247-7708
 HUBER/SPC FED #2-13
 1850' FWL 1820' FSL
 E/SW SEC 13K T35N R08W
 LATITUDE 37° 17' 59.3514" N
 LONGITUDE 107° 41' 54.24" W
 API# 05-067-07683
 LEASE # COC-46245
 CA# COC-543502
 LA PLATA COUNTY, COLORADO

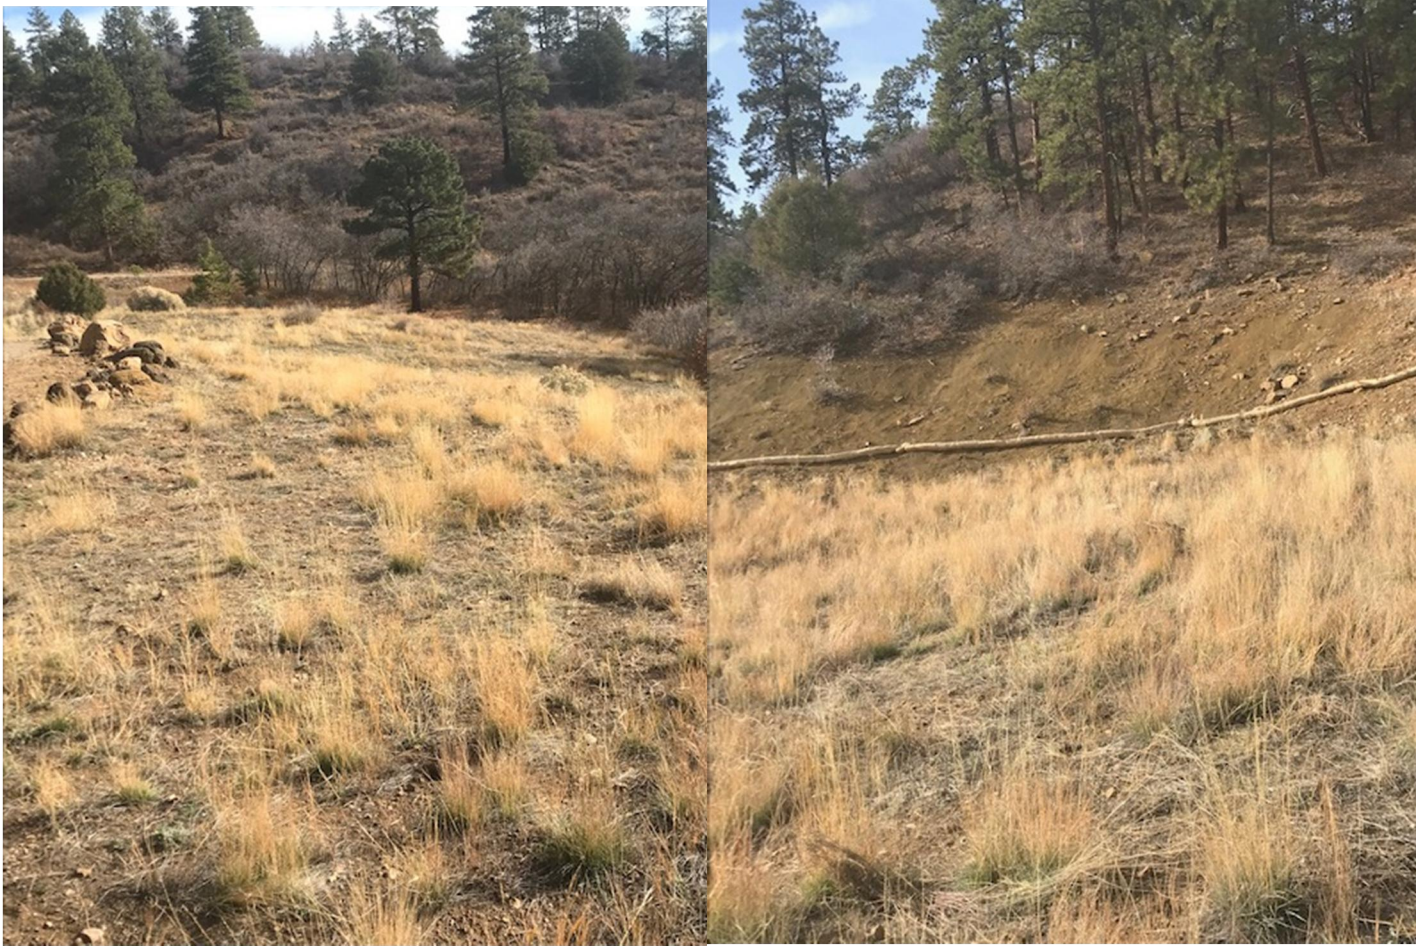
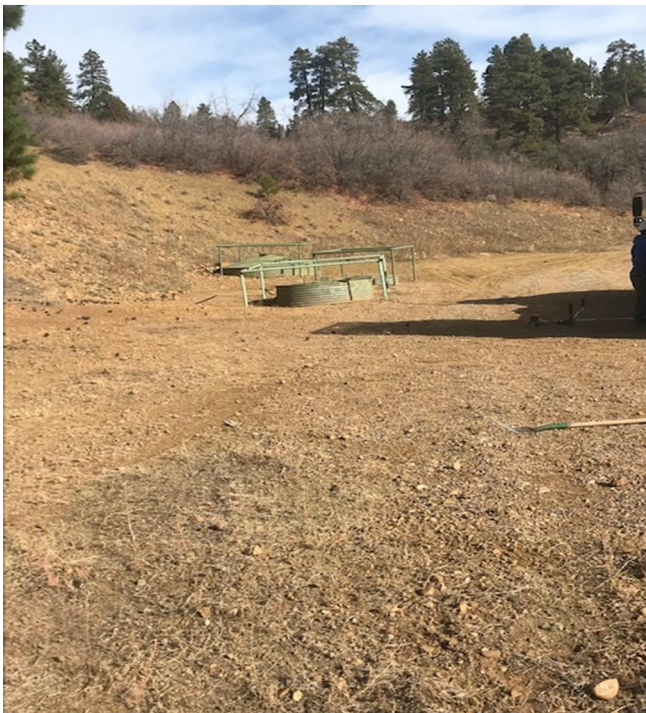
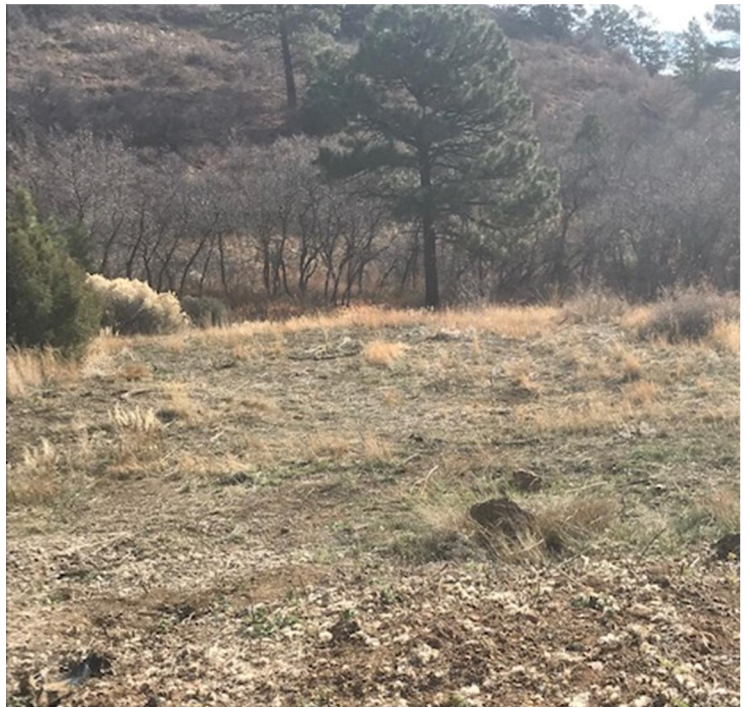
Equipment and road are still active and in use, and unable to be removed and reclaimed. This equipment and road are associated with the pipe line and right-of-way that goes through this P&A'd location.

Musk thistles, Canadian thistles and other weeds have been removed and erosion control has been installed on slope.
