Inspection Photos
Operator: Logos
API: 067-05591
Date: 11/3/2021

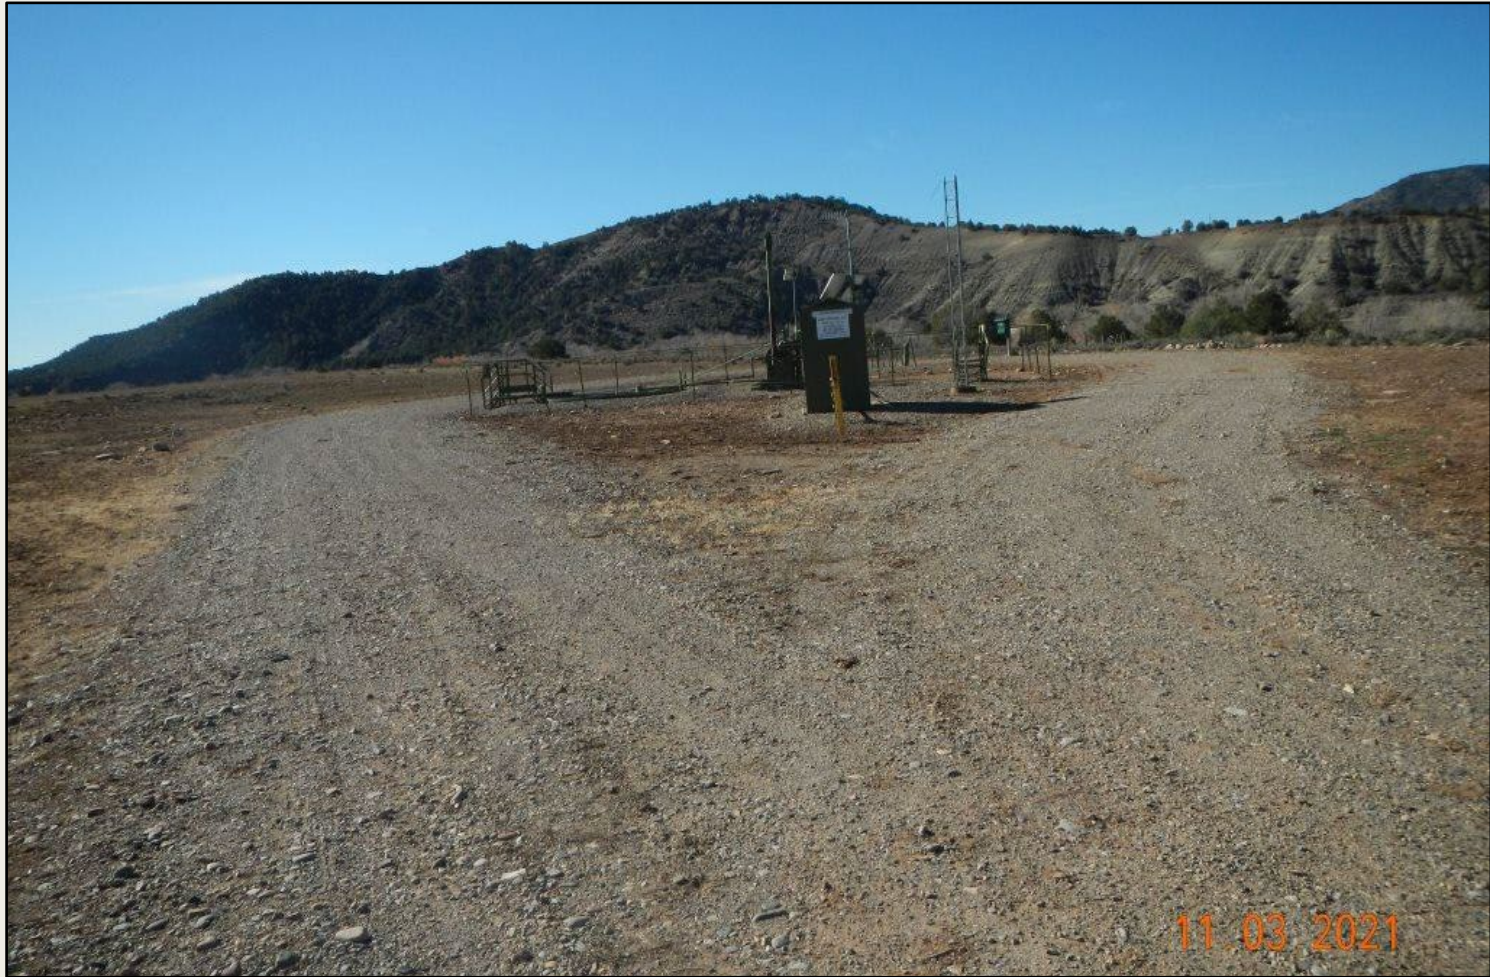
Photo 1. View of the project area from the well pad entrance facing center.

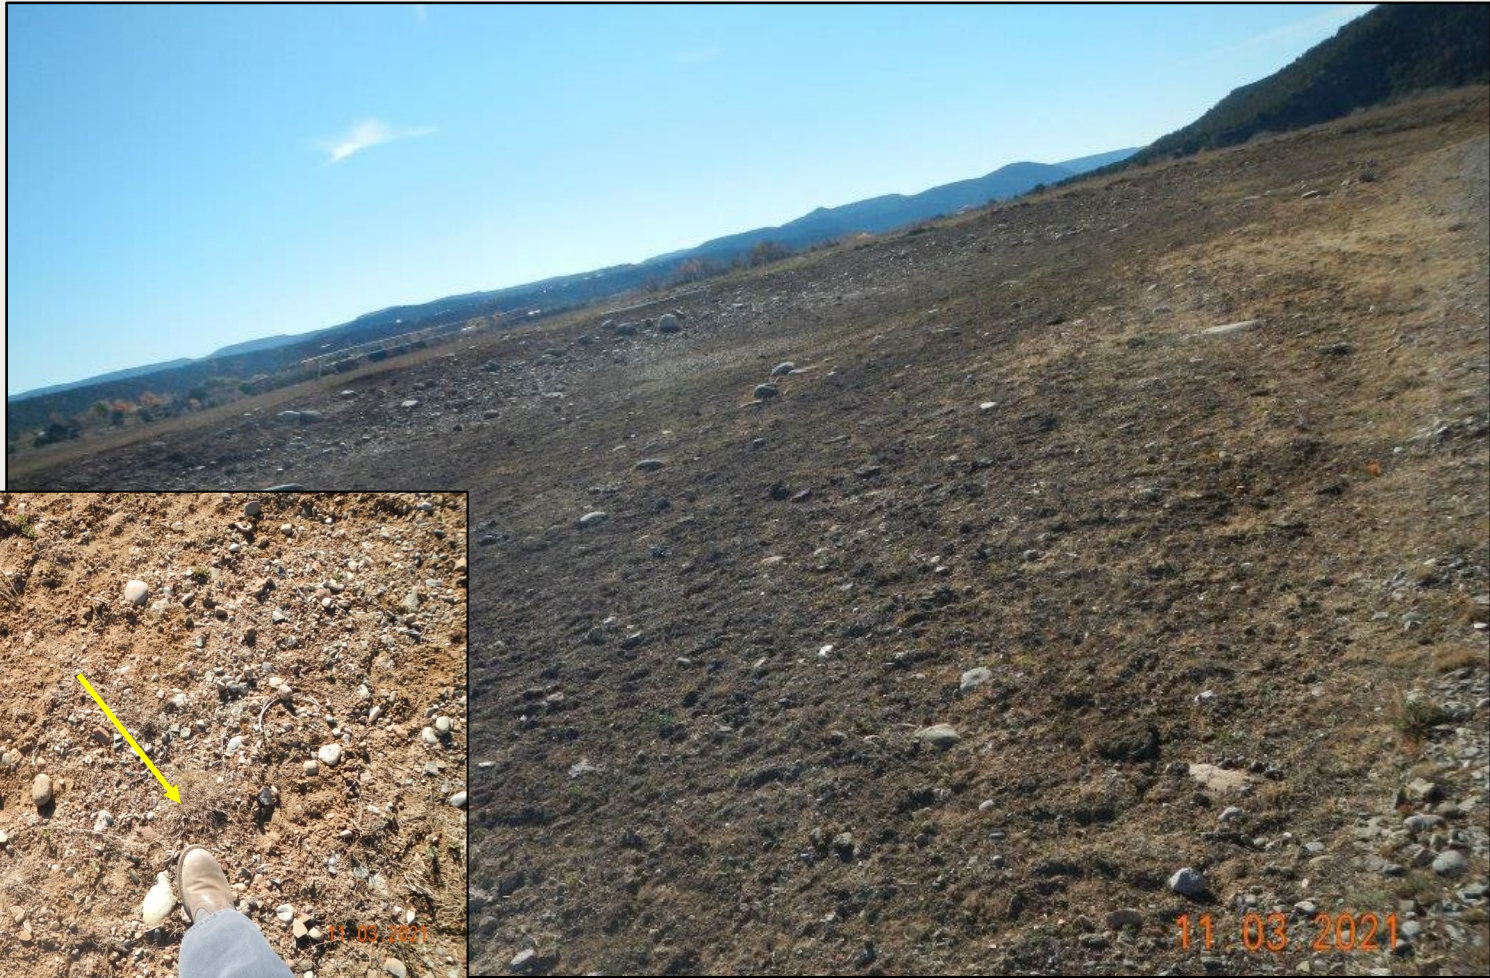
Photo 2. View of the eastern project area from the northeastern corner facing southward. Vegetation is in a grazed vegetative condition. Inset shows a grazed bunchgrass (likely Indian ricegrass) next to boot.

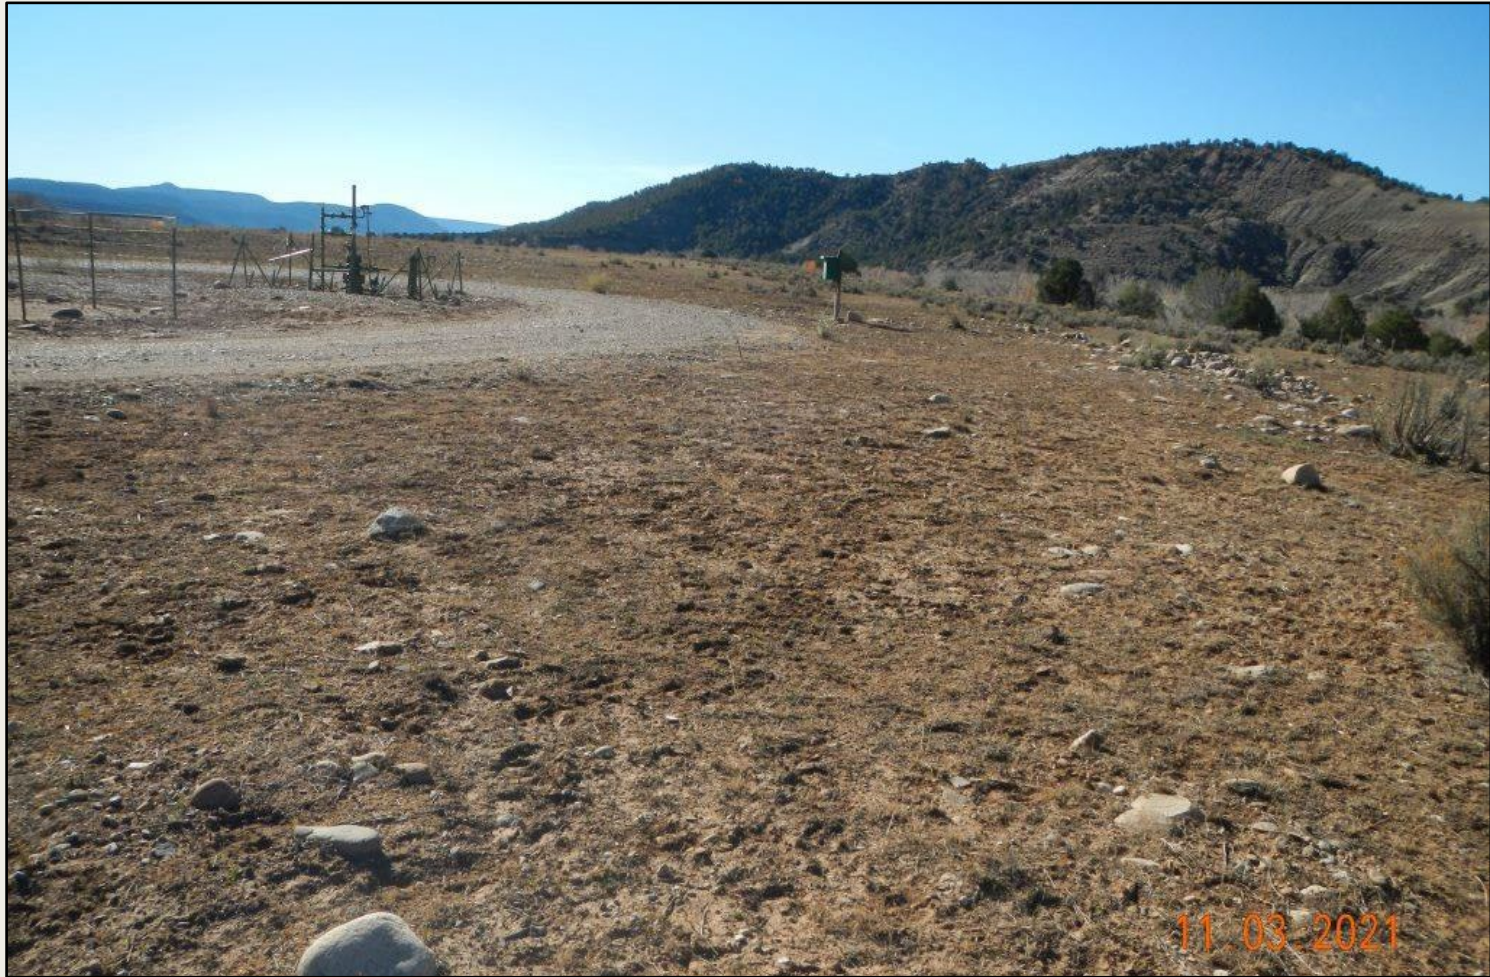
Photo 3. View of the western project area from the northwestern corner facing southward.

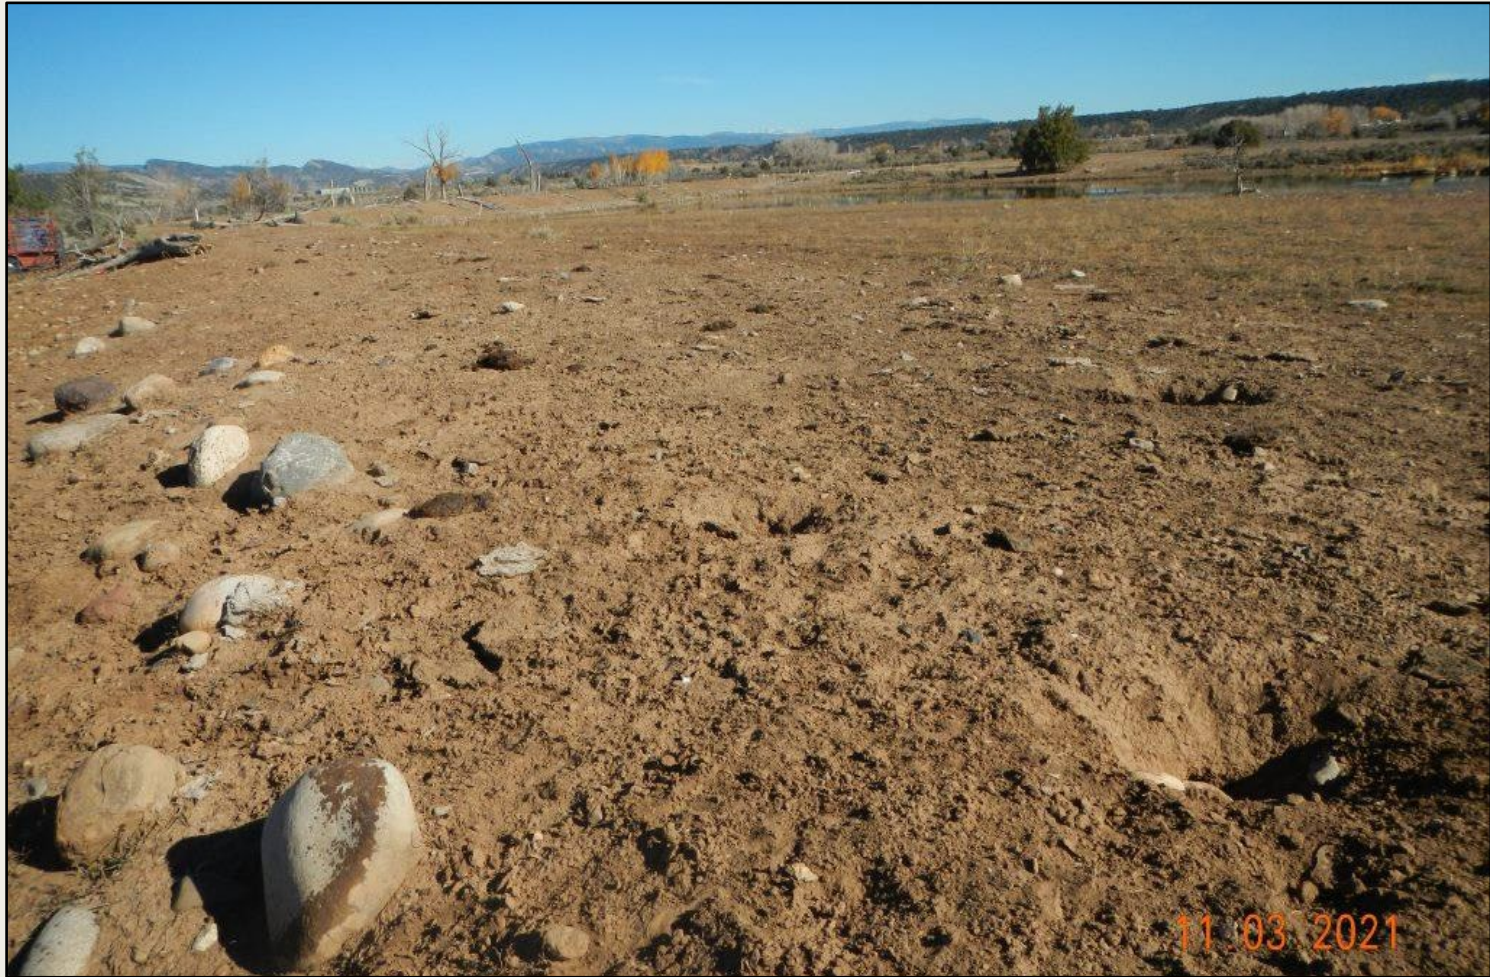
Photo 4. View of reference area comprised of open pasture with grasses and forbs largely in a grazed condition at this time.
