Inspection Photos
Operator: Simcoe
API: 067-06969
Date: 11/8/2021

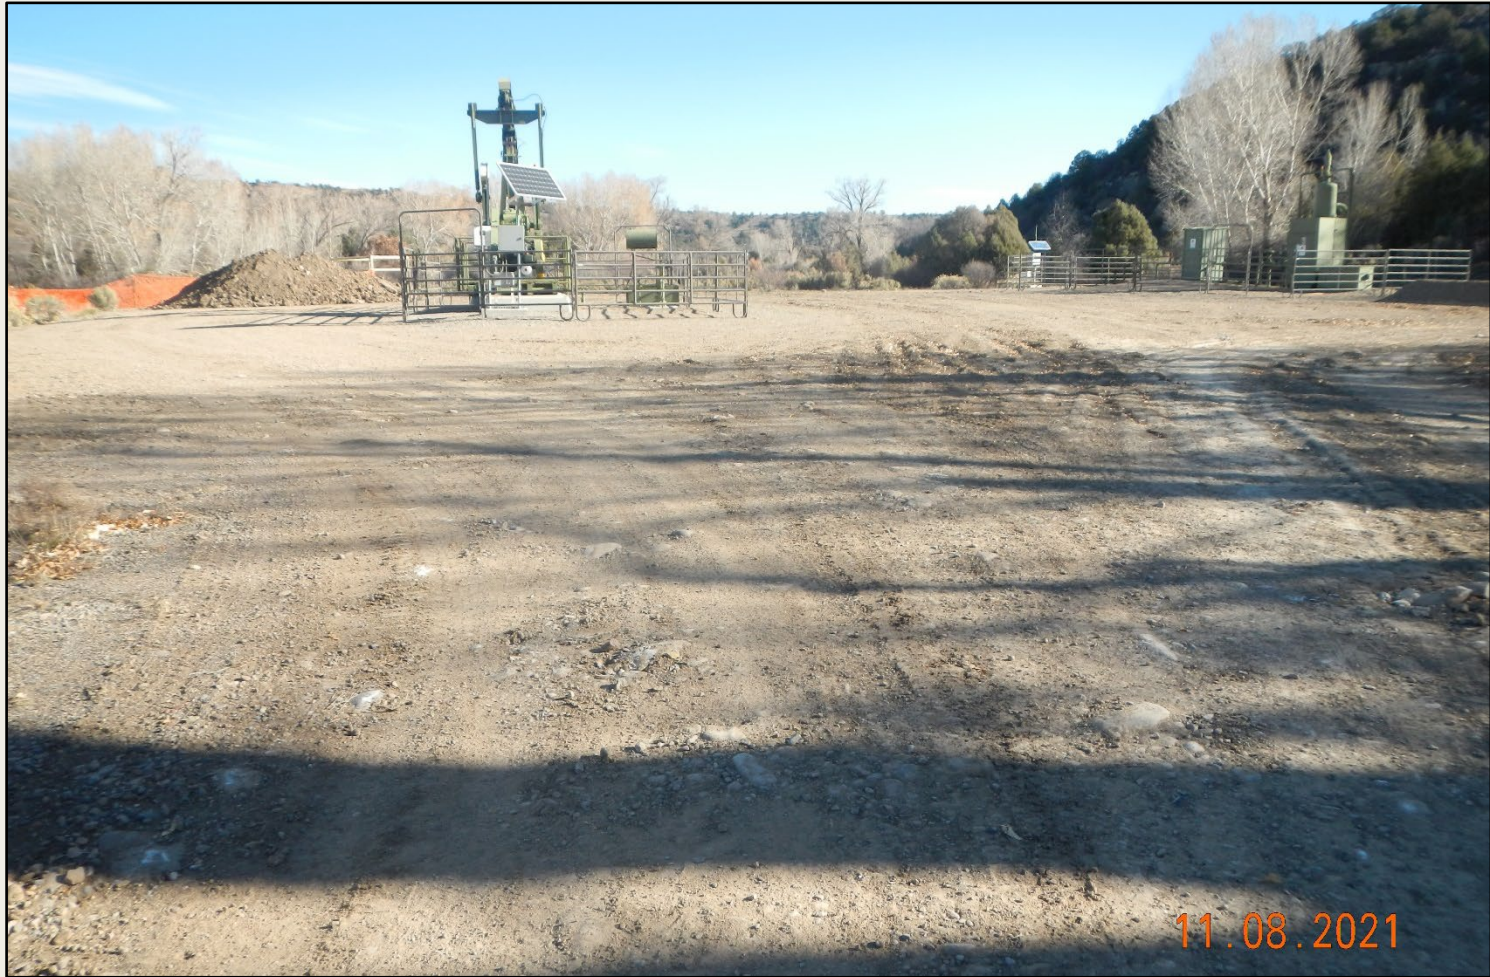
Photo 1. View of the project area from the well pad entrance facing center.

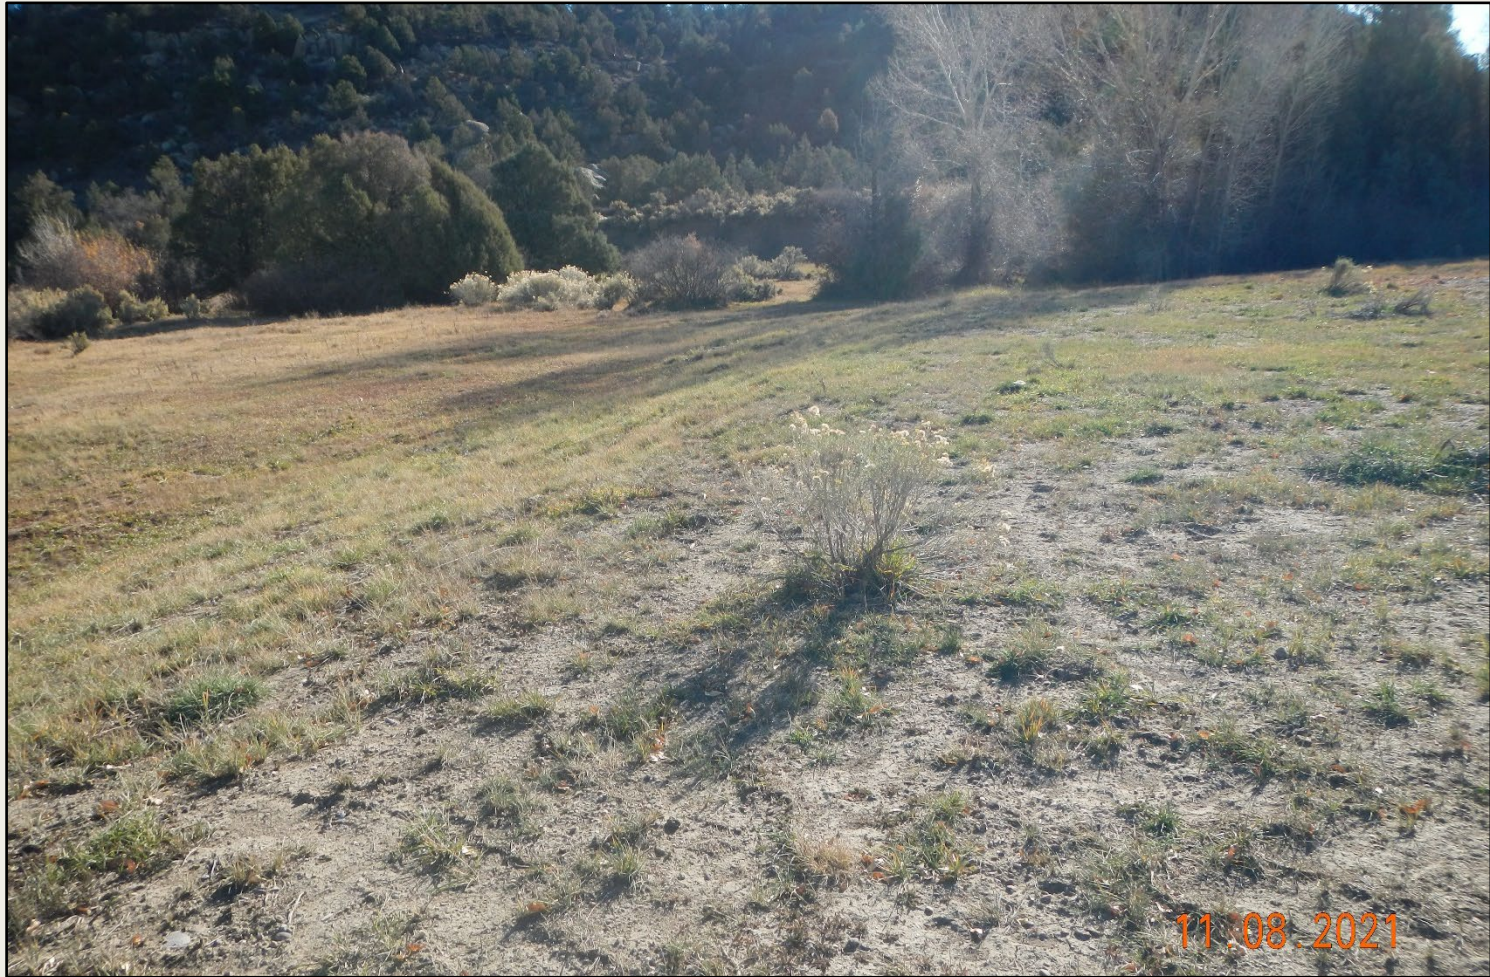
Photo 2. View of the eastern project area from the northeastern corner facing southward. Revegetation is progressing with rubber rabbitbrush, western wheatgrass, and sand dropseed.

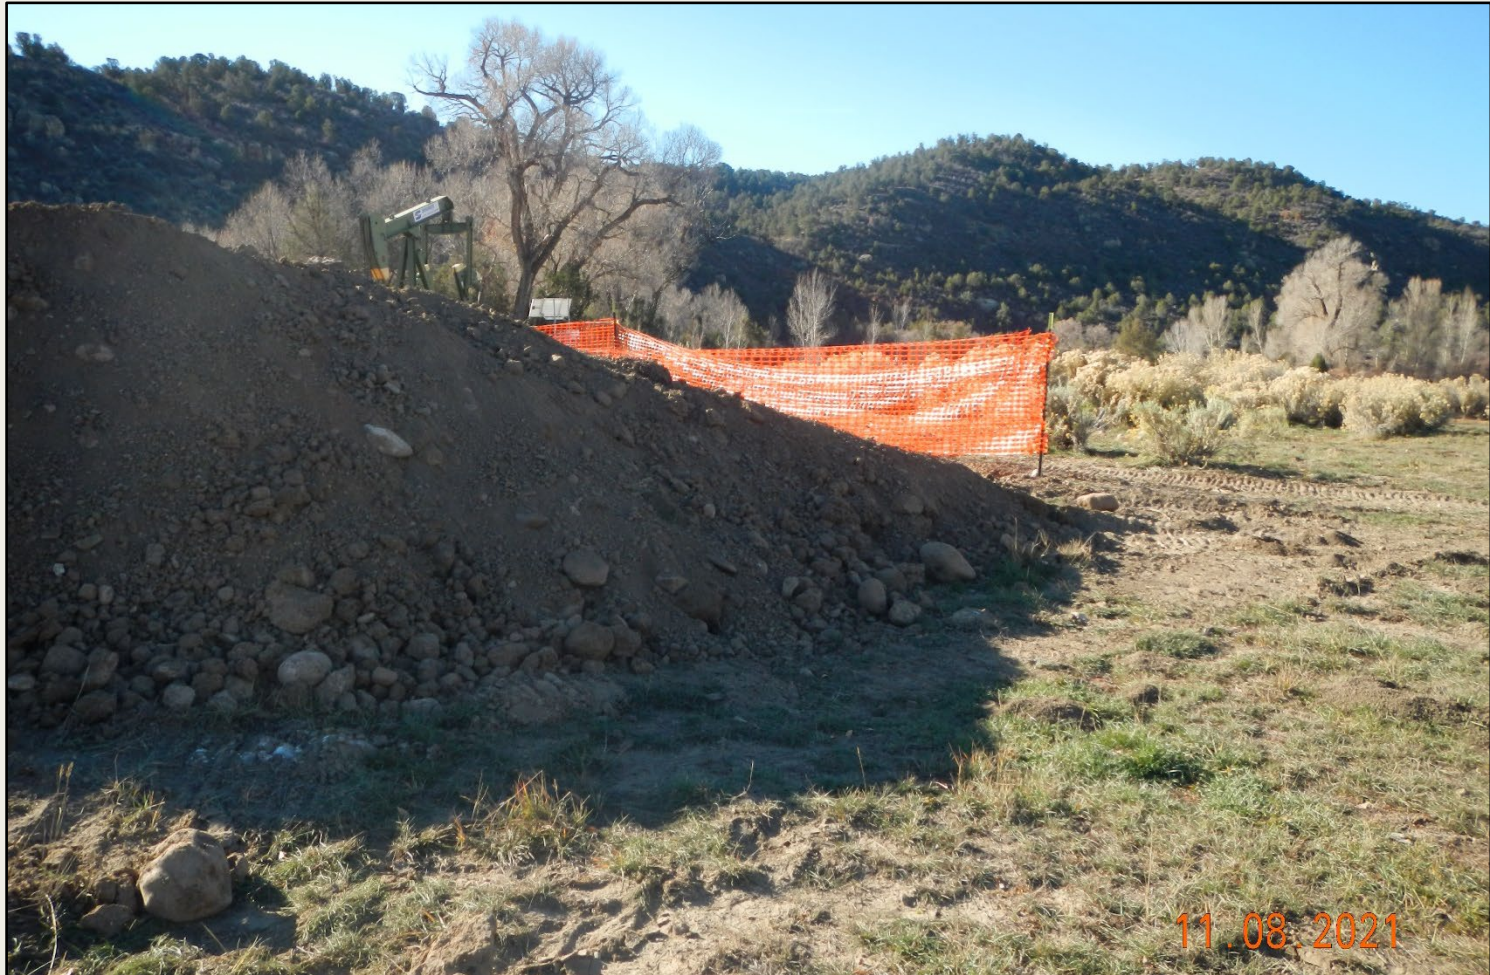
Photo 3. View of the northern project area from the northeastern corner facing westward. Flowline excavation is occurring in the northern project area.

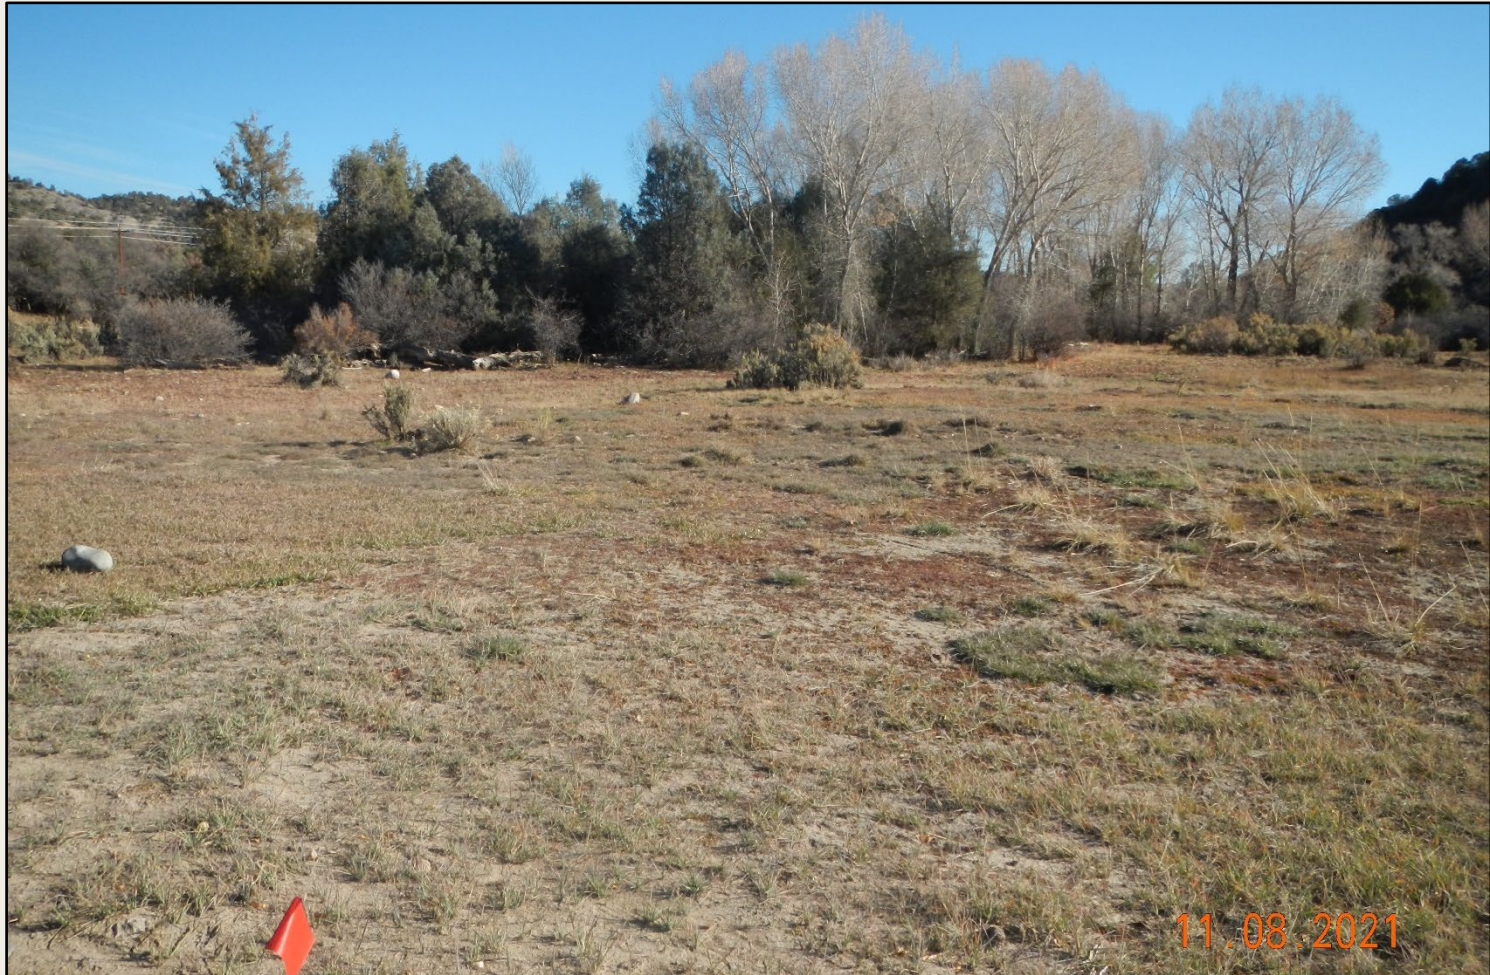
Photo 4. View of reference area comprised of open grass field with western wheatgrass, smooth brome, and scattered sagebrush.
