Inspection Photos
Operator: Simcoe
API: 067-08758
Date: 11/8/2021

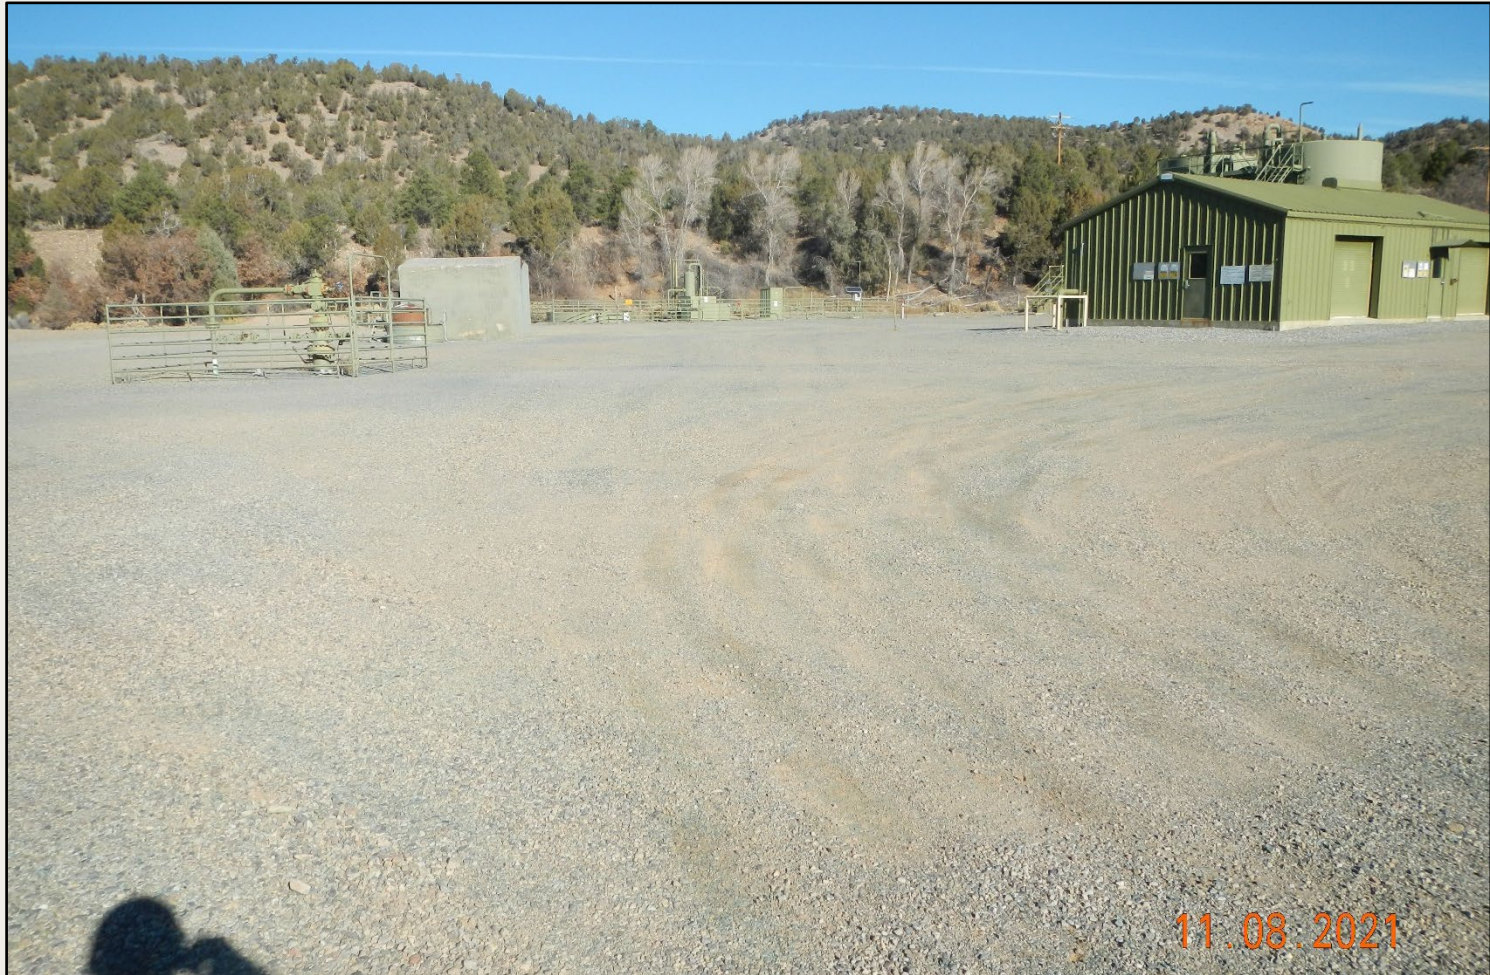
Photo 1. View of the project area from the well pad entrance facing center. Debris observed during previous inspection is not observed.

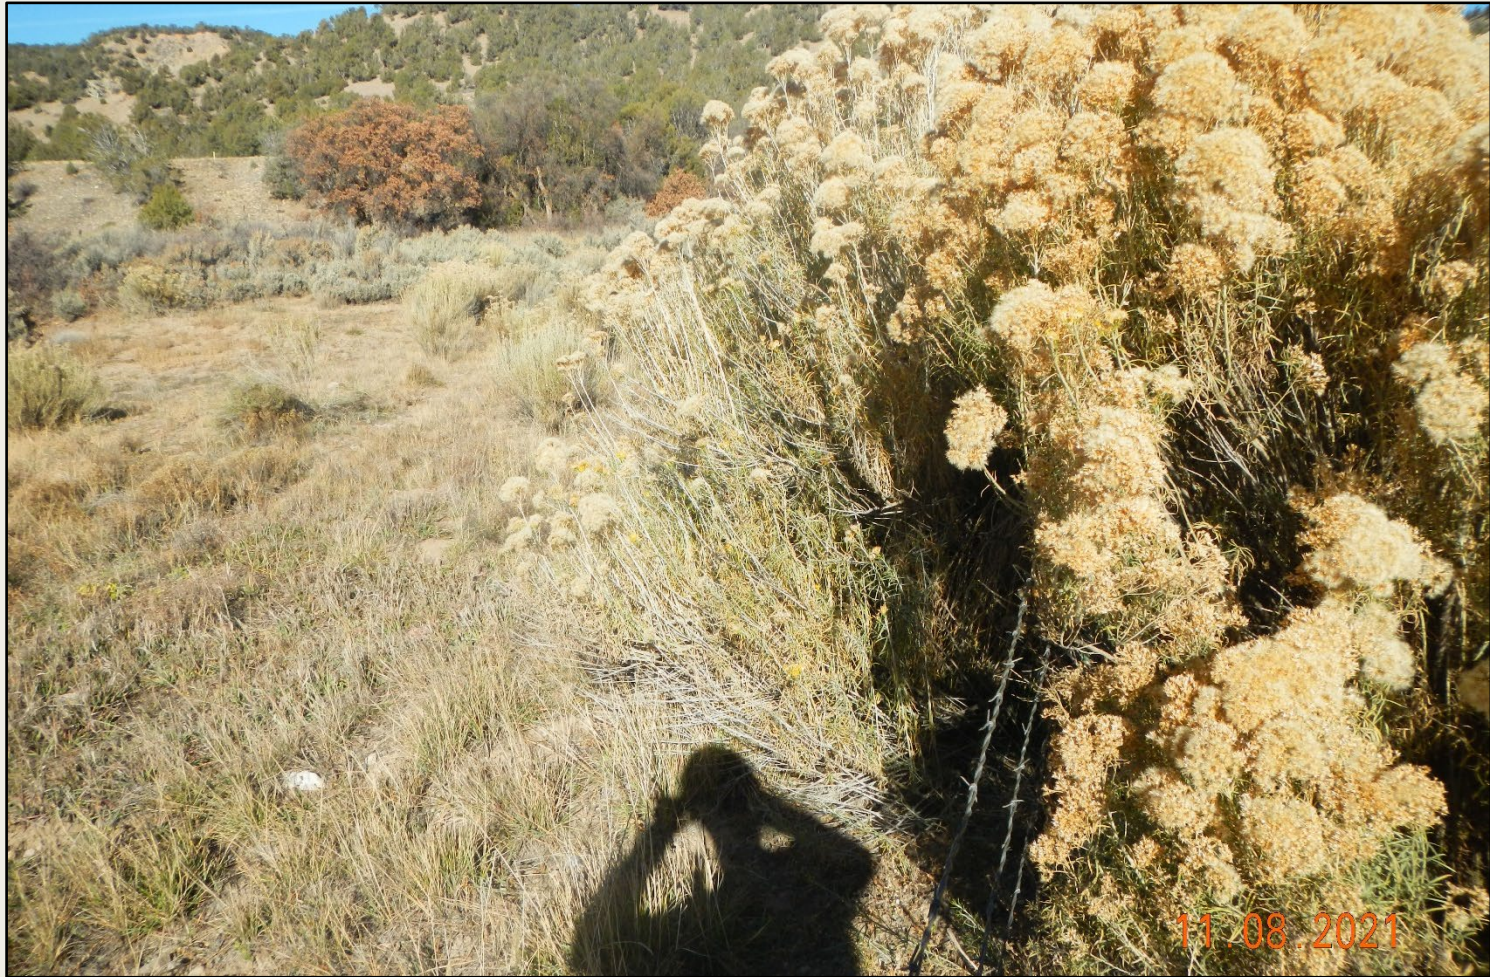
Photo 2. View of the western project area from the southwestern corner facing northward. Revegetation is progressing with rubber rabbitbrush, western wheatgrass, and smooth brome.

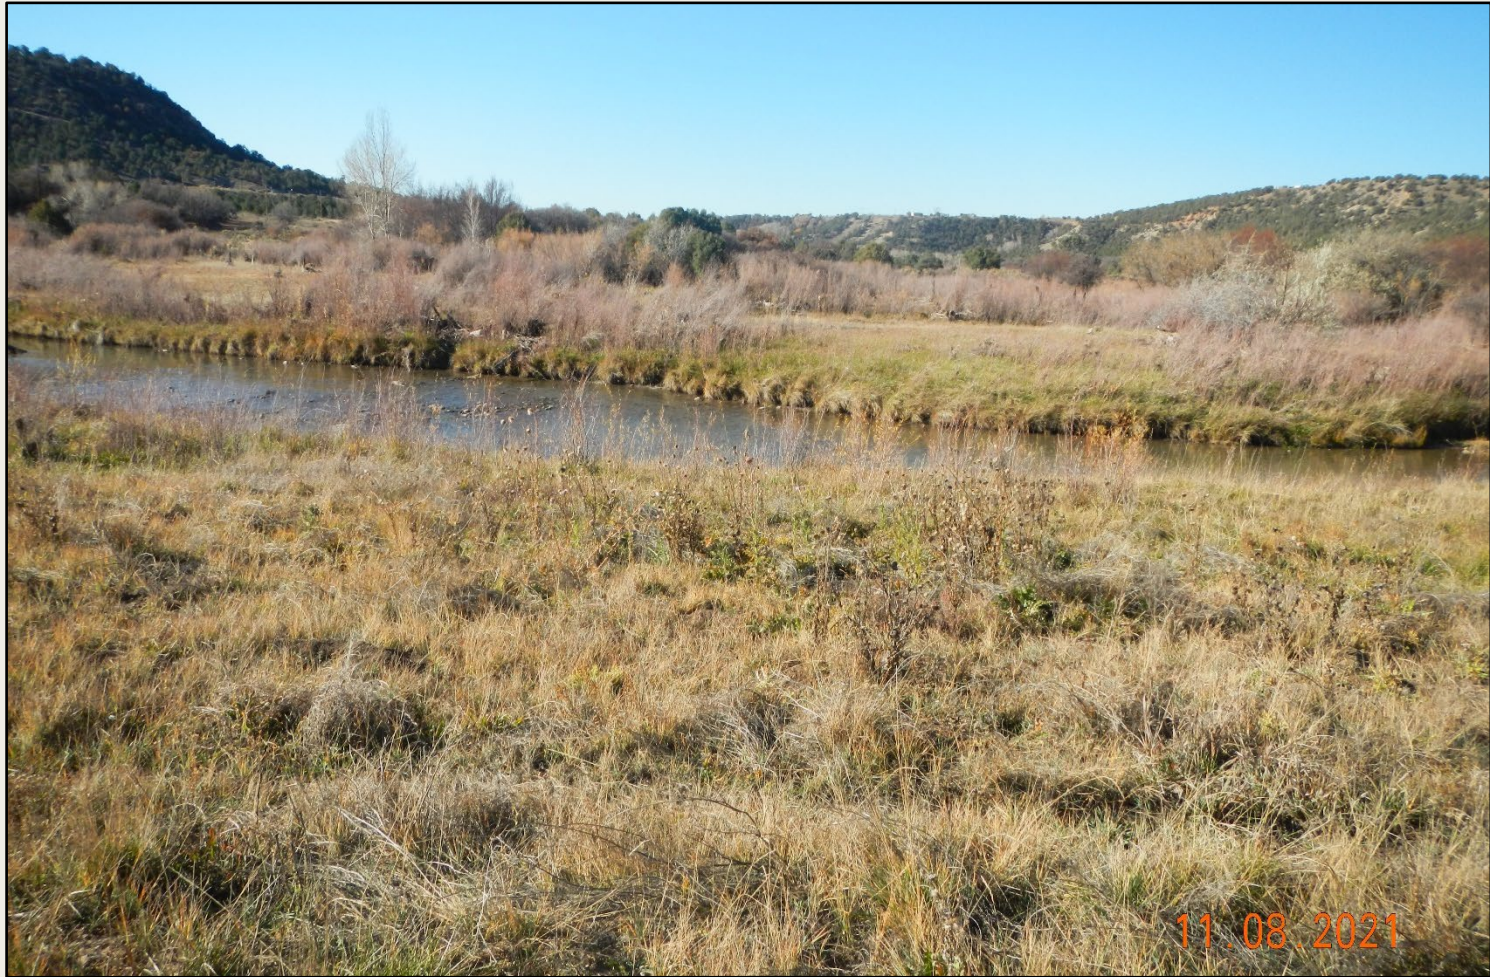
Photo 3. View of reference area comprised of open grass field with western wheatgrass, smooth brome, and thickspike wheatgrass.
