Inspection Photos  
Operator: Simcoe  
API: 067-08707  
Date: 11/8/2021

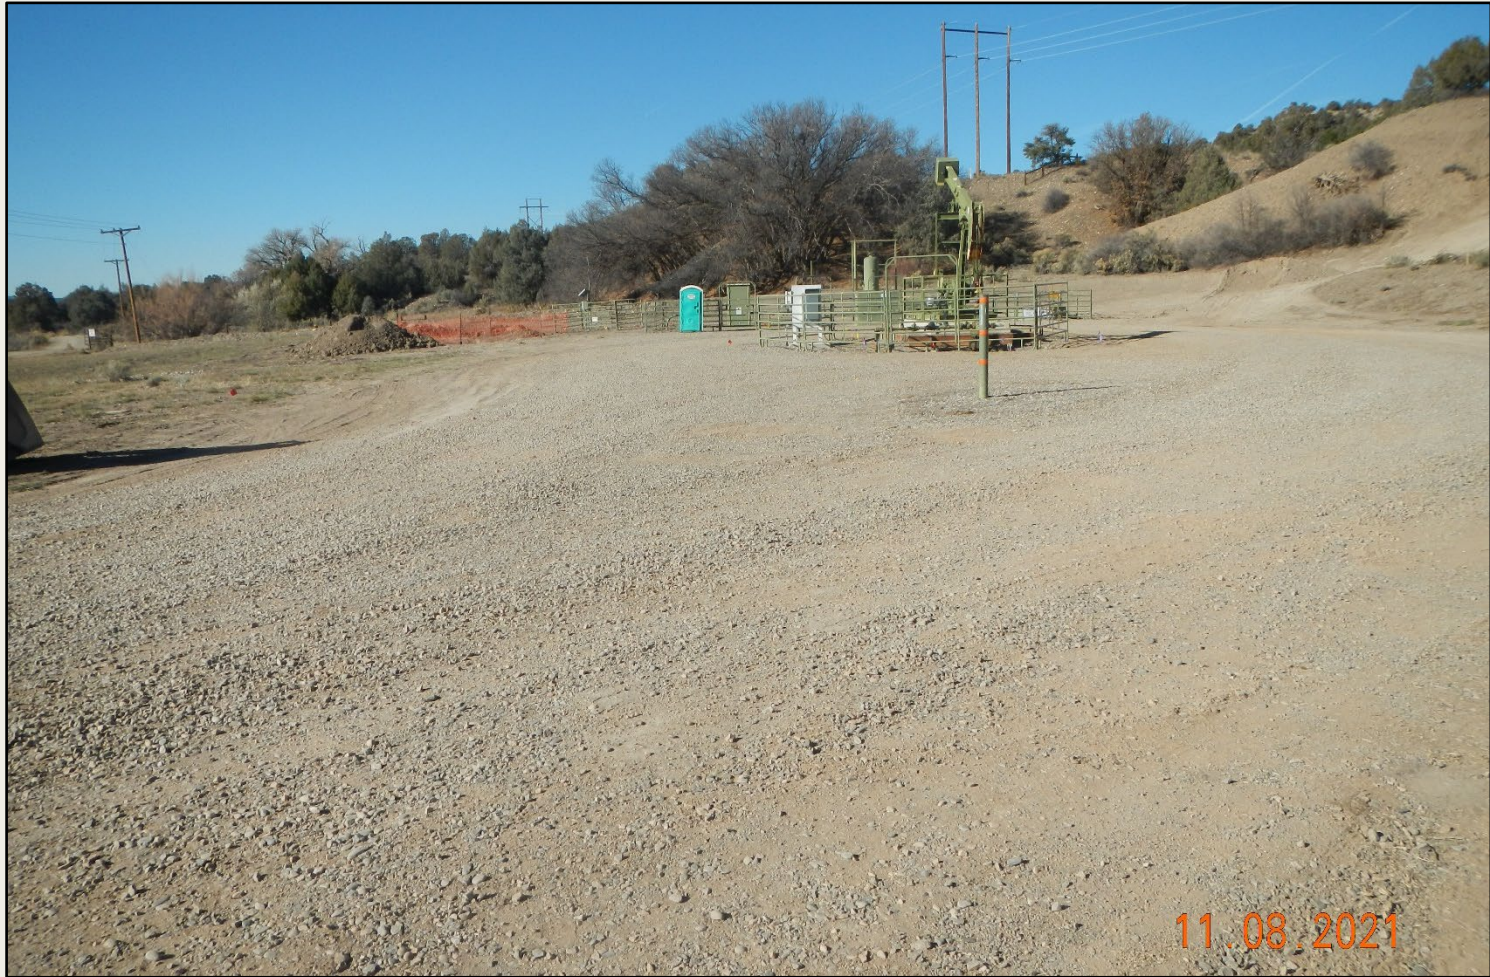
Photo 1. View of the project area from the well pad entrance facing center.

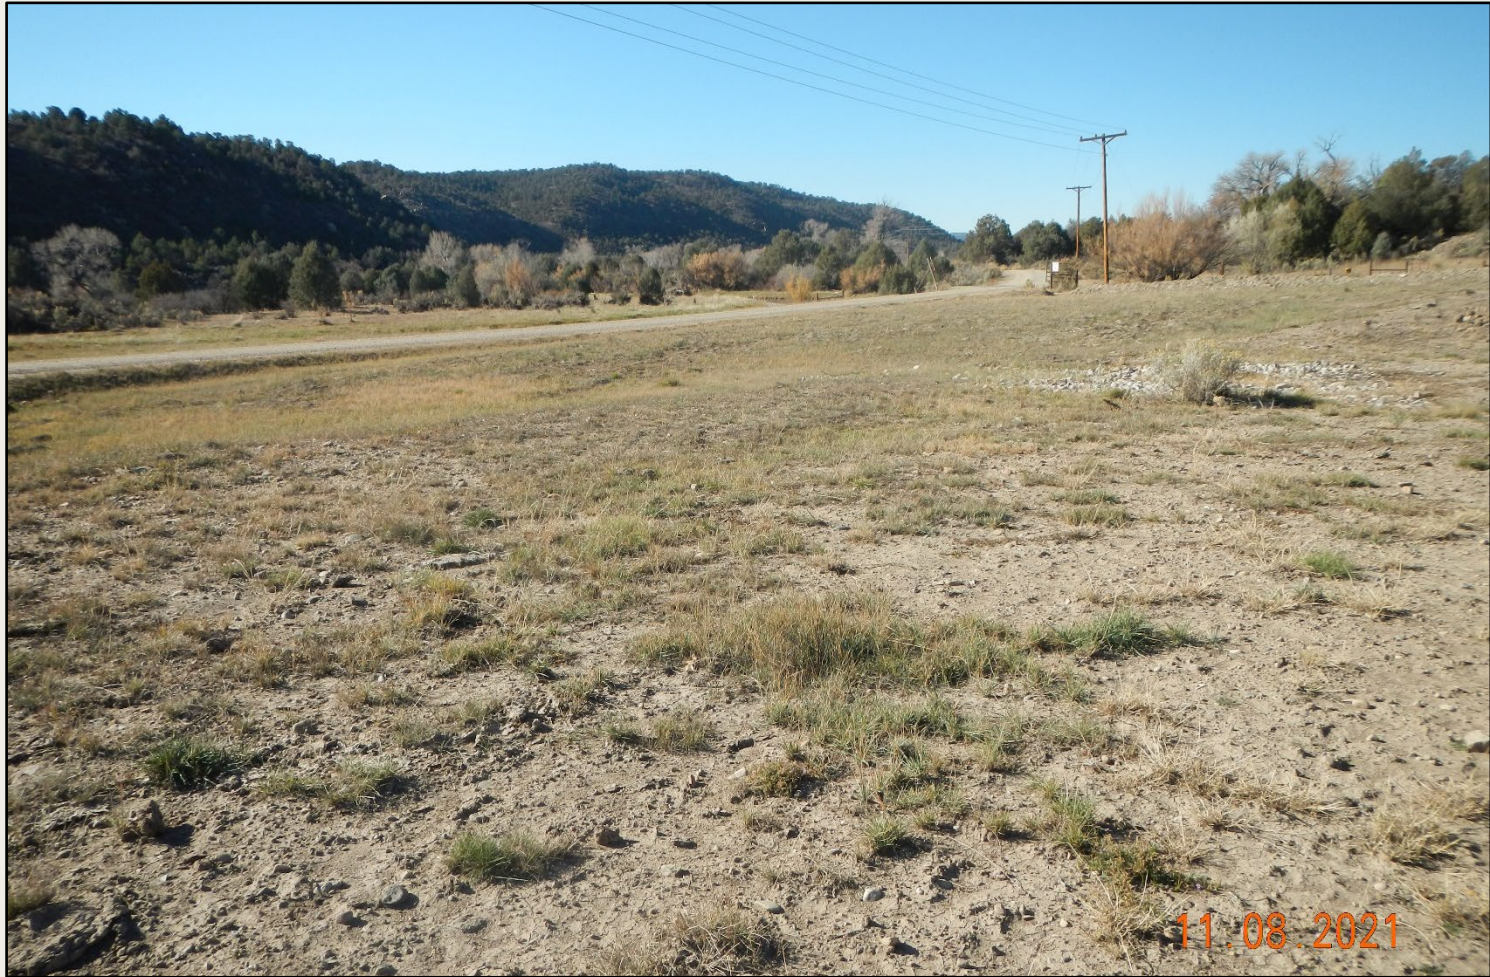
Photo 2. View of the southern project area from the southeastern corner facing westward. Revegetation is progressing with crested wheatgrass, western wheagrass, and sand dropseed. Weeds observed in July 2021 inspection not observed.

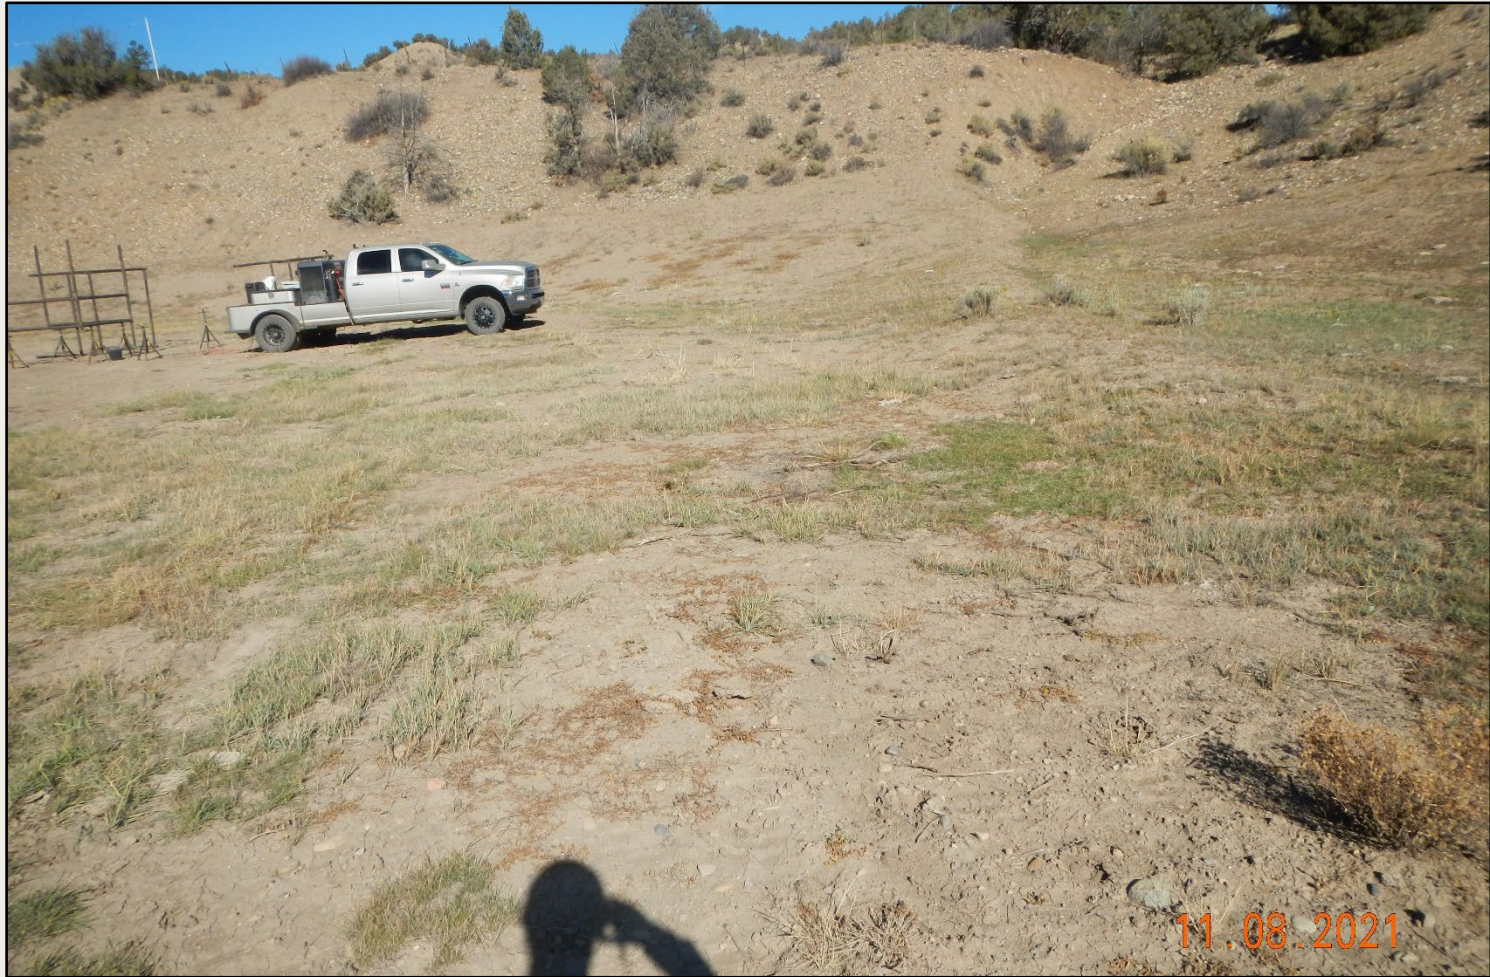
Photo 3. View of the eastern project area from the southeastern corner facing northward.

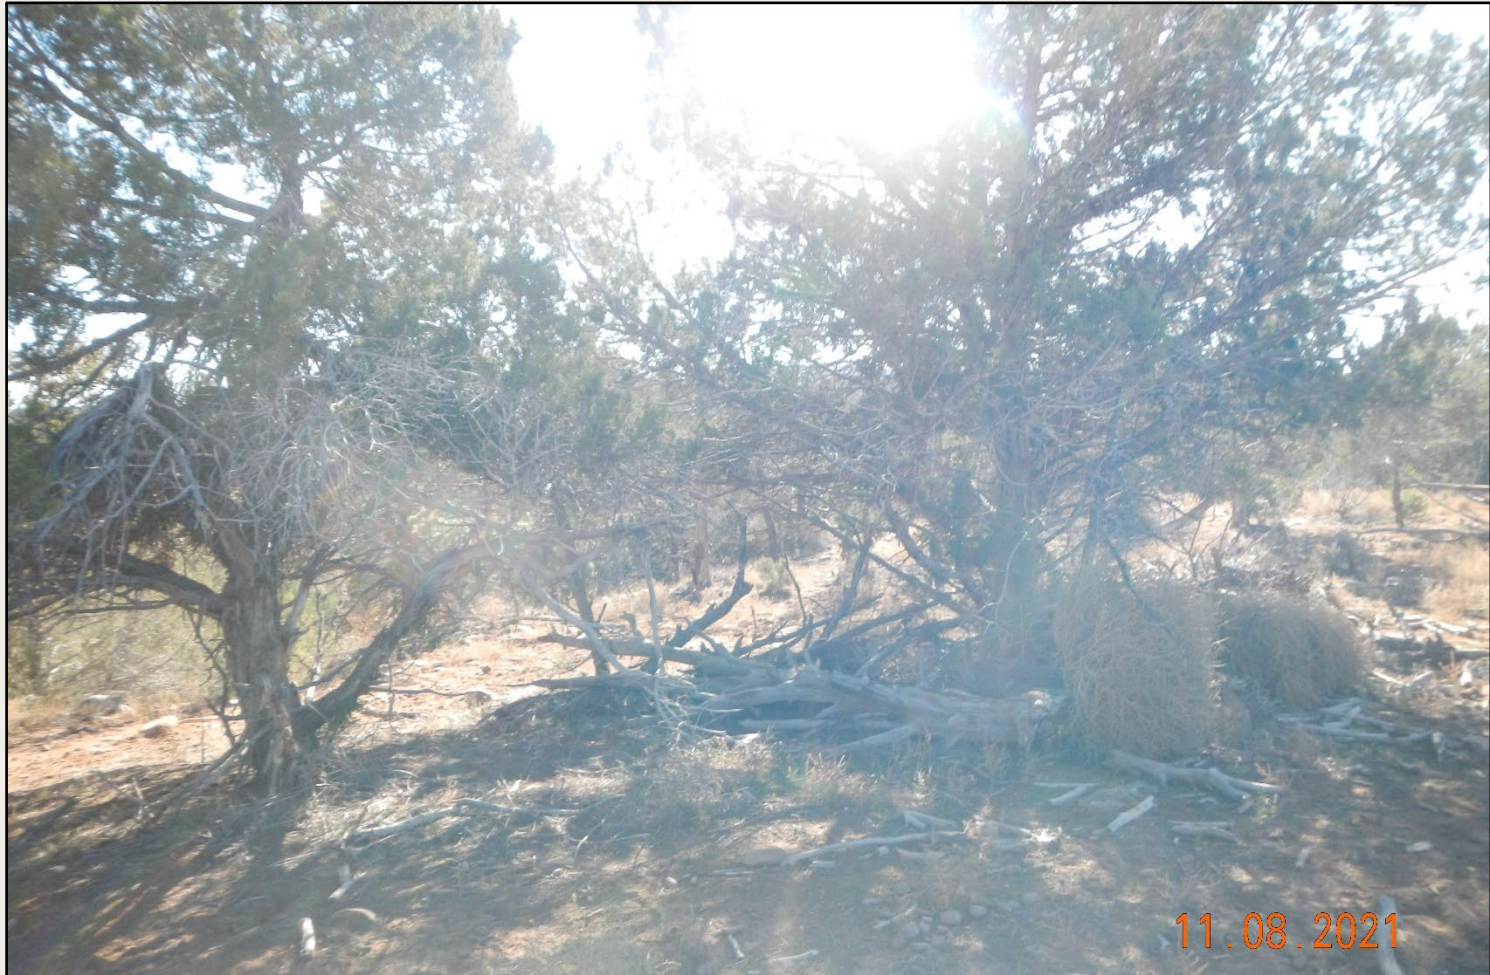
Photo 4. View of reference area comprised of pinyon and juniper woodland with blue grama, prickly pear, and black sagebrush in the understory.
