Inspection Photos
Operator: Simcoe
API: 067-09613
Date: 11/8/2021

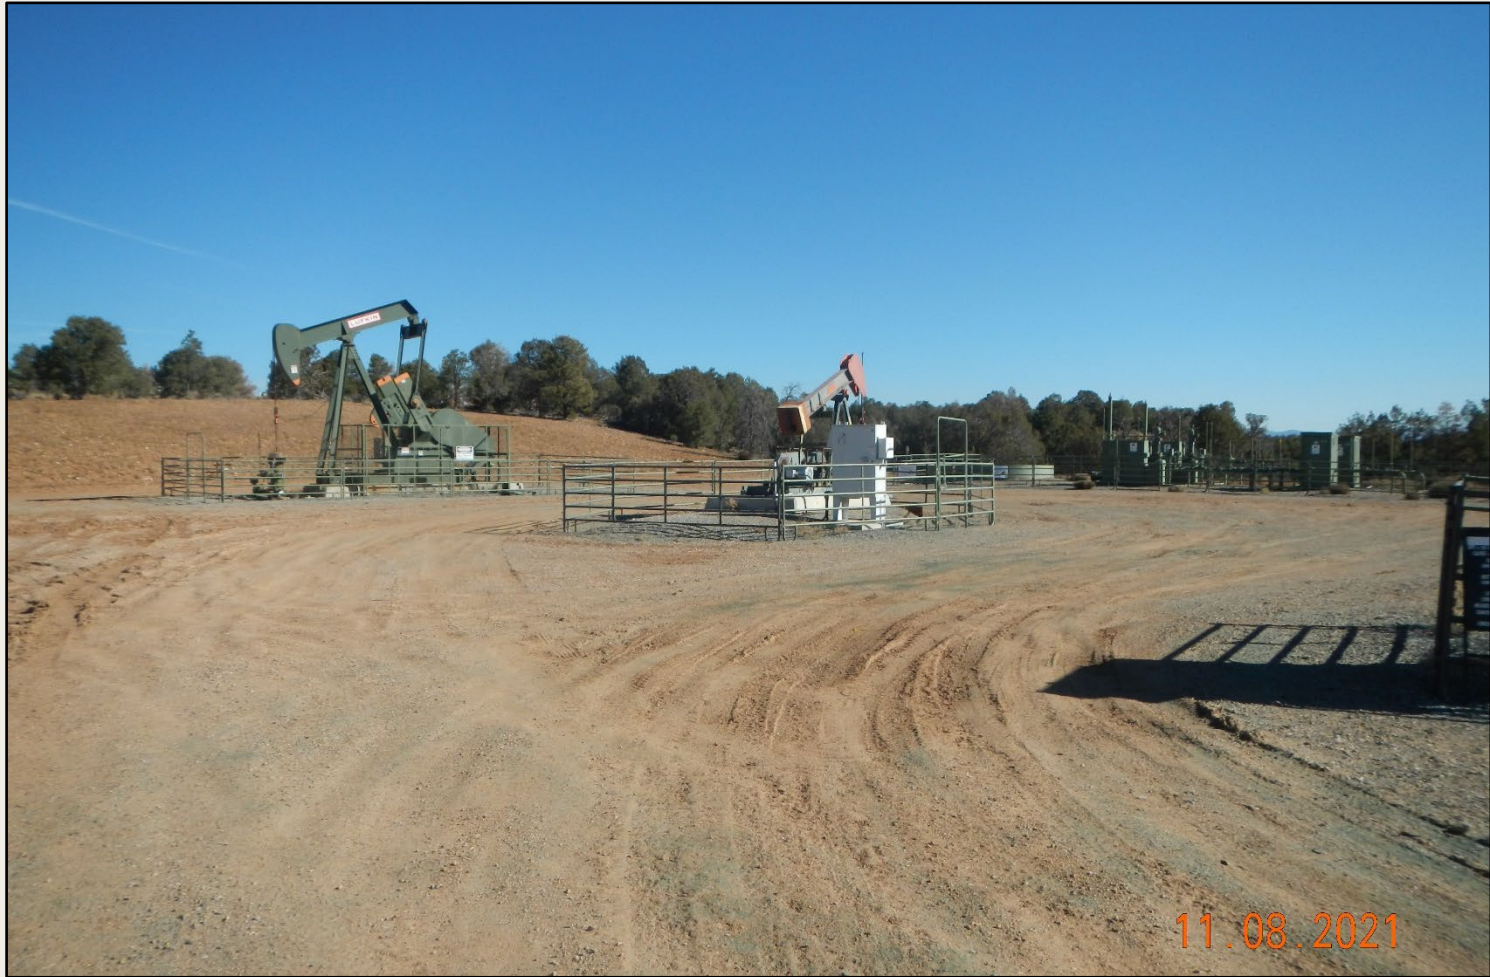
Photo 1. View of the project area from the well pad entrance facing center.

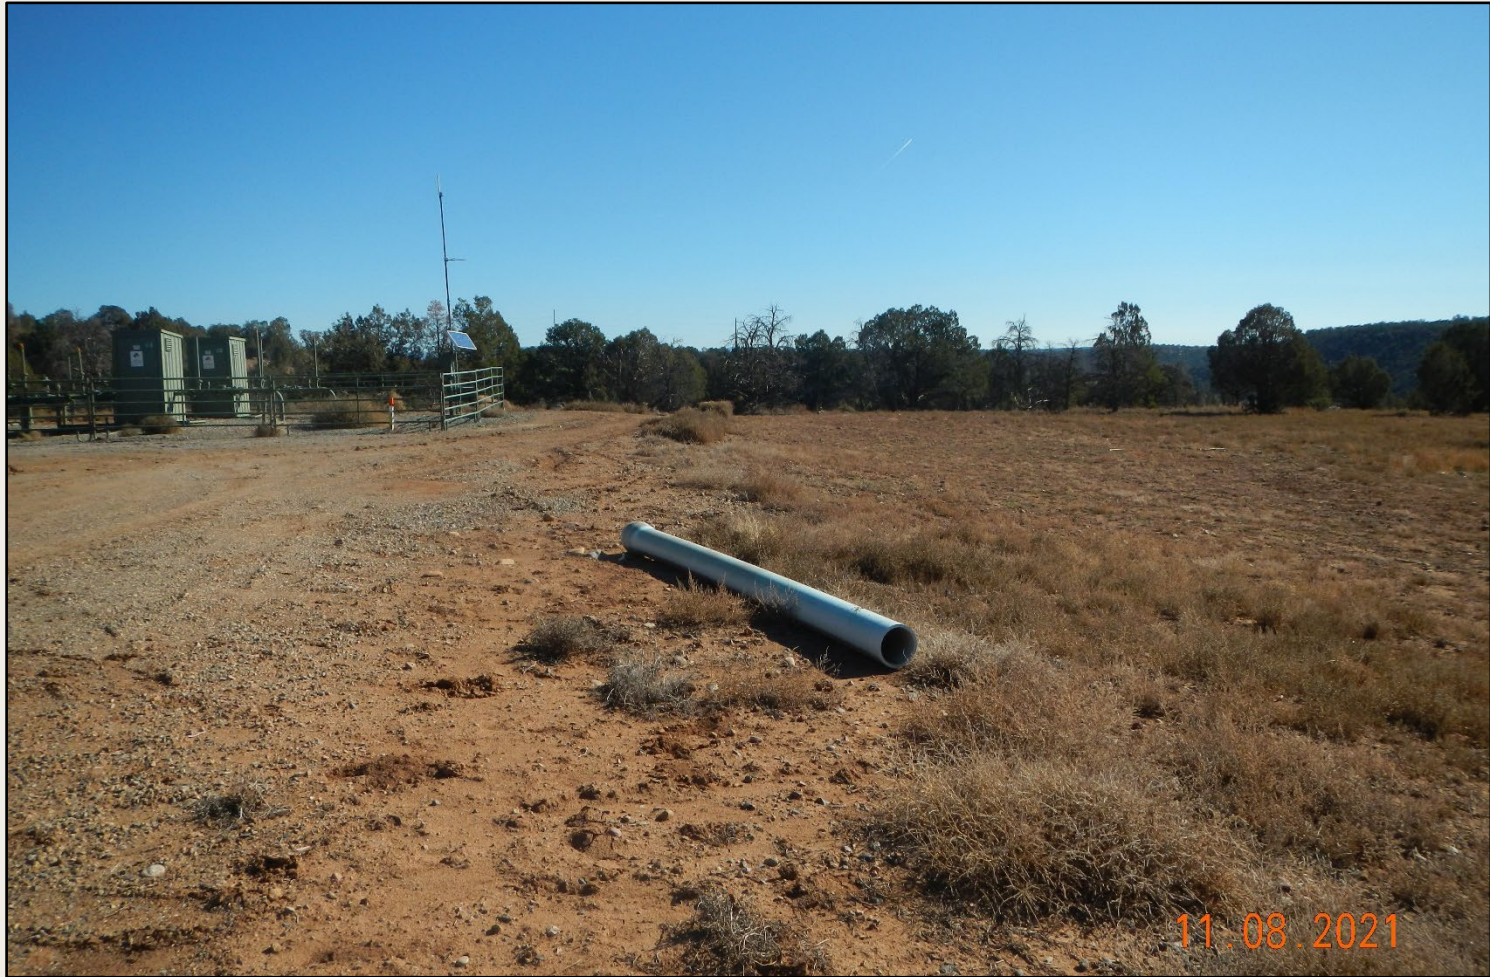
Photo 2. View of the southern project area from the southwestern corner facing eastward. Revegetation is progressing with sand dropseed, crested wheatgrass, largely in a grazed condition. Pipe needs to be removed.

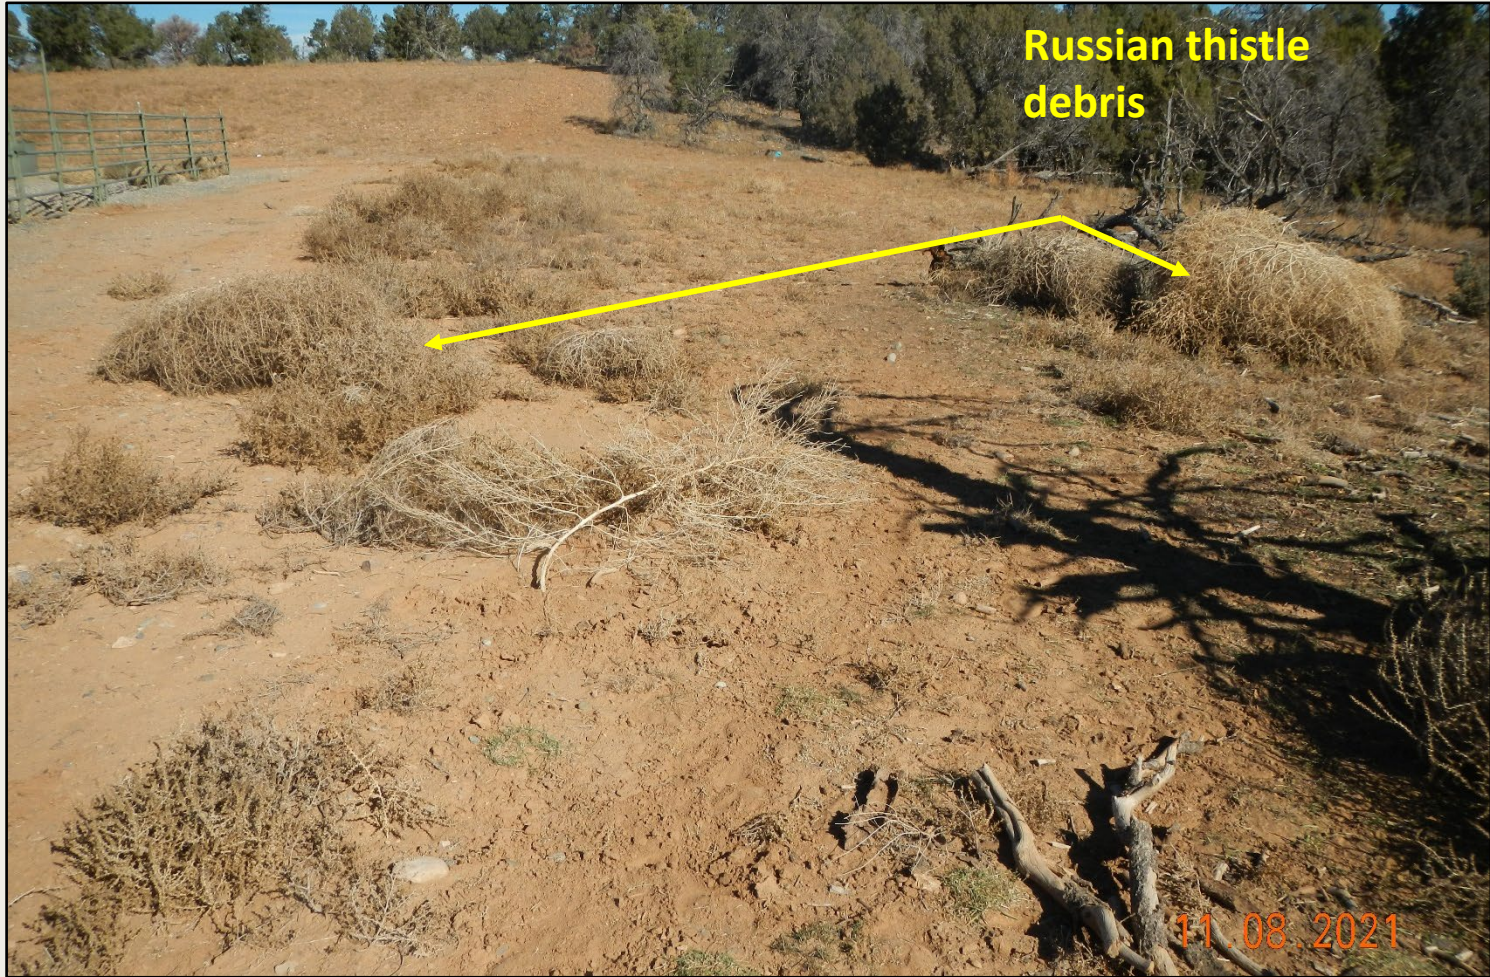
Photo 3. View of the eastern project area facing northward. Russian thistle debris needs to be removed.

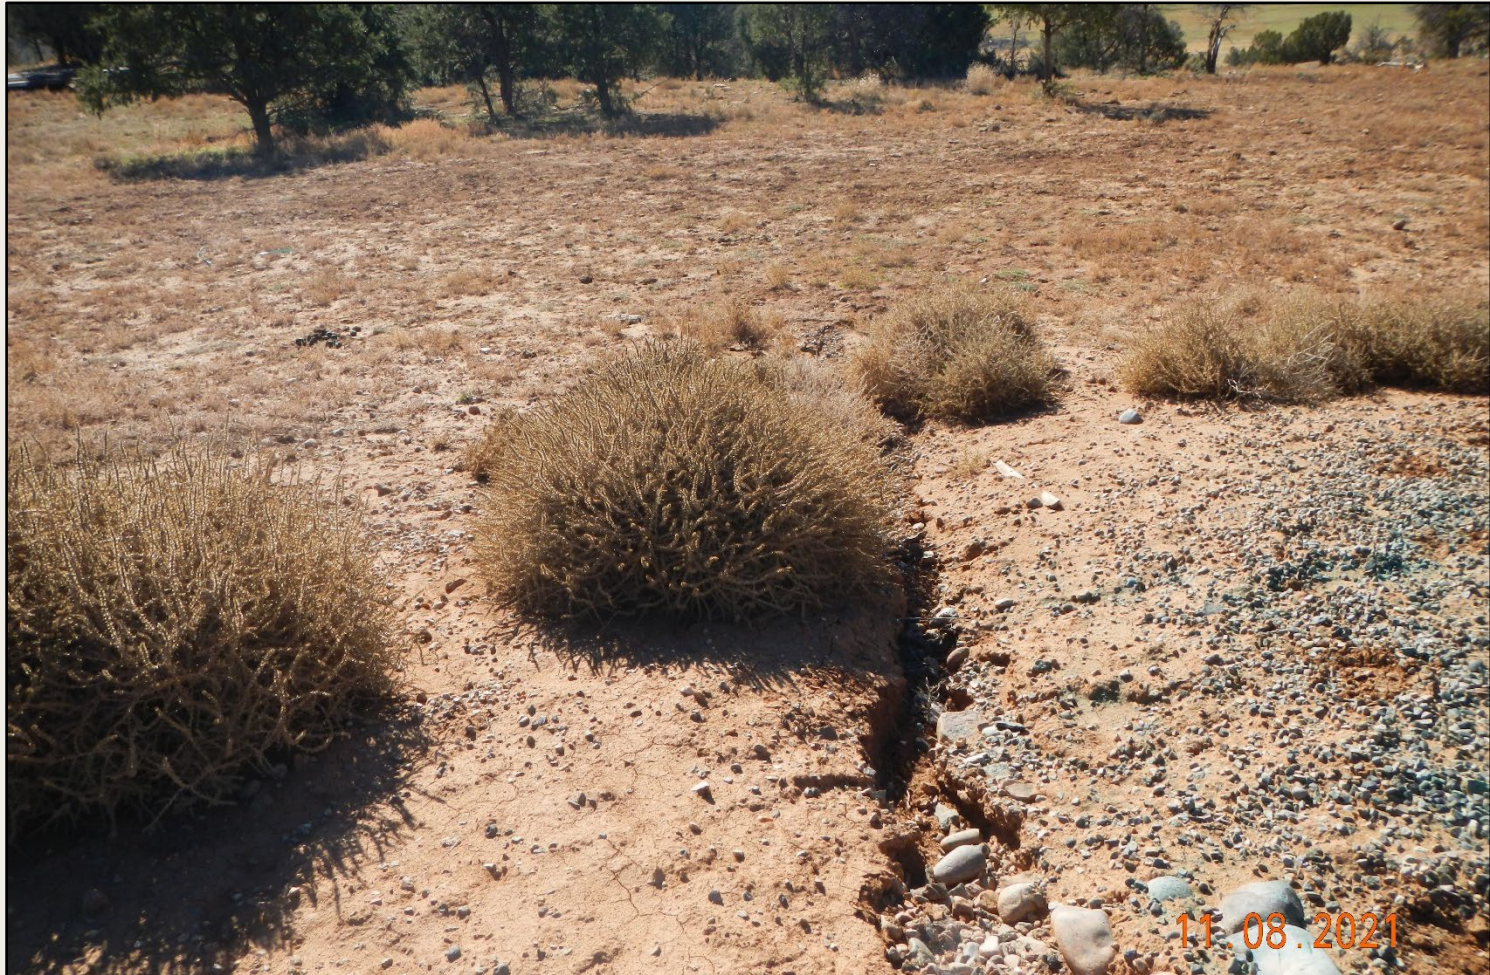
Photo 4. View of erosional channel approximately 6-10 inches wide and deep, forming within the southern project area. Russian thistles debris is also present.

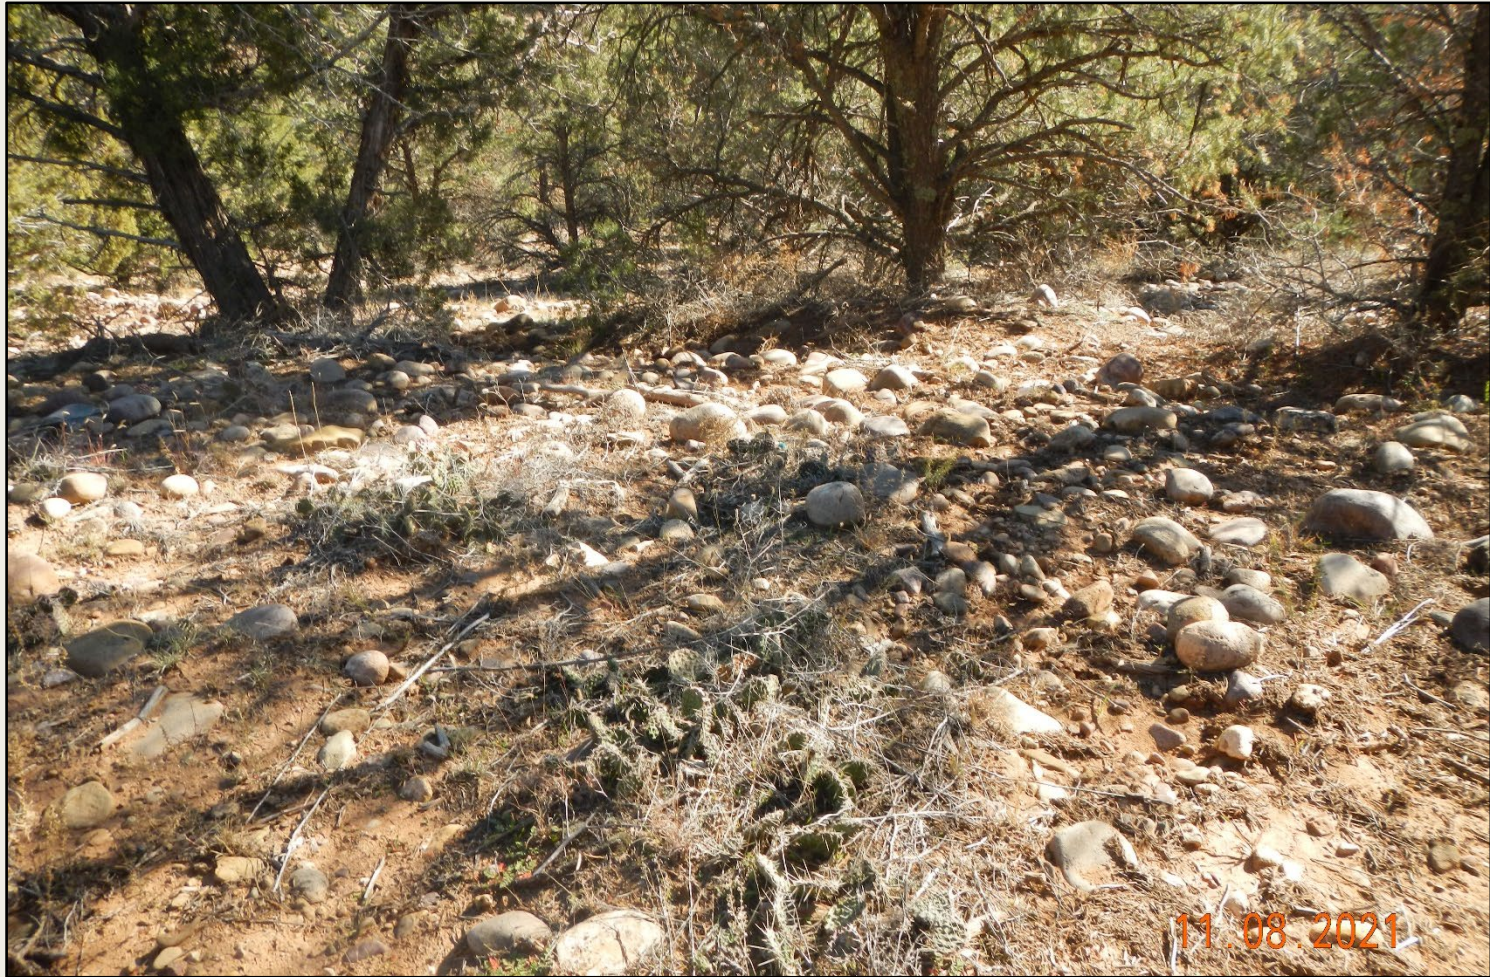
Photo 5. View of flood channel in the northern project area; gravel removed and wattles installed. Banks are not stabilized. Reseeding and stabilization not conducted. Wattle is not an appropriate stormwater control for this area.
