Inspection Photos
Location Name: Wildhorse 18-1834H
Location ID: 430306

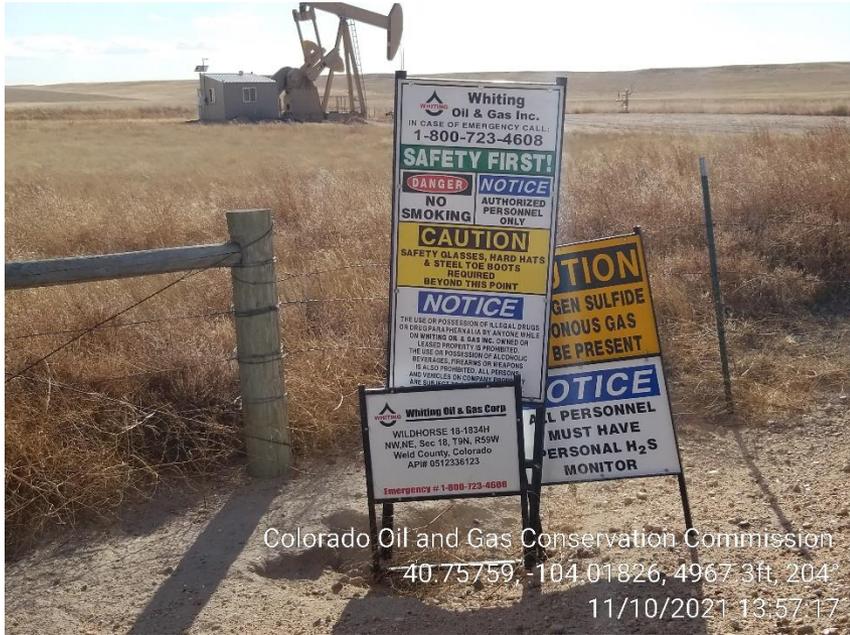
Photo 1 – Sign at Entrance

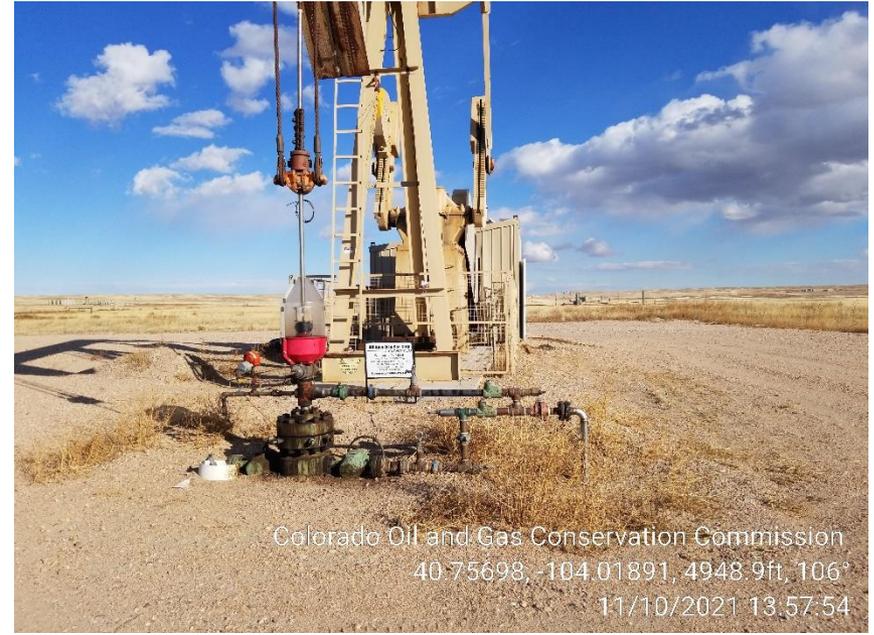
Photo 2 – Wellhead – Weeds

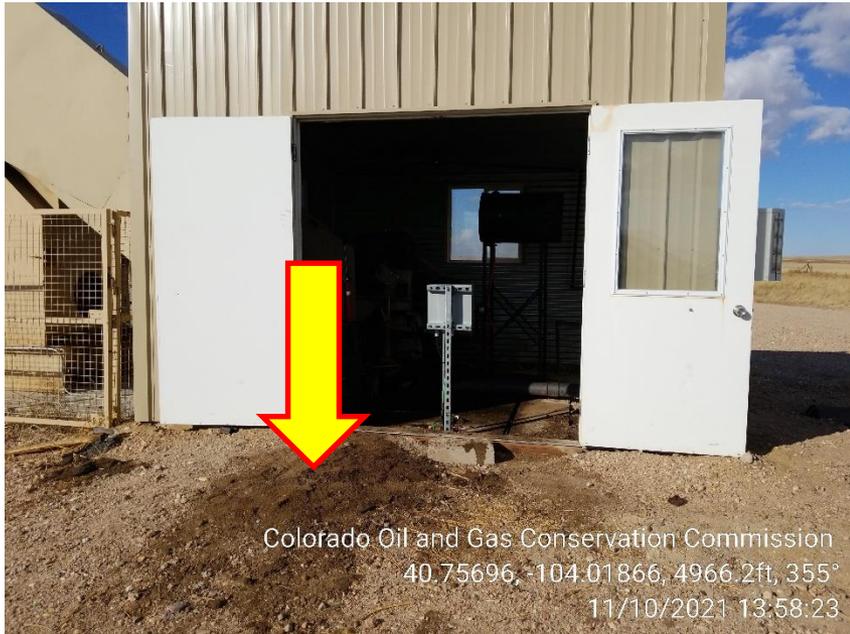
Photo 3 – Stained Soil at Gas Engine

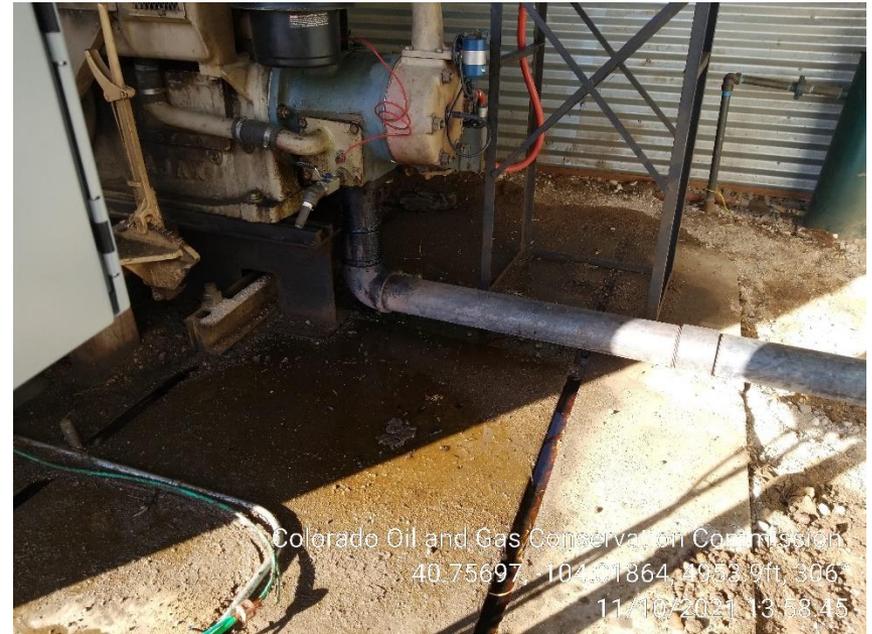
Photo 4 – Stained Soil at Gas Engine

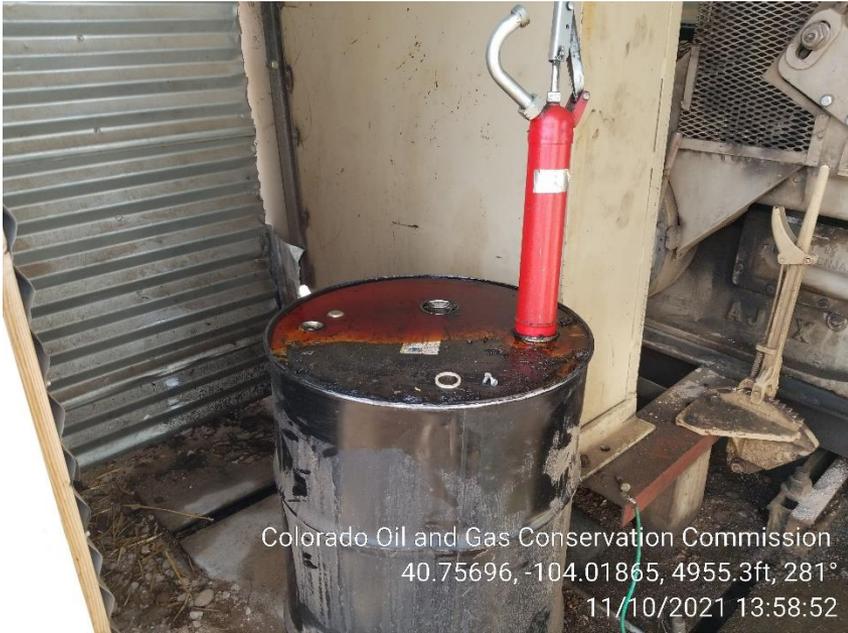
Photo 5 – Oily Waste

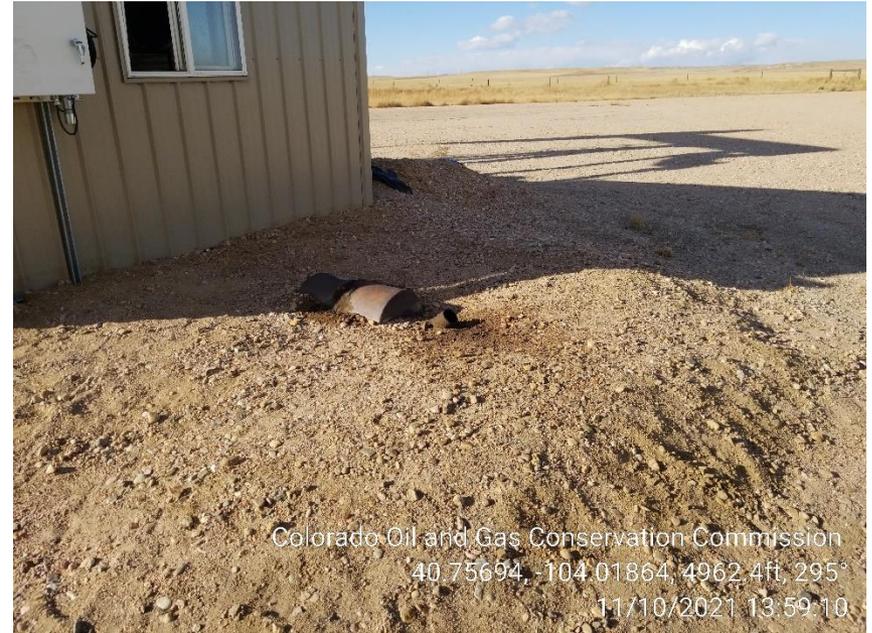
Photo 6 – Stained Soil at Exhaust

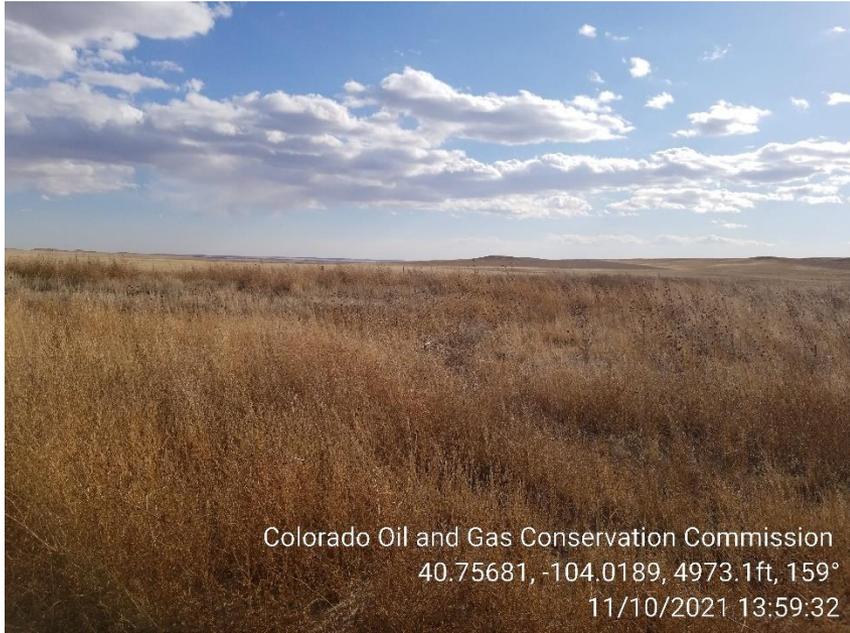
Photo 7 – Weeds in I.R. Area

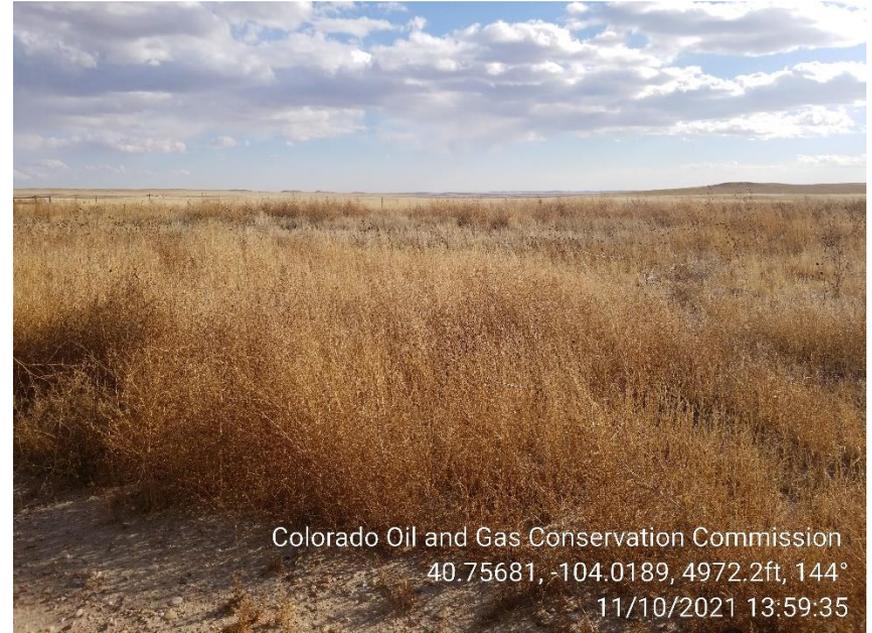
Photo 8 – Weeds in I.R. Area

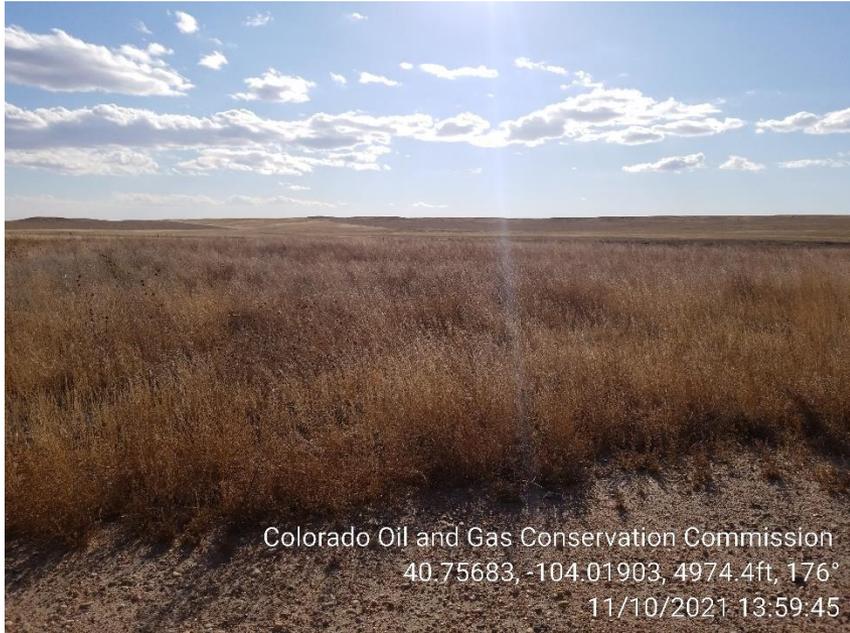
Photo 9 – Weeds in I.R. Area

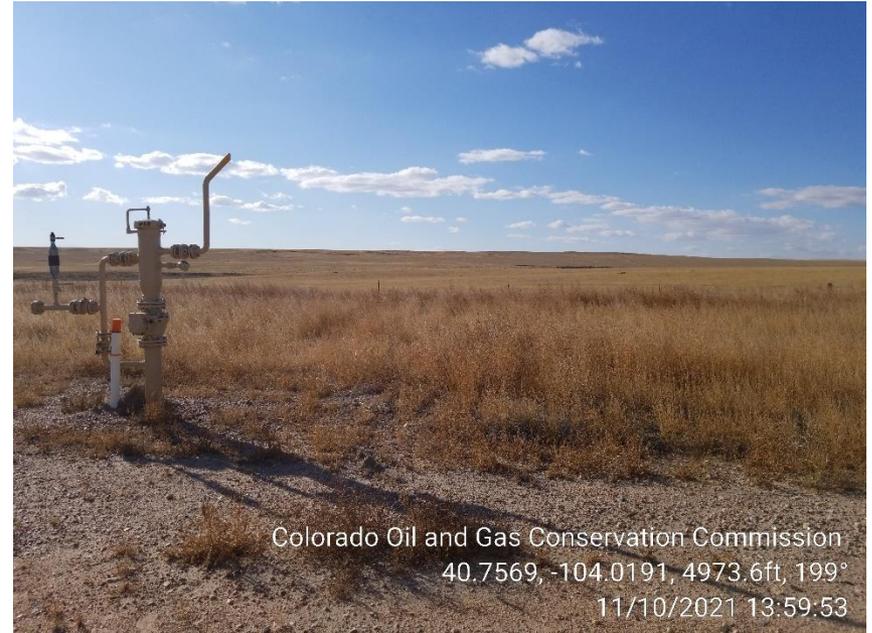
Photo 10 – Weeds in I.R. Area

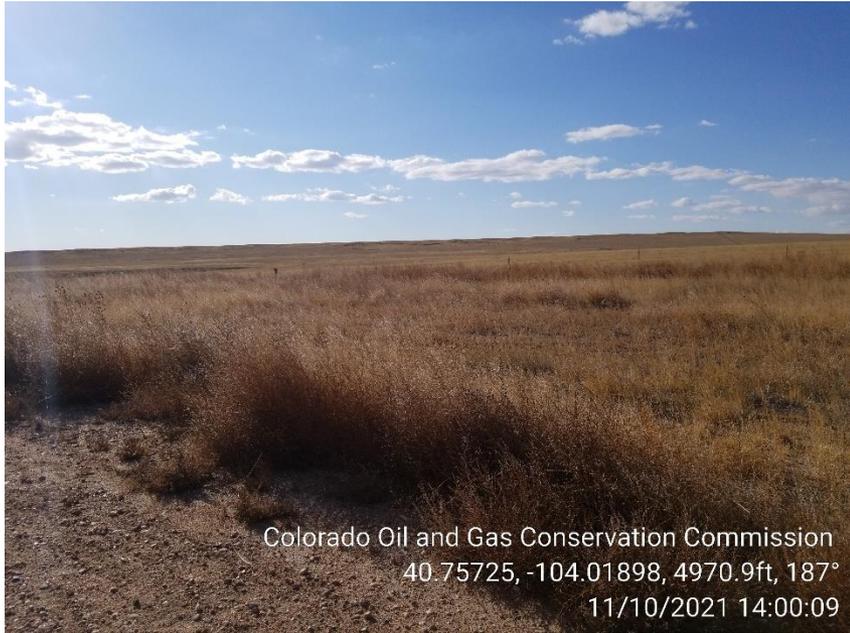
Photo 11 – Weeds in I.R. Area

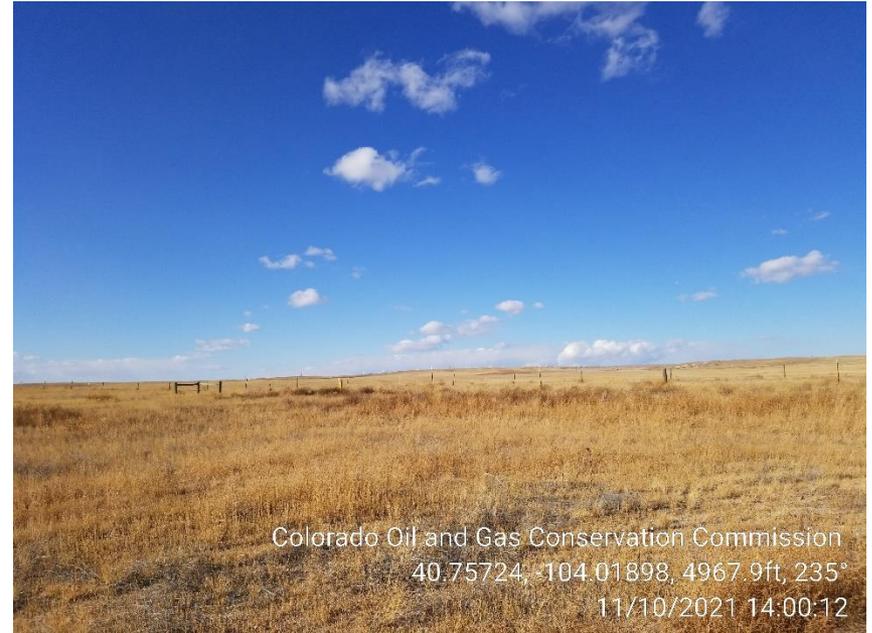
Photo 12 – Weeds in I.R. Area
