Final Reclamation Inspection

Operator: NOBLE ENERGY INC - #100322

Location ID: 305716

Inspection Document #: 697503480

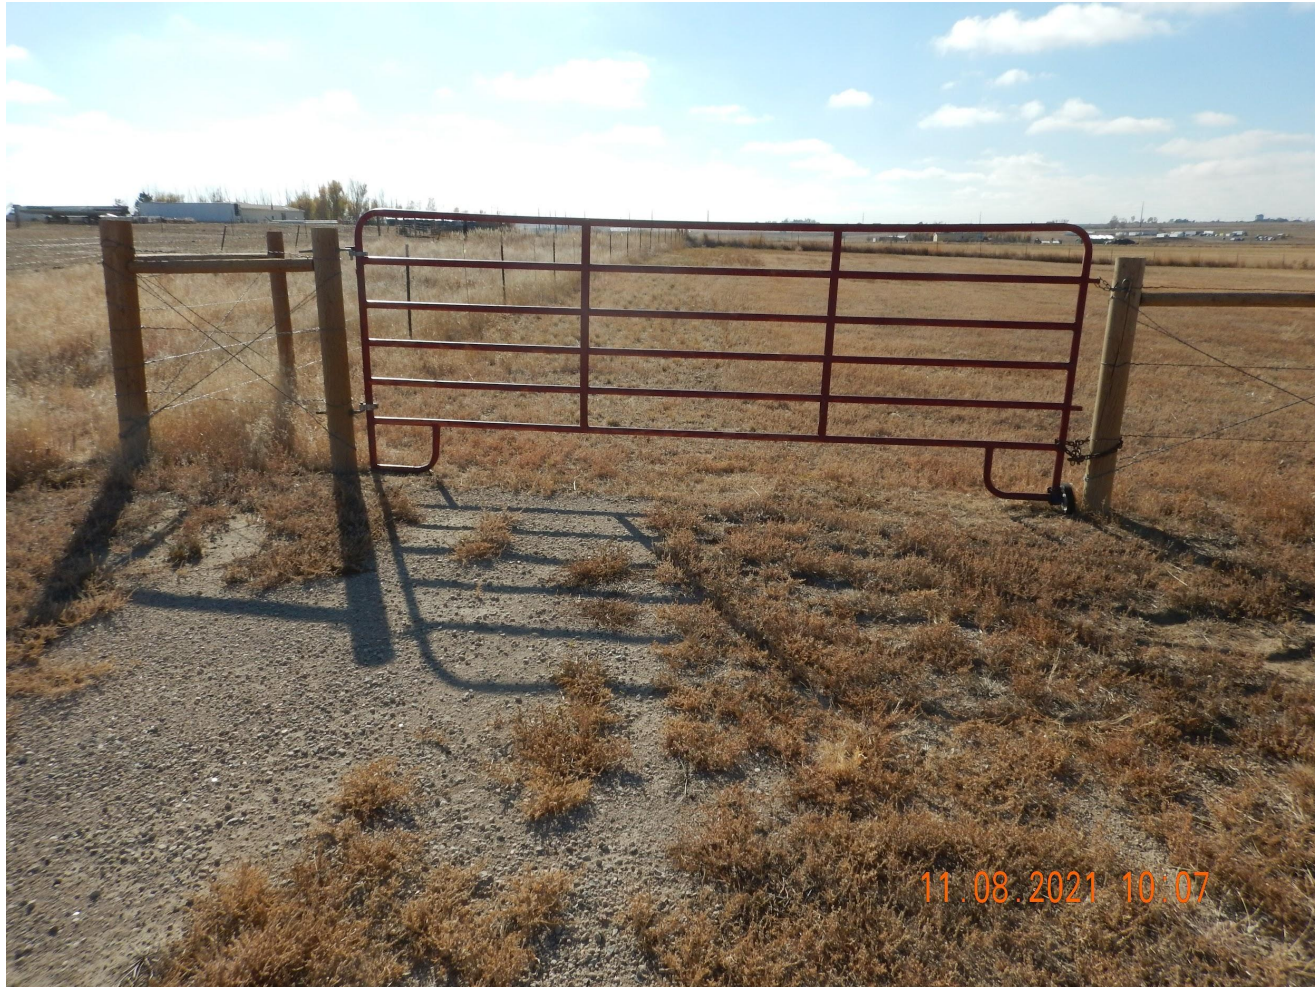
Photo 1. Photo taken from the gate and fencing that was a previous complaint, South. Photo illustrates that complaint item has been completed and no further action required.

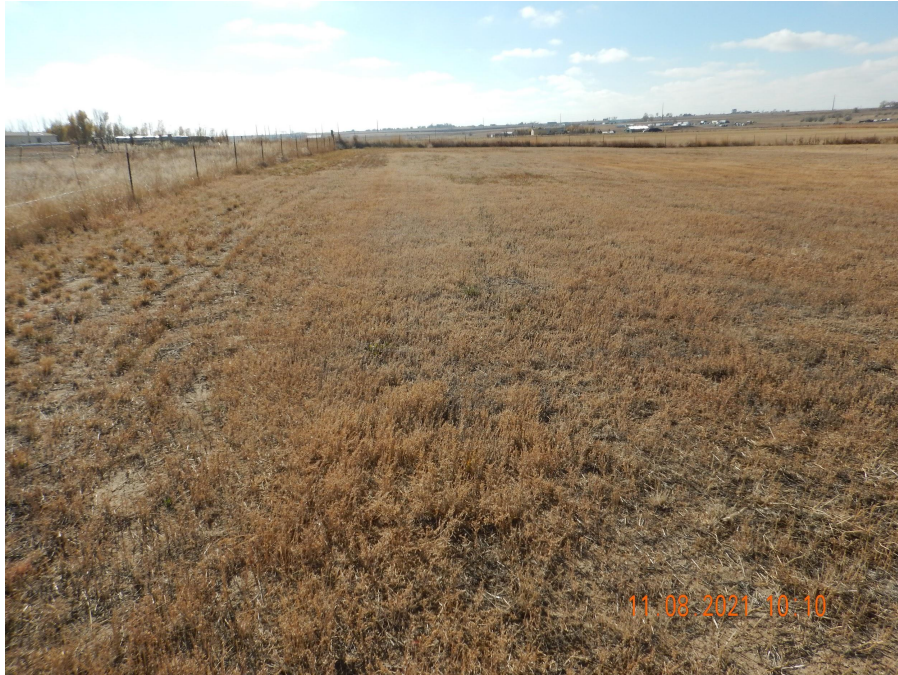
Photo 2. Photo taken from the northern well location, facing South. Photo illustrates germination of desirable plant species along the eastern location but most of the well location consists of Kochia.

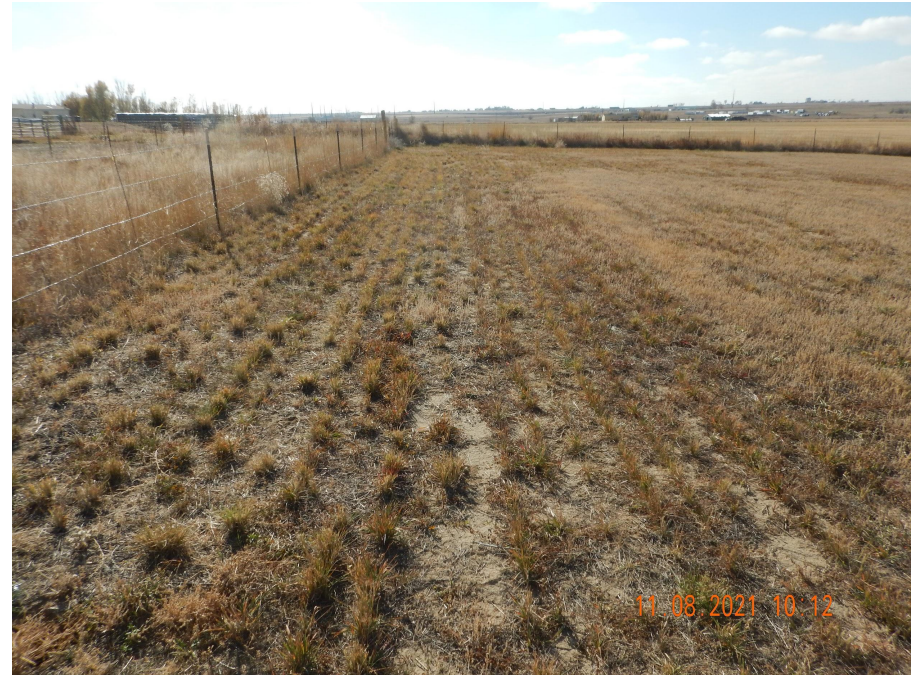
Photo 3. Photo taken from the eastern well location, facing South. See comments under Photo 2.

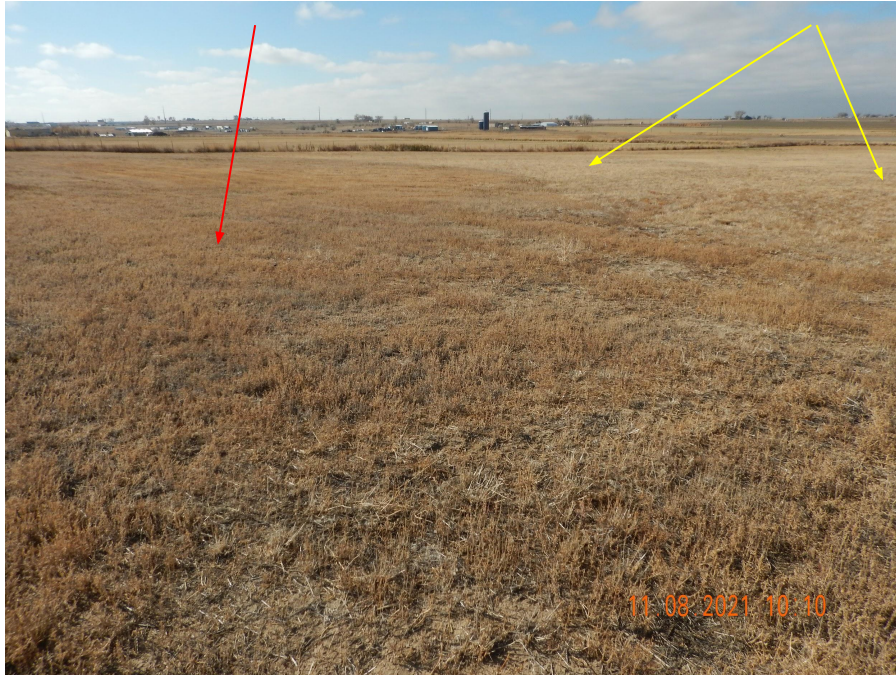
Photo 4. Photo taken from the northern well location, facing Southwest. Photo illustrates the well location (red arrow putting at Kochia) and reference area (yellow arrows pointing at the reference area).

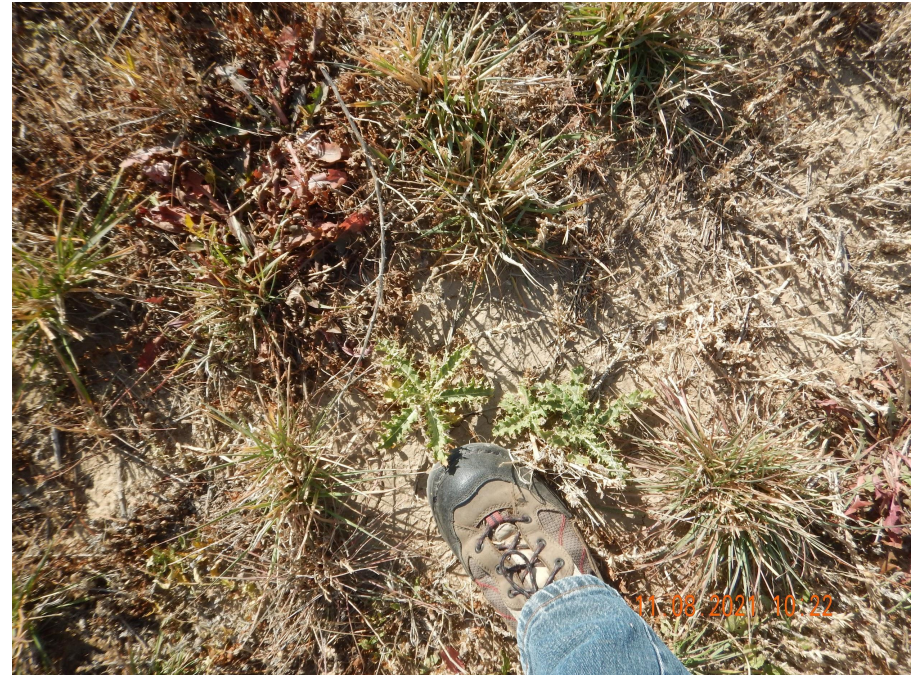
Photo 5. Photo taken from a portion of the well location. Photo illustrates a List B Colorado noxious weed, Canada thistle. Canada thistle rosettes were observed sparratically in areas of the location.

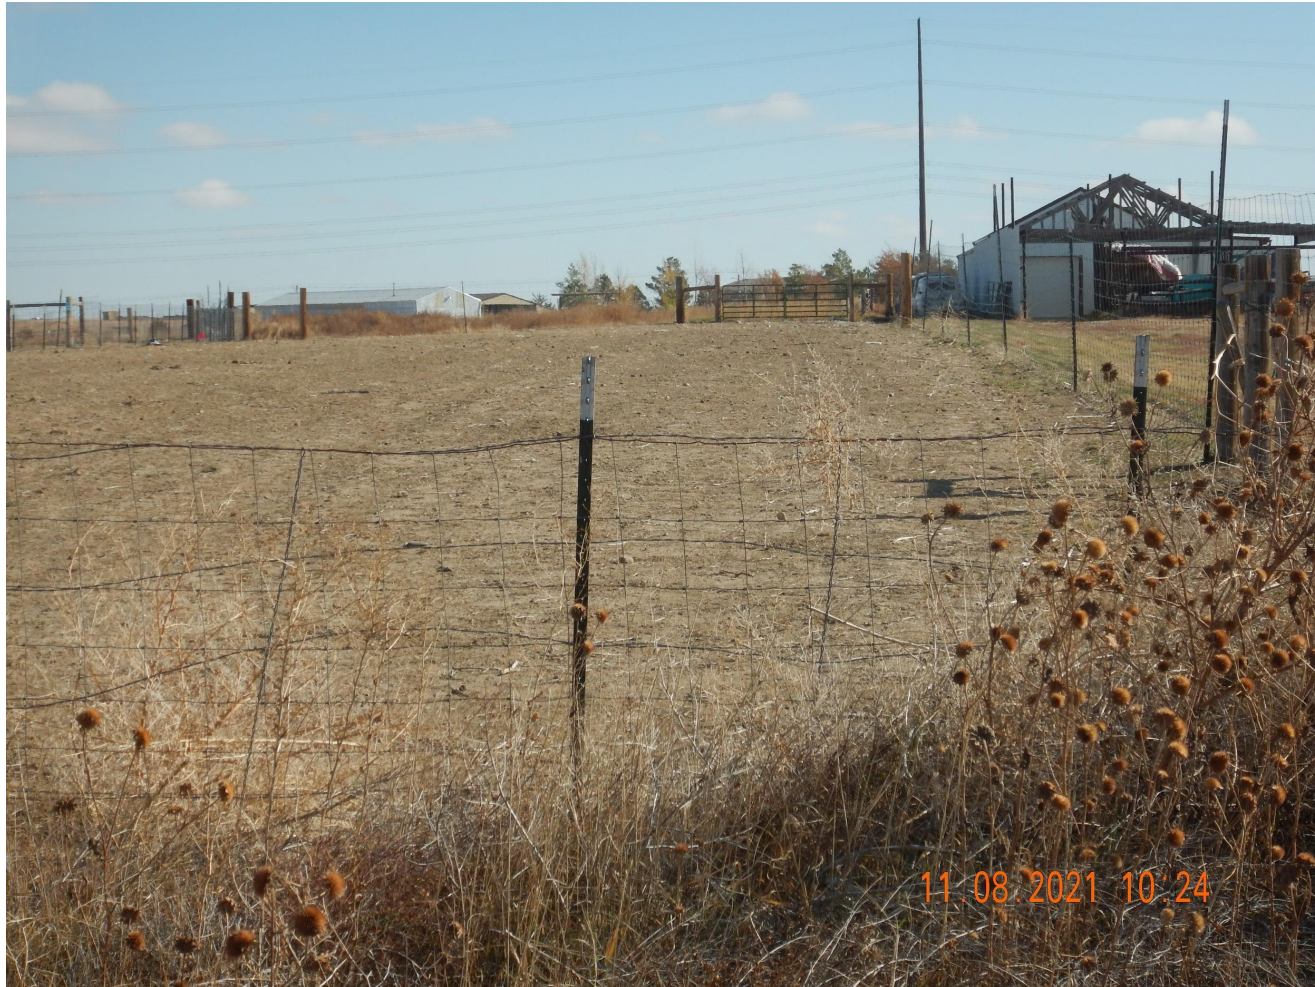
Photo 6. Photo taken from the well location, facing East. Photo illustrates a portion of the access road is now part of a livestock grazing area. The tank battery and remainder of the access road are beyond the gate illustrated in the photo.

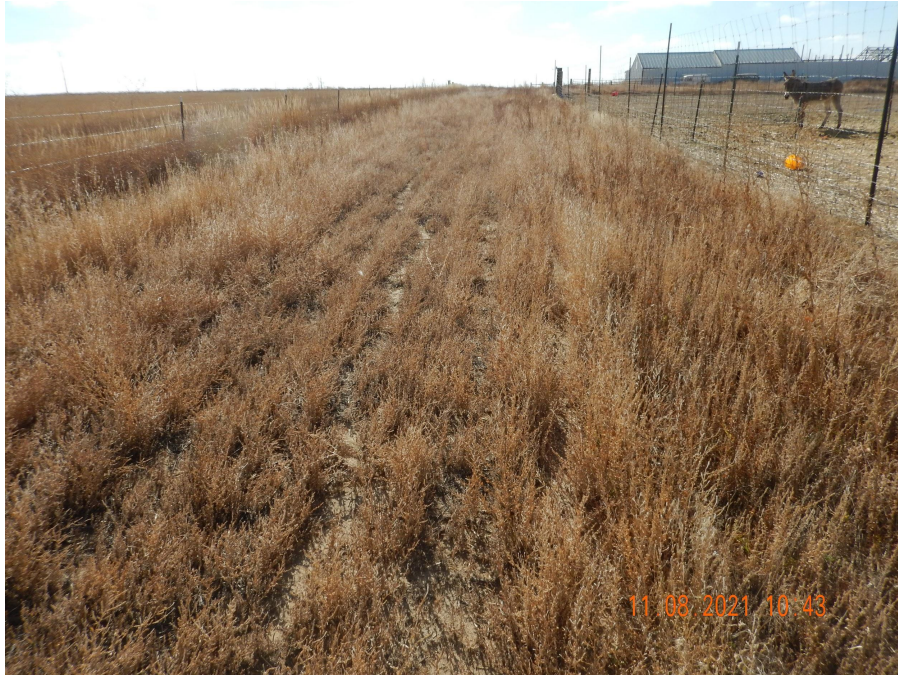
Photo 7. Photo taken from the eastern access road, facing South. Photo illustrates weeds throughout the entire eastern access road with no desirable establishment observed.

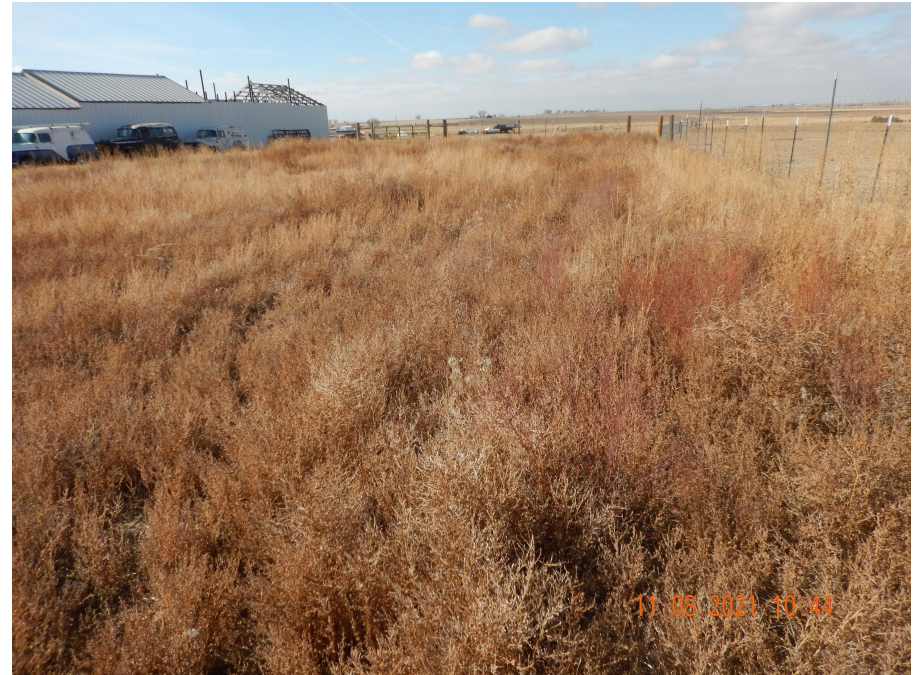
Photo 8. Photo taken from the tank battery, facing West. See comments under Photo 7.
