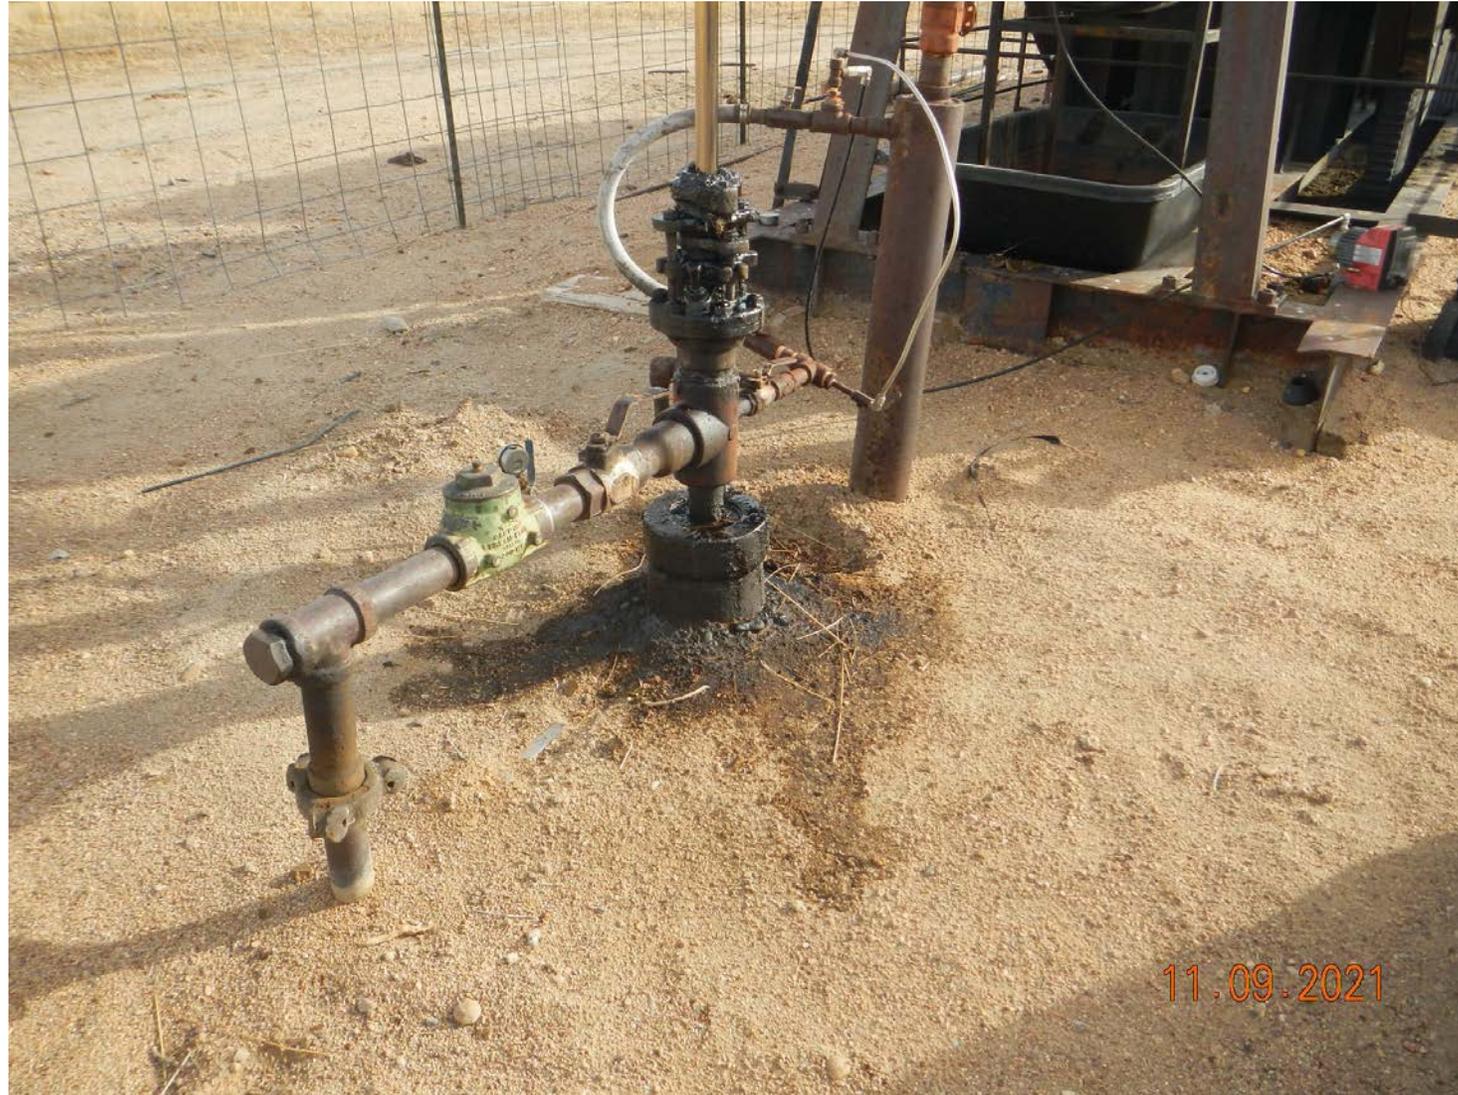
- Photo 3 – Wellhead oil leak

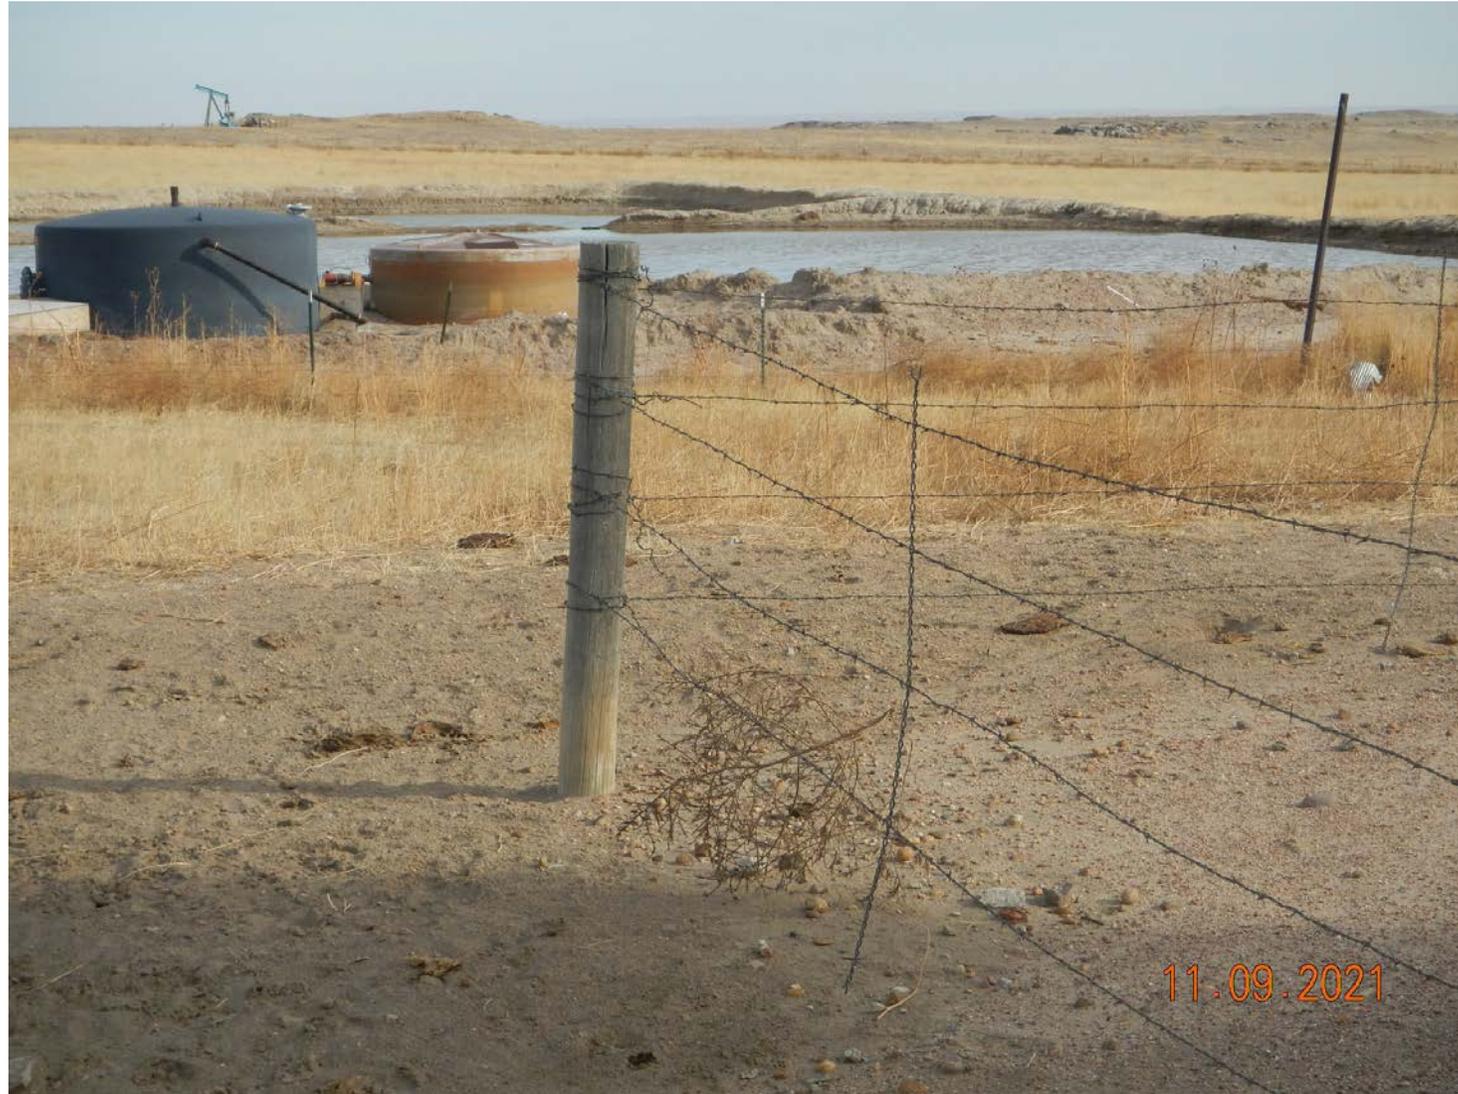
- Photo 5 – Produced water pits not maintaining a minimum of 2 feet of freeboard

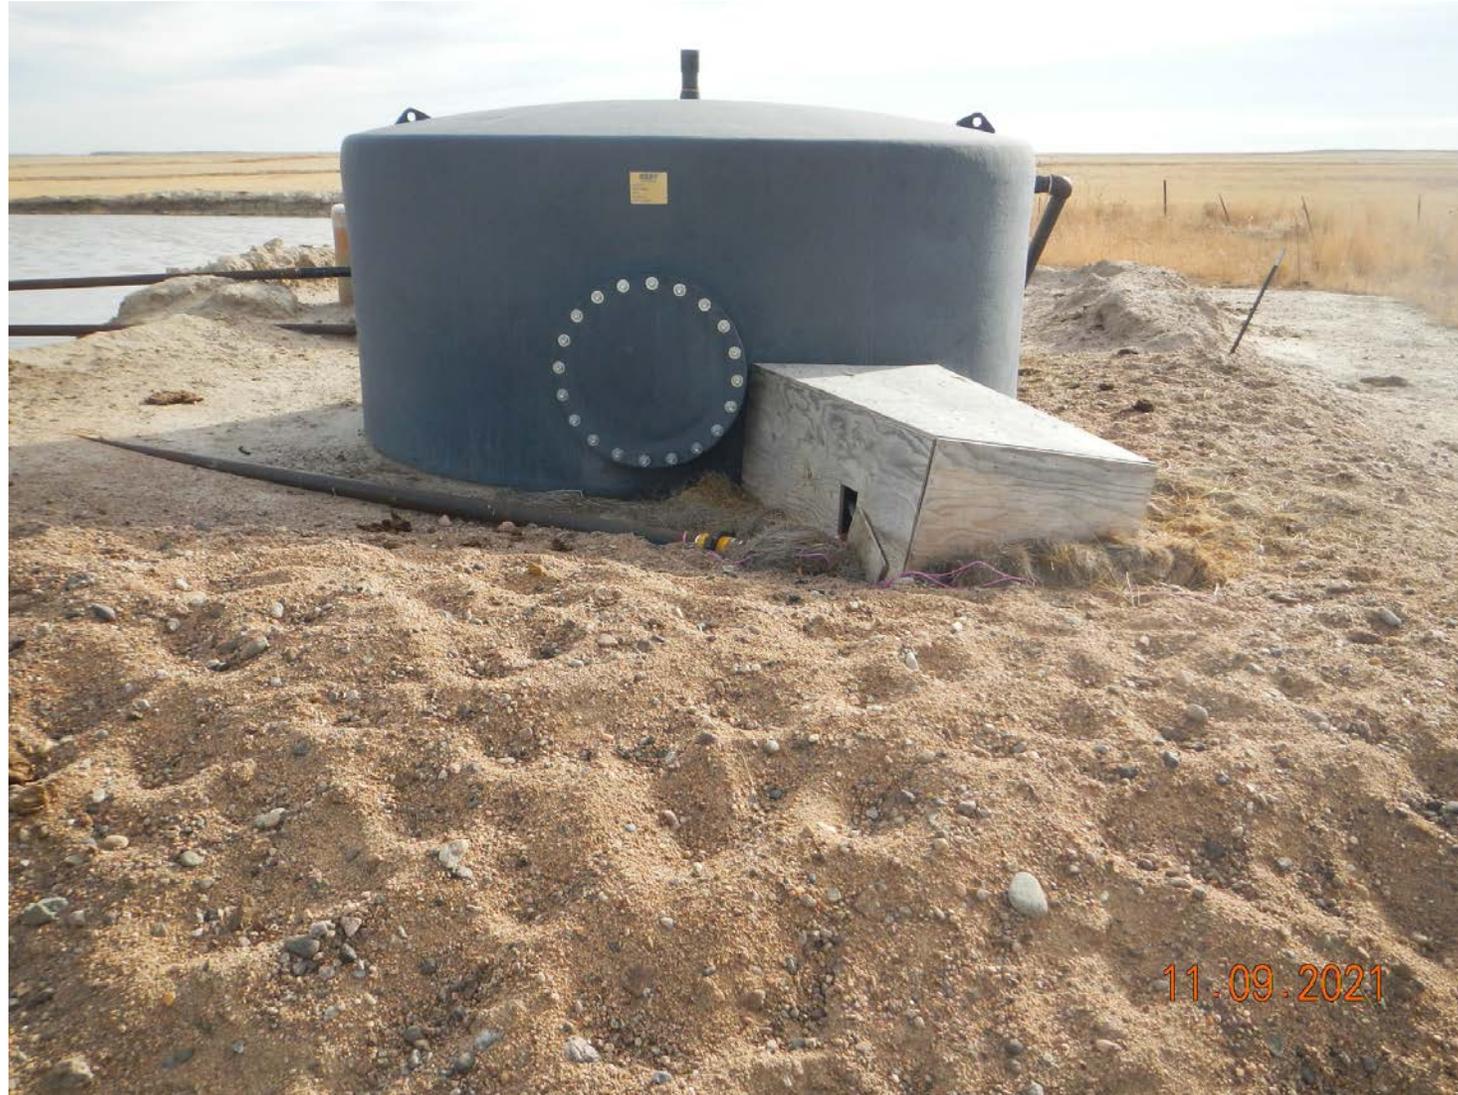
- Photo 6 – Secondary containment around oil skim tank needs improvement

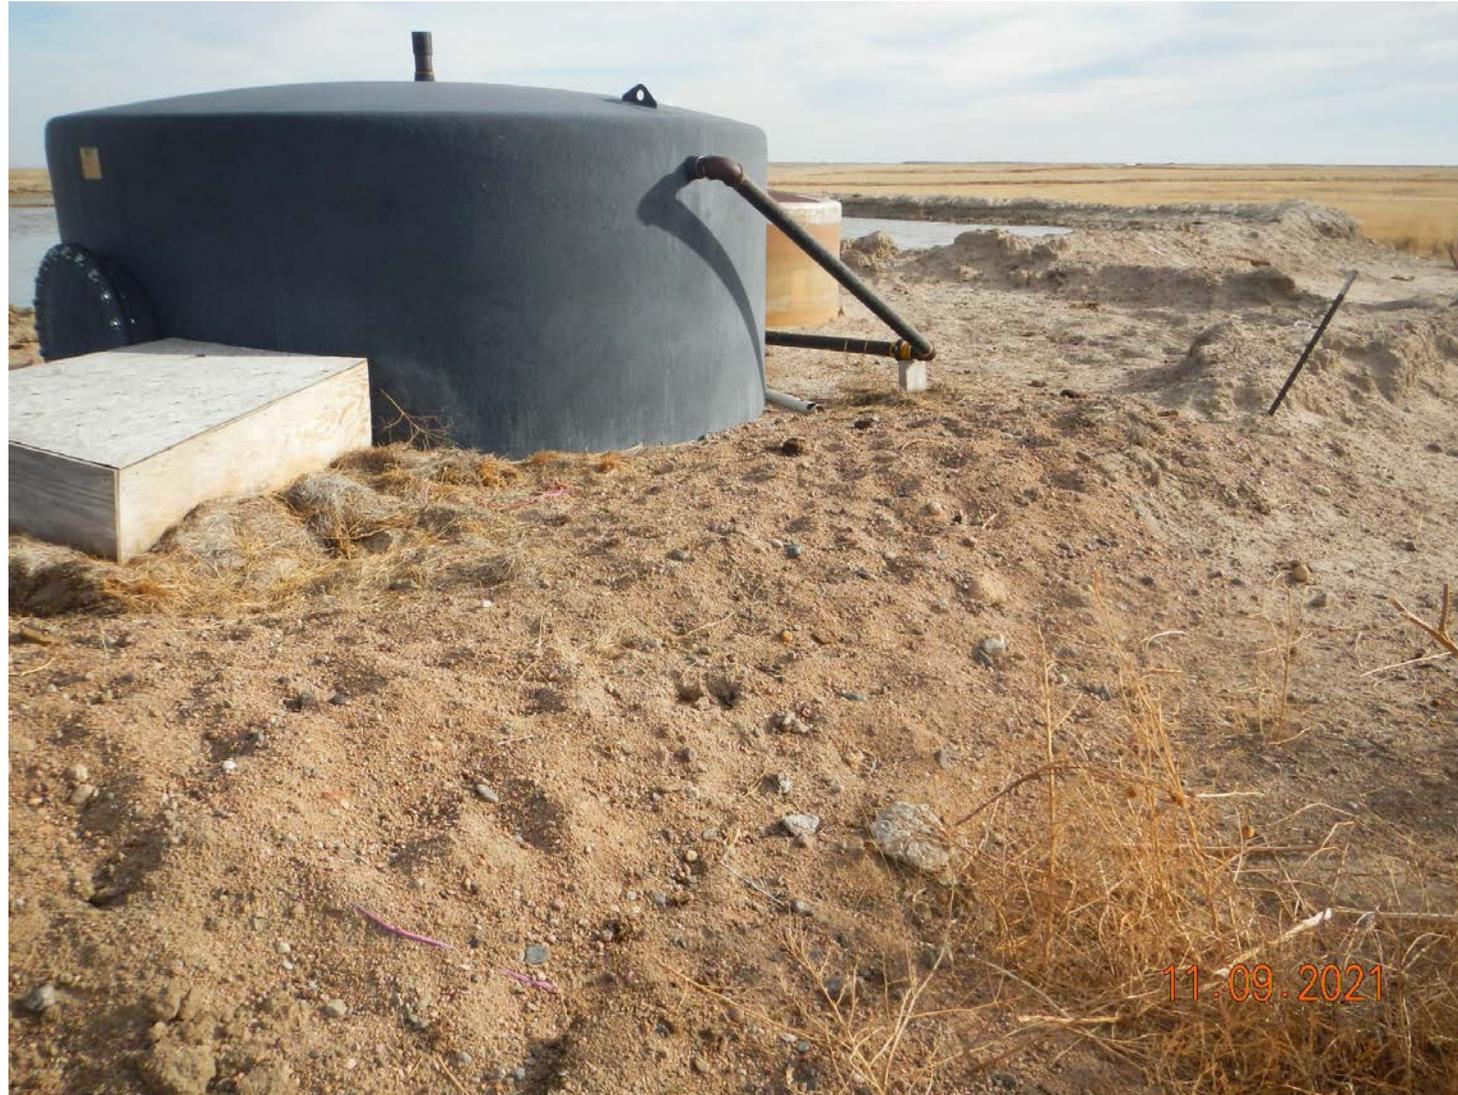
- Photo 7 – Secondary containment around oil skim tank needs improvement

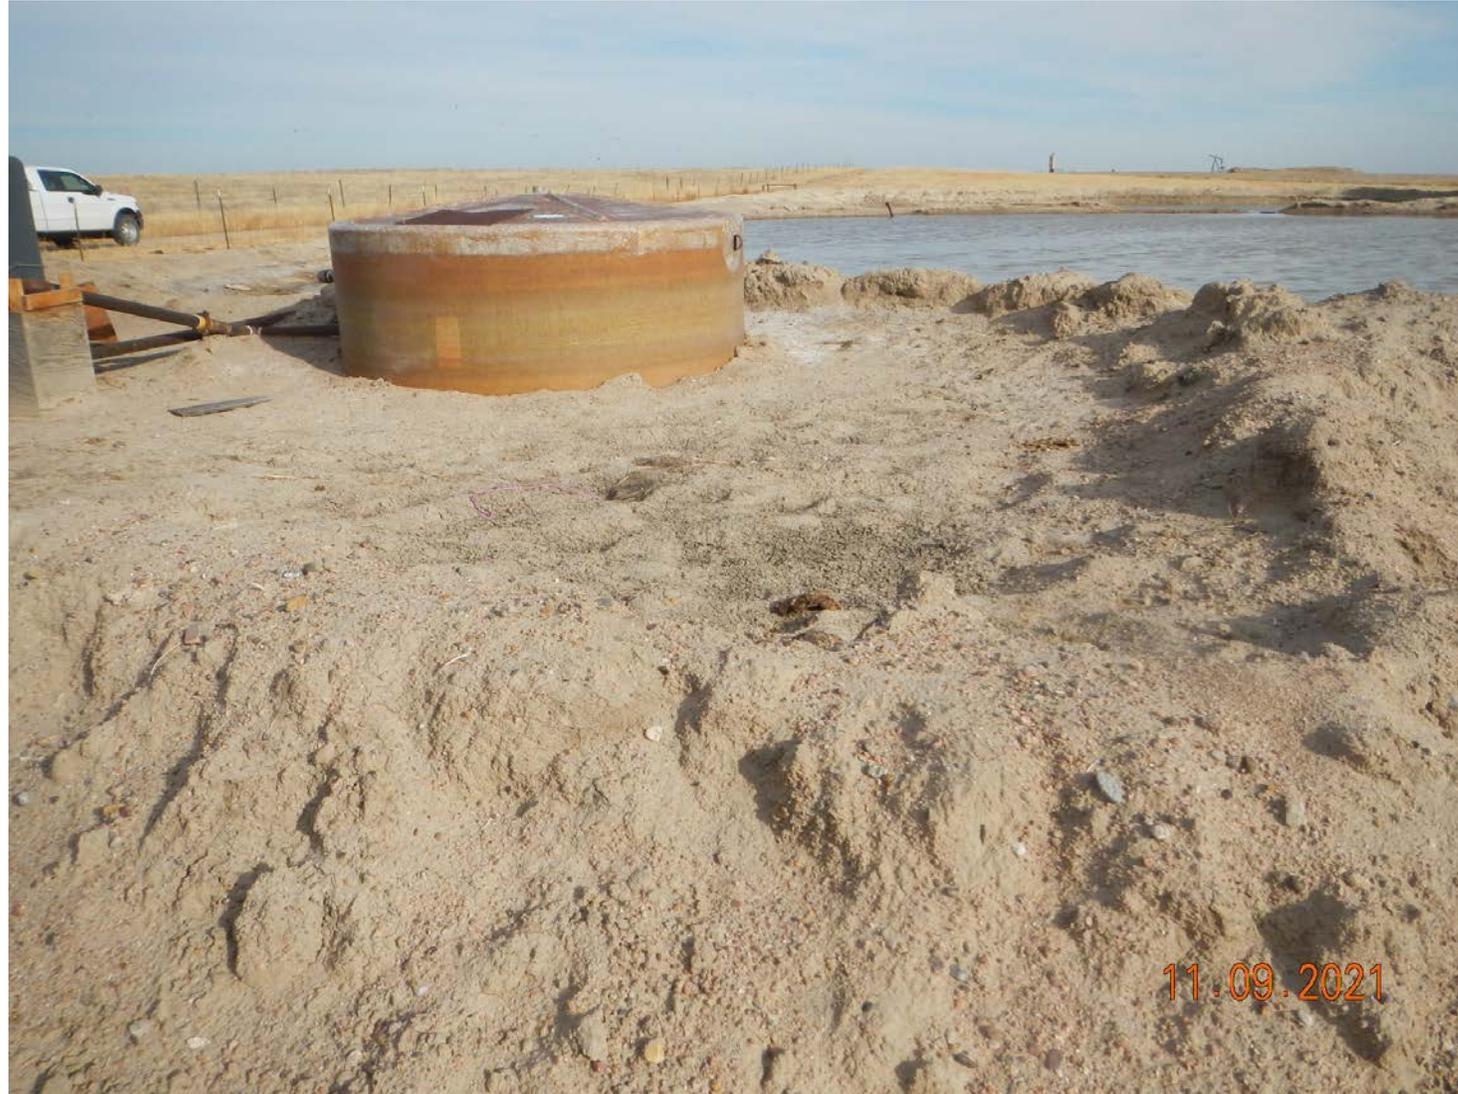
- Photo 8 – Secondary containment around oil skim tank needs improvement

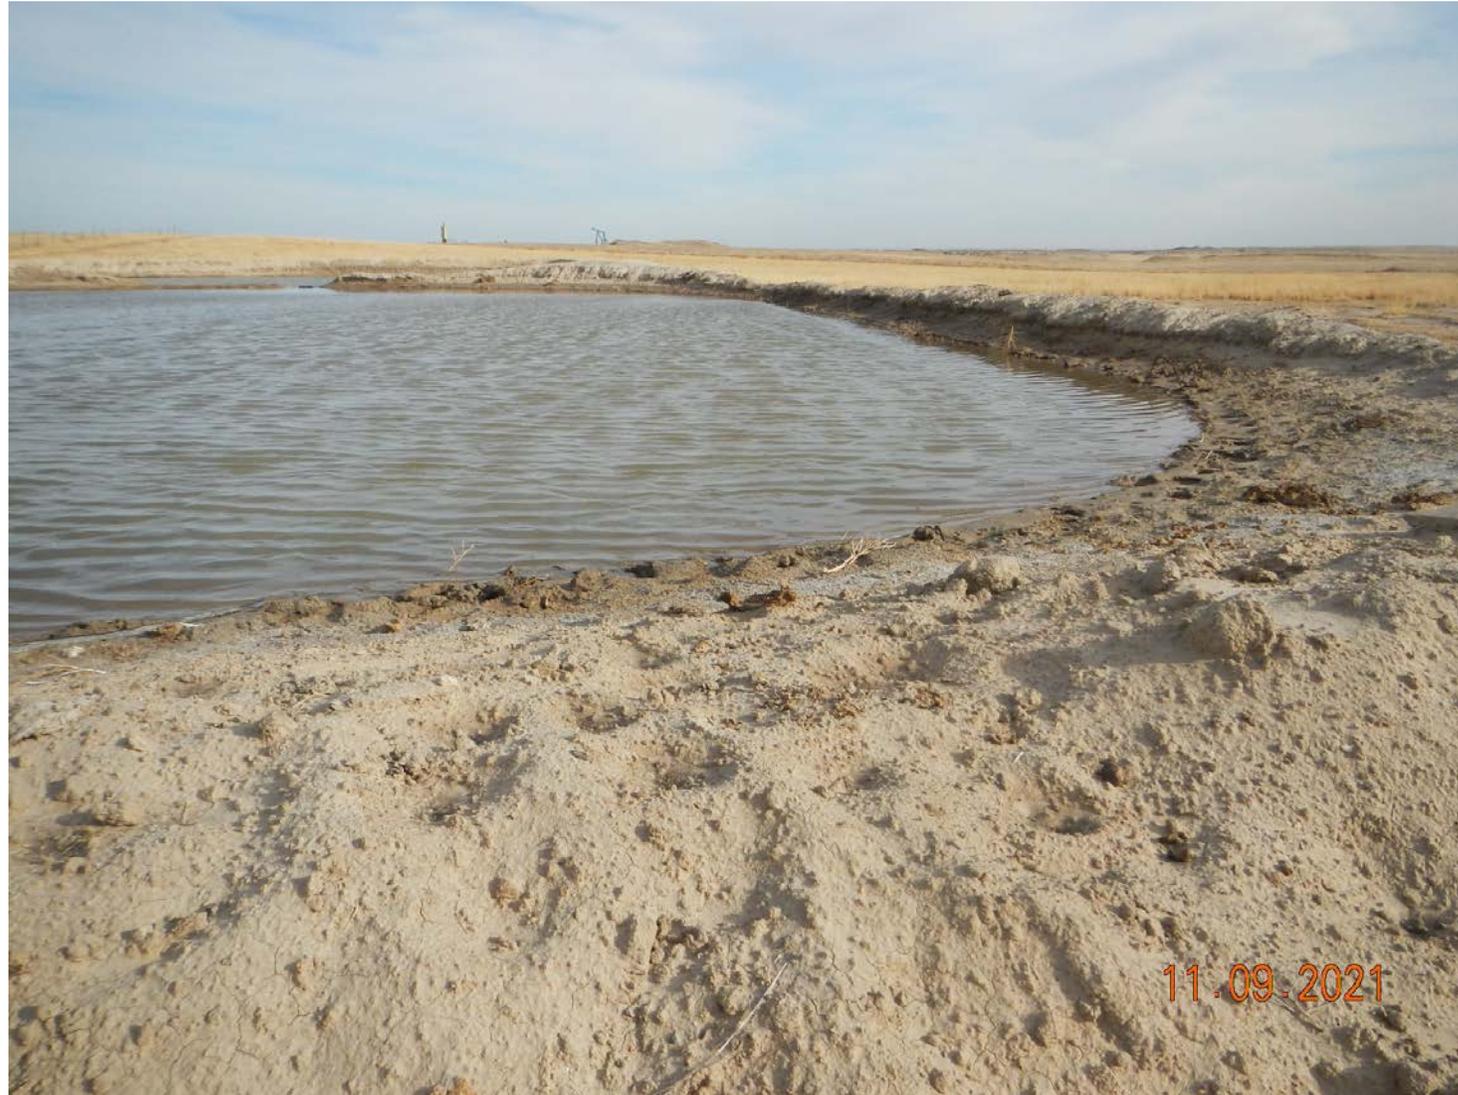
- Photo 9 – Produced water pit not maintaining 2 feet of freeboard, no method to monitor freeboard

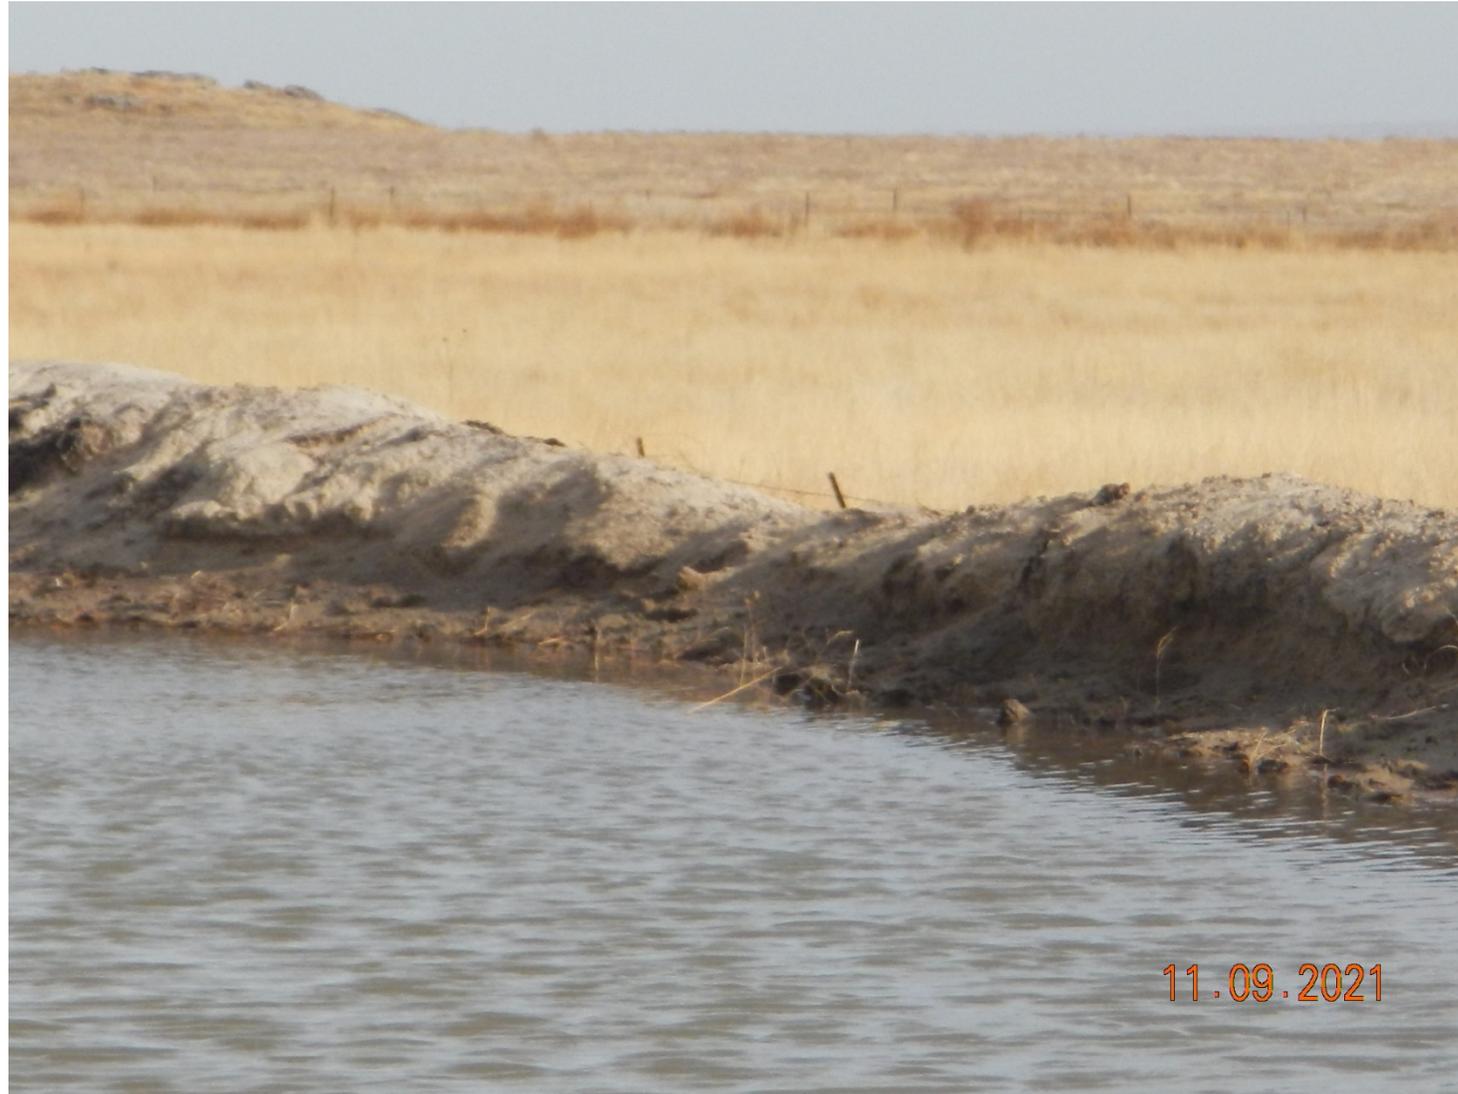
- Photo 10 – Produced water pit not maintaining 2 feet of freeboard, no method to monitor freeboard

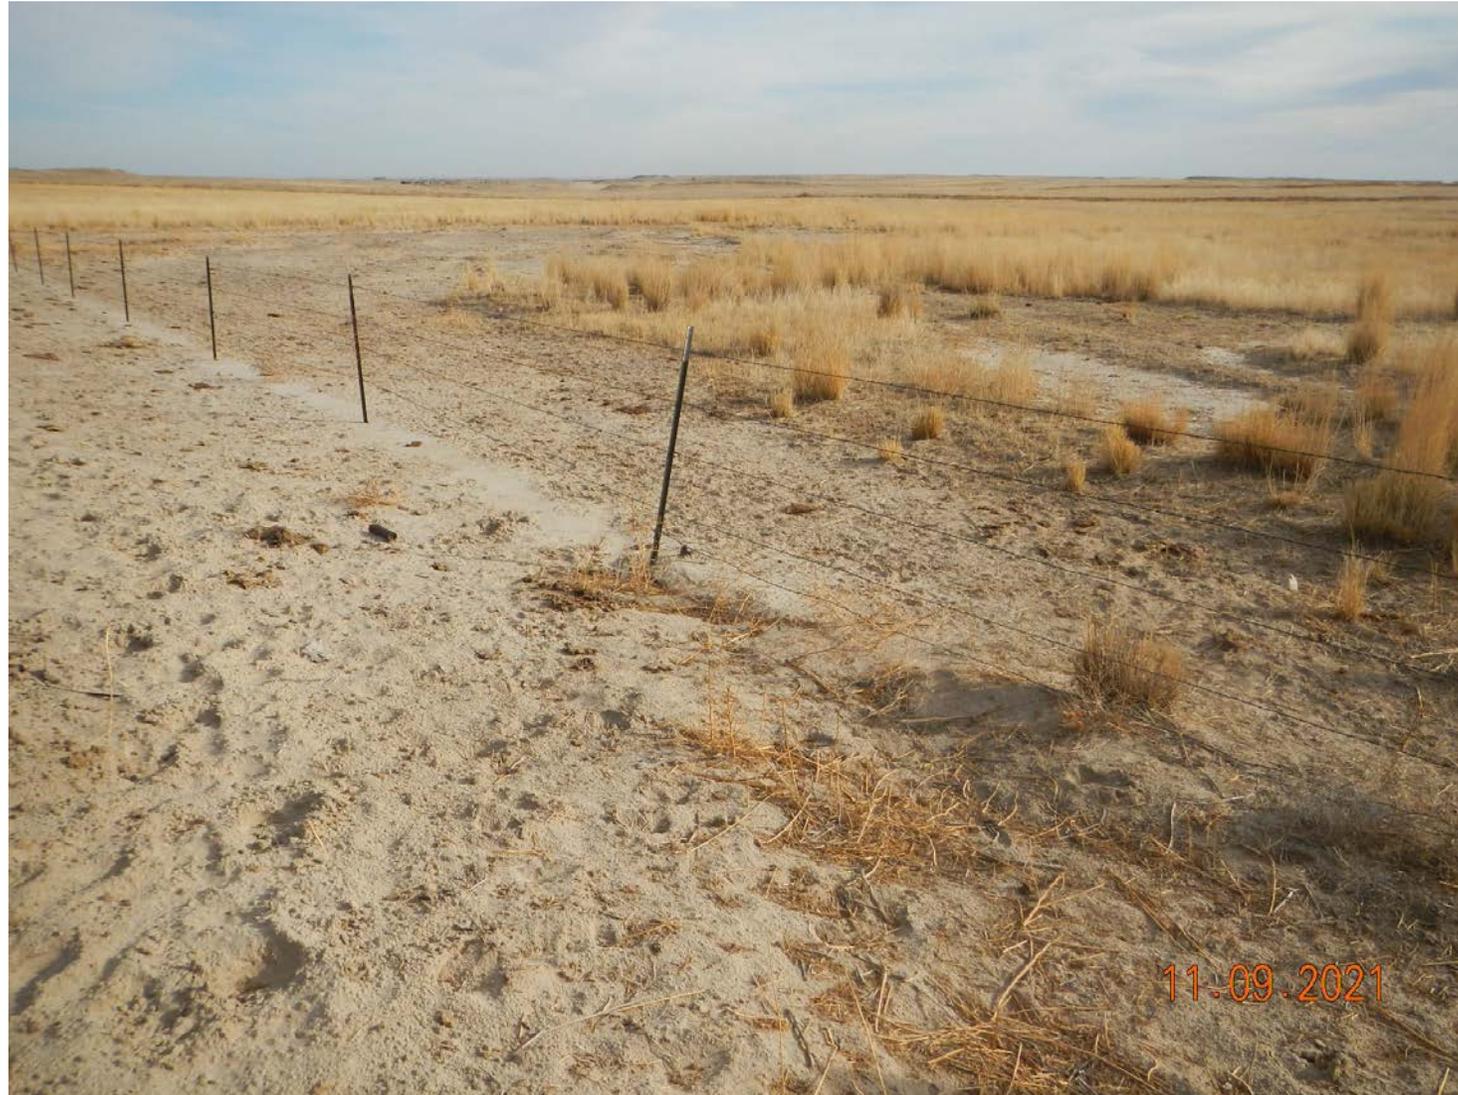
- Photo 11 – Reclamation south of produced water pit is not adequate

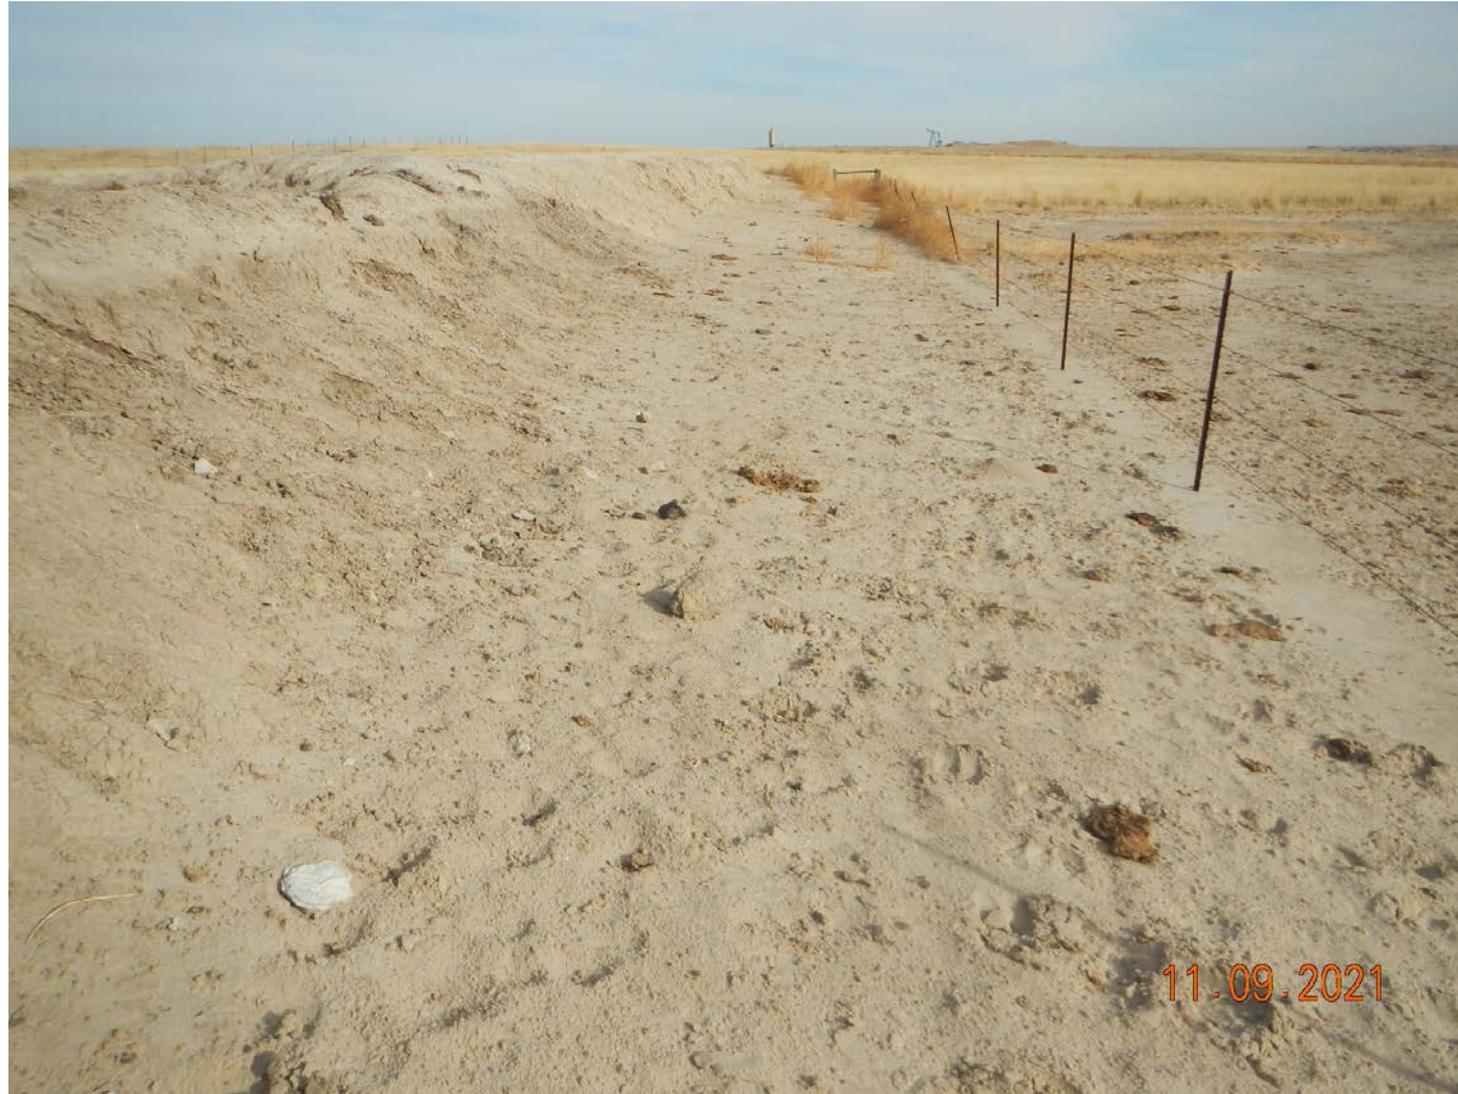
- Photo 12 – BMPs are required south of the produced water pits to prevent offsite sediment migration

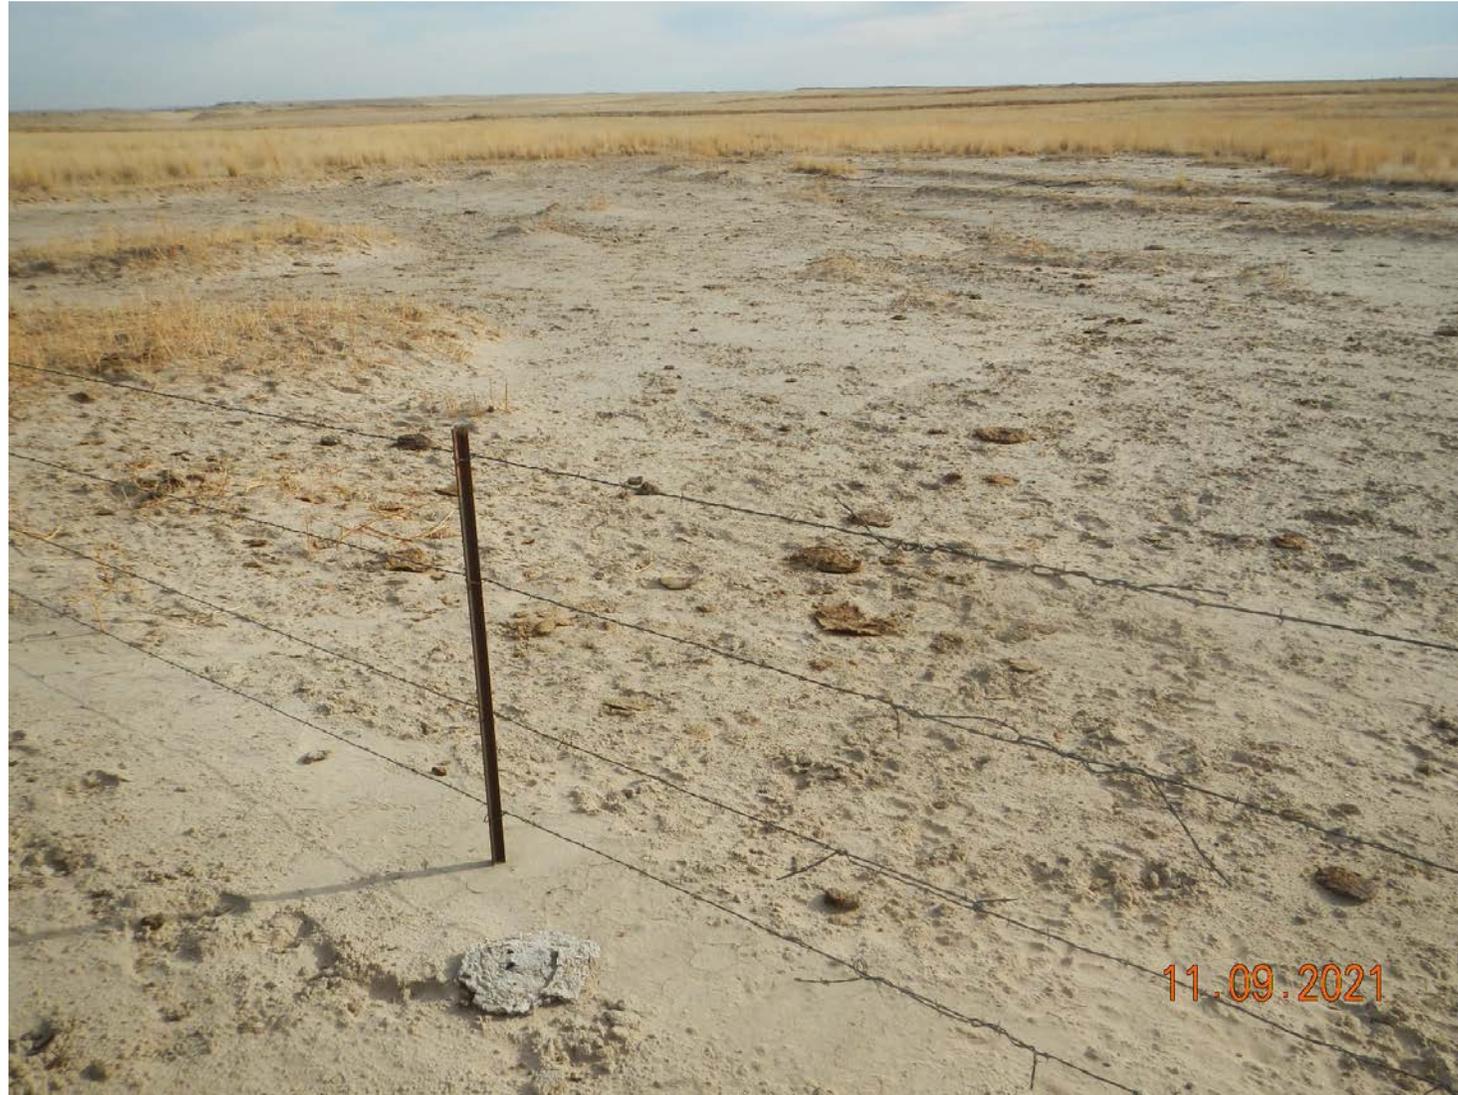
- Photo 13 – Reclamation south of produced water pit is not adequate

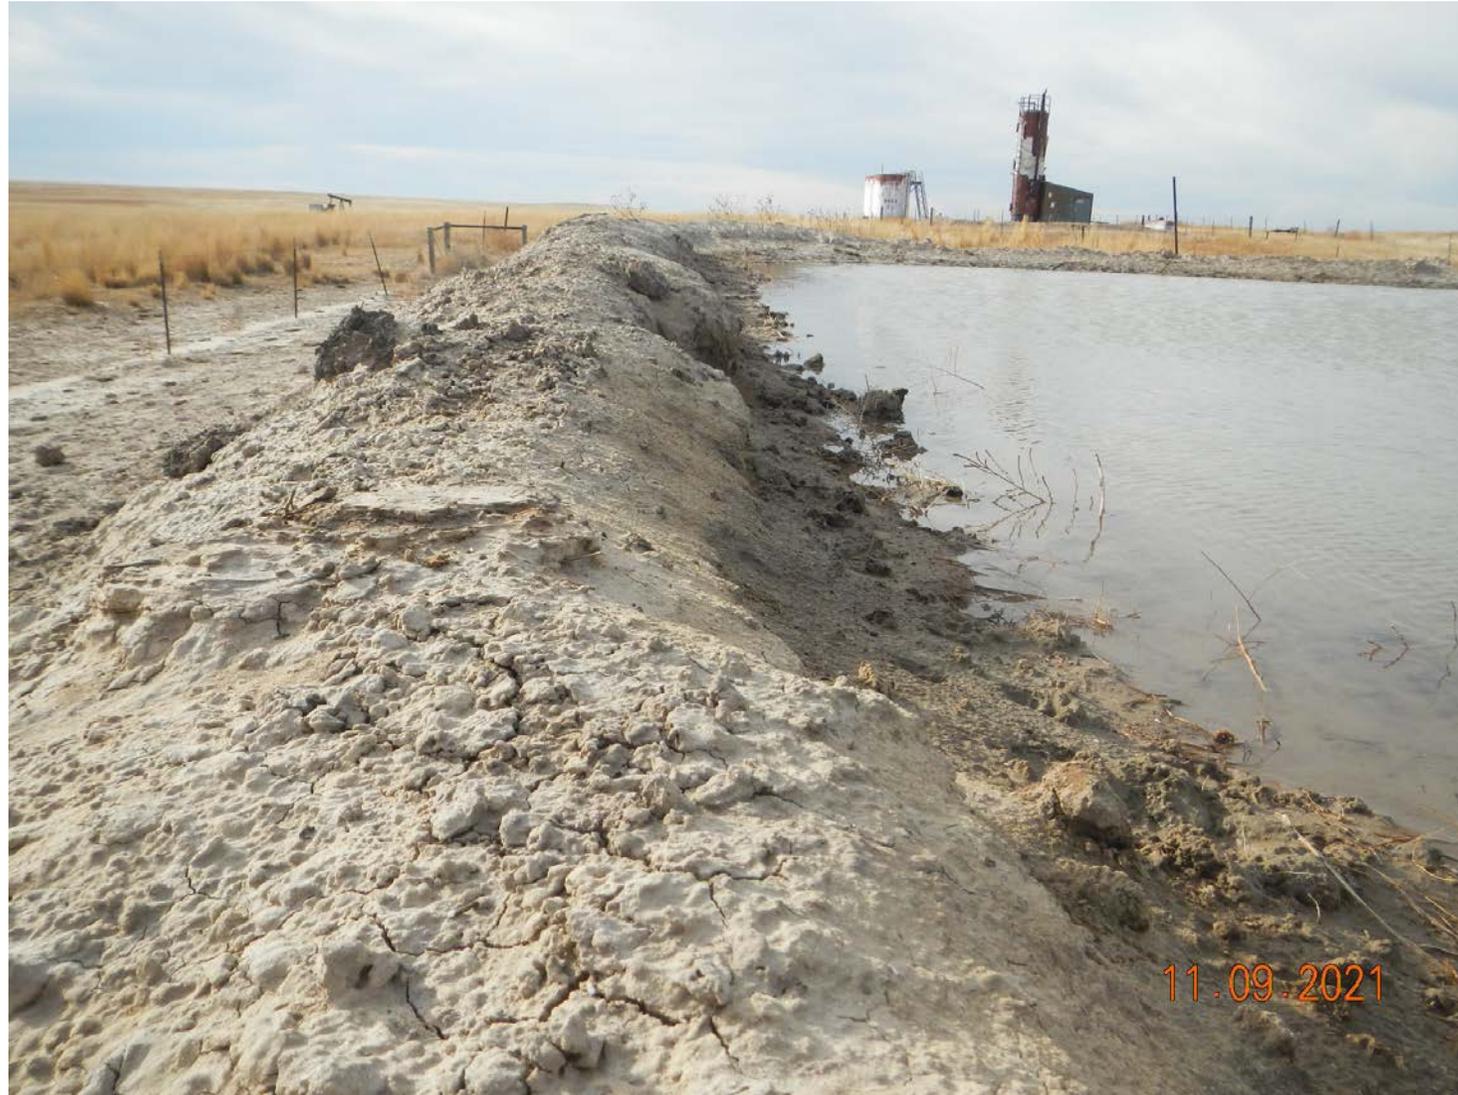
- Photo 14 – Produced water pit not maintaining 2 feet of freeboard

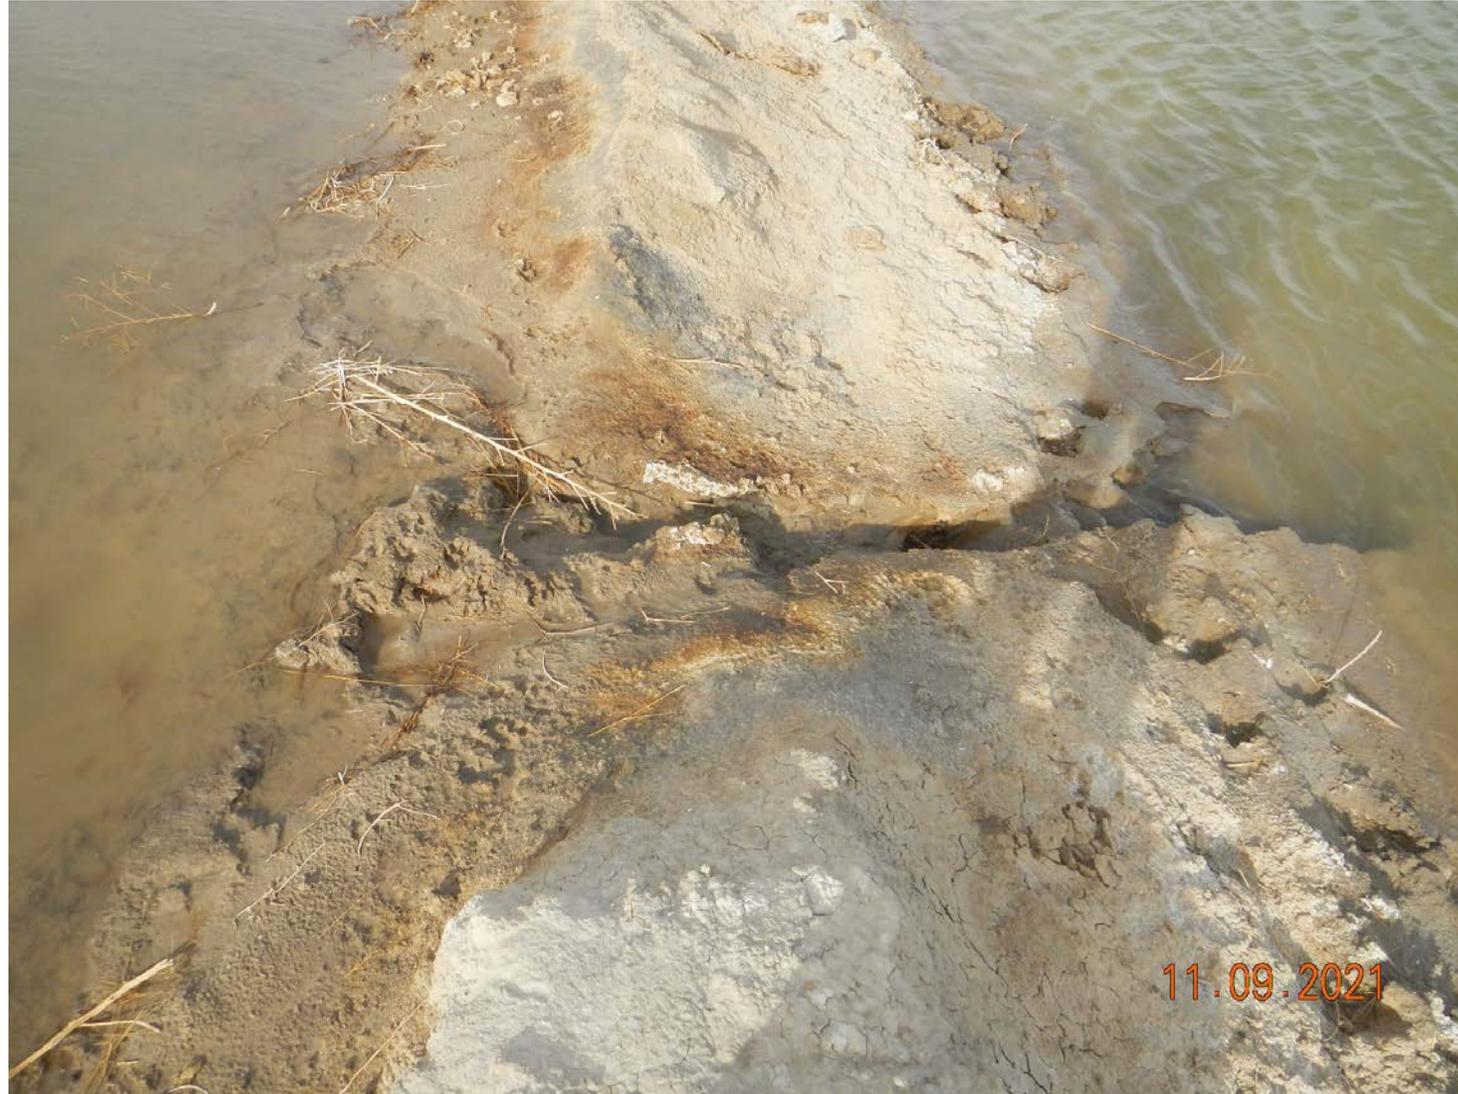
- Photo 15 – Channel cutting to lower (eastern) PW pit. Fluid level control is not adequate

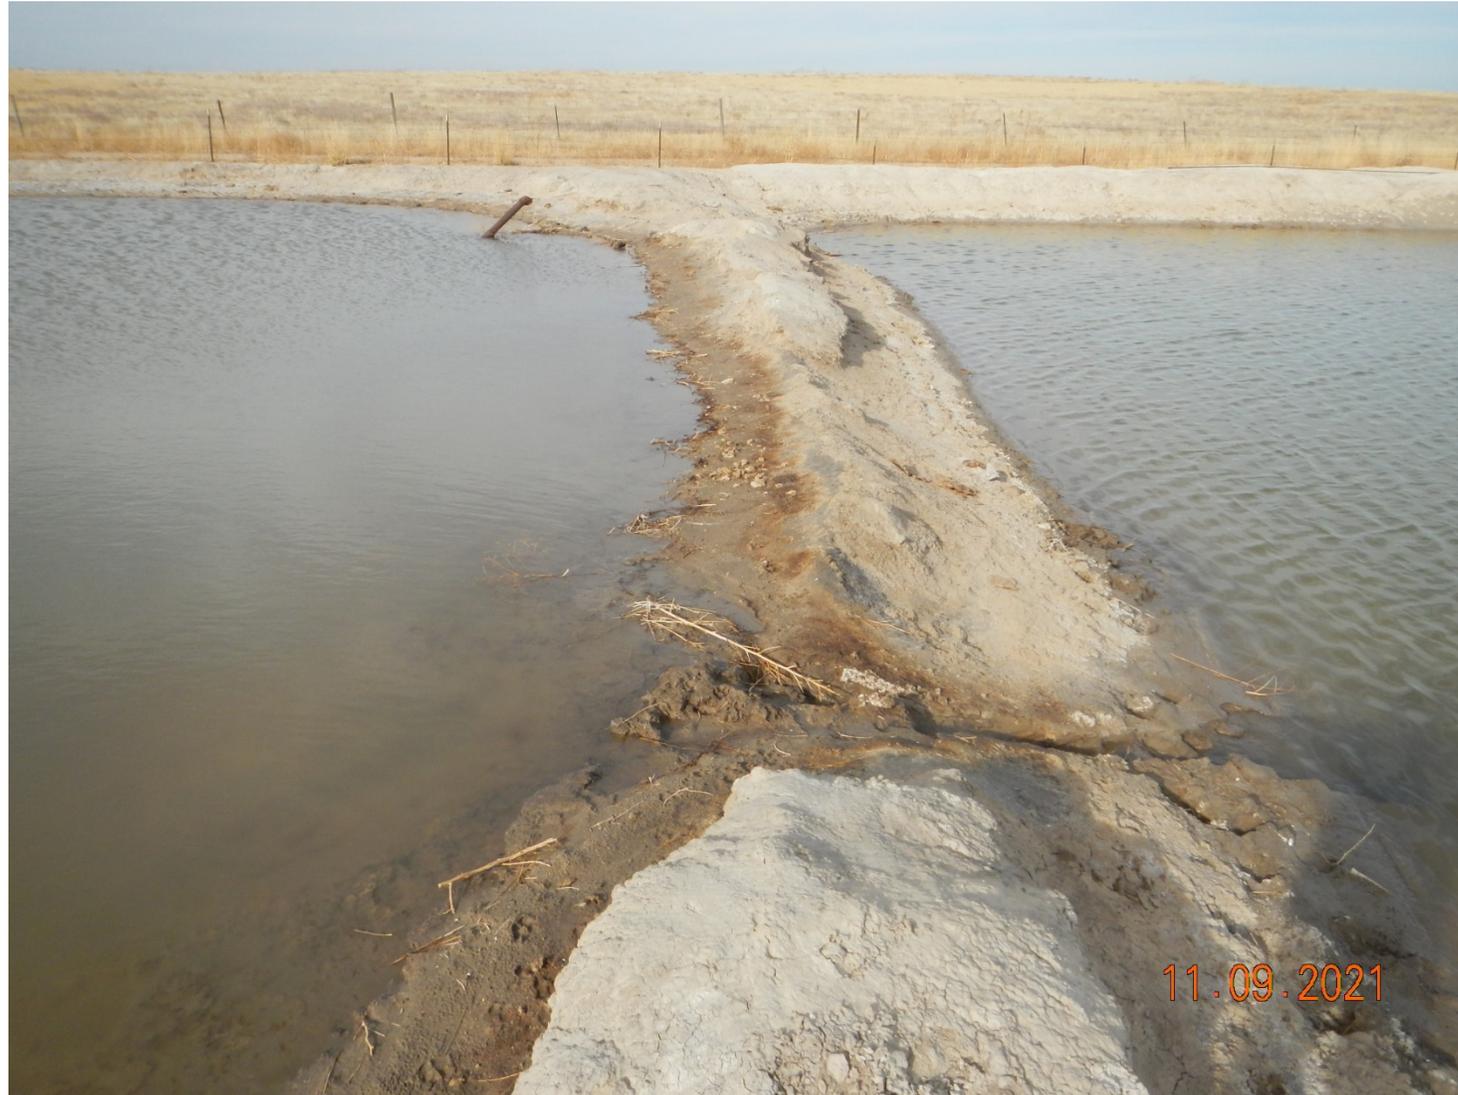
- Photo 16 – Equalization siphon pipe is not performing adequately
