Stormwater Inspection Report

Operator:	Laramie Energy, LLC
Project:	Cascade Creek
Location:	Cascade Creek 697-09-61 Pad
Date:	Thursday, November 11, 2021
Weather:	Mostly Sunny, Breezy, 51°, Lo 22°

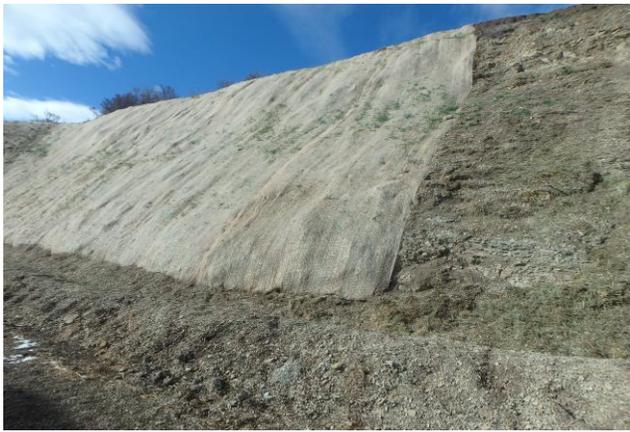
Photo 1

Damaged Erosion Control Blanket after Repairing on the Cascade Creek 697-09-61 Pad

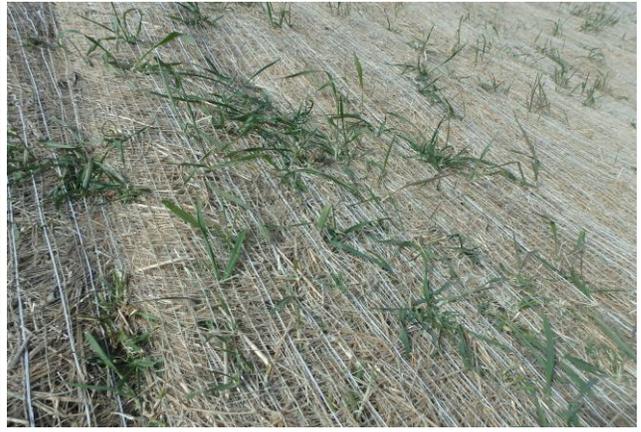
Photo 2

Temporary Seed Germinating through Erosion Control Blankets on the CC 697-09-61 Pad

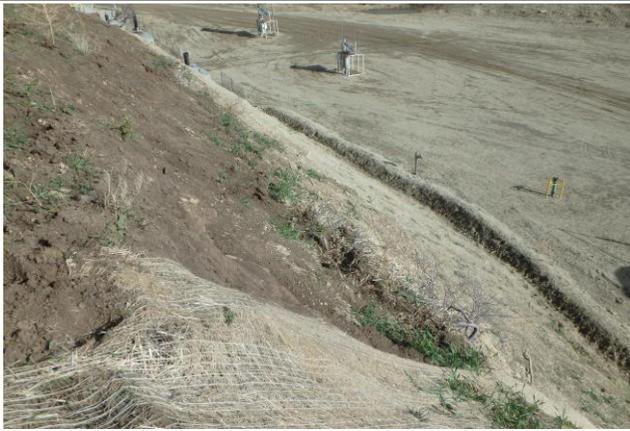
Photo 3

Steep Section of Cut Slope not Treated with Erosion Control Blankets on CC 697-09-61 Pad

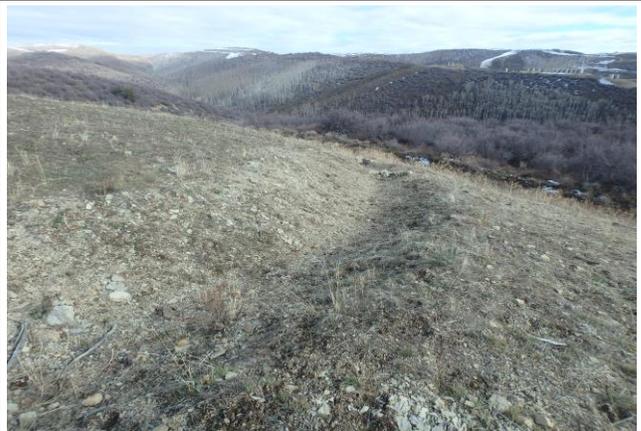
Photo 4

Outlet Channel on the CC 697-09-61 Pad Fill Slope
