Taproot. ER for produced water at the Boomslang Pad near Briggsdale, CO.
EWI Project #212500. A1.

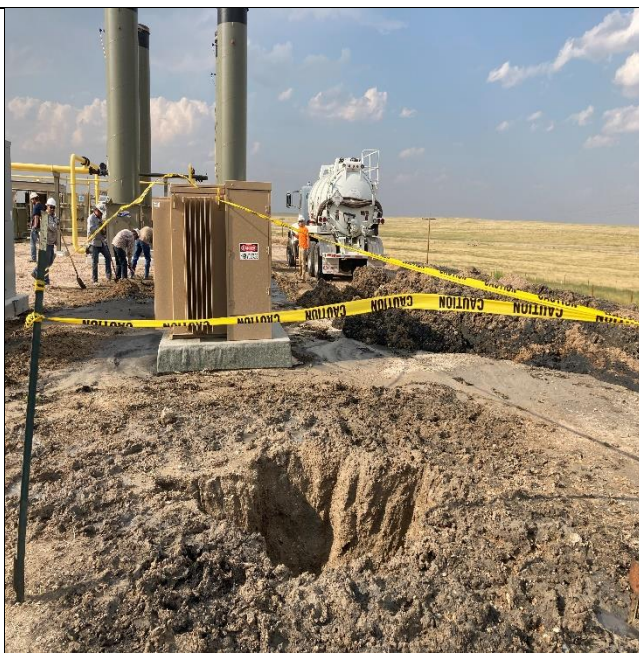
Photo: 2

Initial site conditions at the Boomslang Pad.

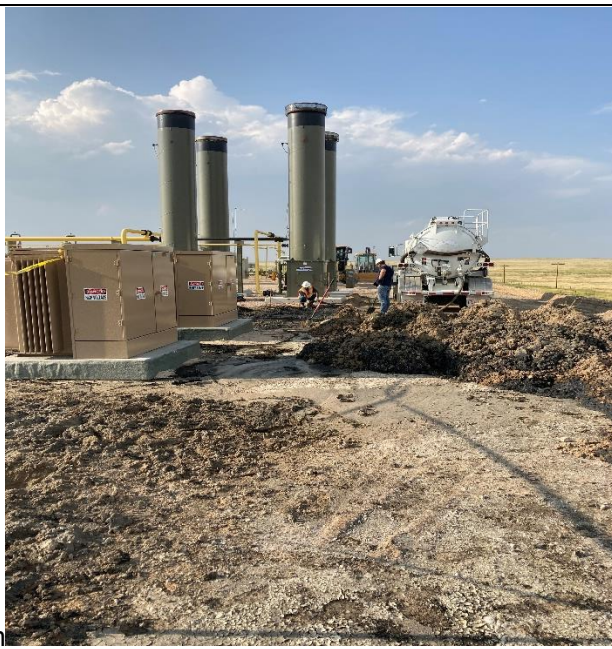
Photo: 3

Initial site conditions at the Boomslang Pad.

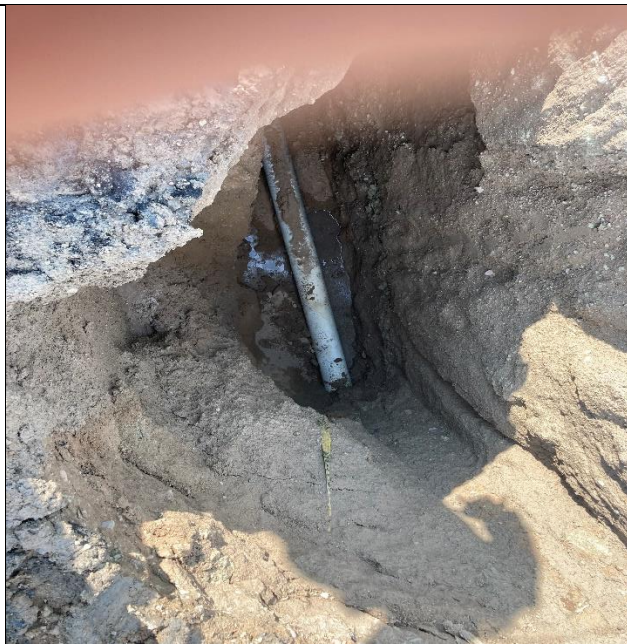
Photo: 4

A view where the line break occurred.

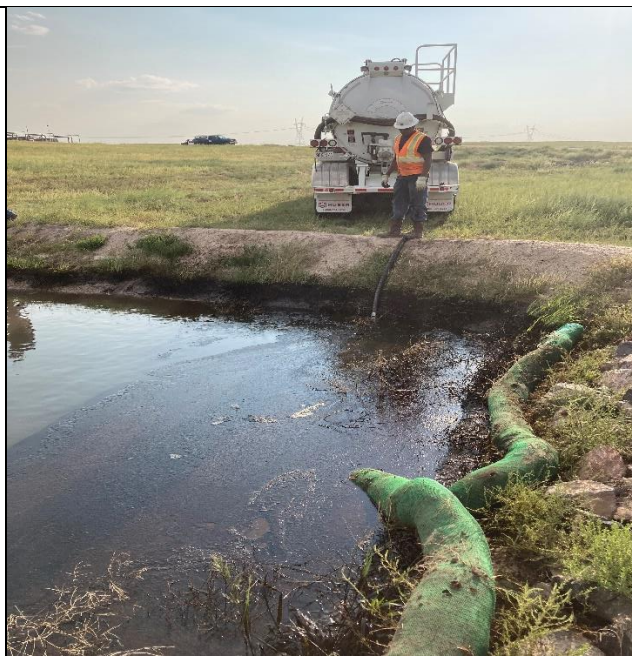
Photo: 6

EWI vacuum truck removing liquids from the pond.

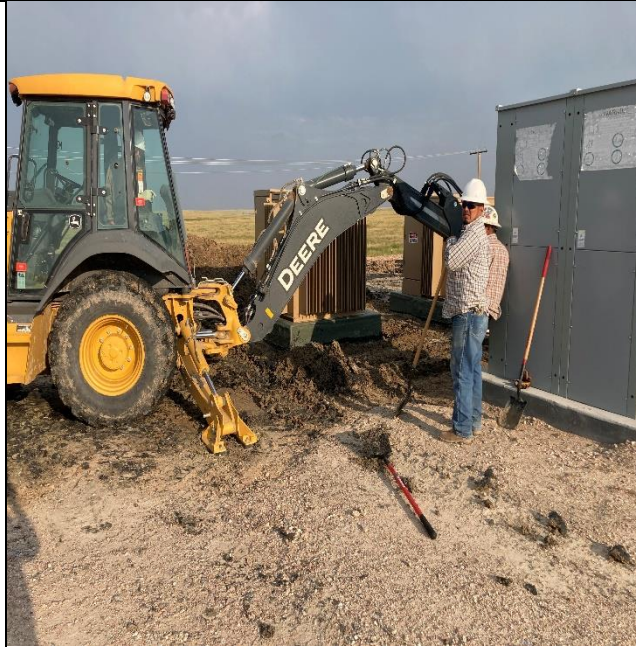
Photo: 7

Surface scrape of shallow impacted soil at the Boomslang Pad.

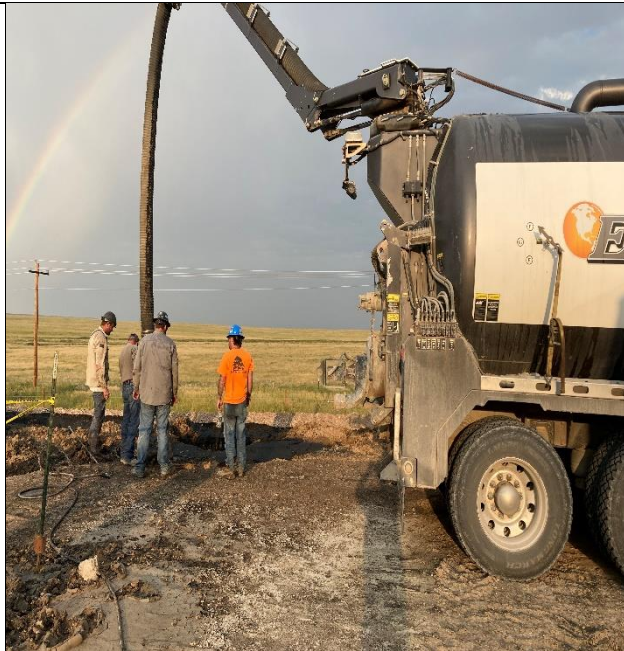
Photo: 8

The hydro-vac excavating and finding the line break.

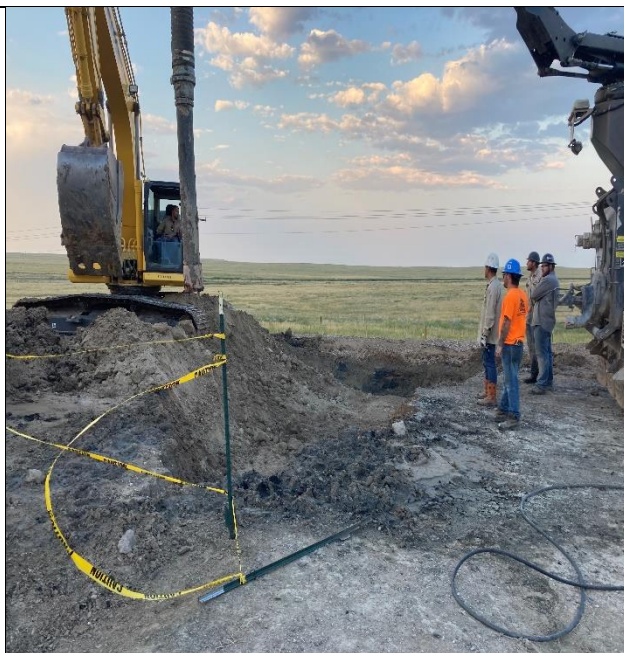
Photo: 9

Excavator onsite to excavate impacted soil.

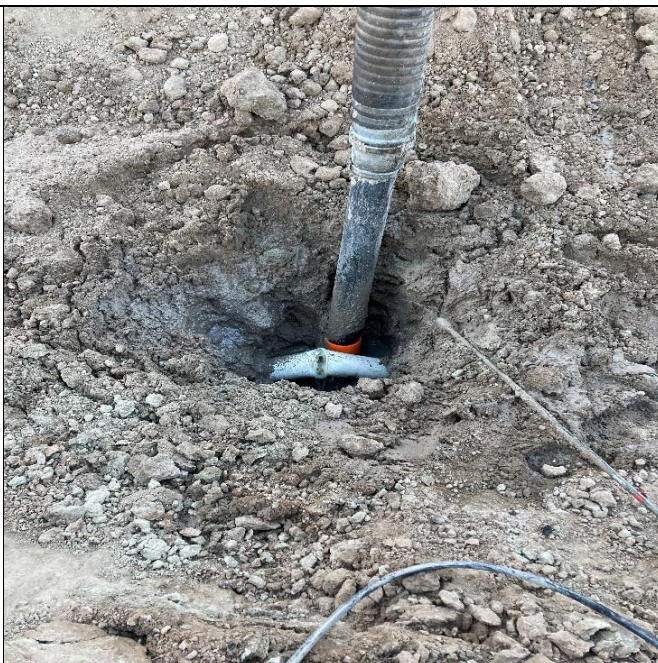
Photo: 10

Line break discovered.

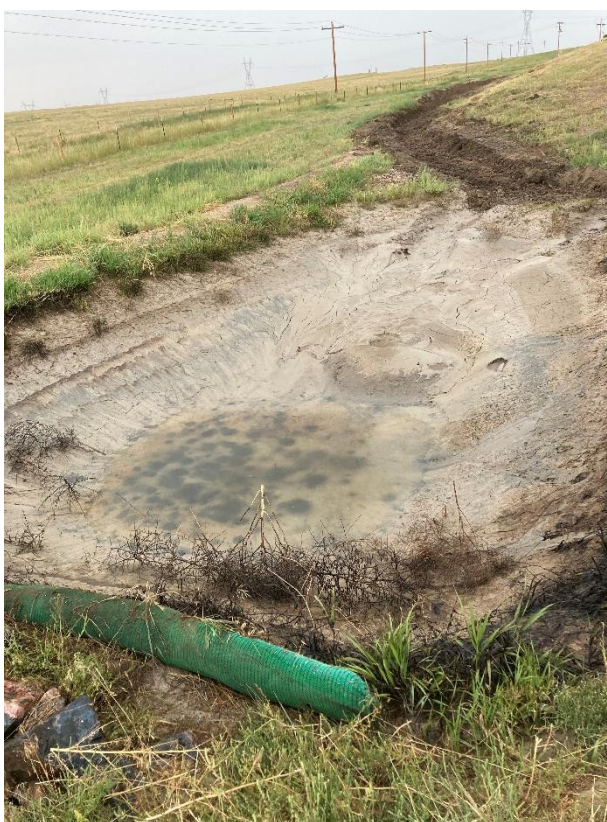
Photo: 11

Retention pond looking south prior to excavation. Also shown is the shallow excavation of soil within the narrow drainage leading to the retention pond.

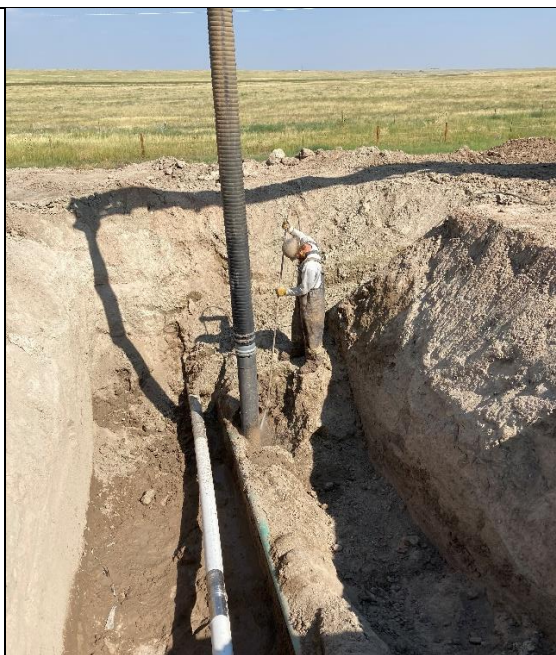
Photo: 12

Final extents of main excavation, looking east.

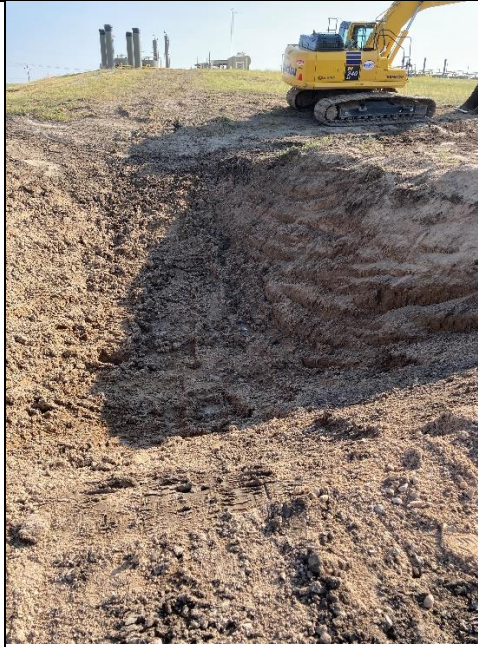
Photo: 13

Final extents of retention pond excavation. 2-4' beneath initial retention pond extents.
