Inspection Photos
Location Name: Dorris Ackerson Unit #2
Location ID: 318223

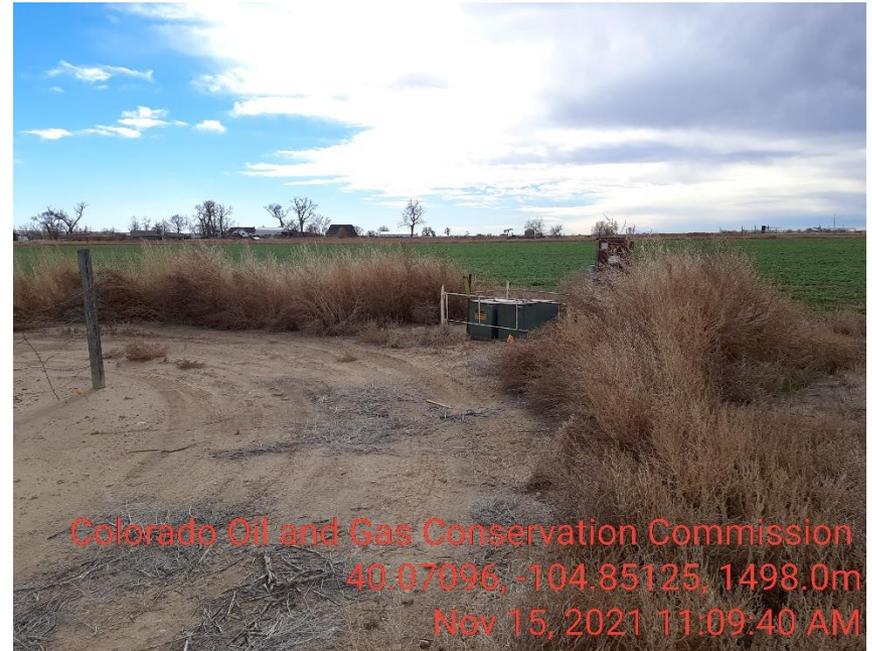
Photo 2 Dead weeds around electric panel and location.

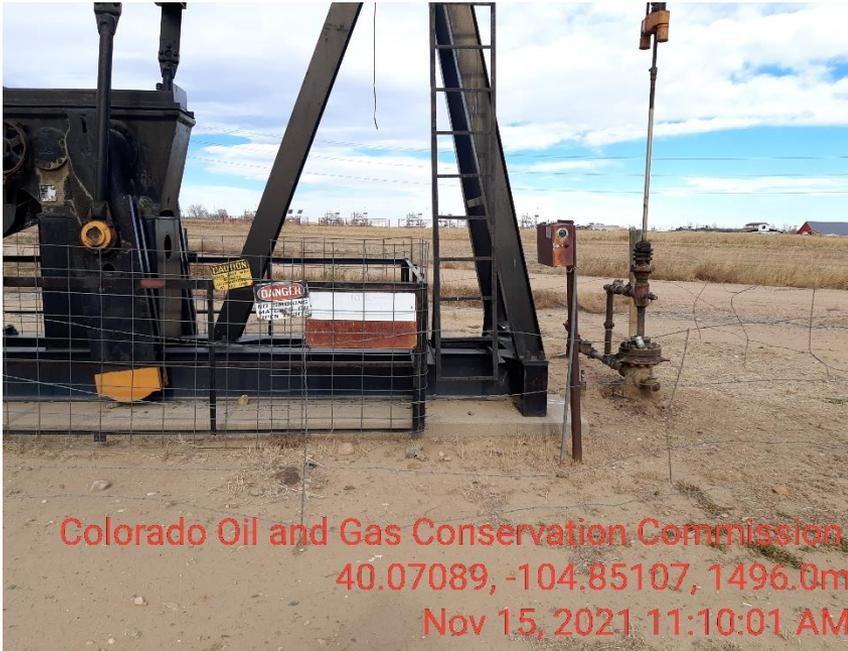
Photo 3 well head sign not readable

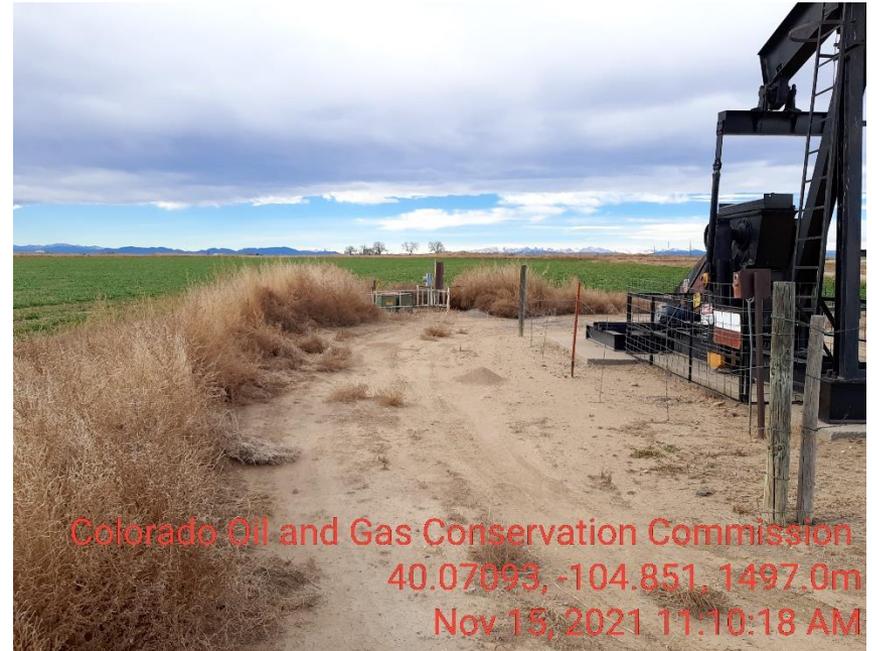
Photo 4 Dead weed around location.
