Stormwater Inspection

Operator: K P KAUFFMAN COMPANY INC - 46290

Location ID: 480127

Inspection Photos
Location Name: RMF Consolidation Line
Location ID: 480127

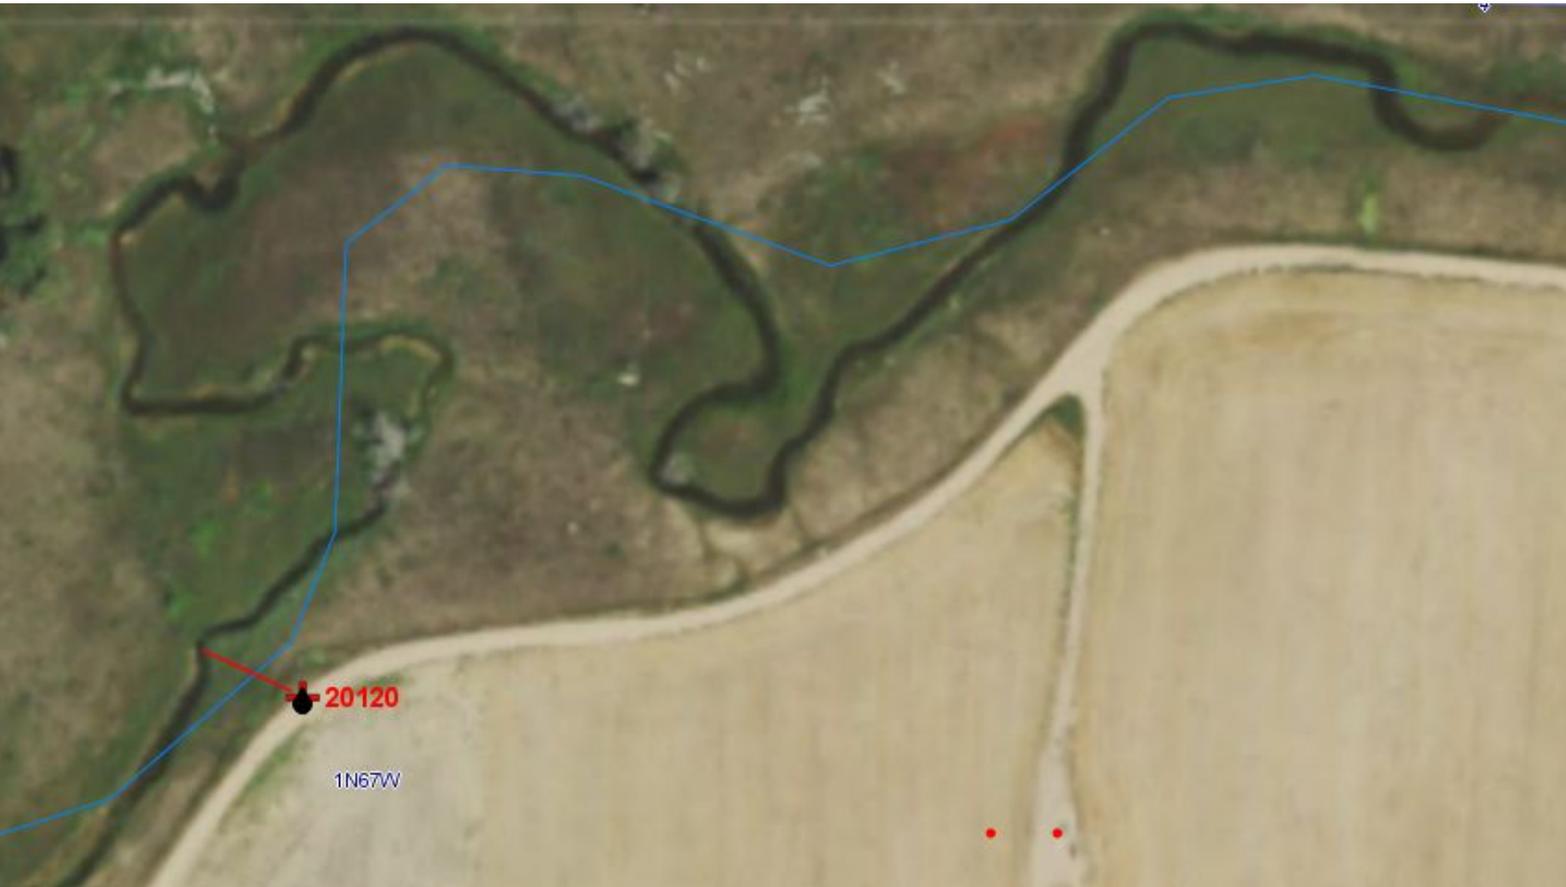
Photo 1. COGCC GISOnline 2019 aerial imagery illustrates the open remediation is approximately 70' from Little Dry Creek. Little Dry Creek is downgradient from the remediation.

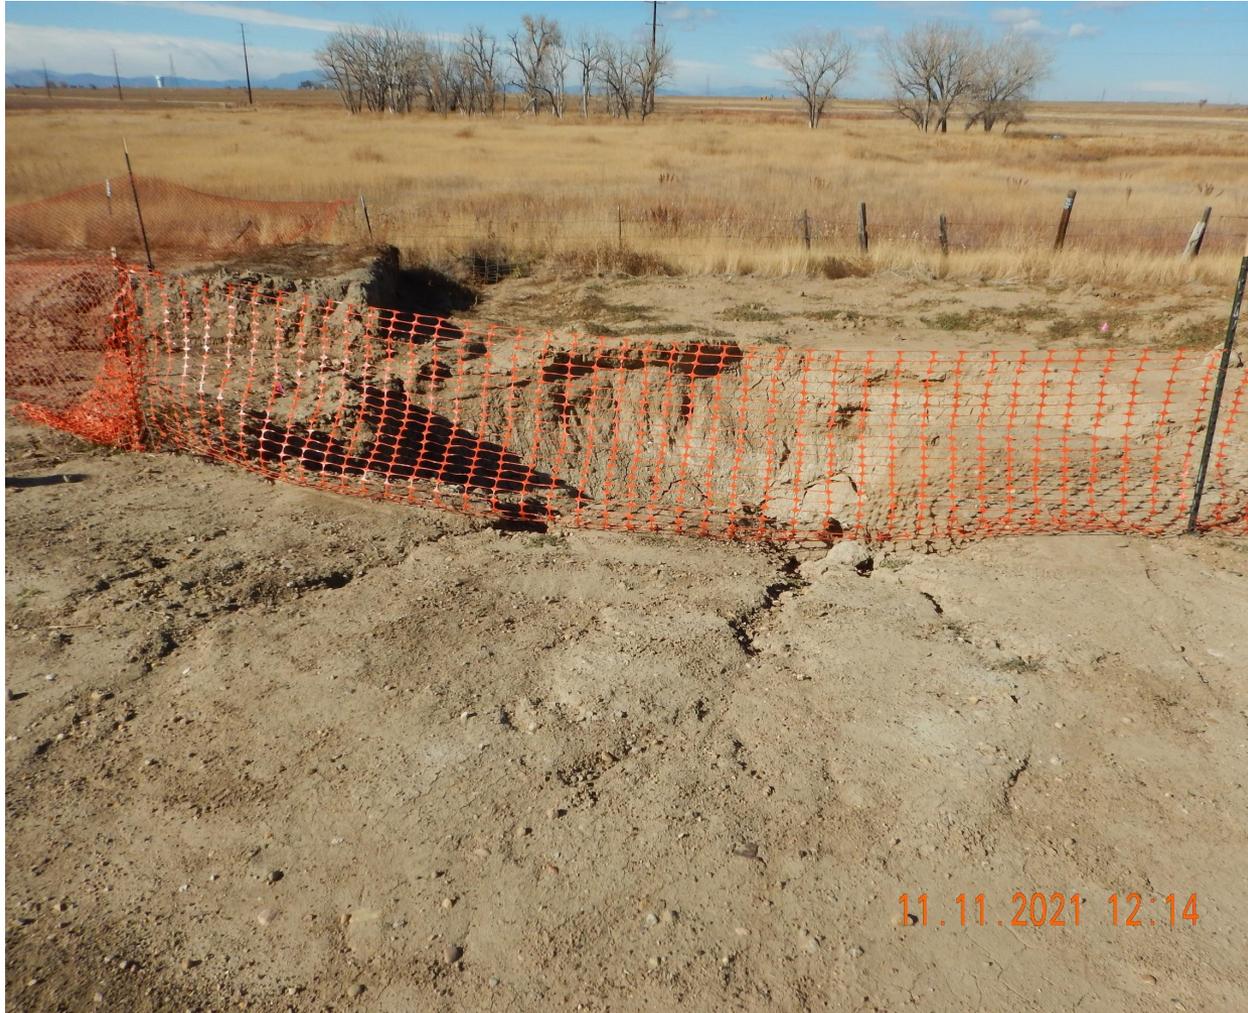
Photo 2. Photo taken from the remediation project, facing Northwest. Photo illustrates unmanaged run-on erosion into an open excavation with no outlet projection.

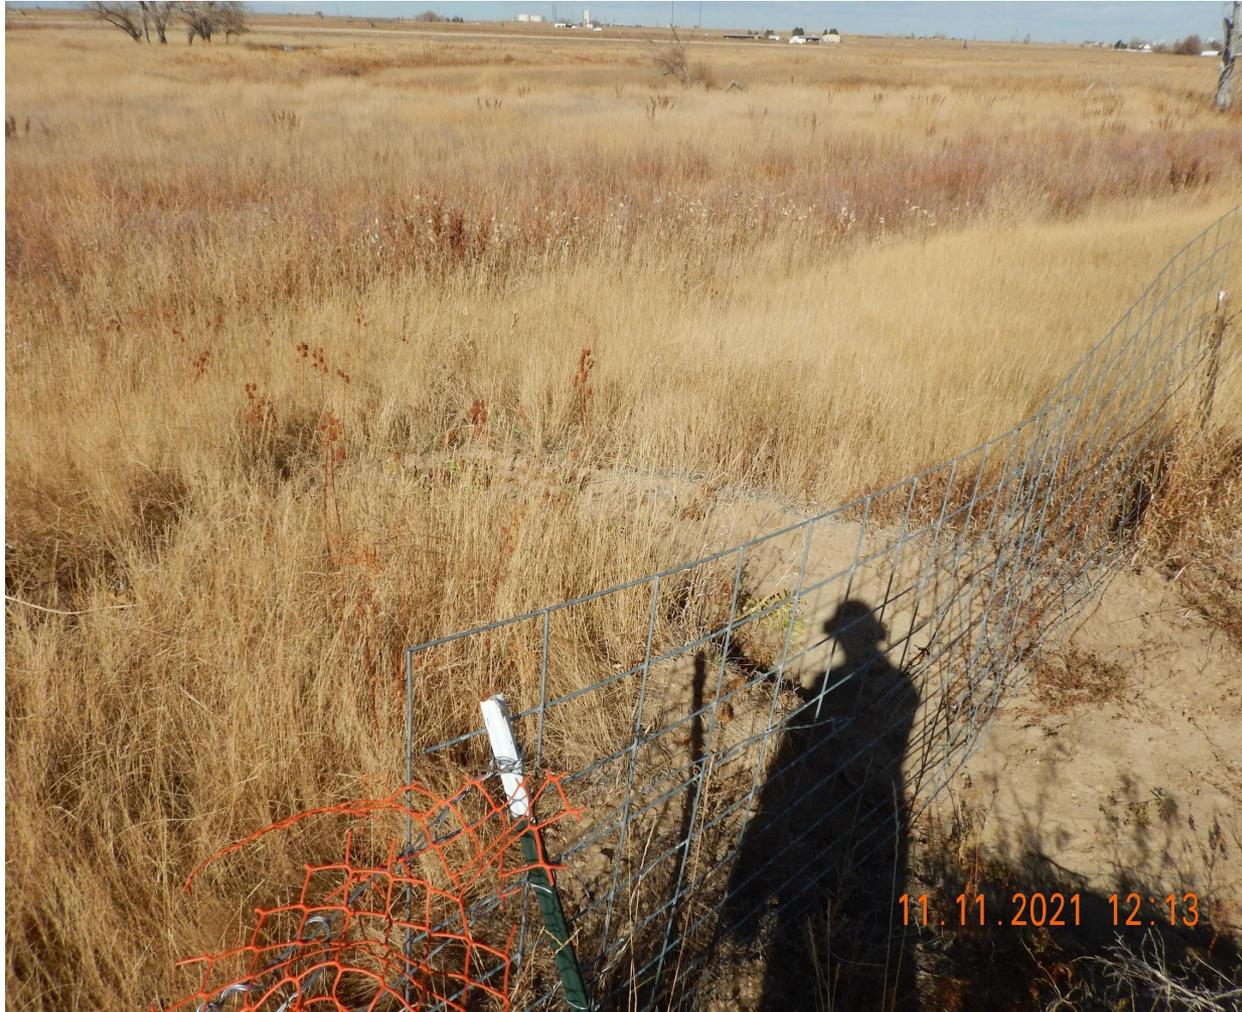
Photo 3. Photo taken from the outlet/discharge point, facing North. Photo illustrates Operator has failed to install any type of stormwater BMP.

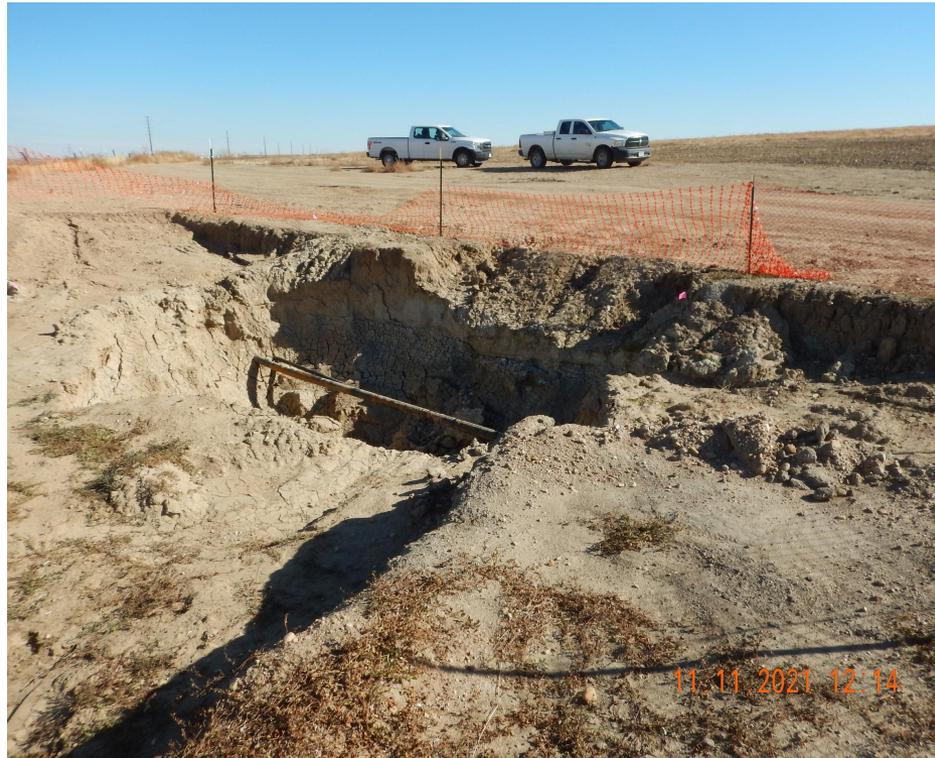
Photo 4. Photo taken from the remediation project, facing Southeast. See comments under Photo 2. Photo also illustrates an inadequate fence to prevent access when site is not attended.

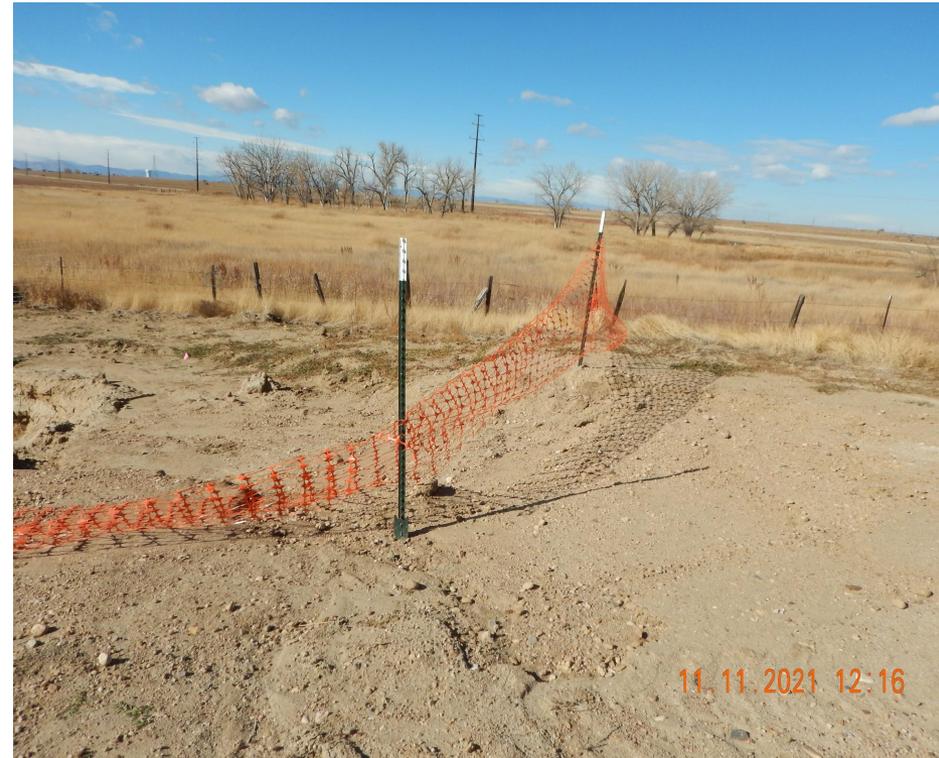
Photo 5. Photo taken from the remediation project, facing North. See comments under Photo 4.
