Inspection Photos
Operator: Simcoe
API: 067-07853
Date: 11/11/2021

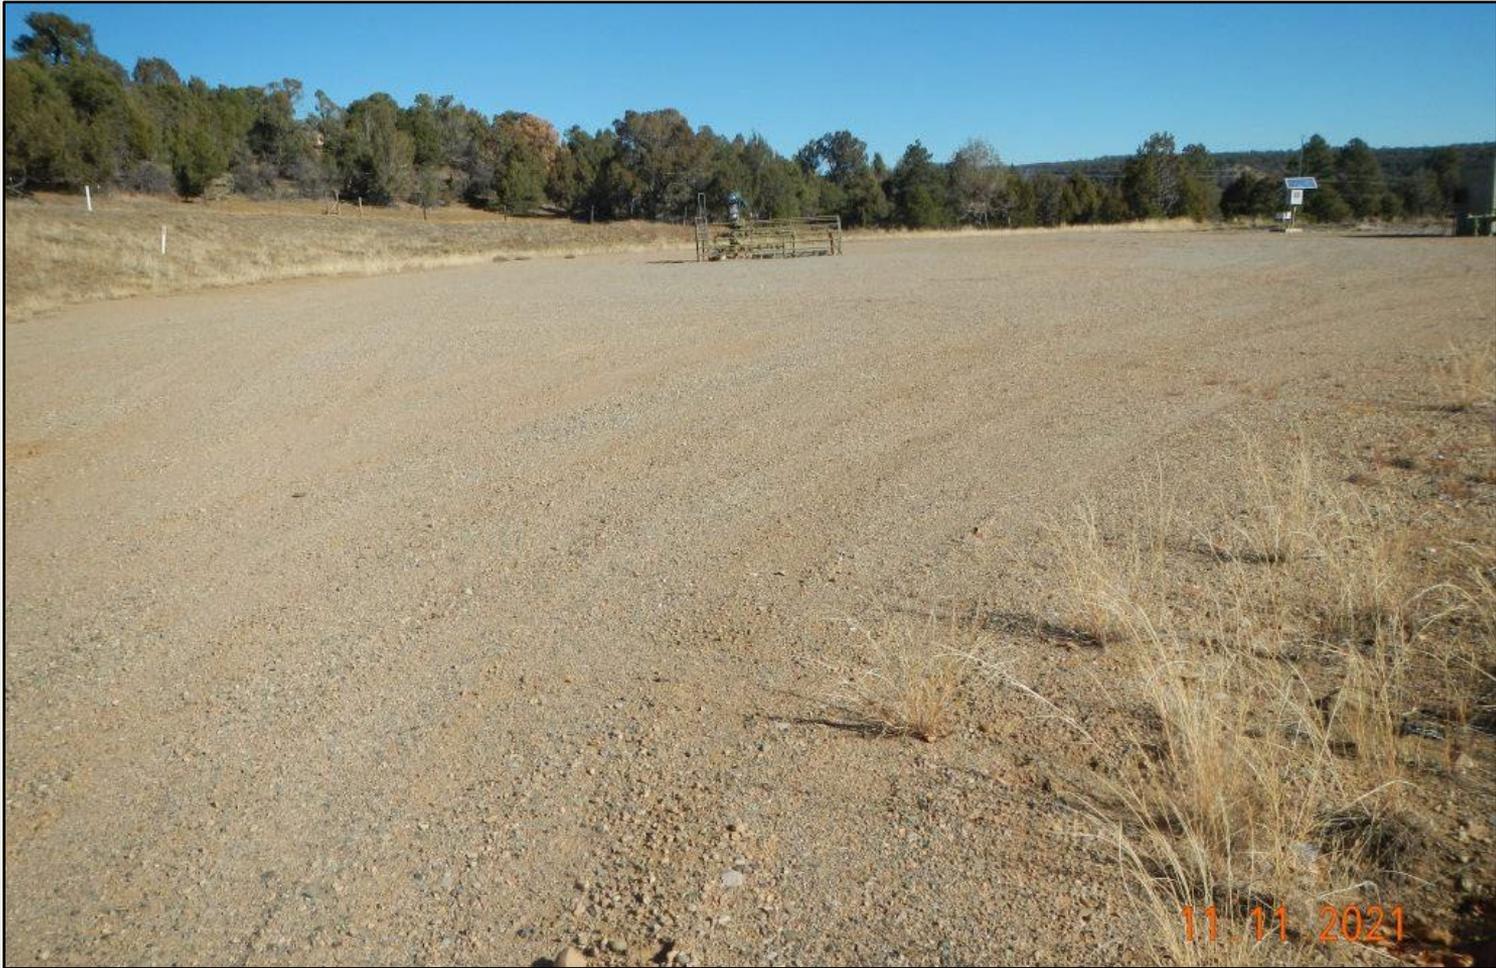
Photo 1. View of the project area from the well pad entrance facing center.

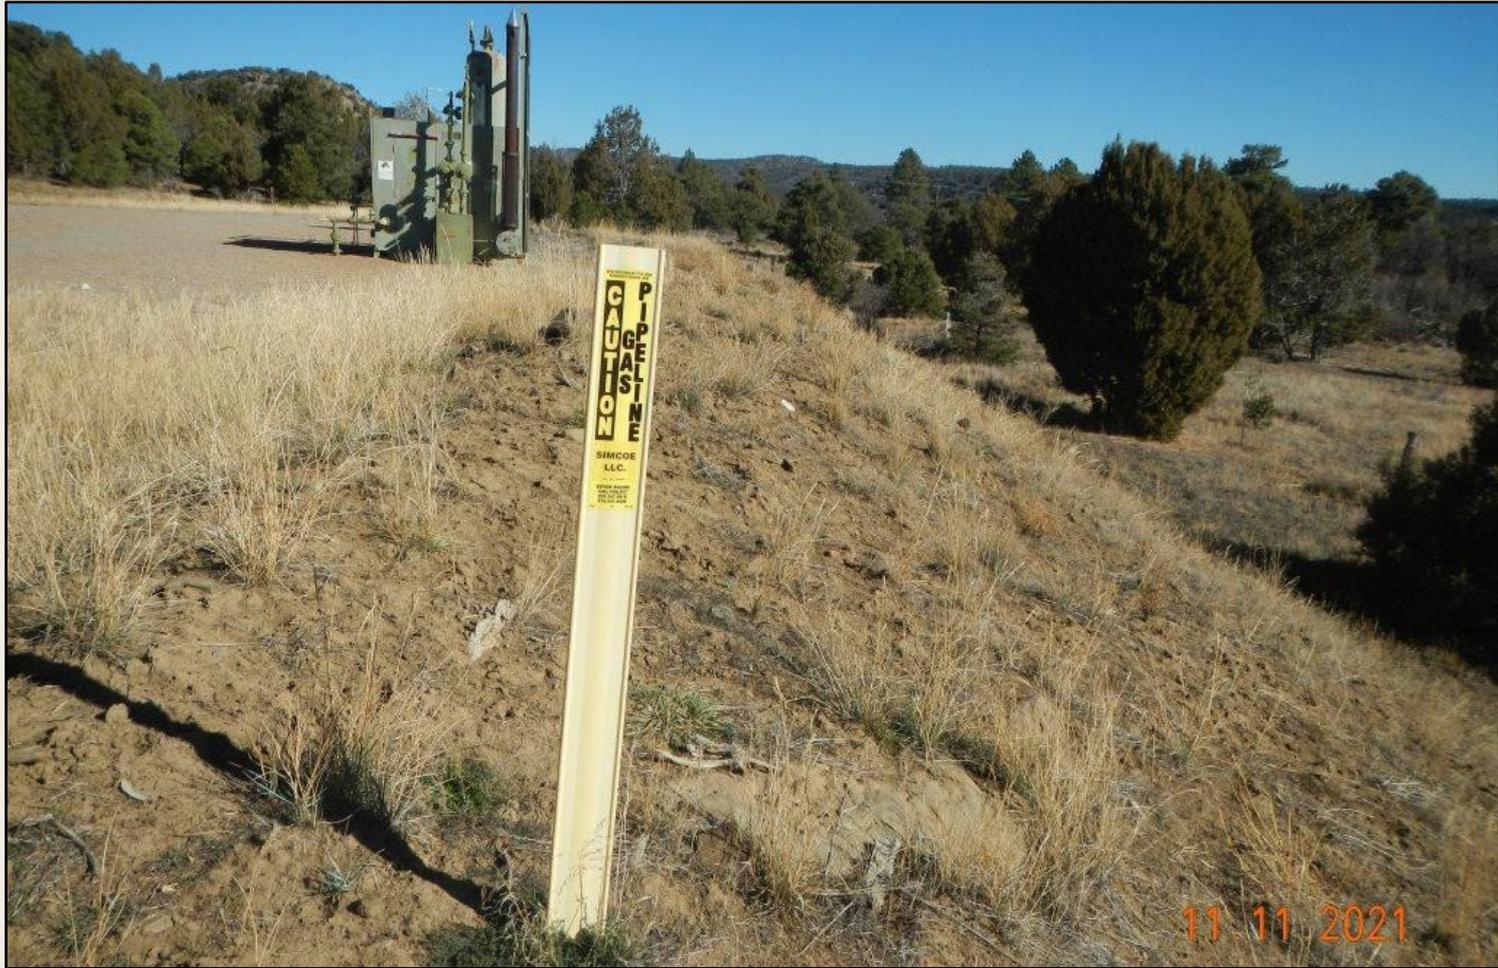
Photo 2. View of the eastern project area from the southeastern corner facing northward. Revegetation is progressing largely with crested wheatgrass, smooth brome, and sand dropseed.

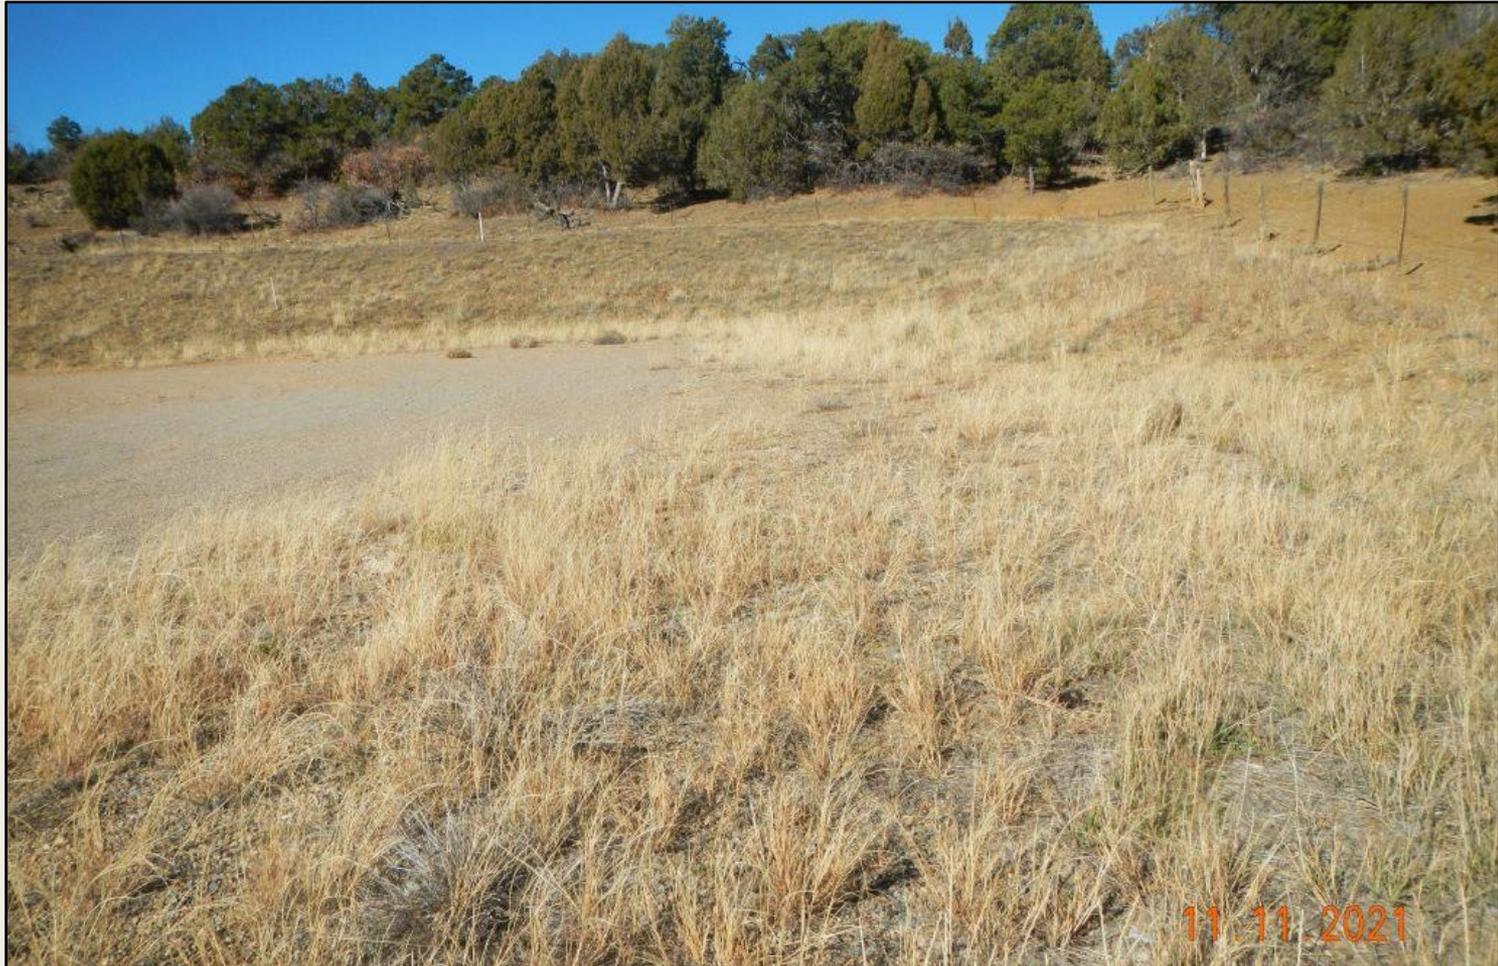
Photo 3. View of the northern project area facing westward from the northeastern corner.

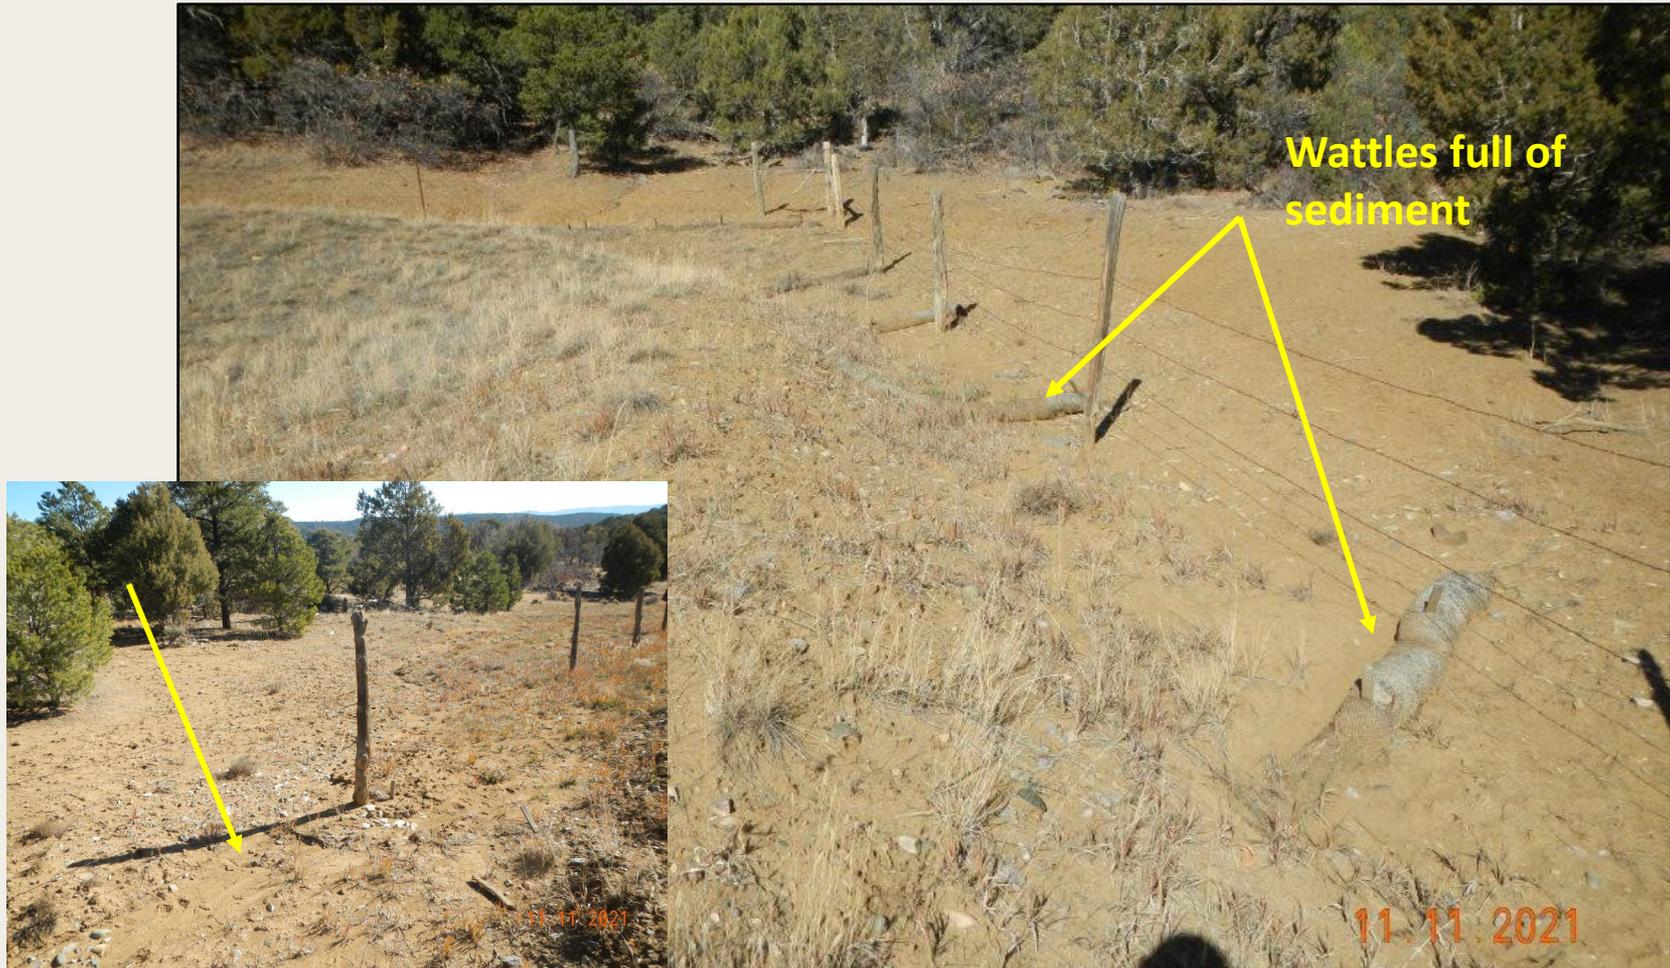
Photo 4. View of straw wattles full of sediment in the northwestern project area. Inset shows erosion downstream from wattles where additional stabilization is needed.

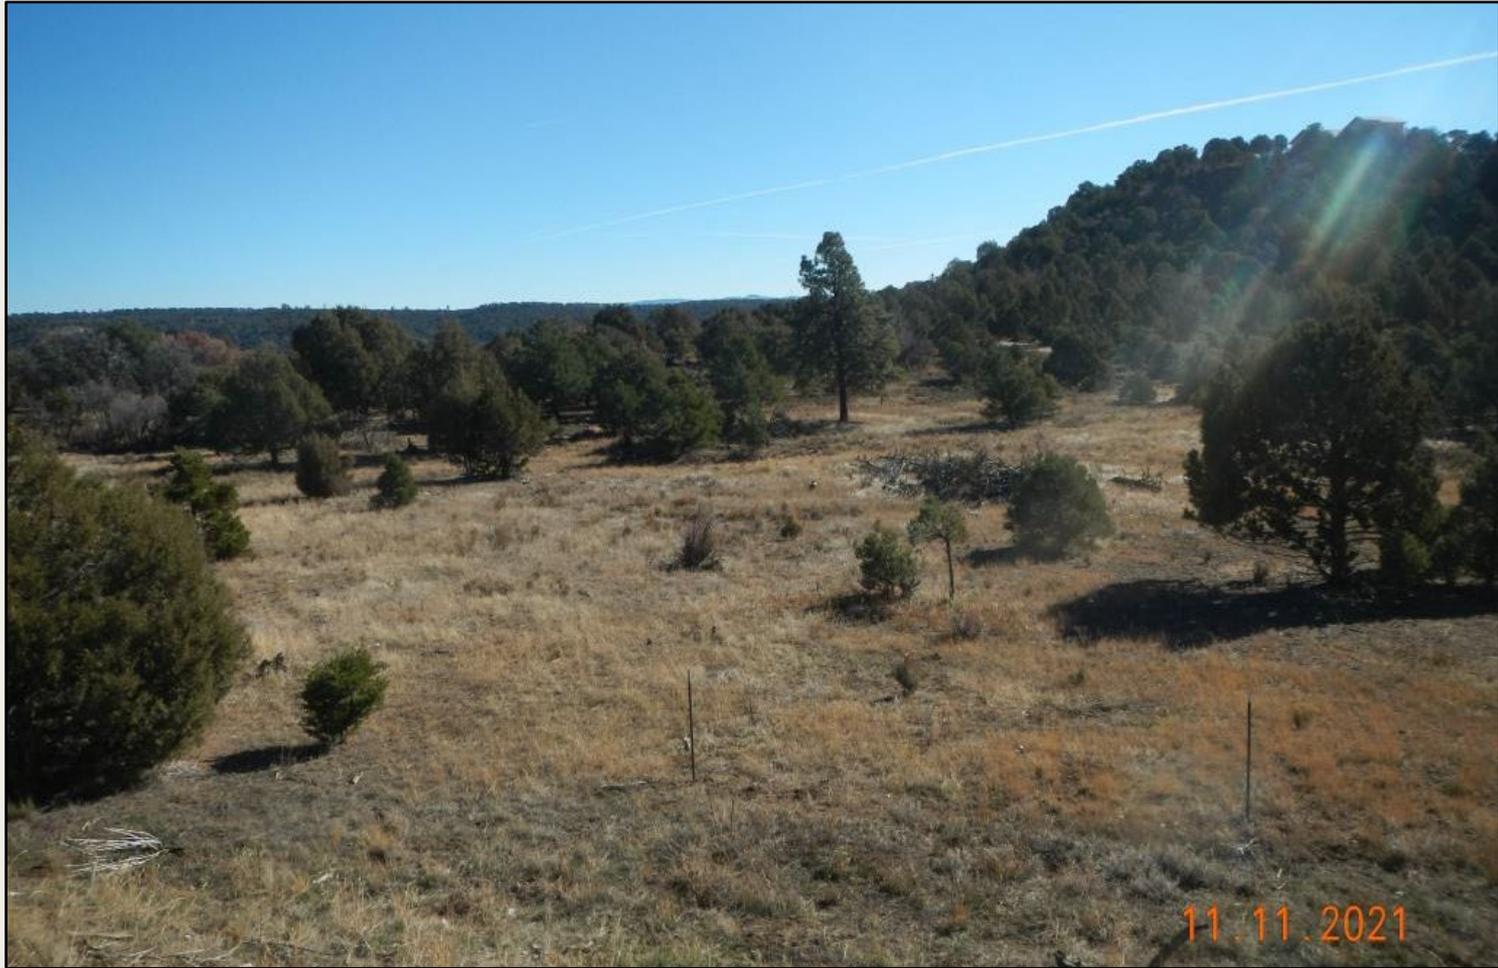
Photo 5. View of the reference area comprised of open pinyon and juniper woodland, with understory of gambel oak, western wheatgrass, sagebrush, and threadleaf sunflower.
