# Inspection Photos

API: 071-07766

Operator: EVERGREEN NATURAL RESOURCES

Inspection Date: 11/12/2021

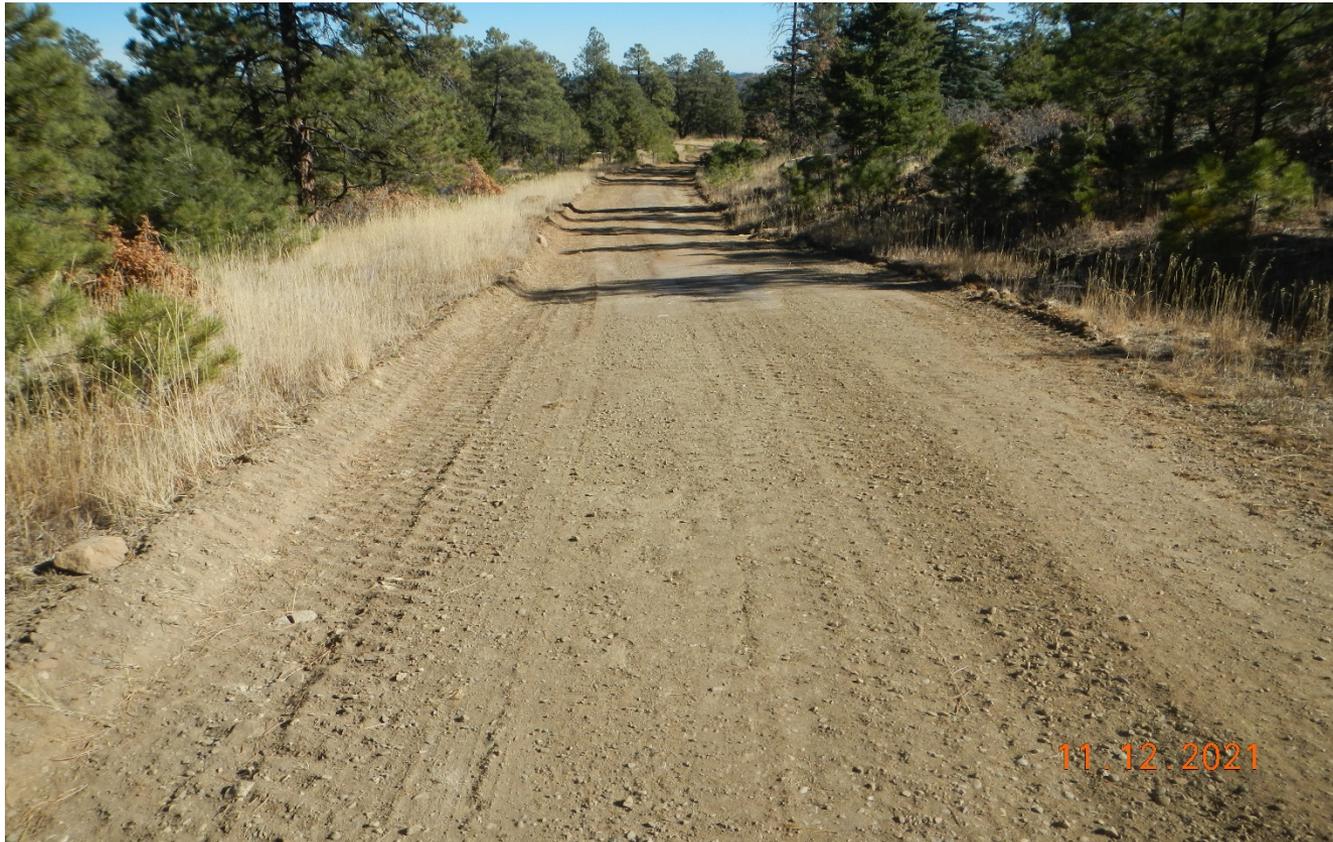
**Photo 1.** Facing northeast along the access road. The erosion along the road has been graded and repaired..

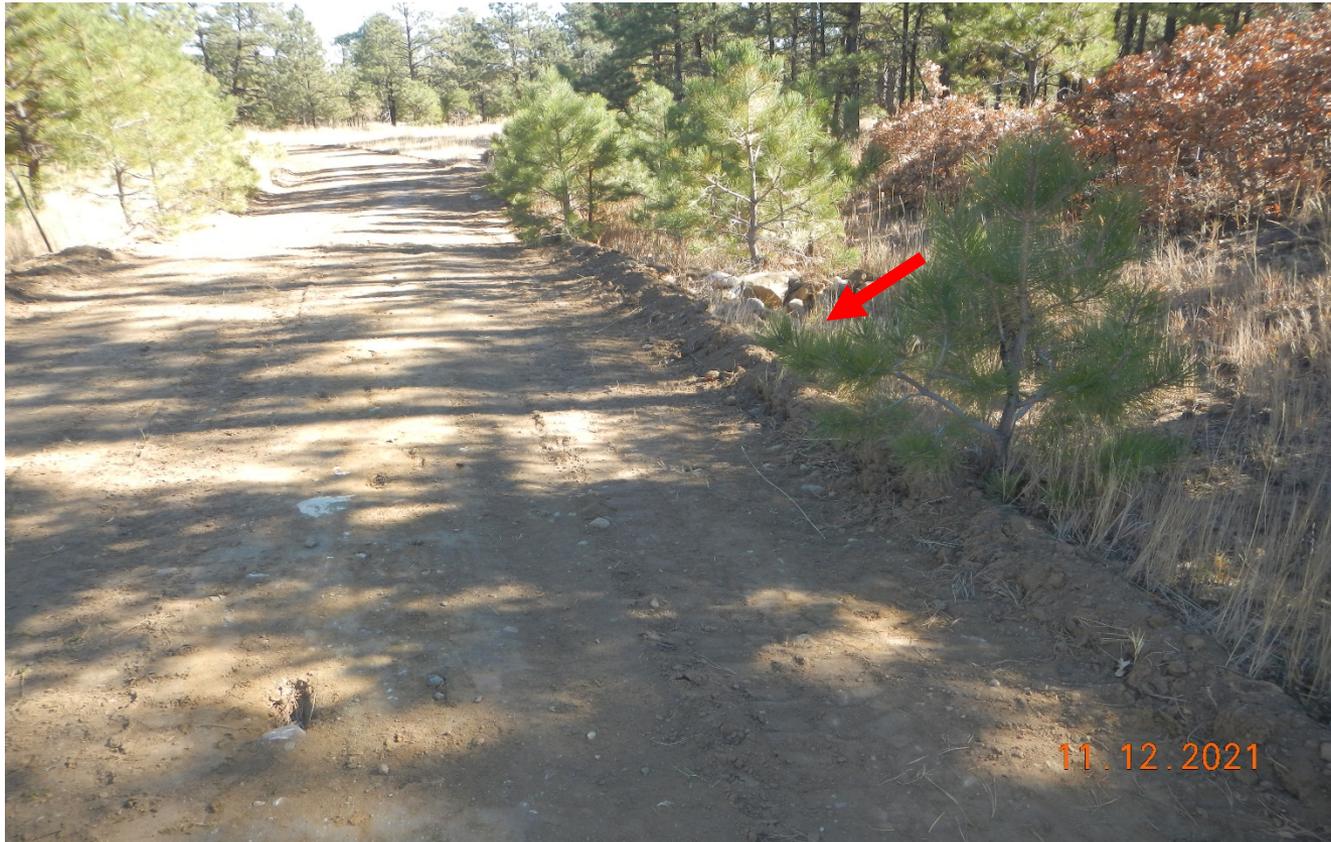
**Photo 2.** The grading created has pushed dirt into a row which blocks stormwater from flowing toward the culvert shown at red arrow.

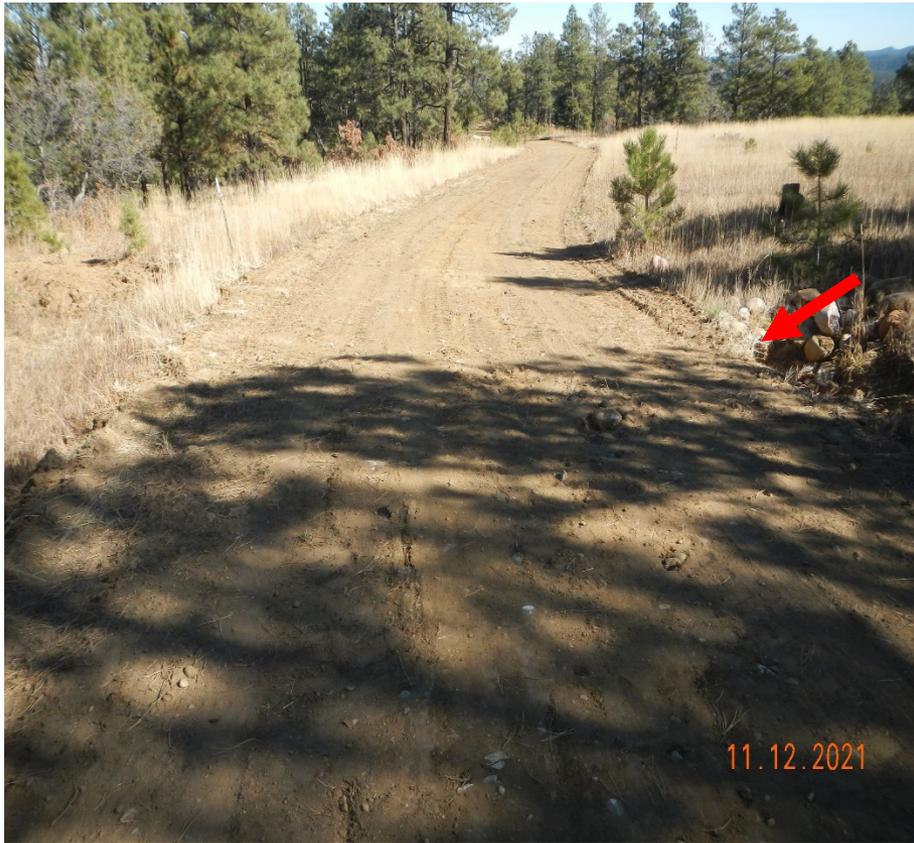
**Photo 3.** There is a culvert shown at the red arrow which is filled in with sediment.

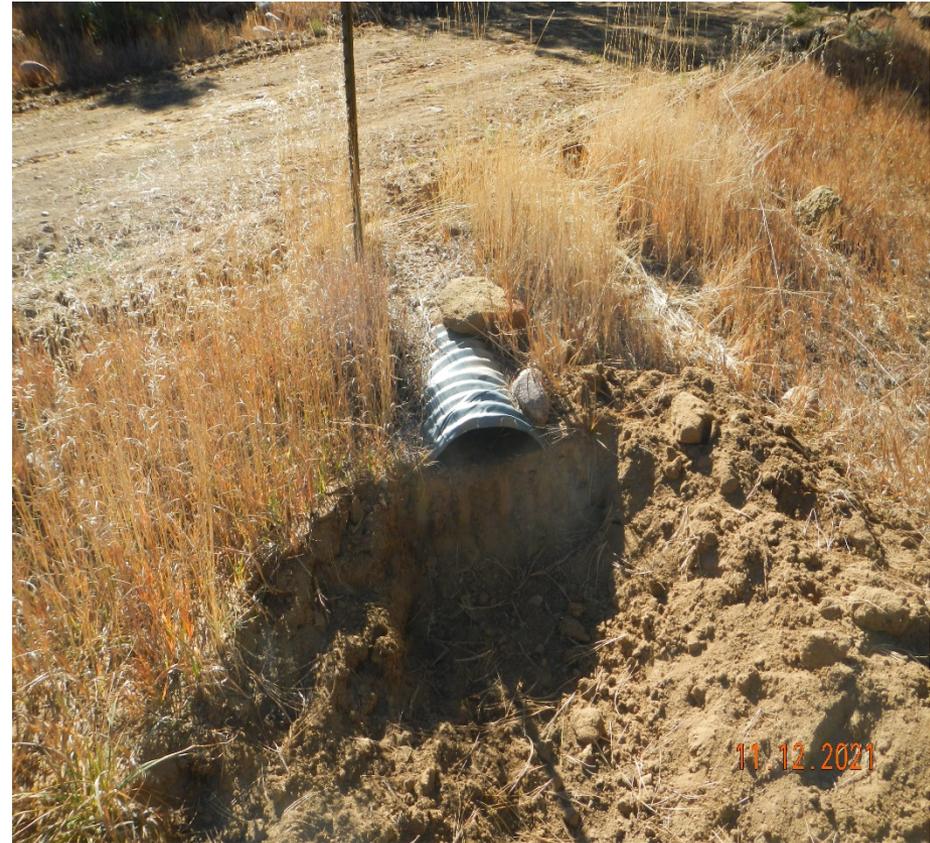
**Photo 4.** The culvert outlet needs to be cleaned out.

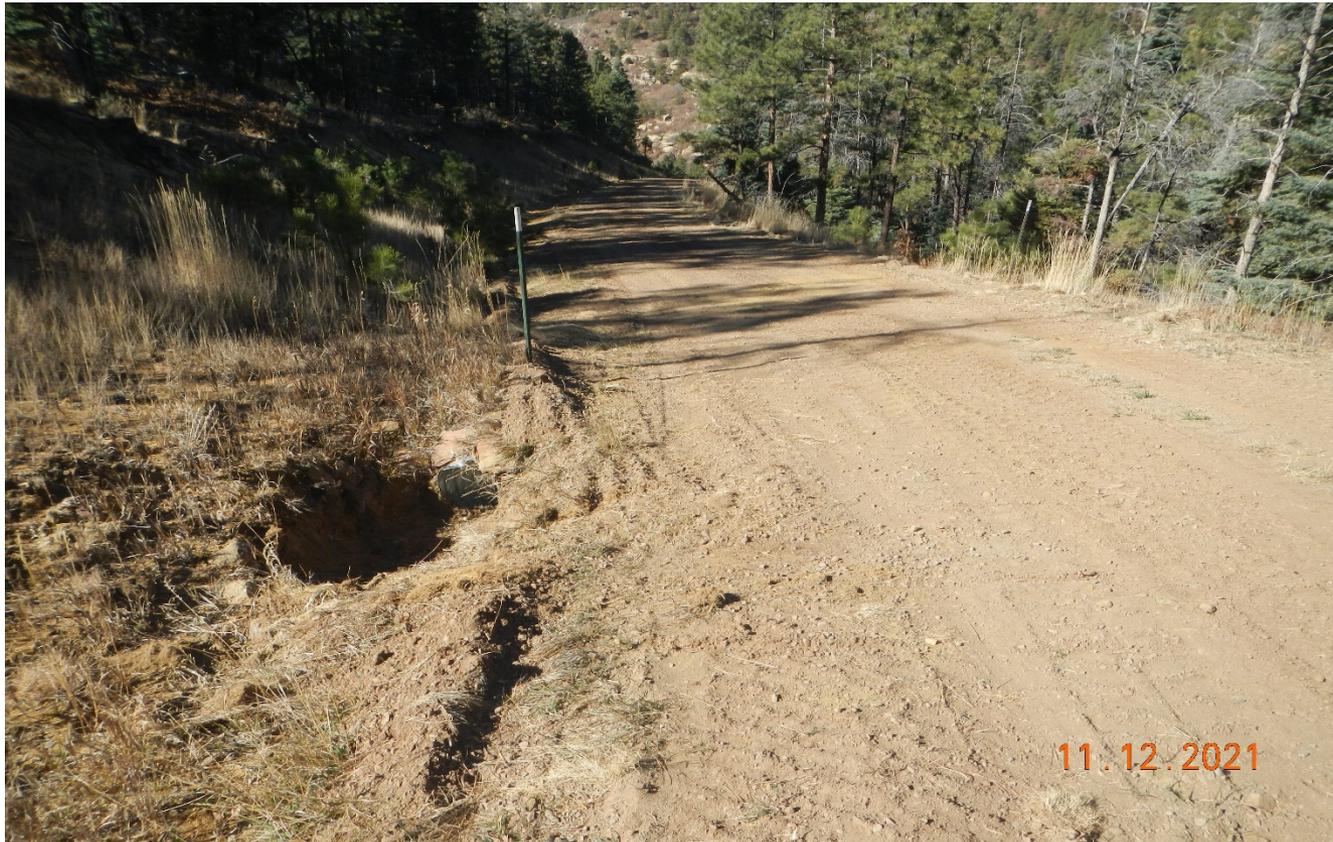
**Photo 5.** Facing northwest toward road turns down the hill side into the canyon. The culverts have been cleaned out. There is gravel along this portion of the road but further down the road gravel was not observed.

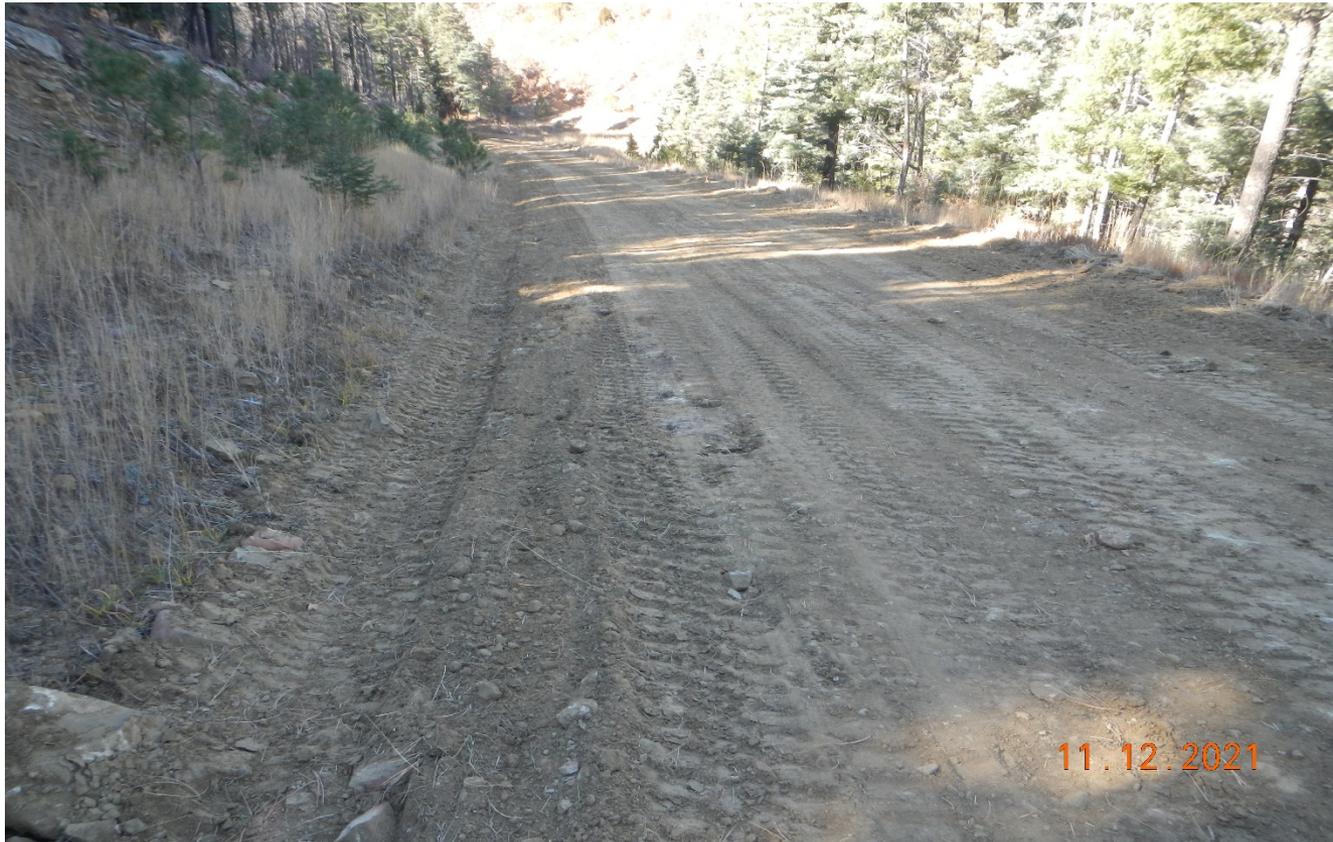
**Photo 6.** The road was graded down to the canyon bottom and erosion was repaired however there is no insufficient stabilization of the road and road side. There is no gravel along this steep portion of the road.

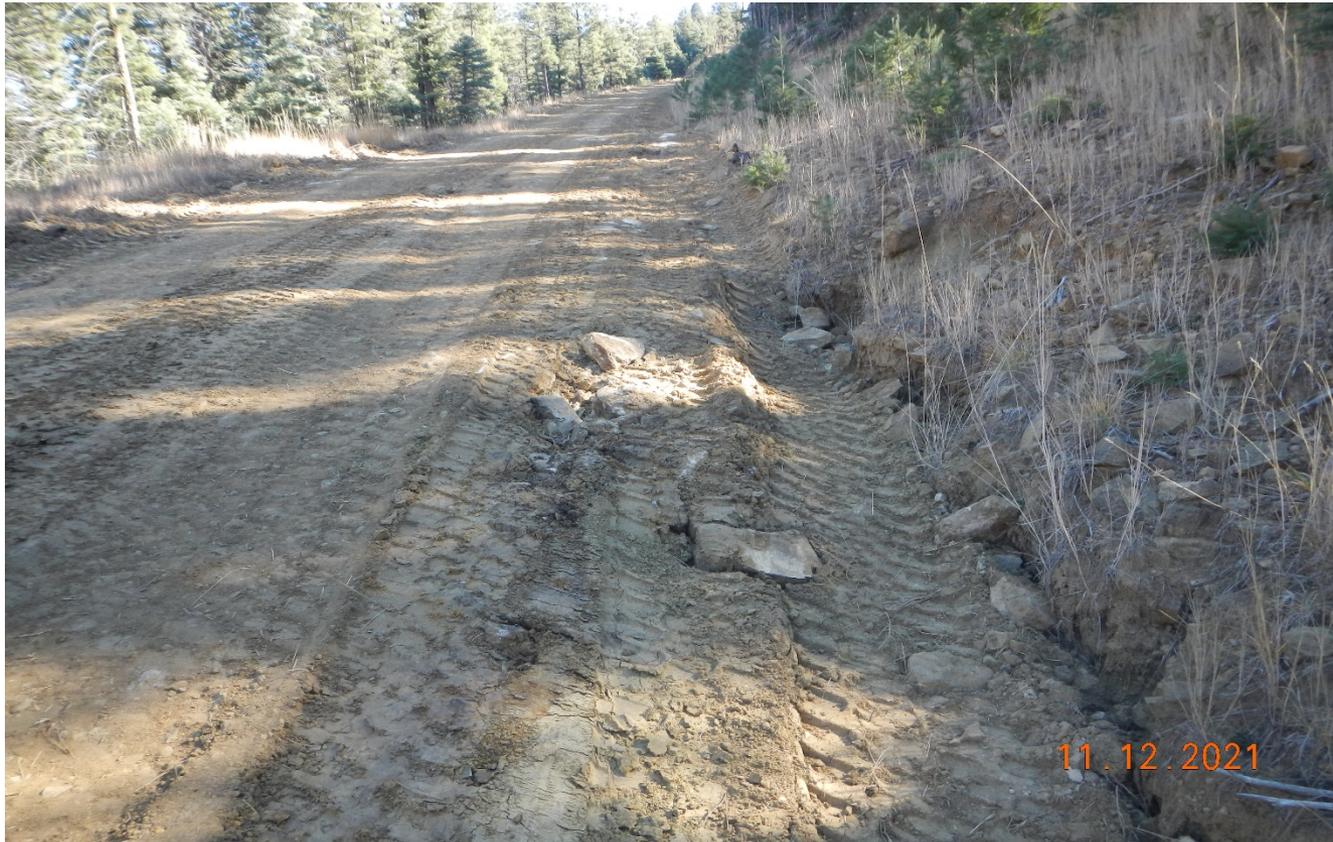
**Photo 7.** The erosion along the road side was filled but is not stabilized.

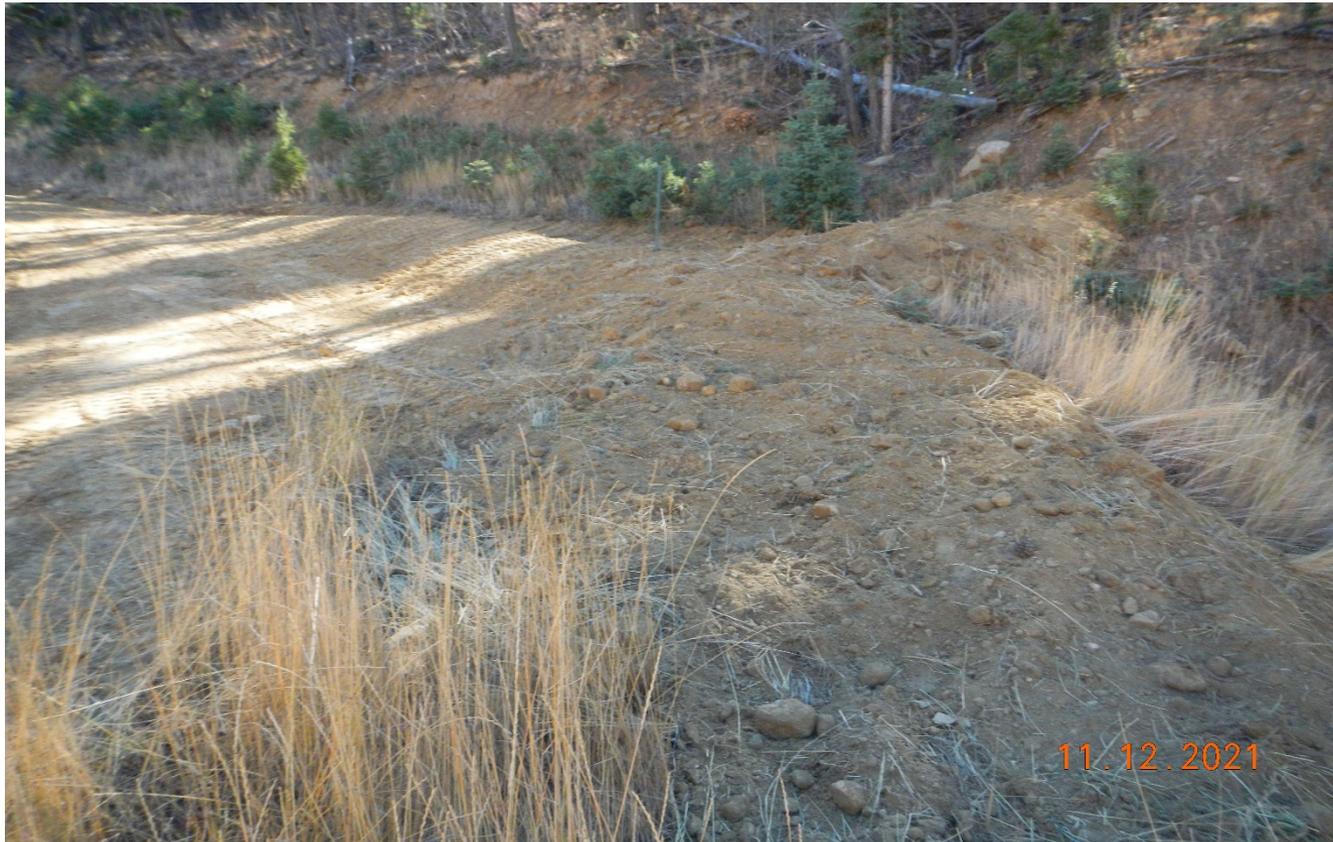
**Photo 8.** Standing at where road turns at the bottom of the canyon. Disturbed soils have not been seeded and stabilized.

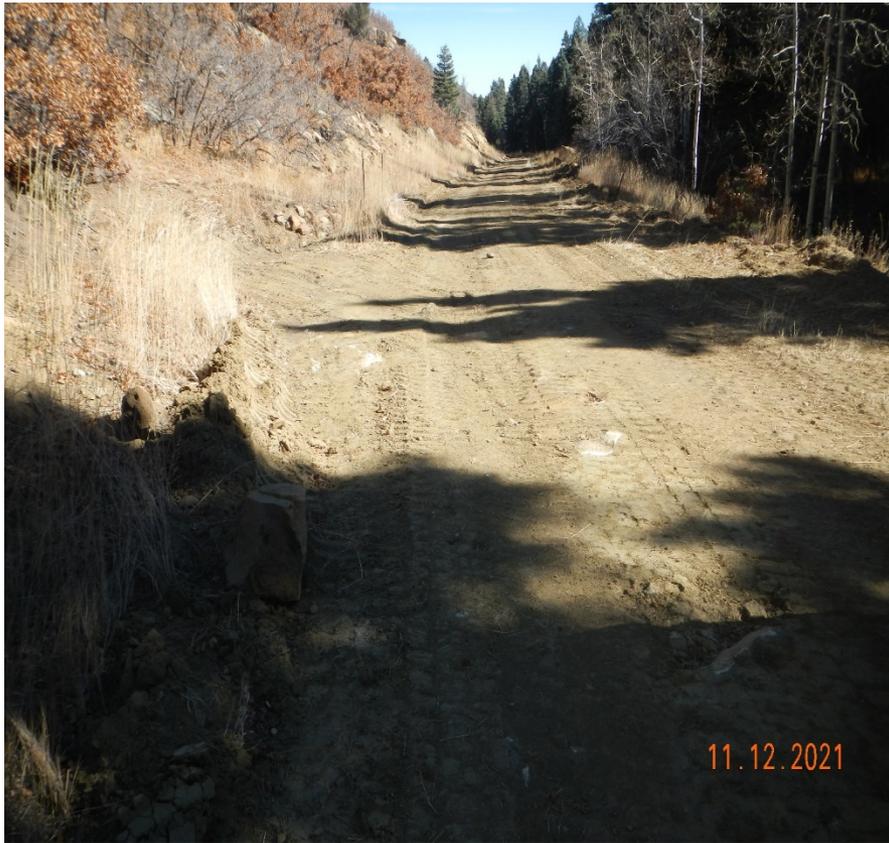
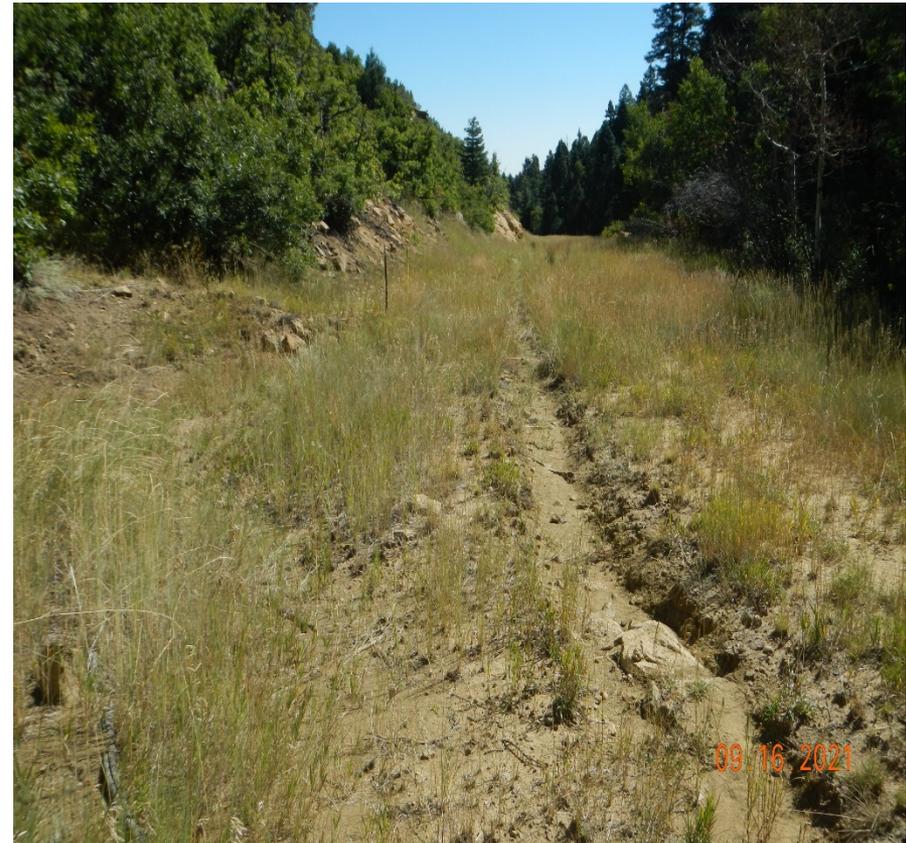
**Photo 9&10.** Facing east along the access road. The road was graded which created additional disturbance of the road. The photo on the right is the same area of erosion which could have been repaired with hand tools to avoid disturbance.

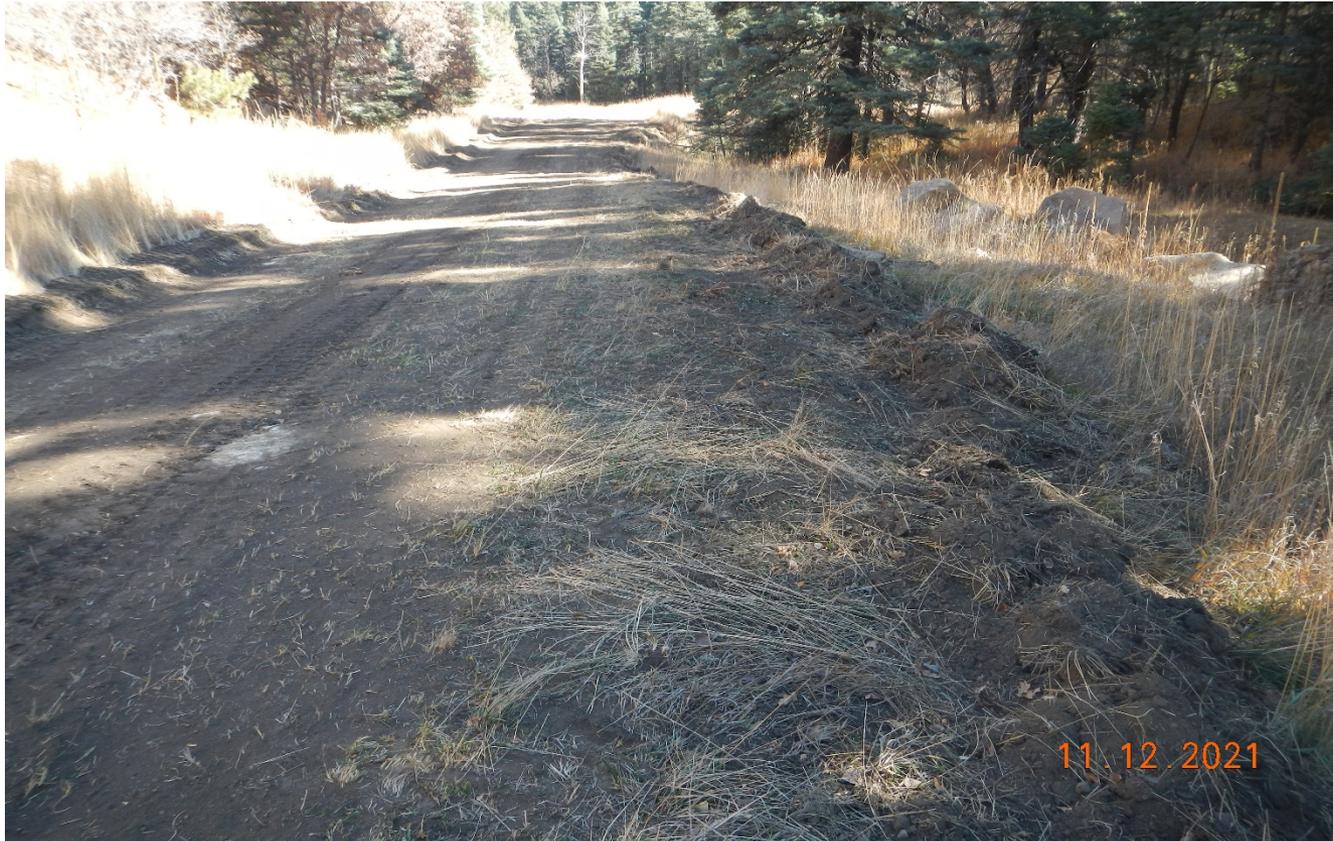
**Photo 11.** Facing east along the access road. Grading of the road has pushed soil into a row which needs to be raked/leveled out.
