Inspection Photos
Operator: Simcoe
API: 067-07124
Date: 11/11/2021

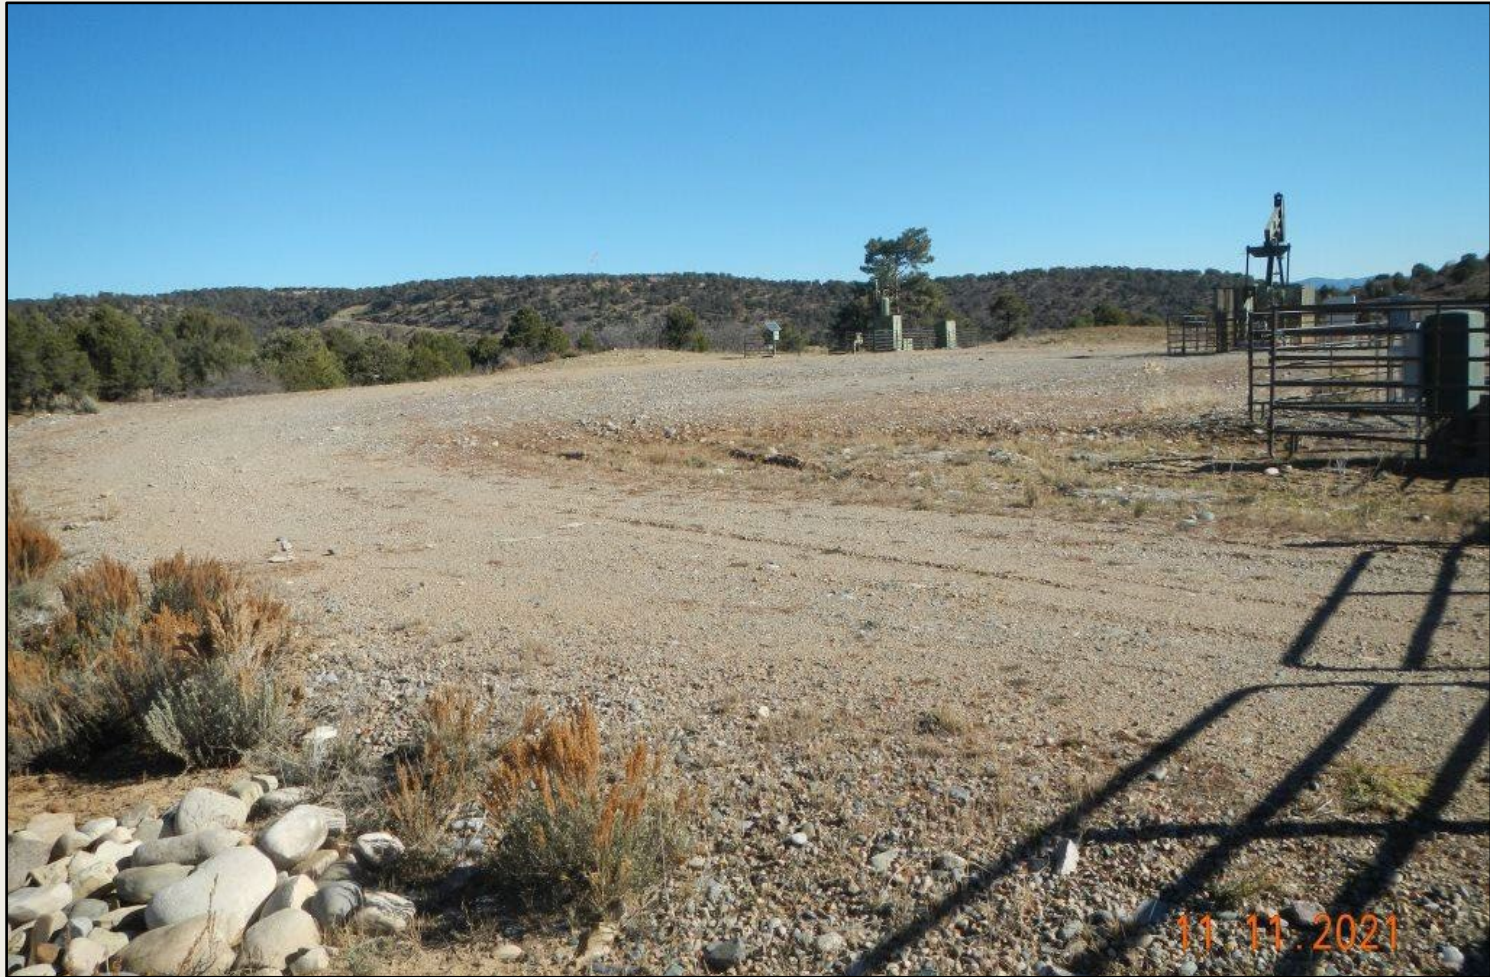
Photo 1. View of the project area from the well pad entrance facing center.

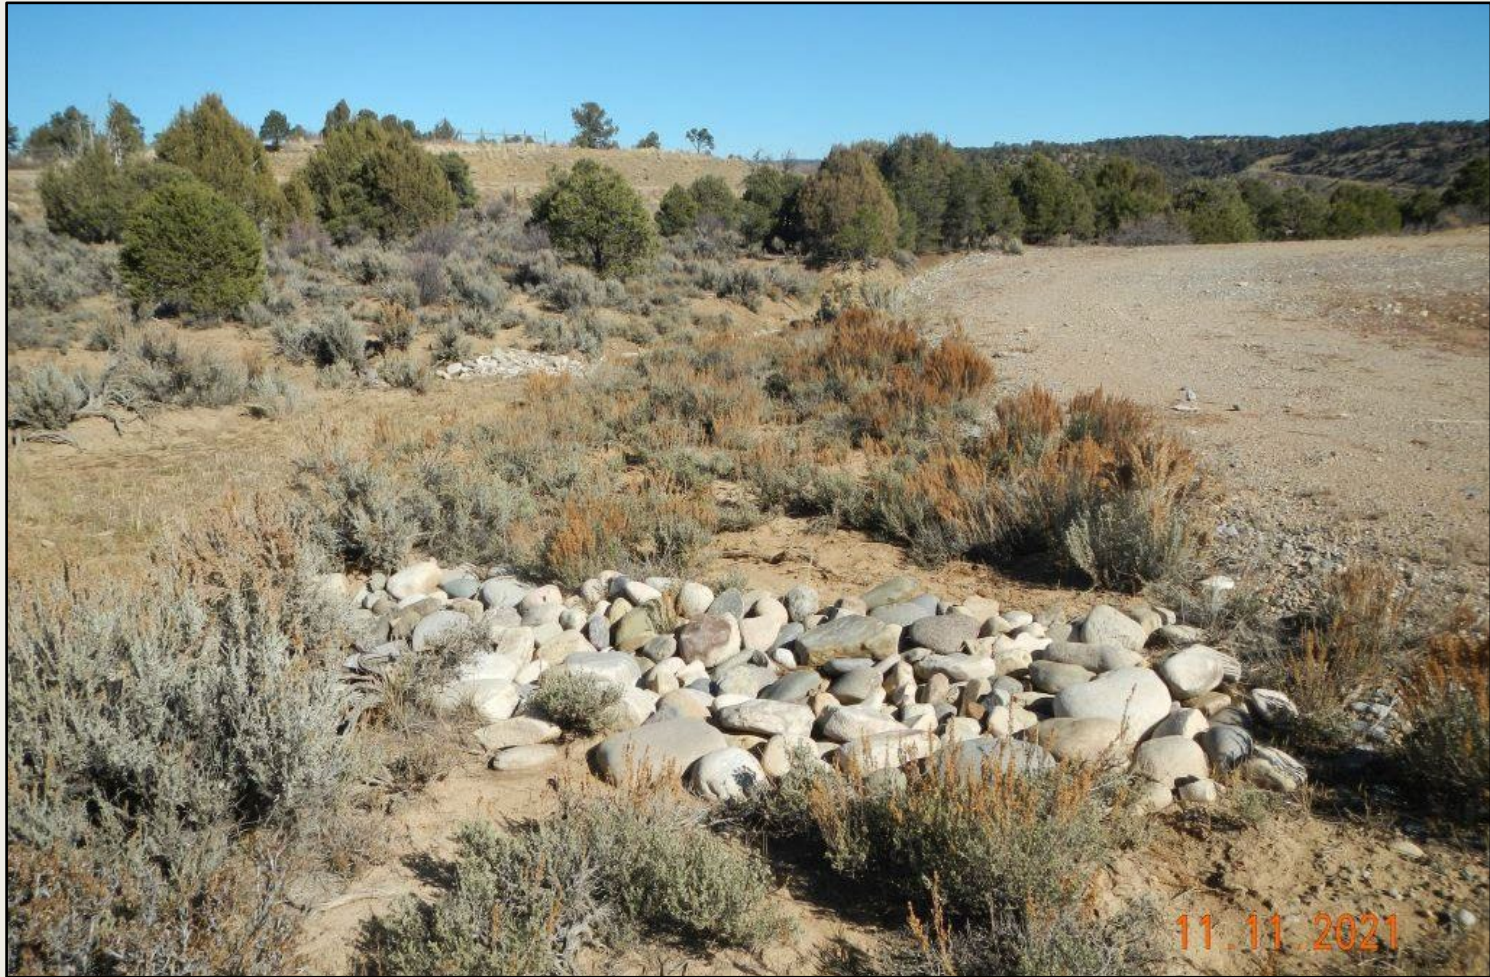
Photo 2. View of the western project area from the southwestern corner facing northward. Revegetation is progressing largely with western wheatgrass, black sagebrush, and sand dropseed.

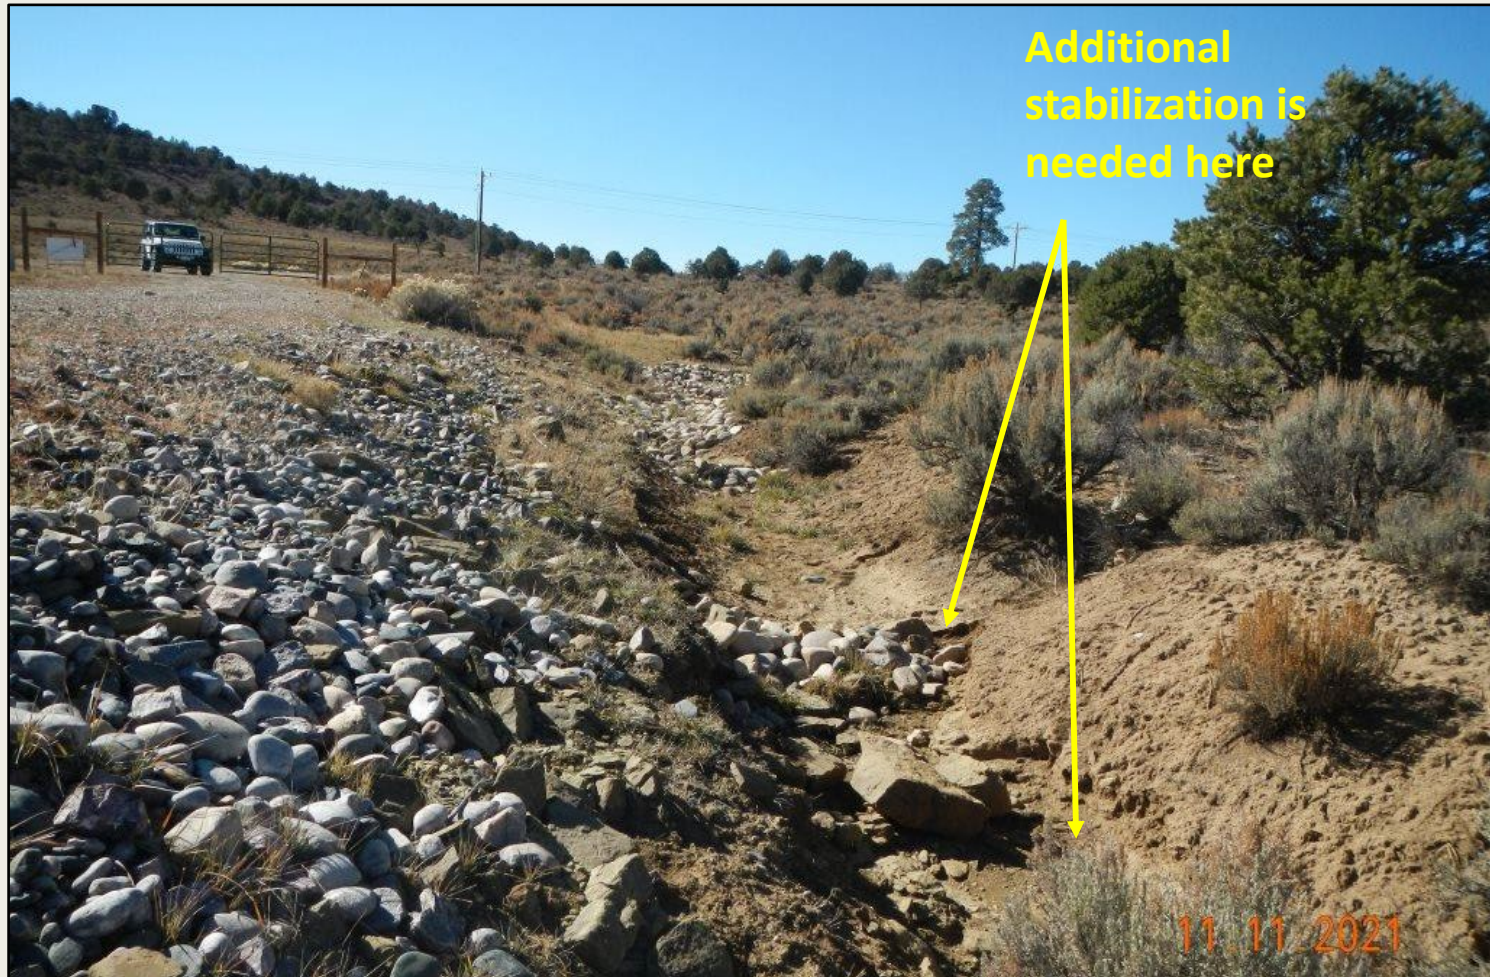
Photo 3. View of stormwater controls installed within the western project area. Additional stabilization is needed in the northwestern portion of the project area where erosion continues around rock check.

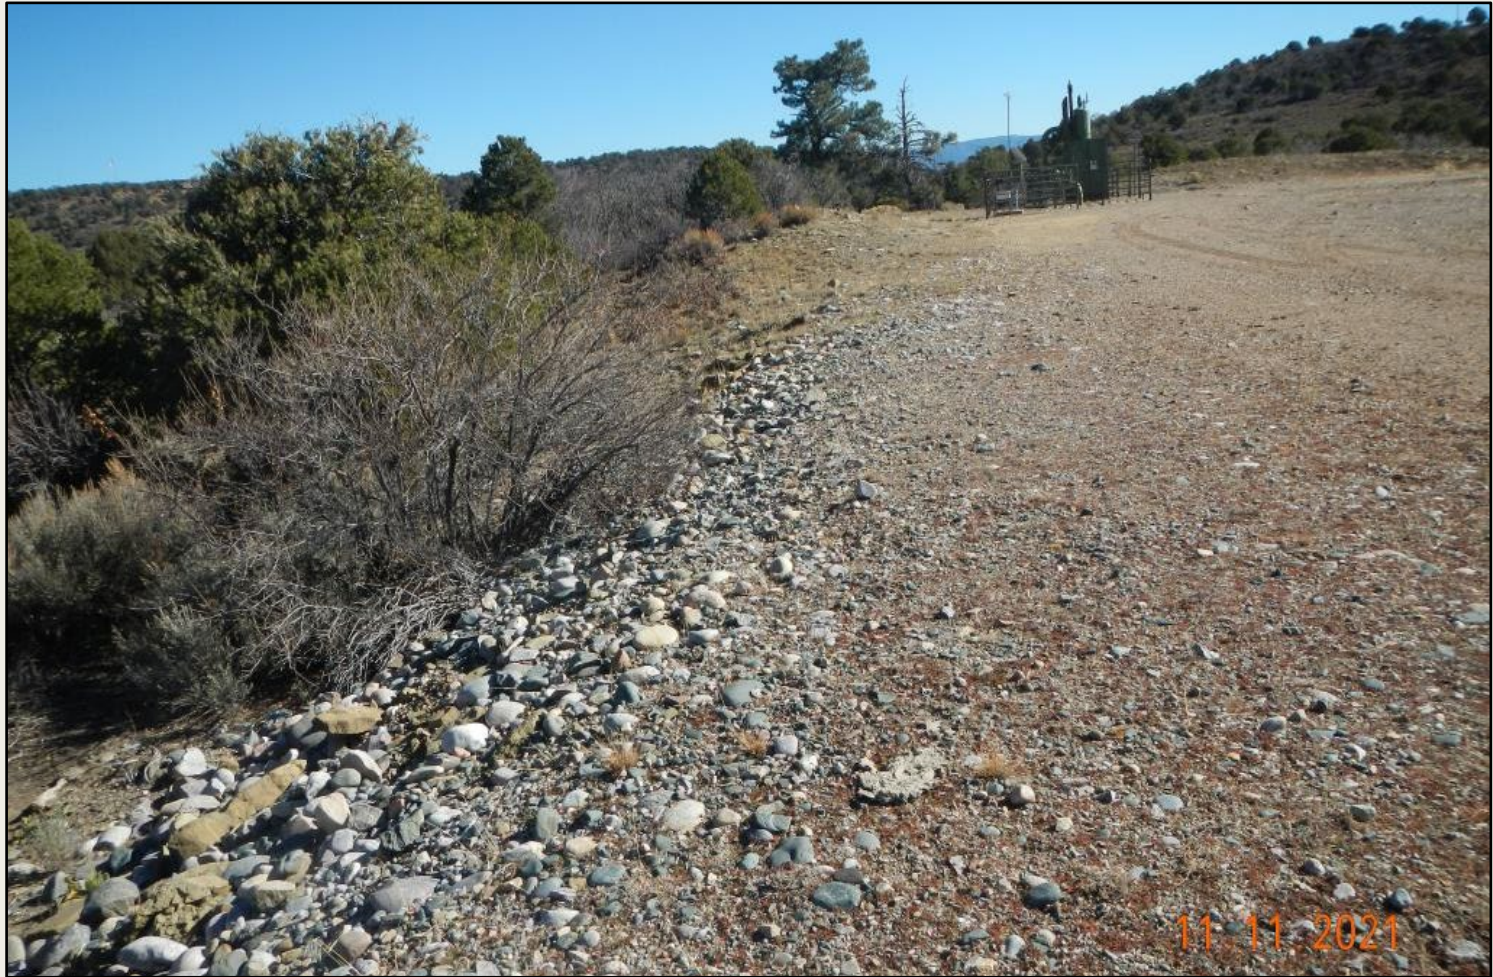
Photo 4. View of the northern project area from the northwestern corner facing eastward.

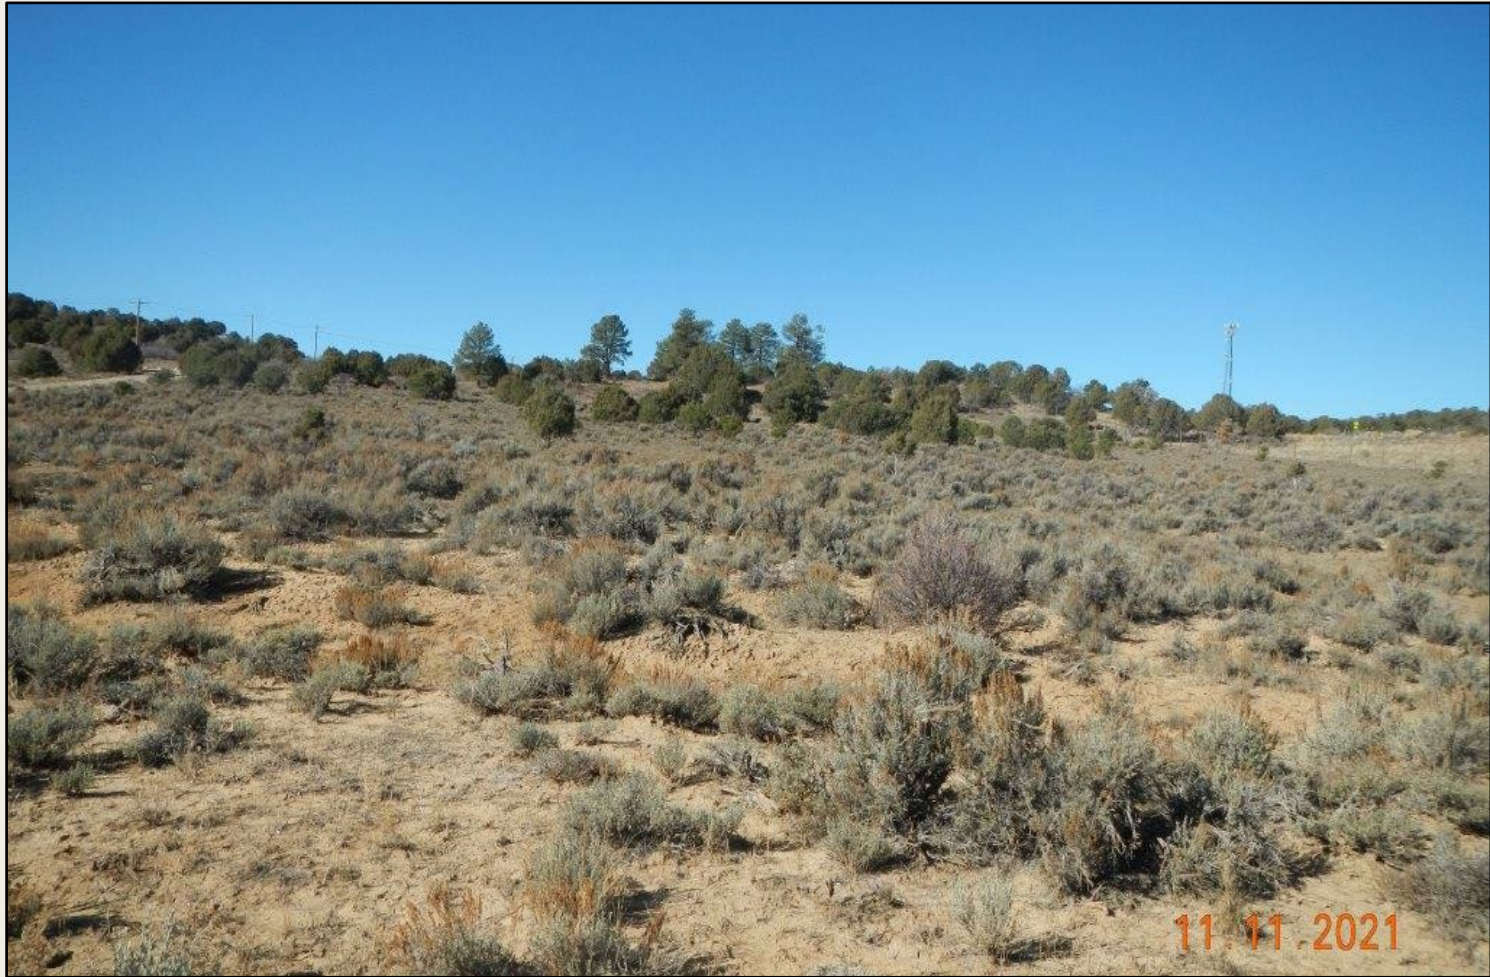
Photo 5. View of the reference area comprised of black sagebrush shrubland with western wheatgrass, purple threeawn, and penstemons in the understory.
