Inspection Photos  
Operator: Simcoe  
API: 067-08704  
Date: 11/11/2021

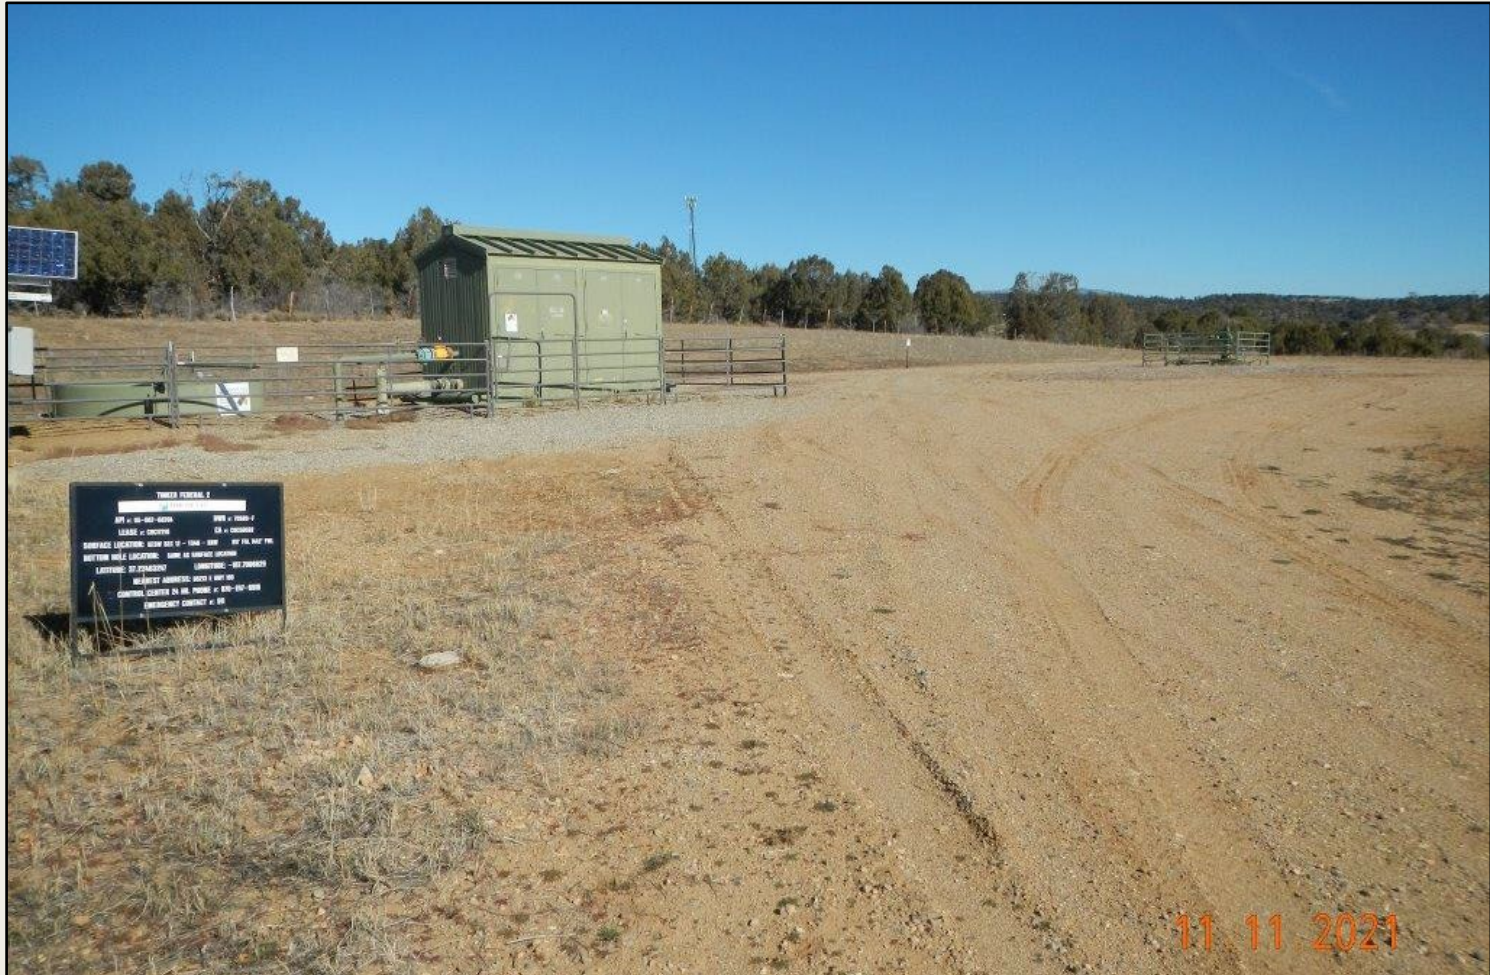
Photo 1. View of the project area from the well pad entrance facing center.

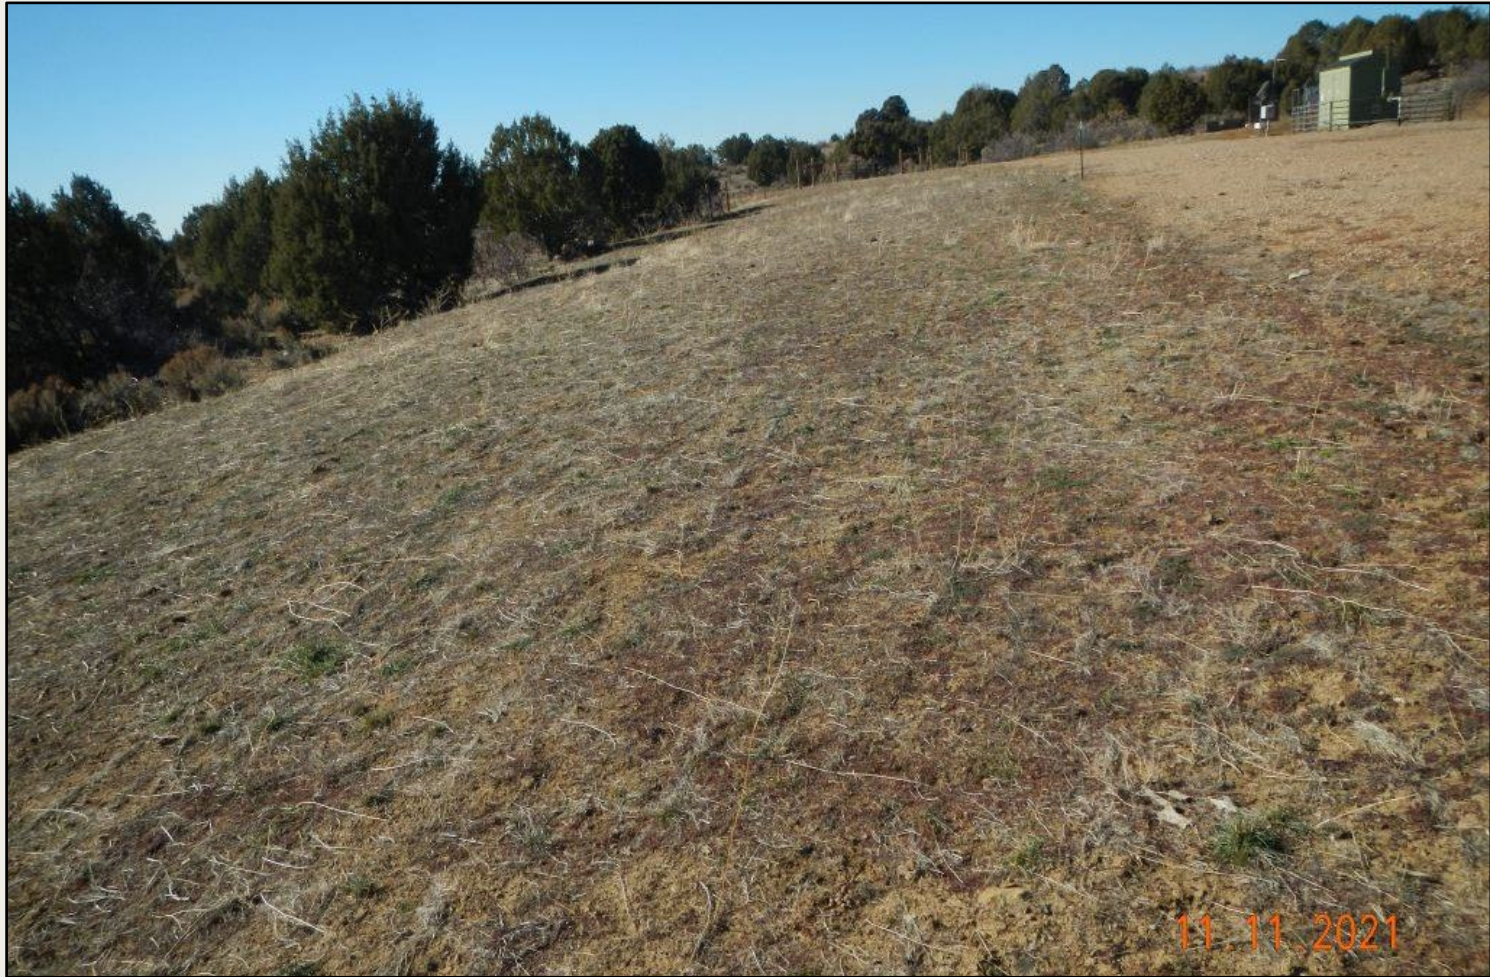
Photo 2. View of the southern project area from the southeastern corner facing westward. Revegetation appears to be progressing in an early and grazed vegetative condition. Hay mulch from seeding remains in place.

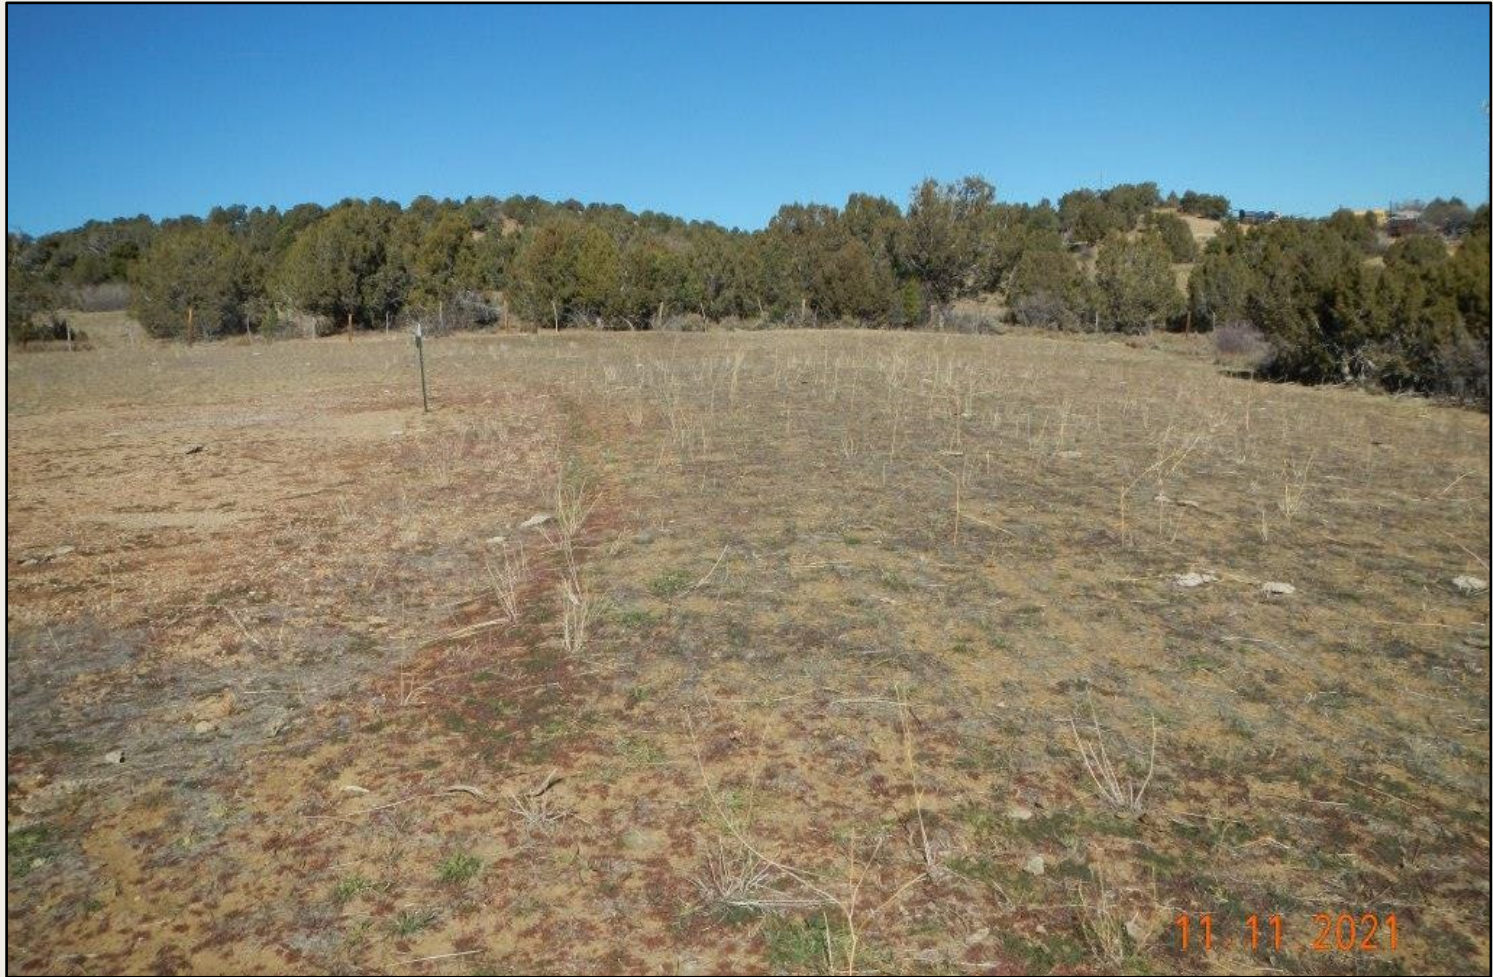
Photo 3. View of the eastern project area from the southeastern corner, facing northward.

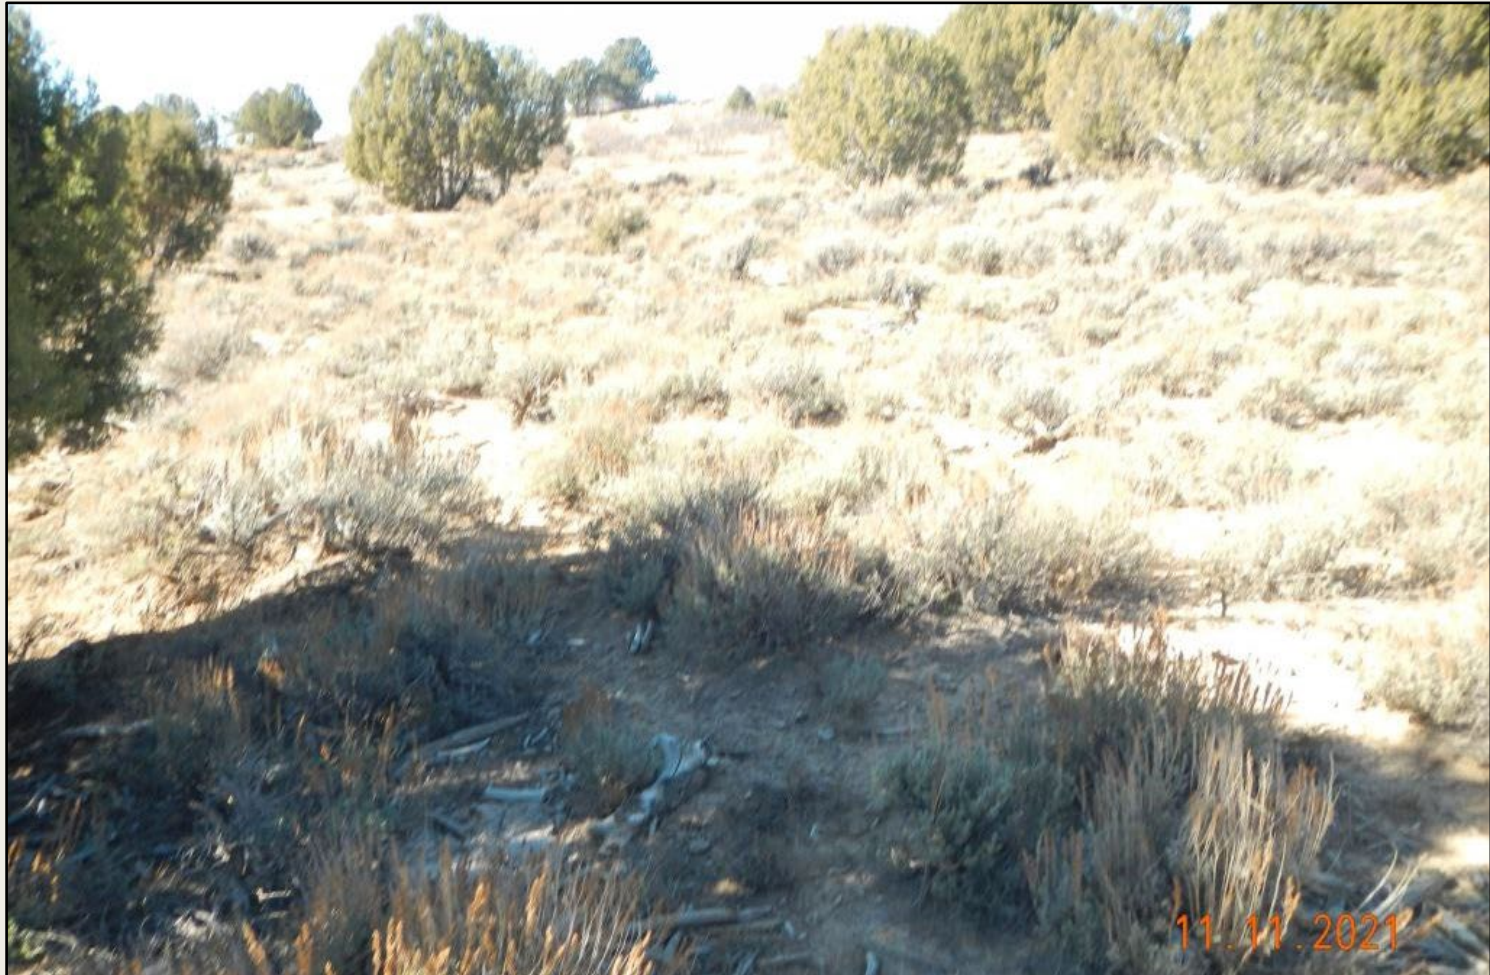
Photo 4. View of the reference area comprised of sagebrush shrubland with western wheatgrass, blue grama, snakeweed, in the understory.
