# Interim Reclamation Inspection

Operator: K P KAUFFMAN COMPANY INC - 46290

Location ID: 317861

Inspection Photos  
Location Name: CARL R DEEPE B #1  
Location ID: 317861

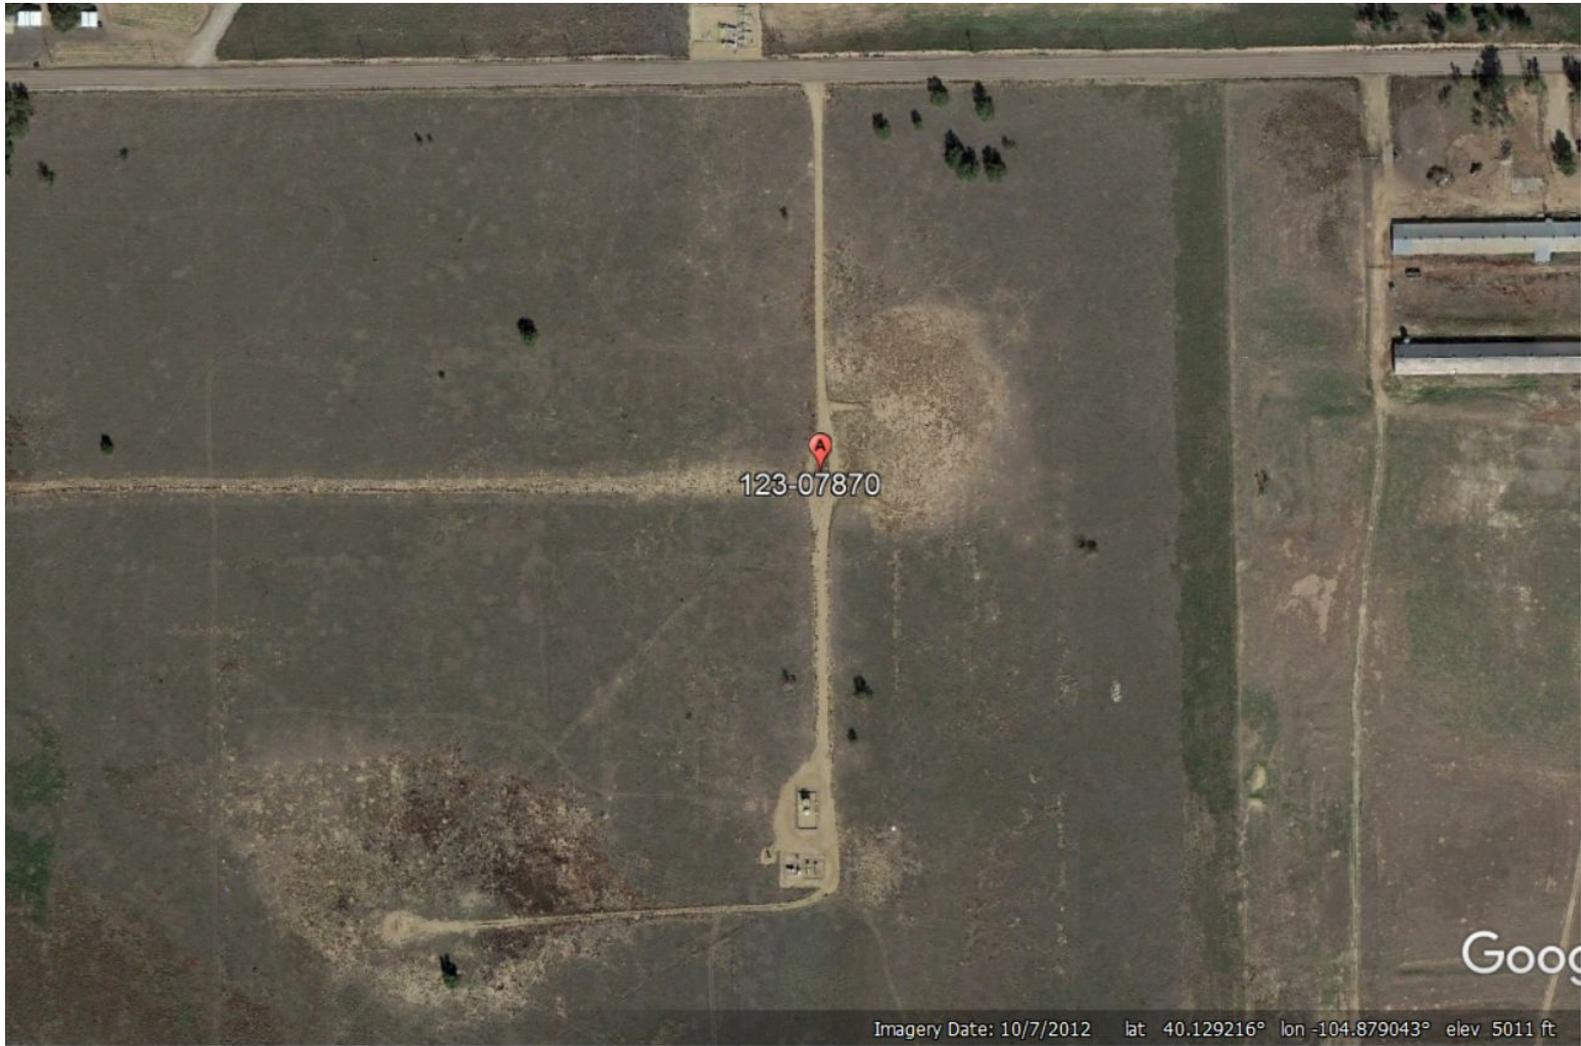
**Photo 1.** Google Earth aerial imagery taken 10/7/2012 prior to the Kerr McGee Deep locations. Photo illustrates the access road, which was planned to be used by Kerr McGee after their new locations were built.

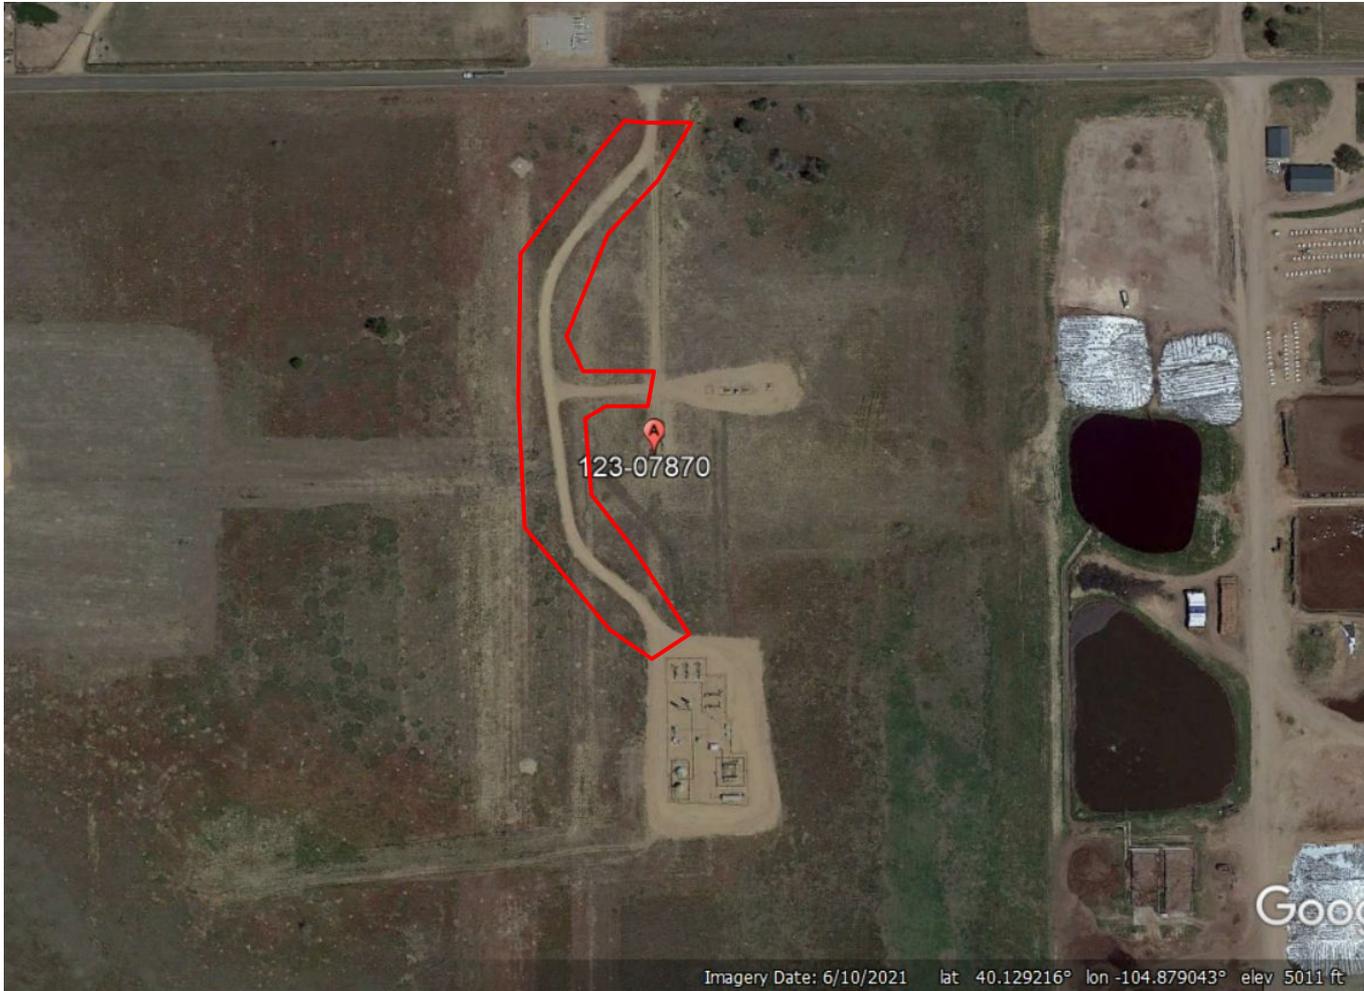
**Photo 2.** Google Earth aerial imagery taken 6/10/2021 after the Kerr McGee Deep locations were built. Photo illustrates a new access road built by Kerr McGee, which is not what was planned to be used. Kerr McGee was planning to use the previous access route illustrated in the previous photo.

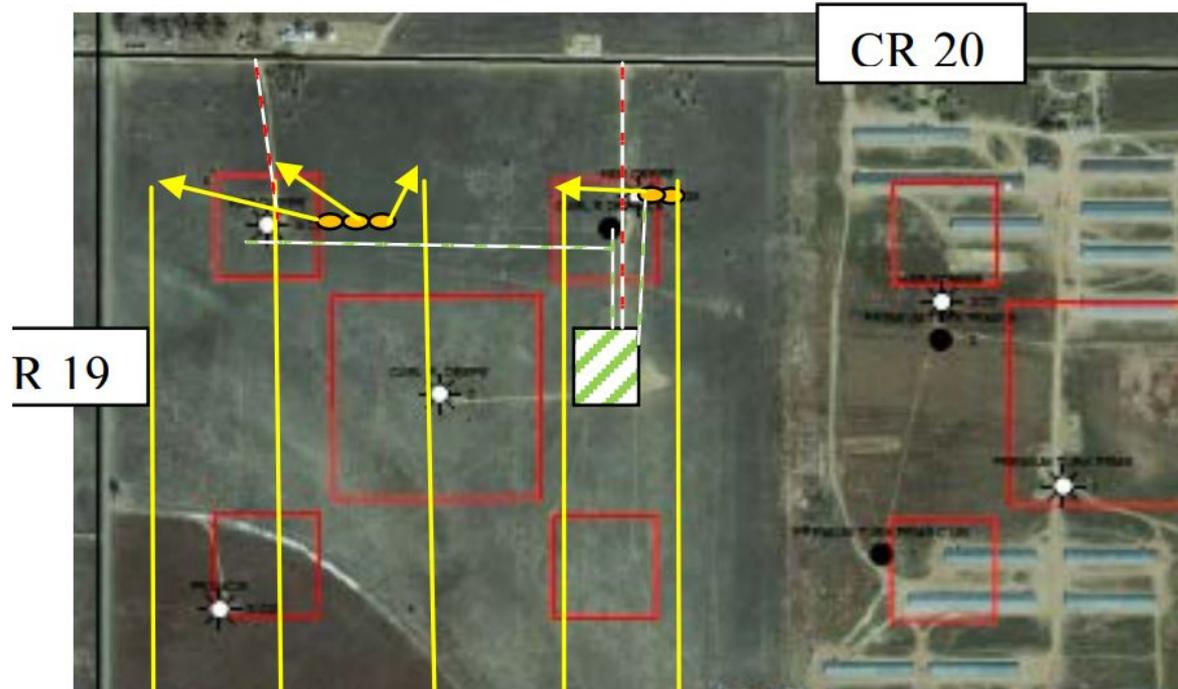
## ACCESS ROAD MAP

**Photo 3.** Kerr McGee aerial imagery of the planned and approved access road to be used. Kerr McGee built new access roads that were not approved.

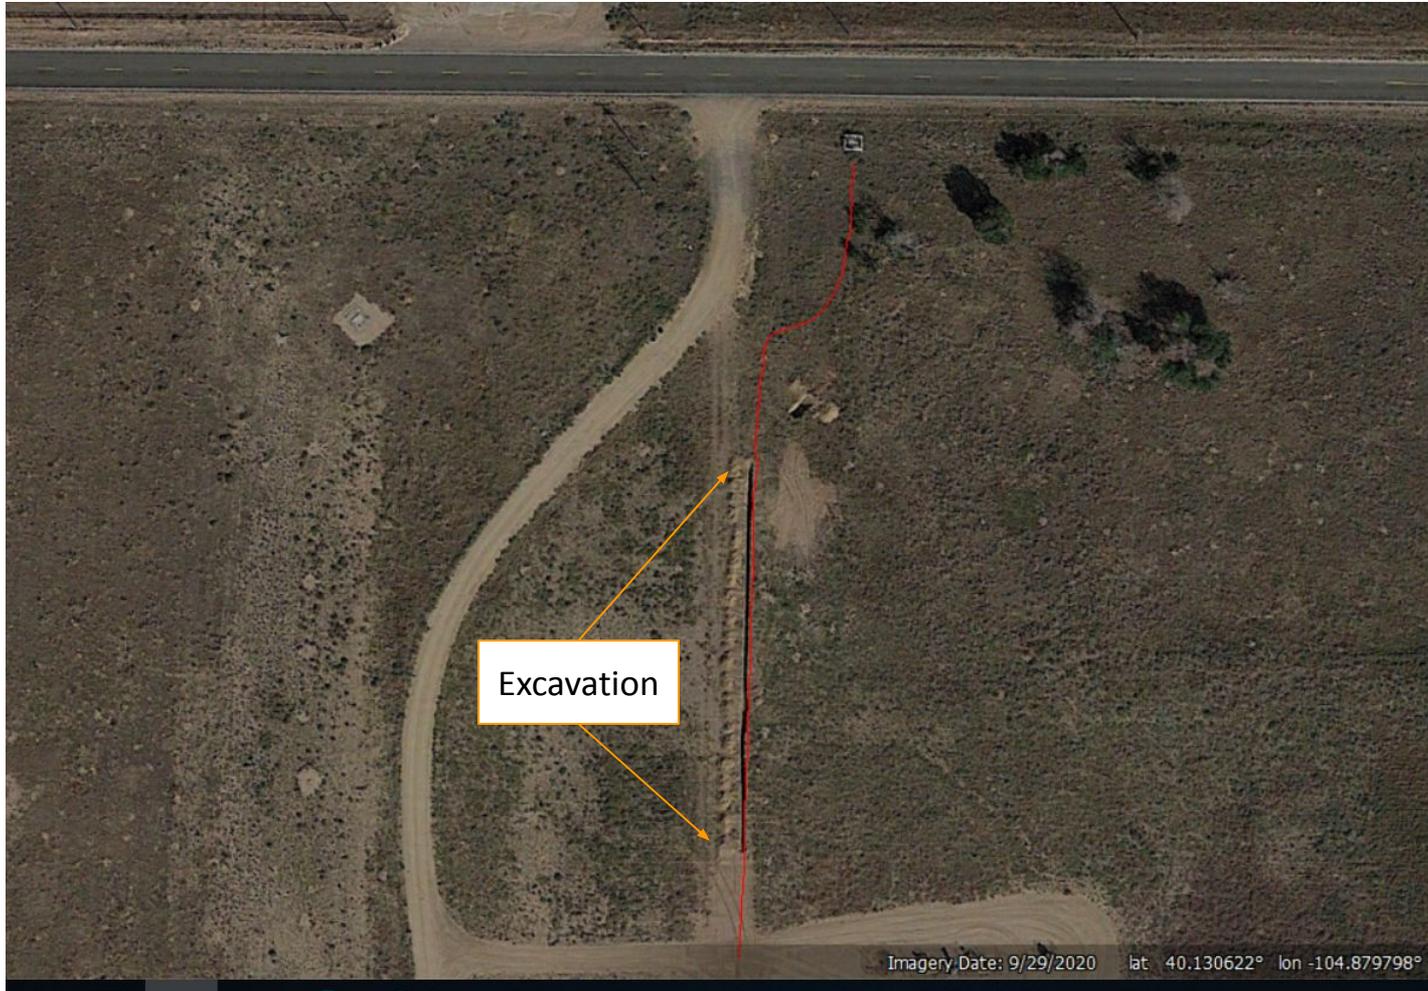
**Photo 5.** Google Earth aerial imagery taken 9/29/2020. Photo illustrates excavation of what appears to be a flowline. Complainant stated the flowline has subsided. COGCC Staff mapped the subsidence of what appears to be a flowline (red line).

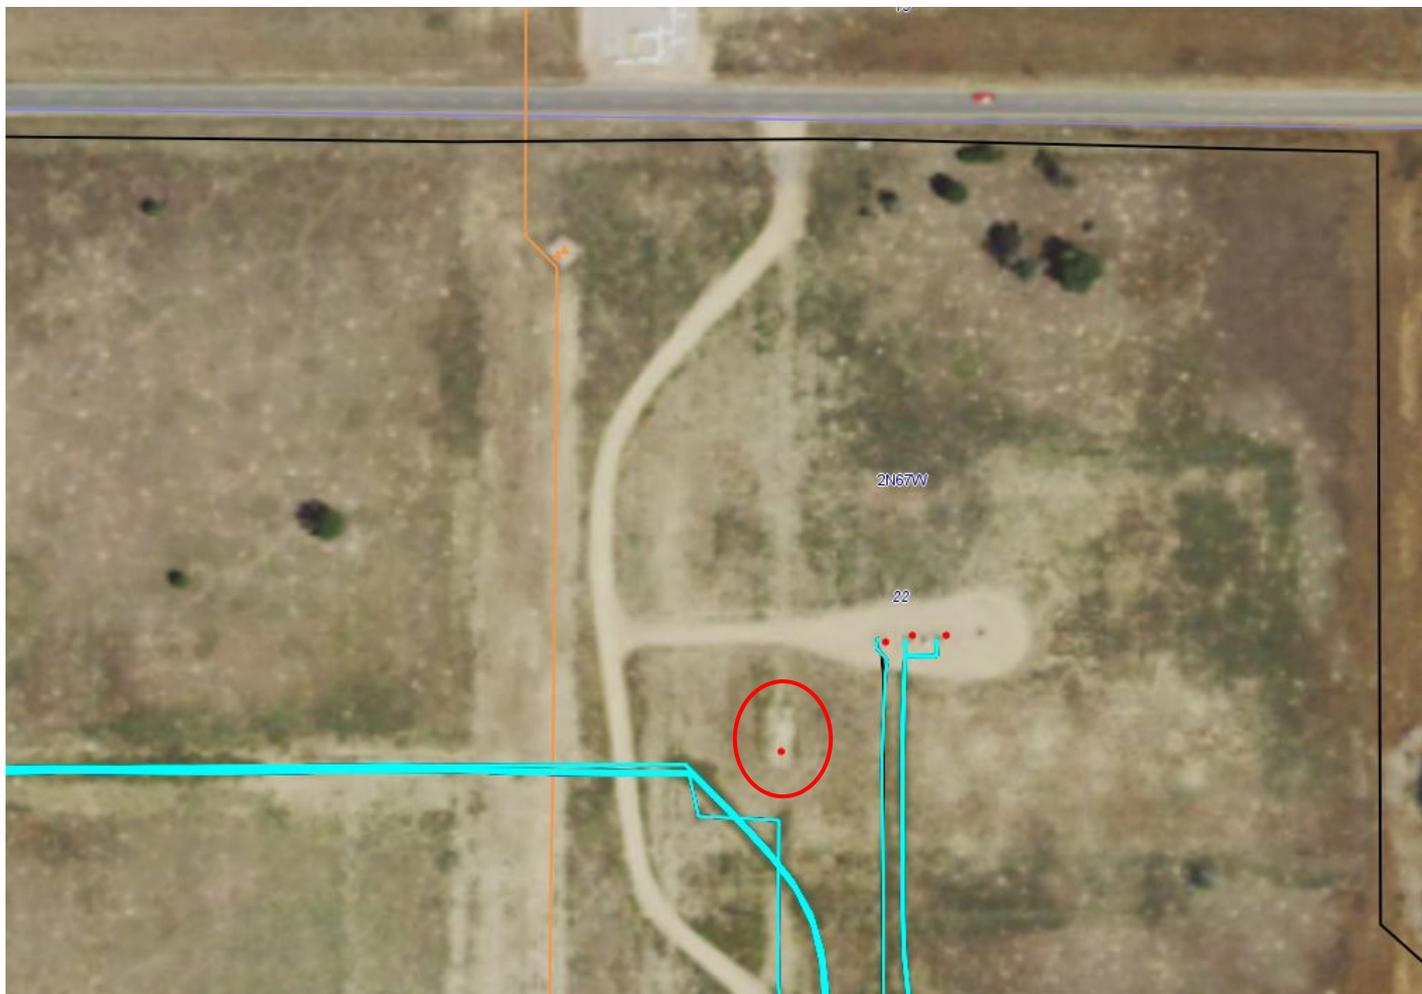
**Photo 6.** COGCC GISOnline flowline data is turned ON and there is no reported flowline traveling north from well API# 123-07870 (red circle).

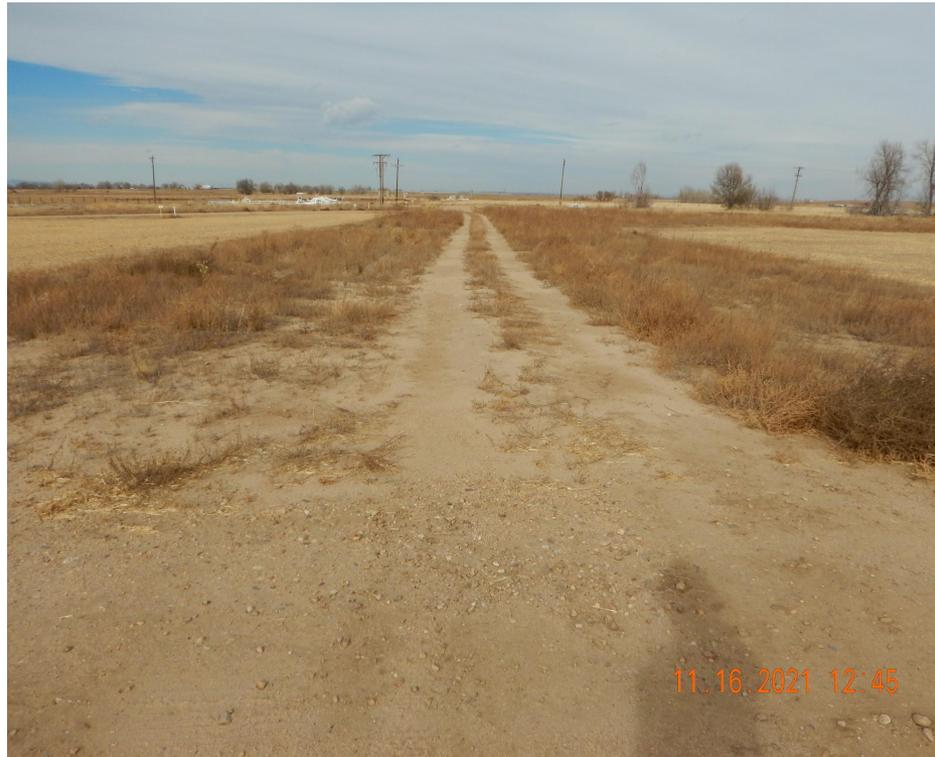
**Photo 7.** Photo taken from well API# 123-07870, facing North. Complainant has concerns that KPK is not utilizing the new Kerr McGee access road. However, this is the road that Oxy was approved to use for the Deep locations.

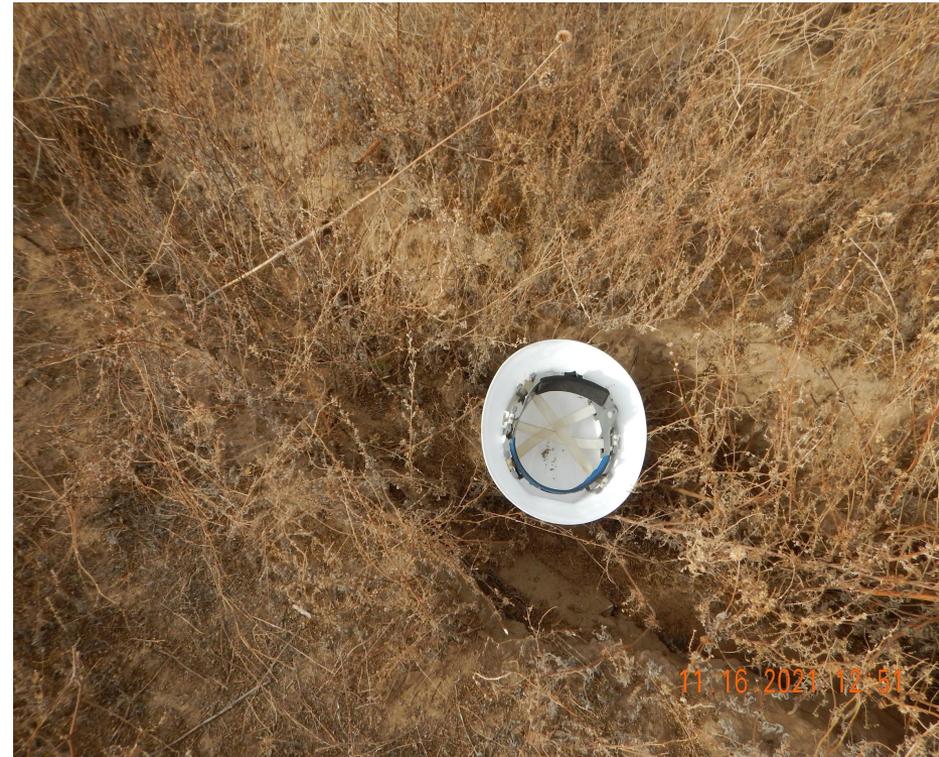
**Photo 8.** Photo taken along what is believed to be a flowline, illustrating subsidence. Subsidence was observed throughout the majority of the flowline.

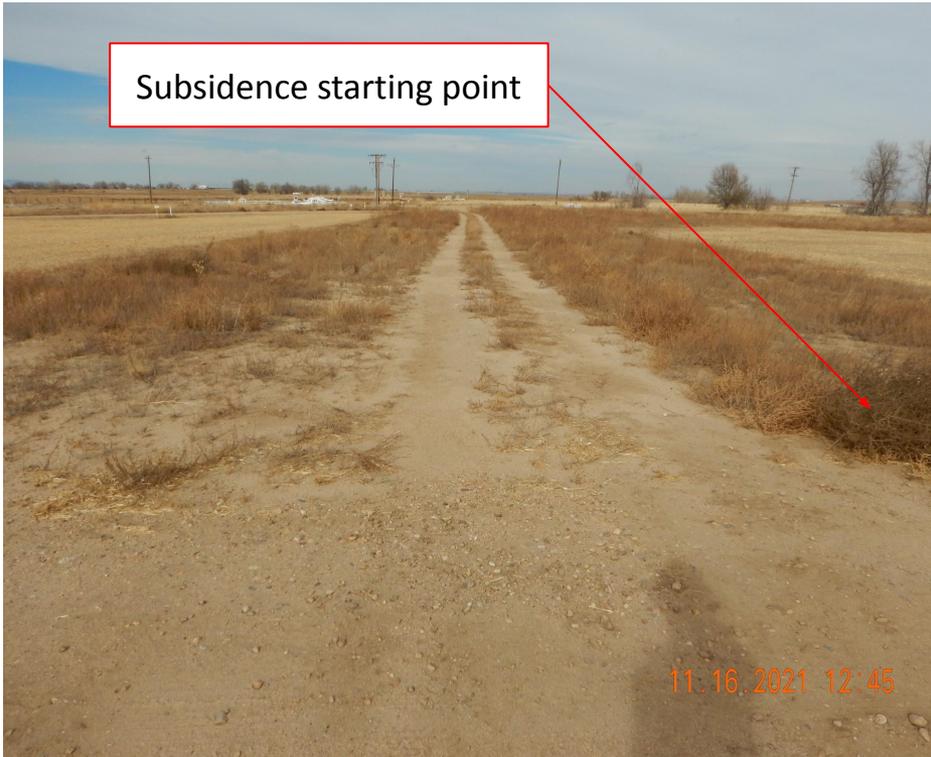
**Photo 9.** Photo taken from well API# 123-07870, facing North. Photo illustrates the approximate starting point of subsidence.

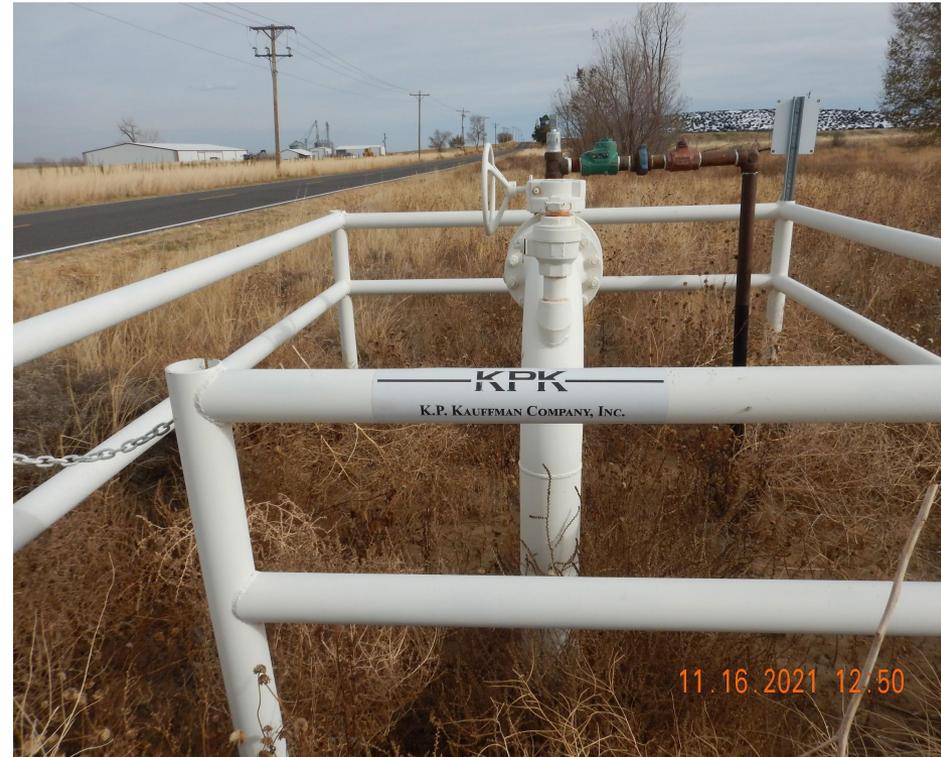
**Photo 10.** Photo taken from the believed end point of the flowline.
