Inspection Photos
Operator: Simcoe/Logos
API: 067-08731/067-08138
Date: 11/8/2021

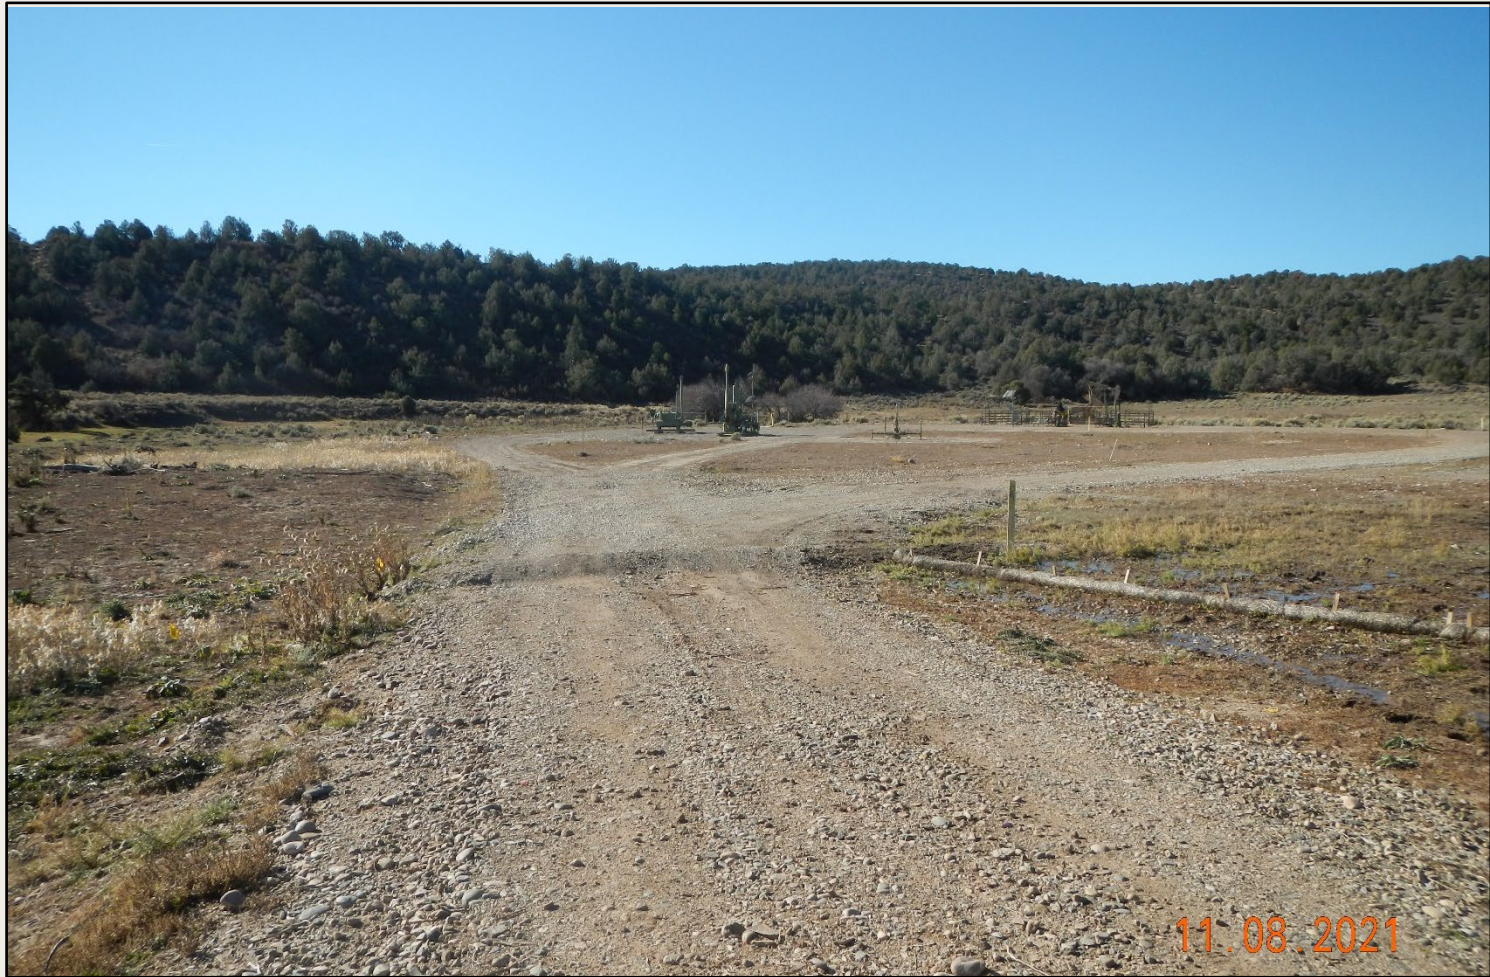
Photo 1. View of the project area from the well pad entrance facing center. Approximately 10-inch berm installed at entrance.

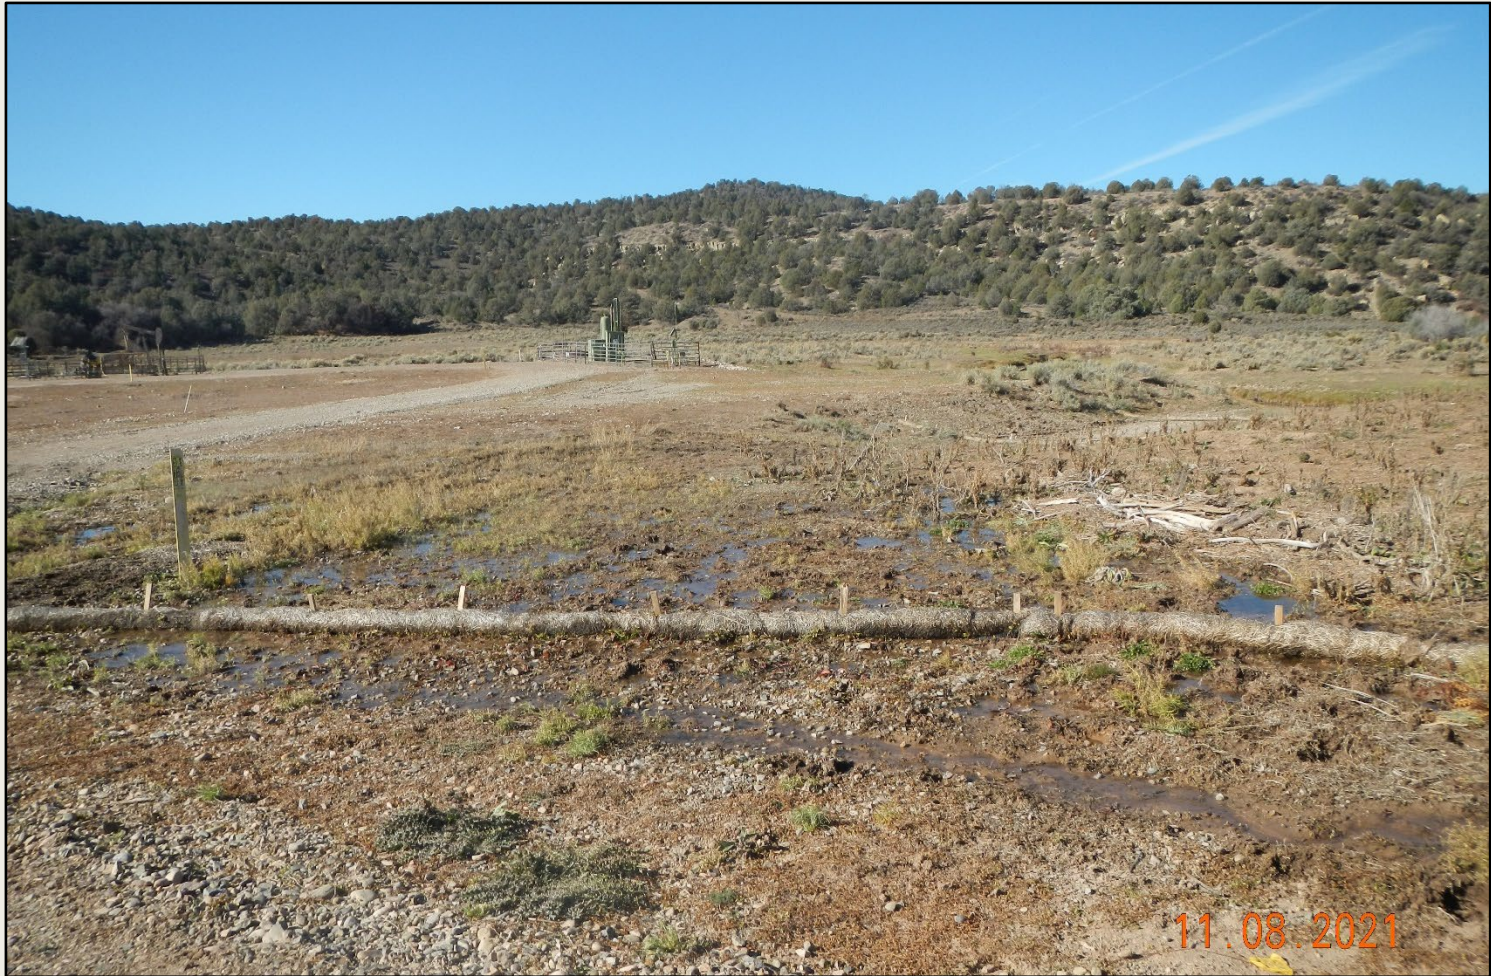
Photo 2. View of straw wattle in the northern project area. This is not an appropriate stormwater control for this area. Wattles are not properly installed.

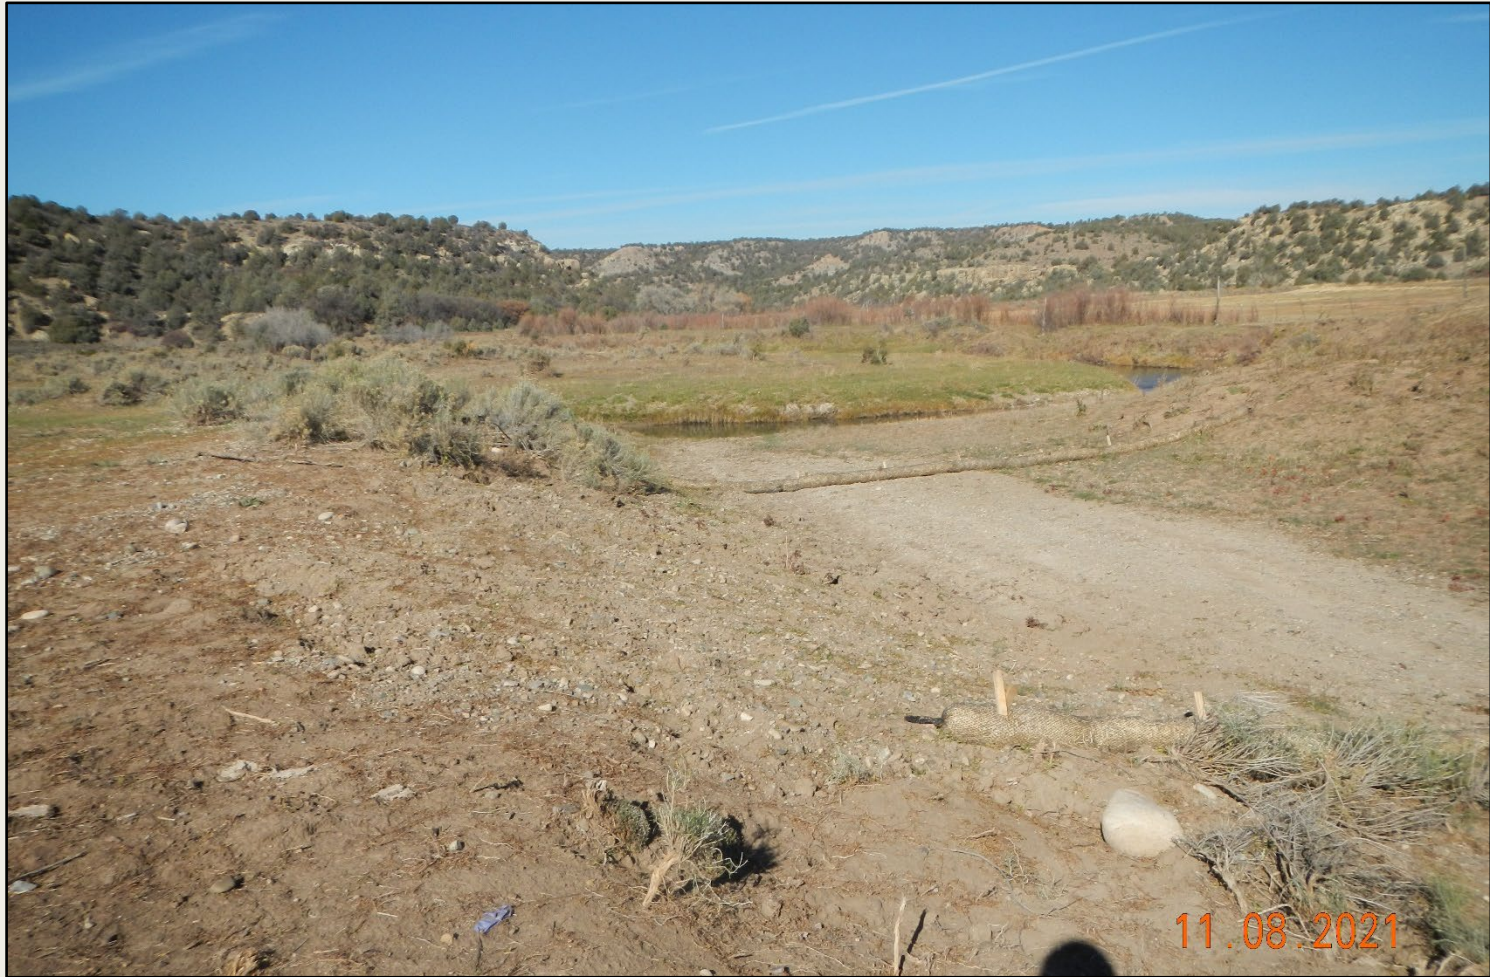
Photo 3. View of swale north of the well pad; gravel removed and wattles installed. Reseeding and stabilization not conducted on scoured soils. Wattle is not a appropriate stormwater control for this area.

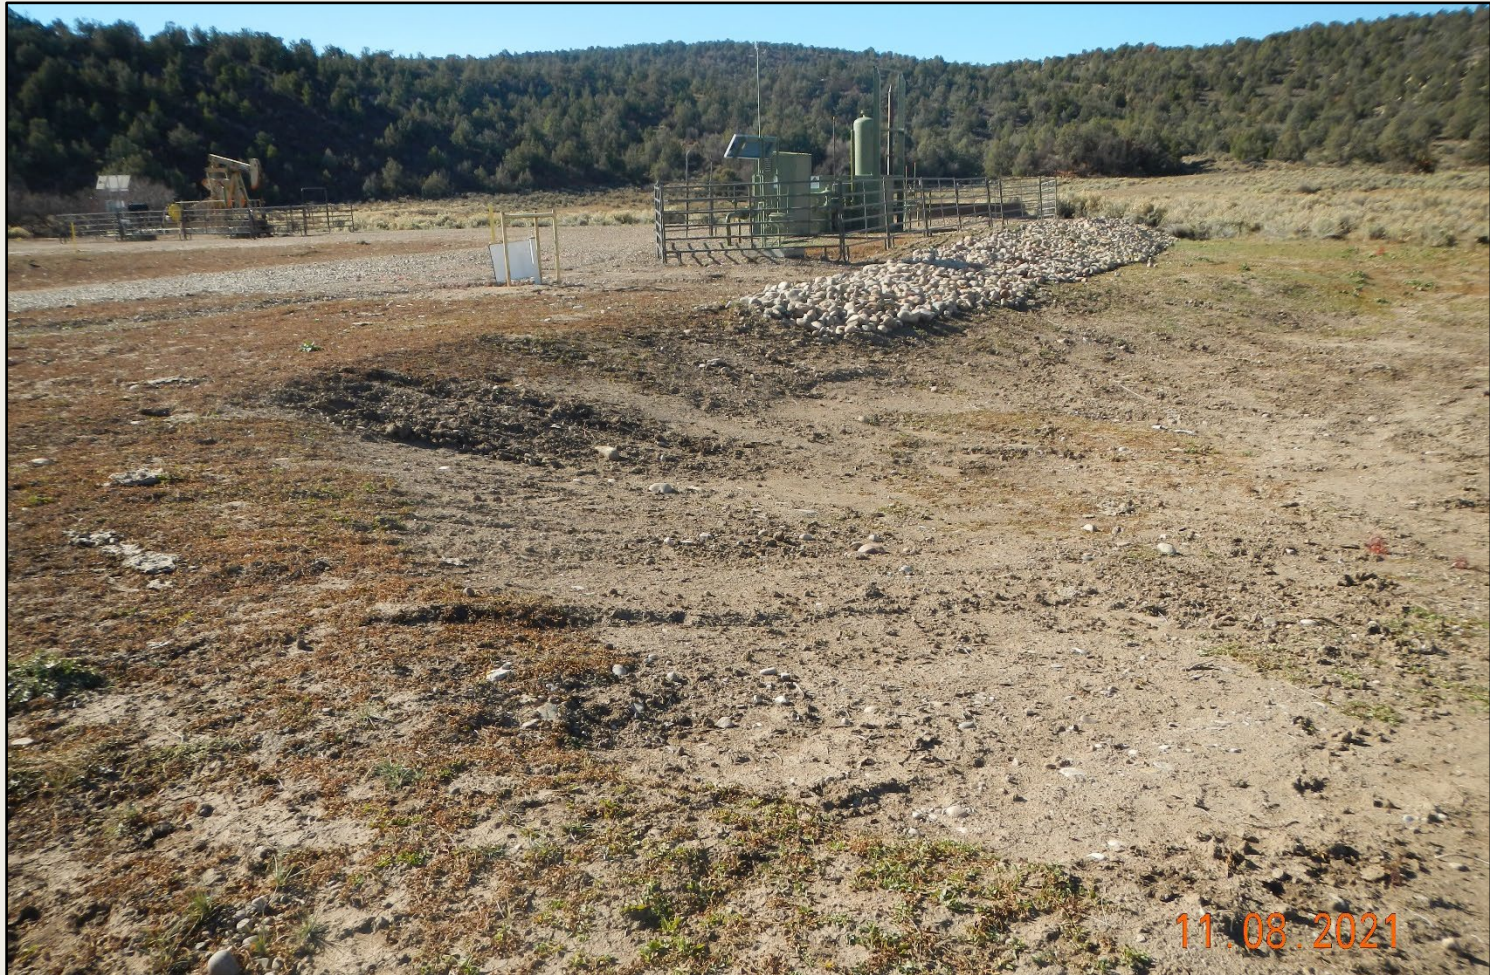
Photo 4. View of the western project area. Eroded areas are recontoured and cobbles placed on western (downstream) edge of facilities area. Cobbles are approximately 4-6 inches in diameter are not adequately sized to prevent erosion.

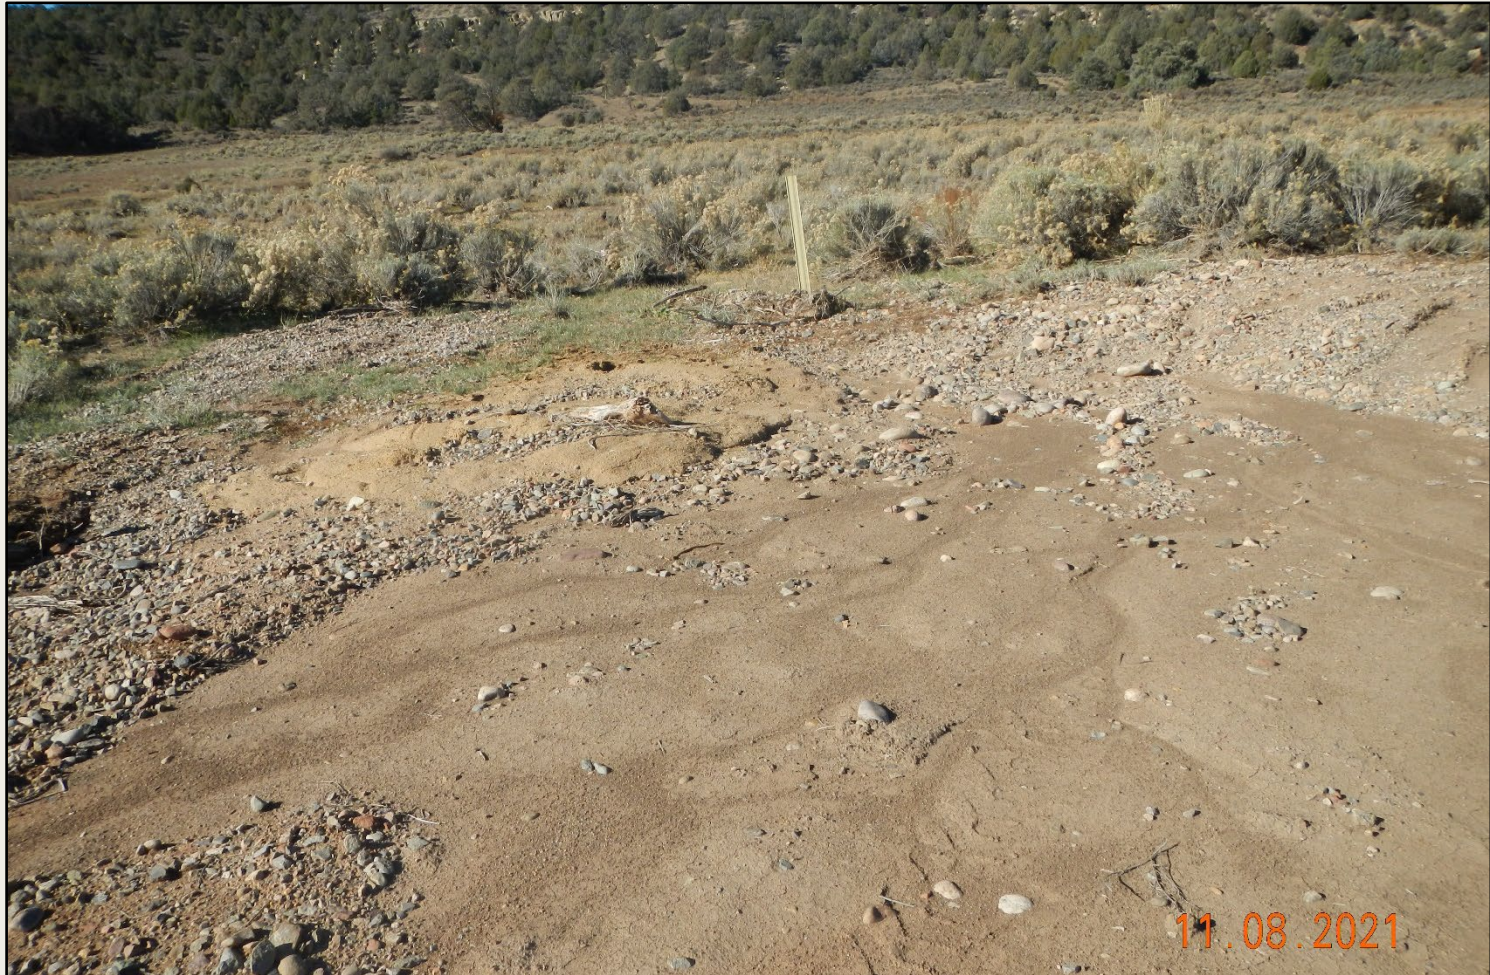
Photo 5. View of the southern project area, where gravel is washed down-slope and off of the well pad. Bare soils are scoured.

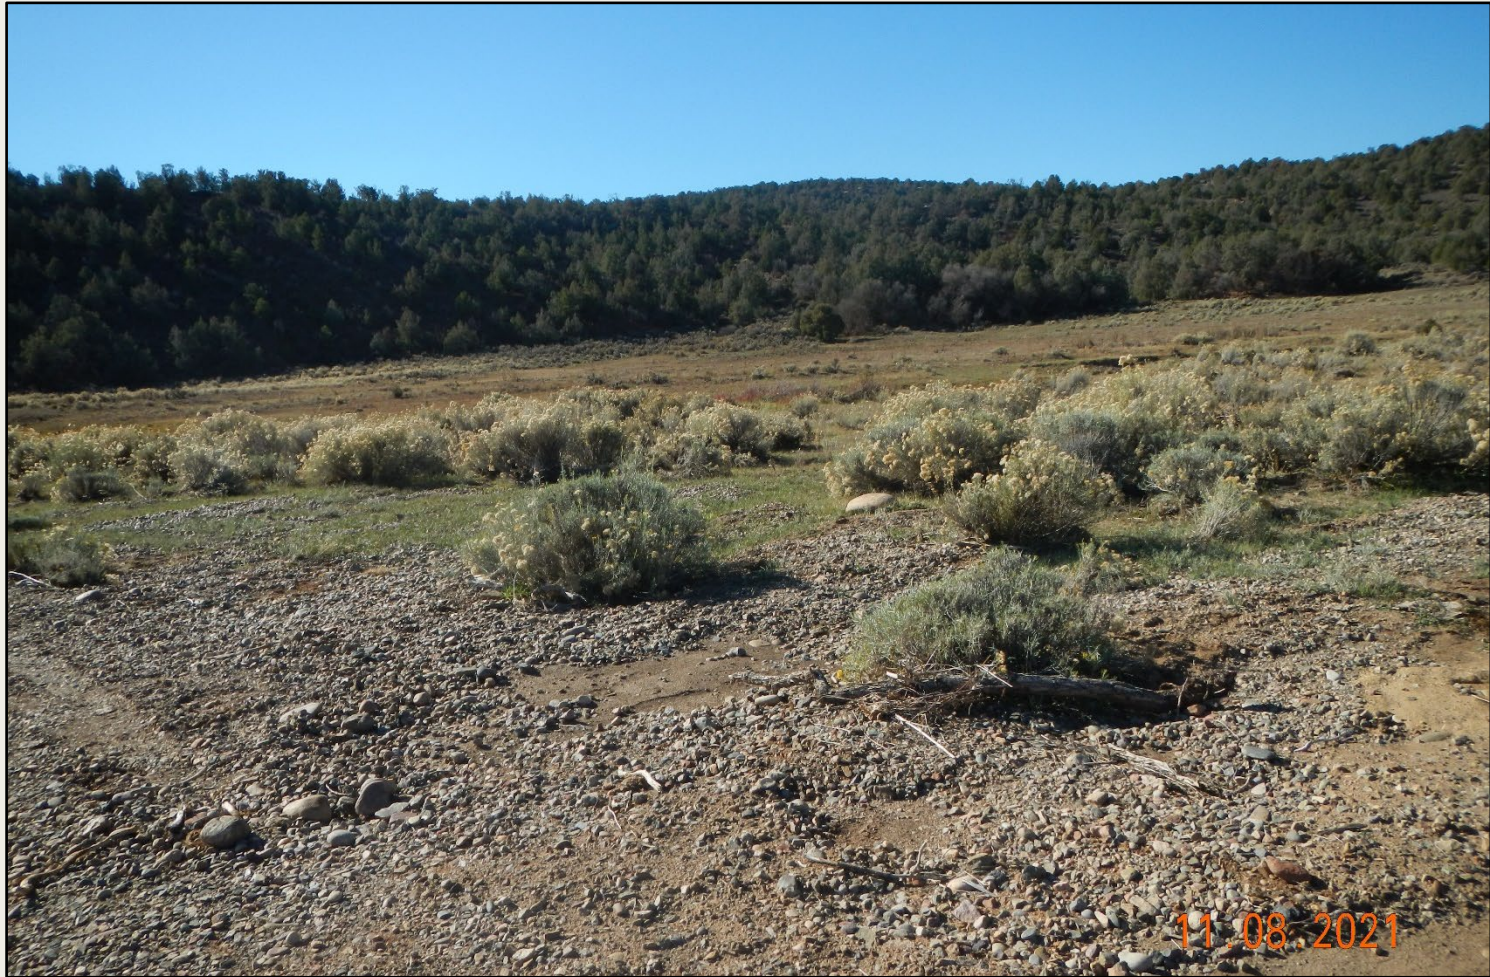
Photo 6. View of another area in the southern project area where gravel is washed off location.

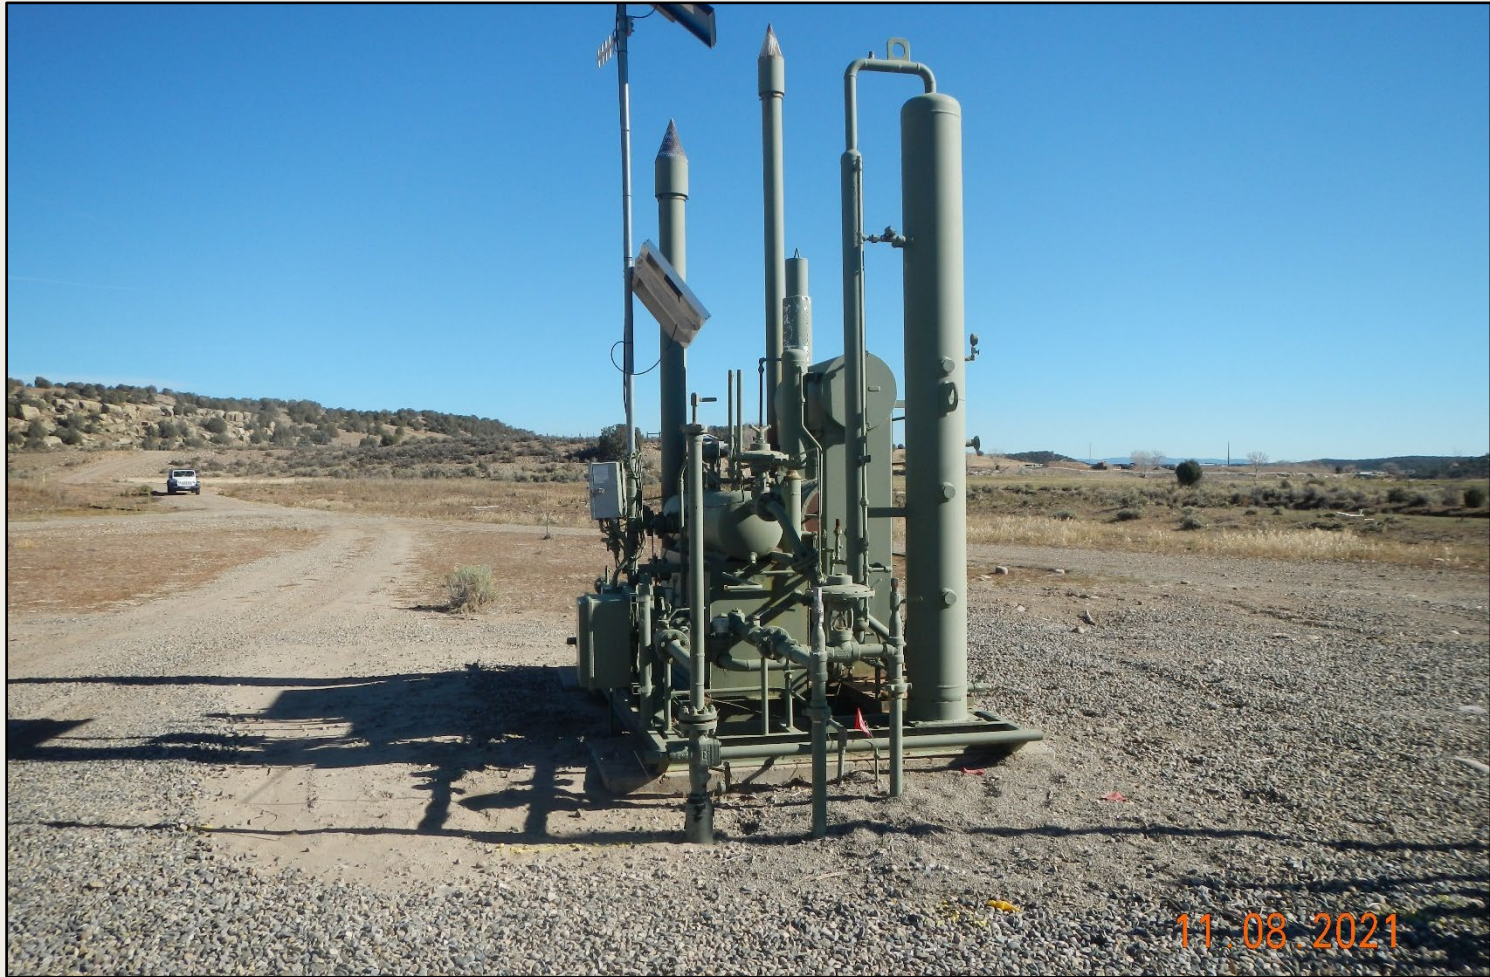
Photo 7. View of exposed facilities within the northern project area. Debris is removed.

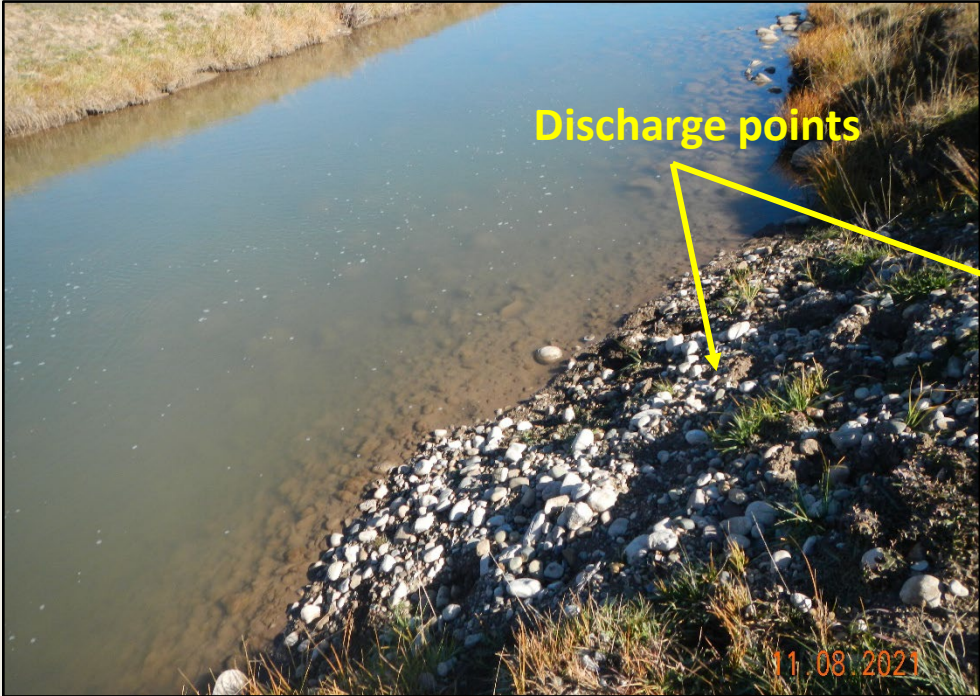
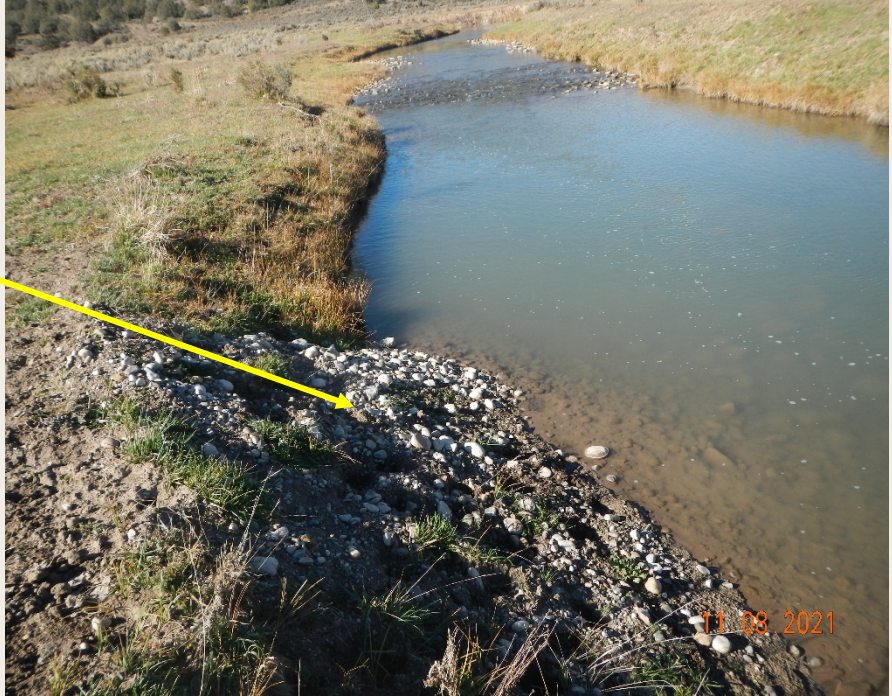
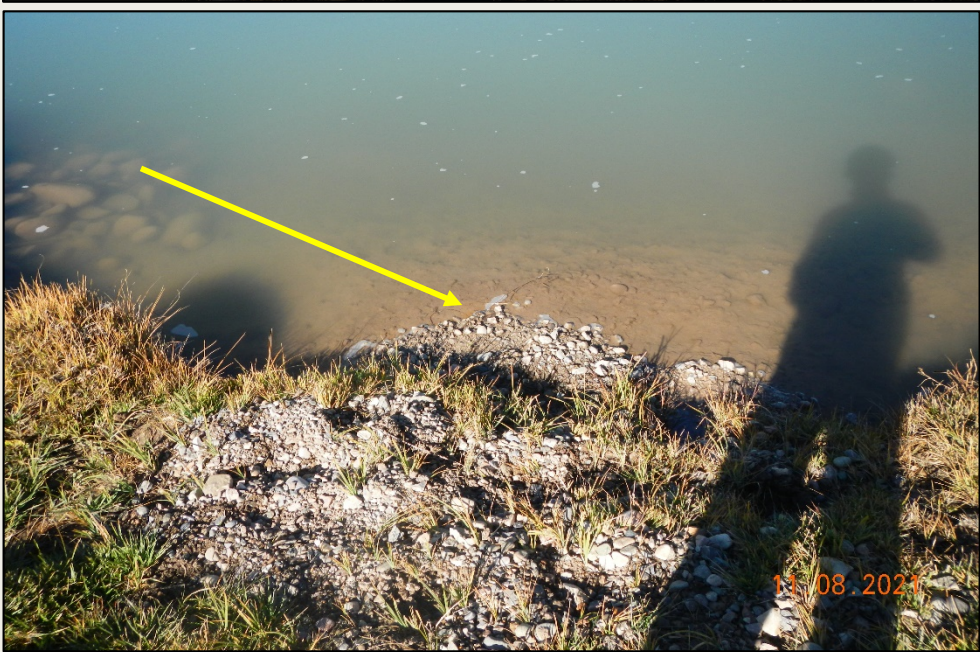
Photos 8-10 View of areas where sediment, gravel, cobble, and other materials from the well pad were discharged into the Florida River (waters of the state).
