Inspection Photos
Location Name: UPRR 48 Pan Am H1
Location ID: 319999

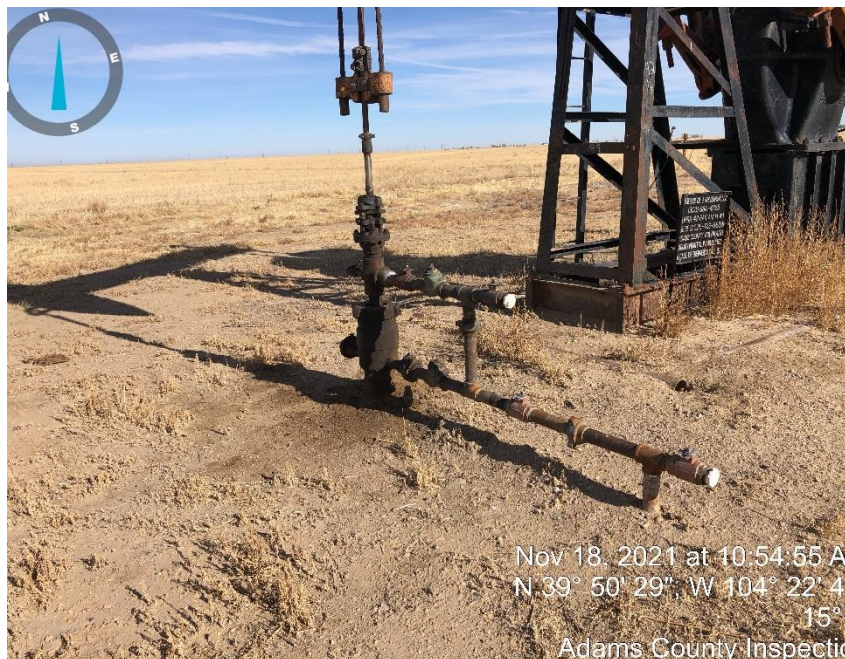
Photo #4 stained soil around well head.

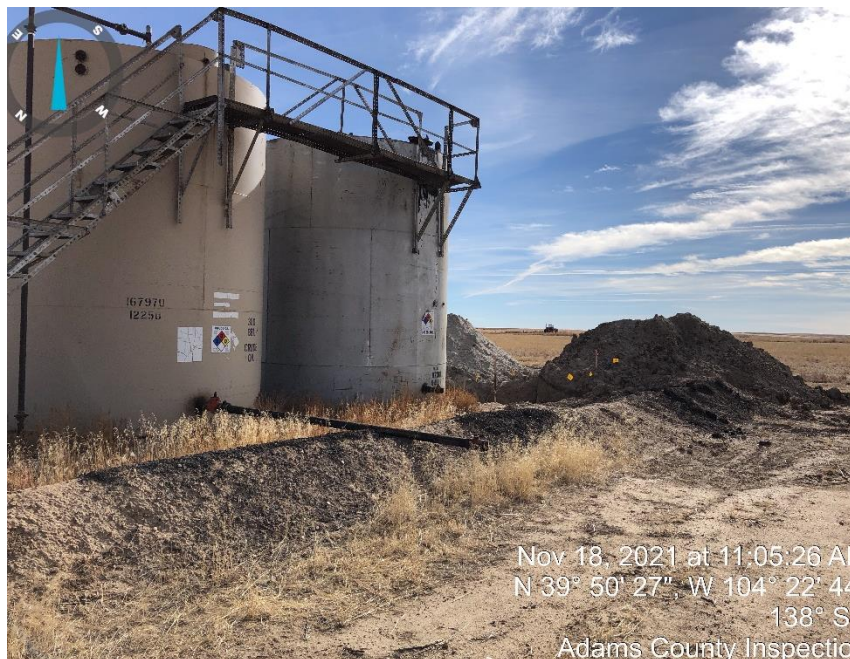
Photo #5 stained soil

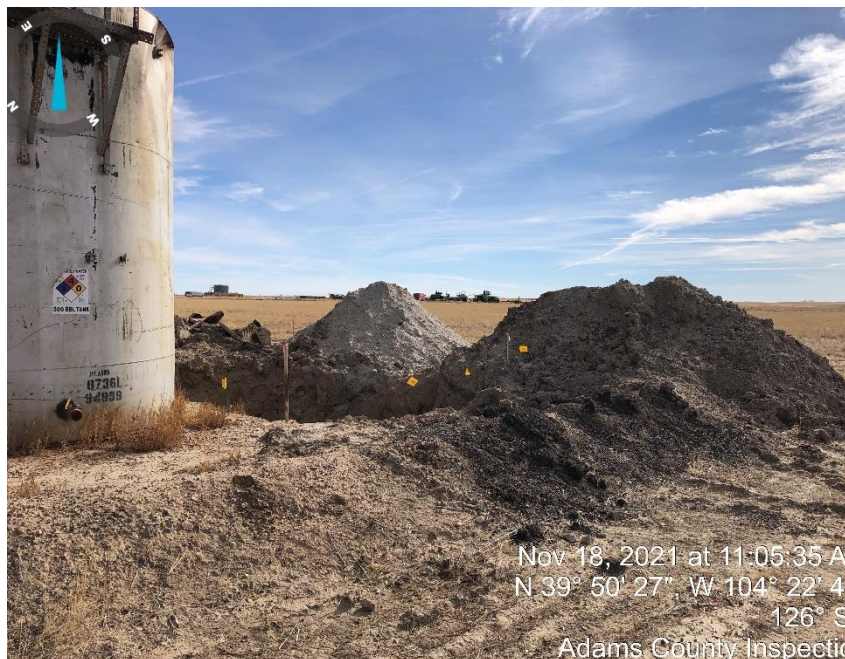
Photo #6 stained soil

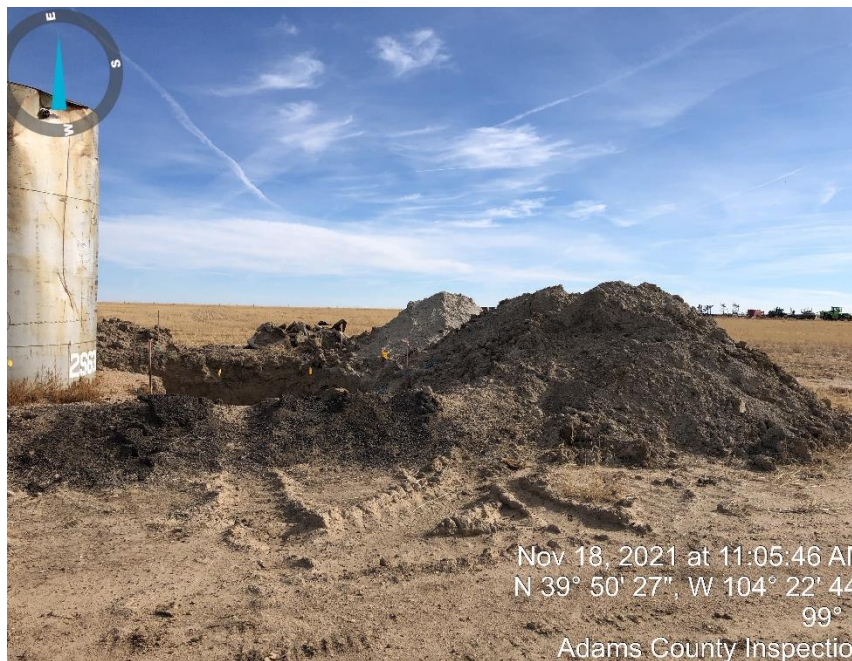
Photo #7 stained soil

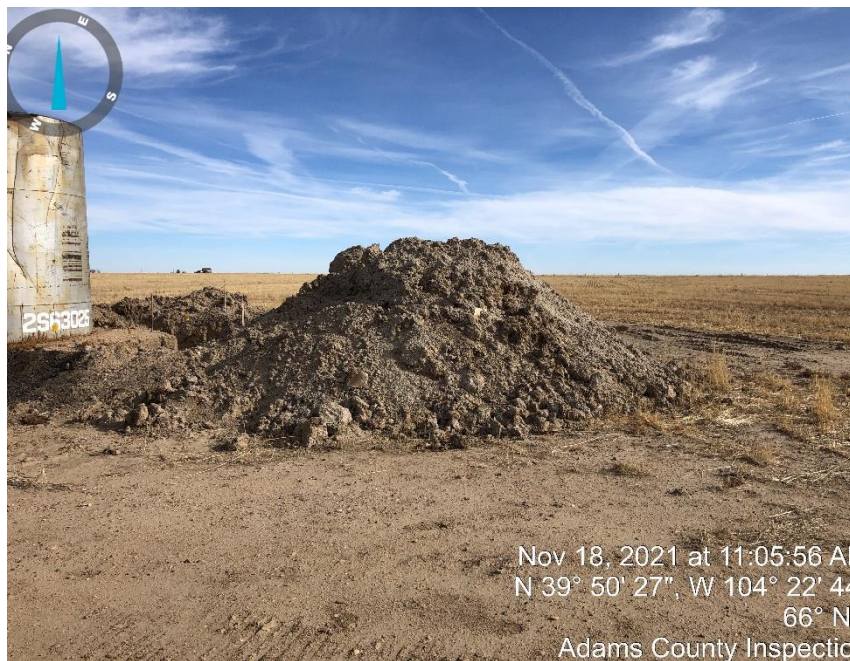
Photo #8 stained soil

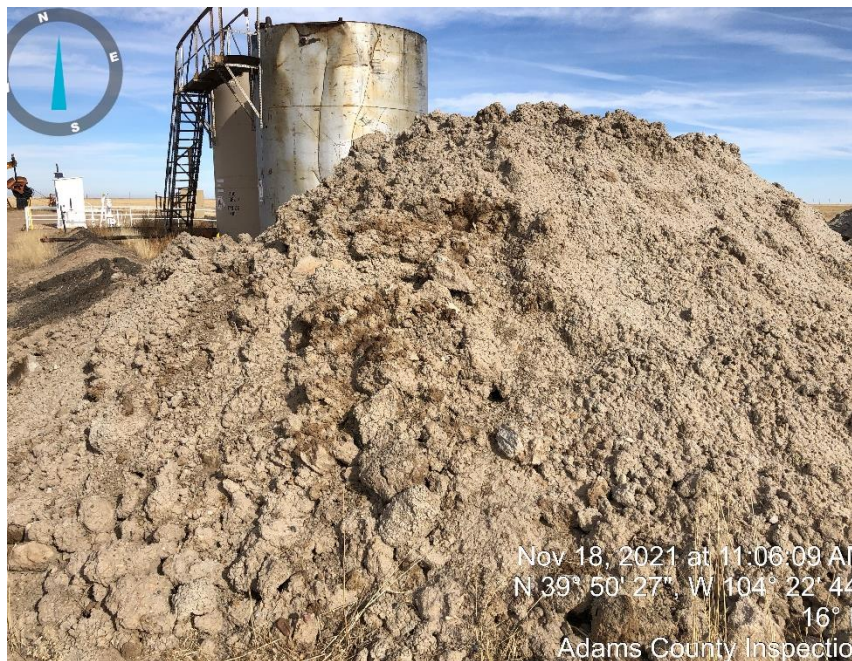
Photo #9 stained soil

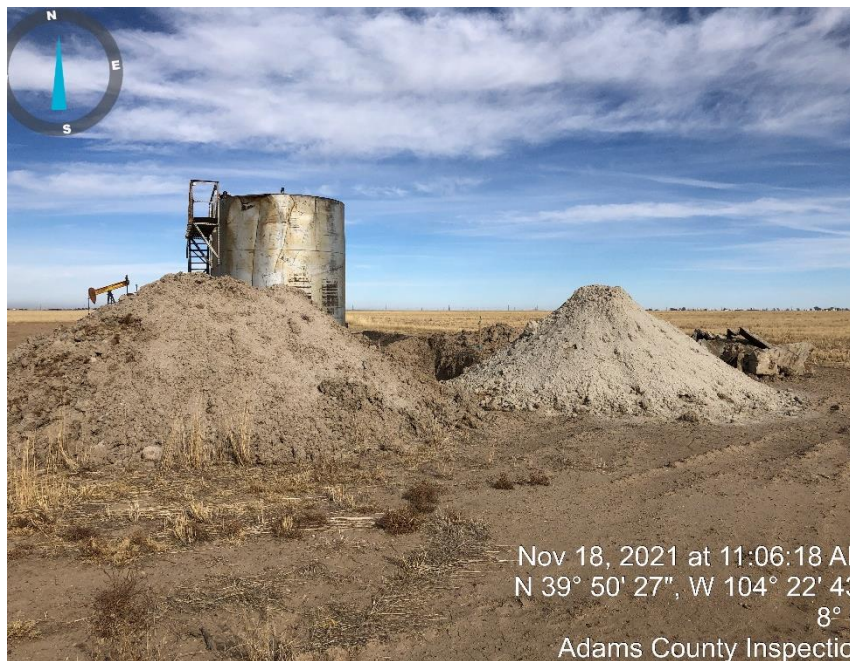
Photo # 10 stained soil

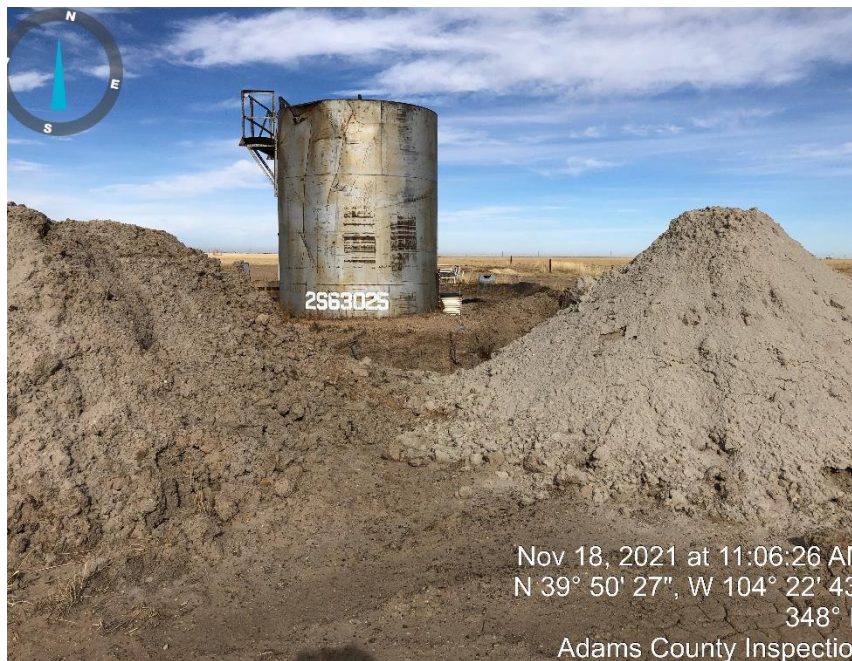
Photo #11 stained soil

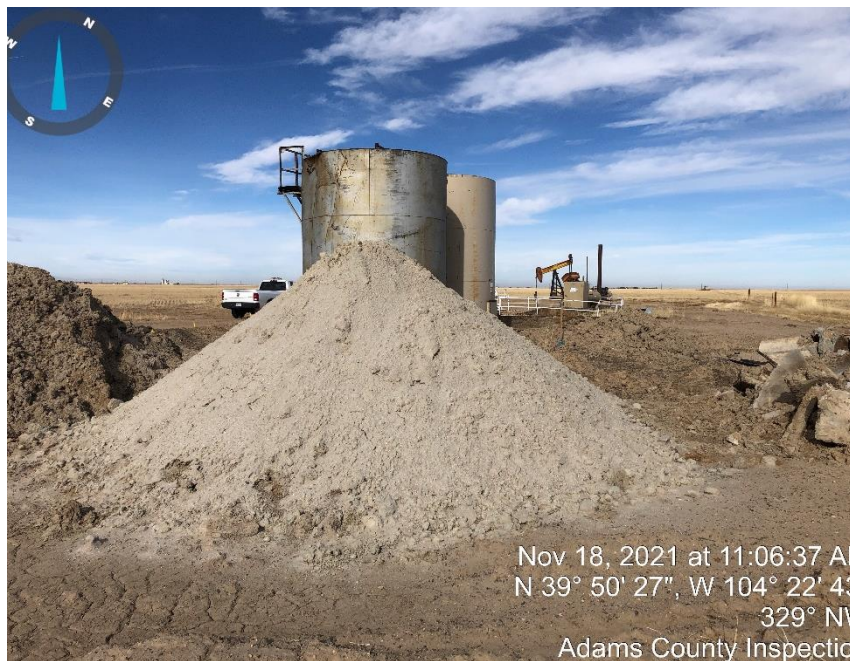
Photo #12 stained soil

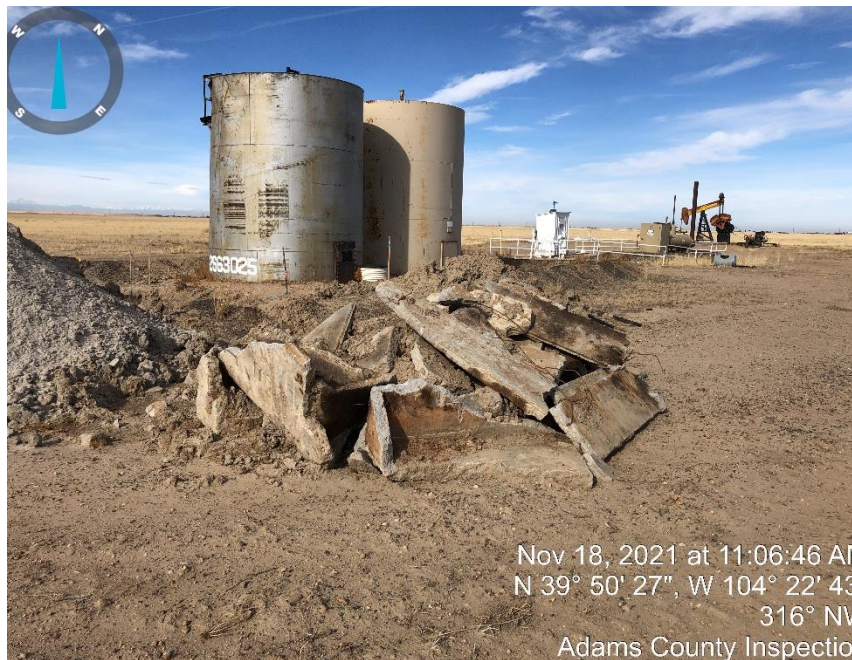
Photo #13 stained soil

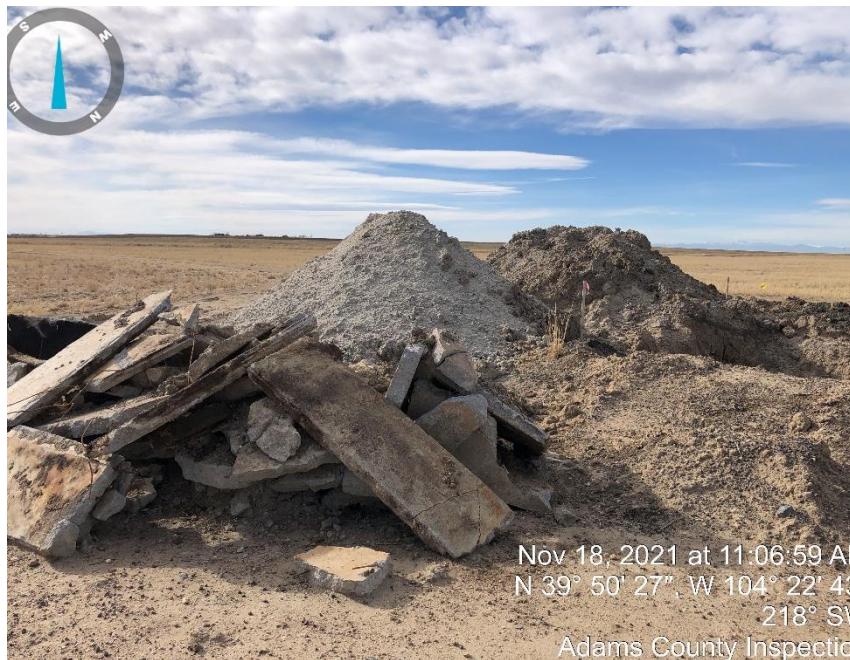
Photo #14 stained soil

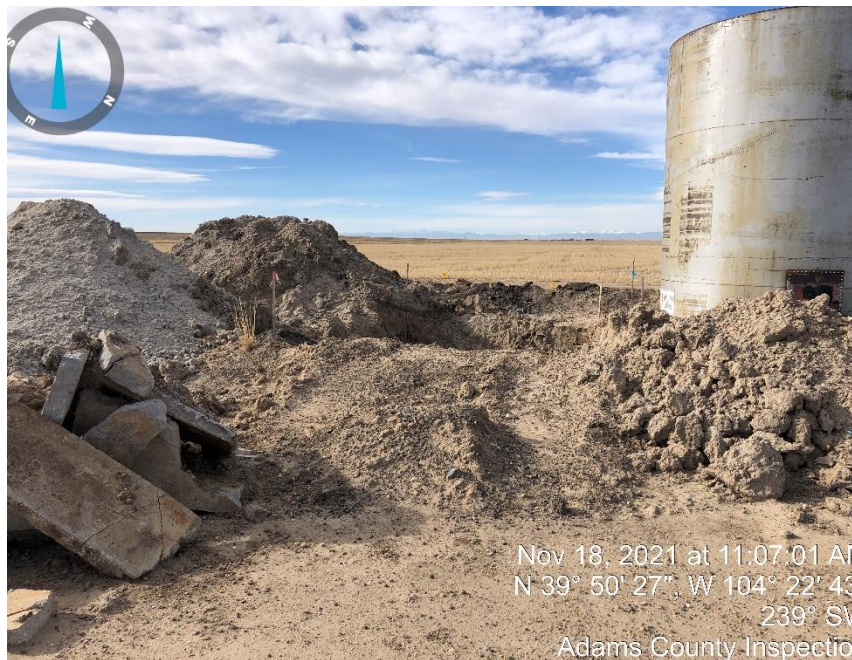
Photo # 15 stained soil

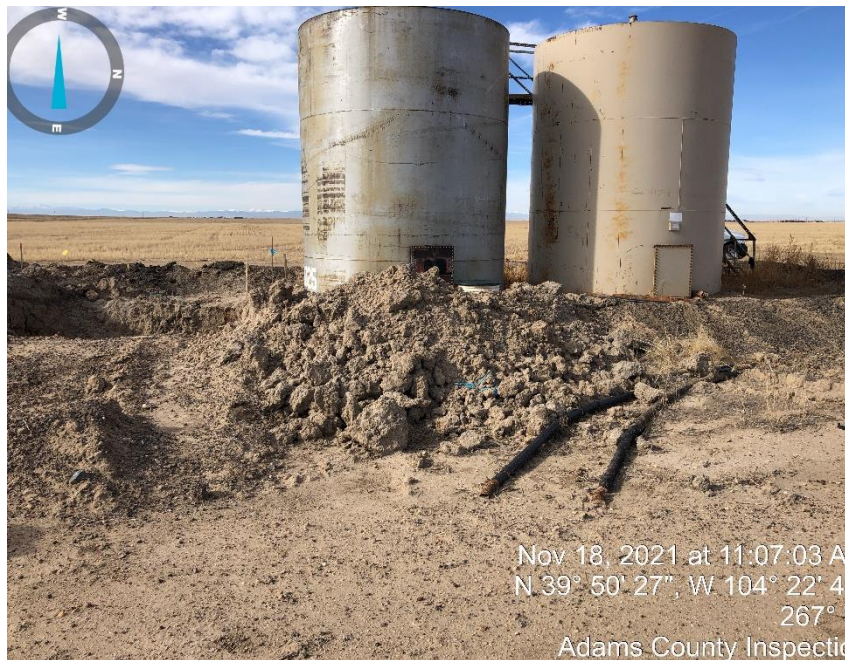
Photo #16 stained soil

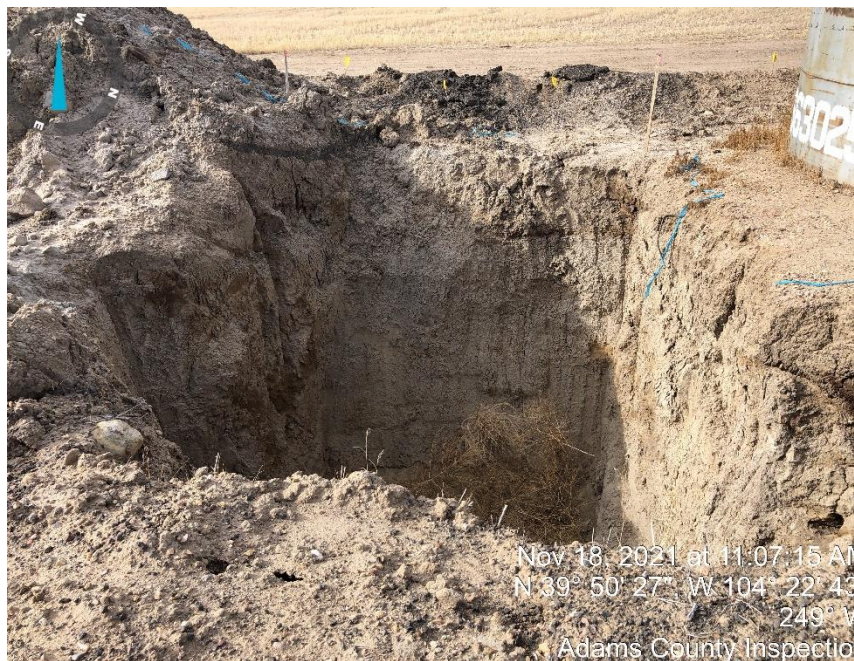
Photo #17 stained soil

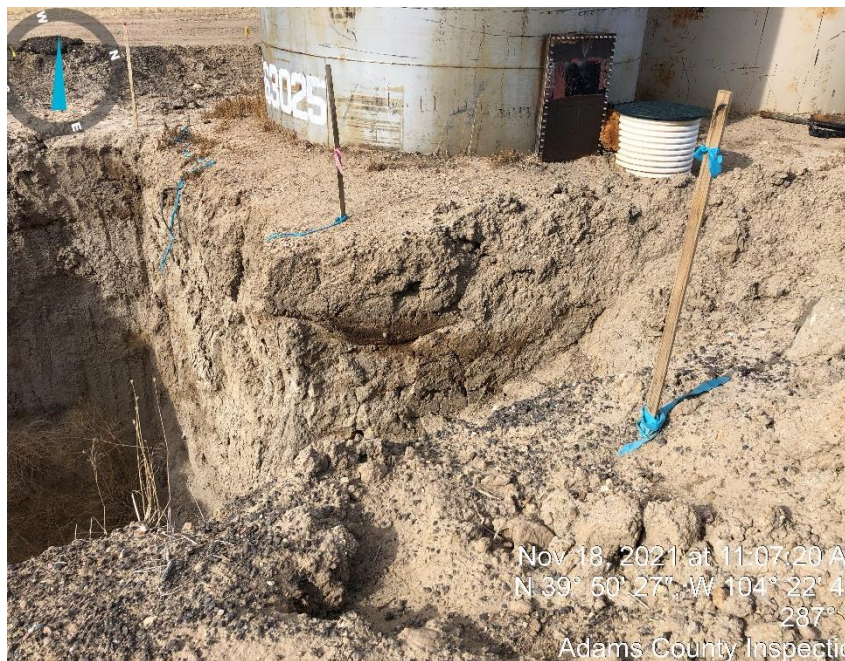
Photo #18 stained soil

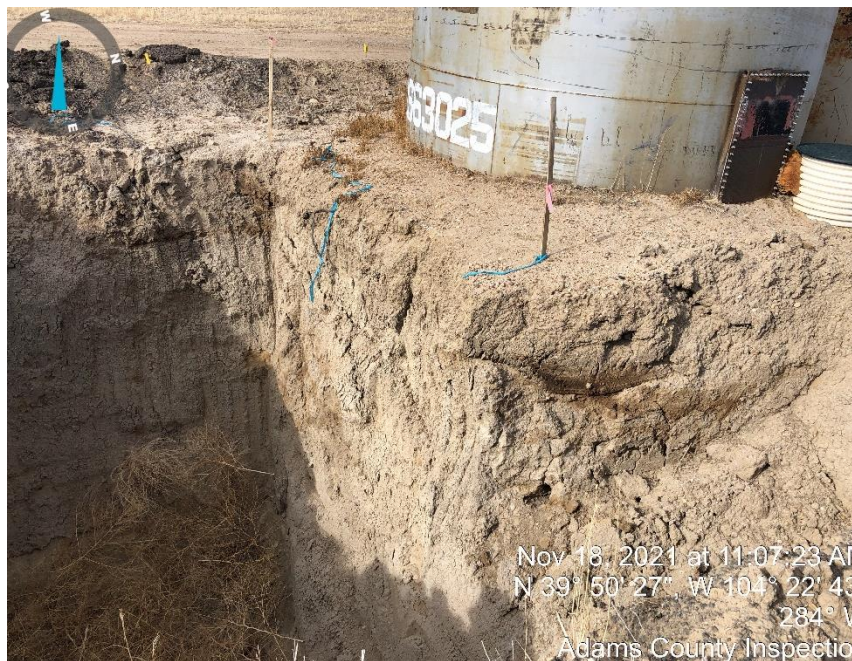
Photo #19 stained soil

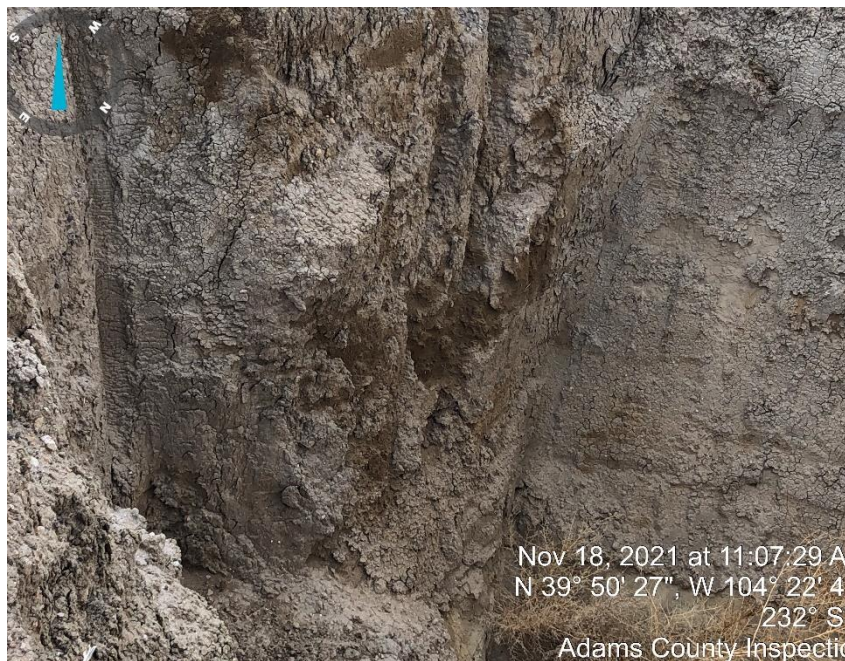
Photo #20 stained soil

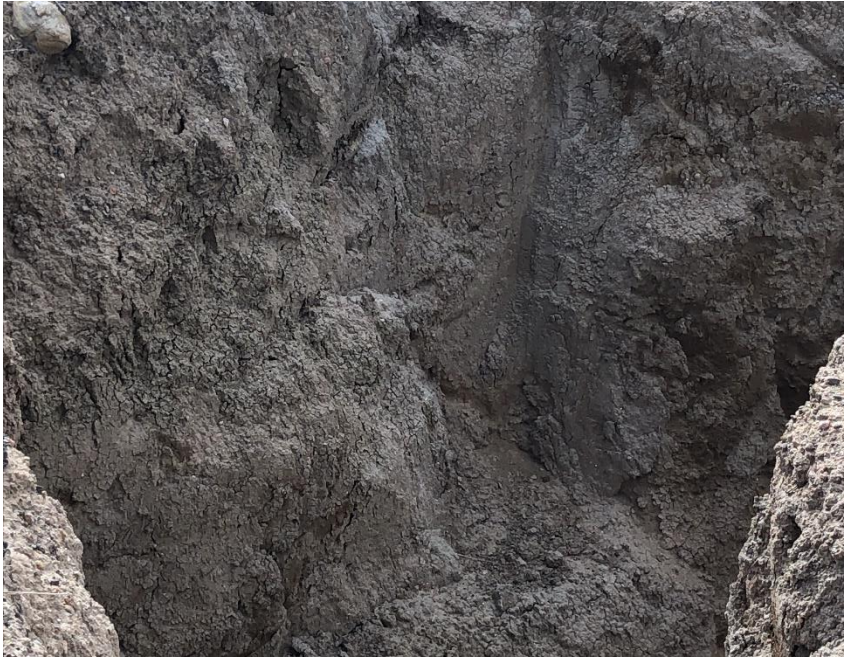
Photo # 21 stained soil

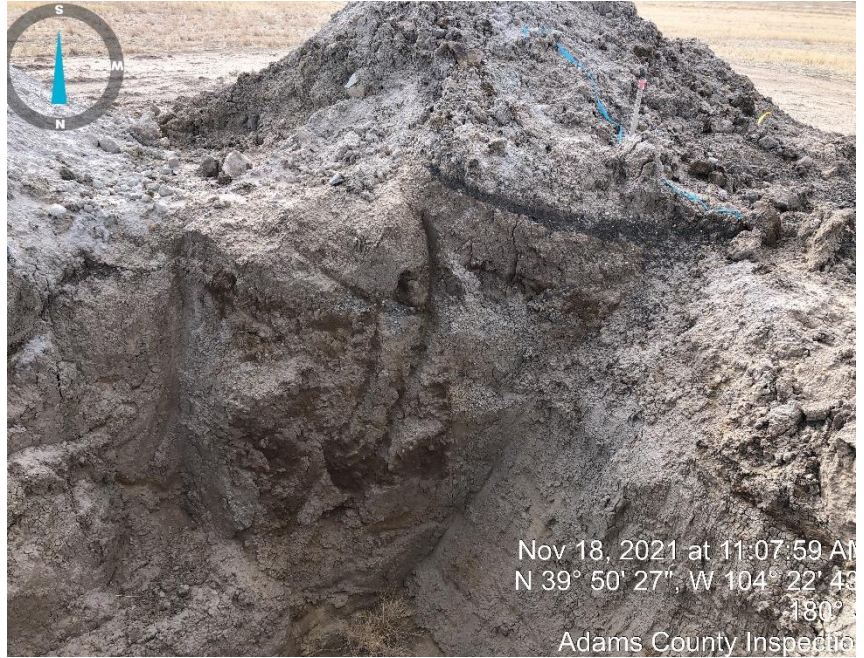
Photo #22 stained soil

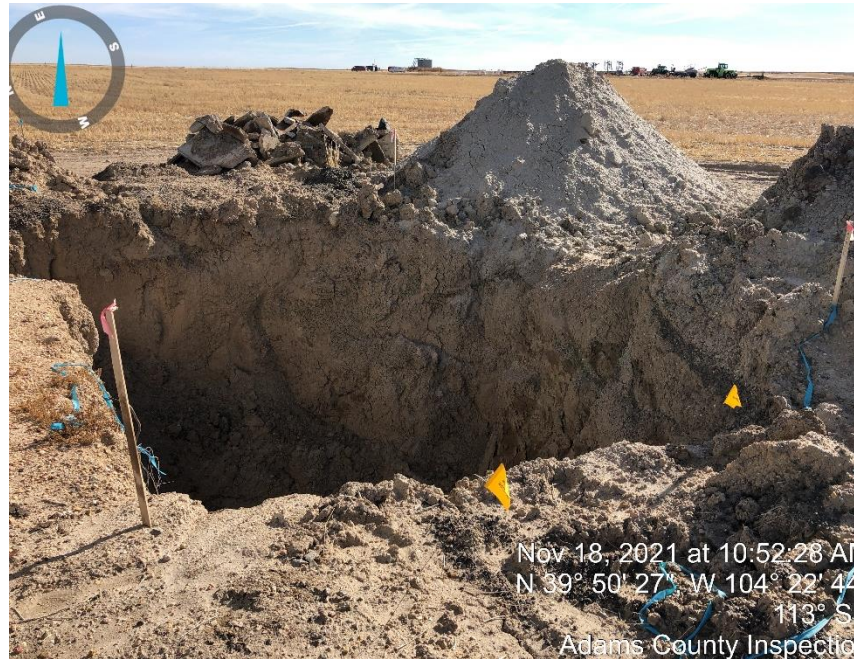
Photo #23 stained soil
