Stormwater Inspection Report

Operator:	Laramie Energy, LLC
Project:	Cascade Creek
Location:	Cascade Creek 697-16A2
Date:	Monday, November 15, 2021
Weather:	Mostly Sunny, Calm, 60°, Lo 35°

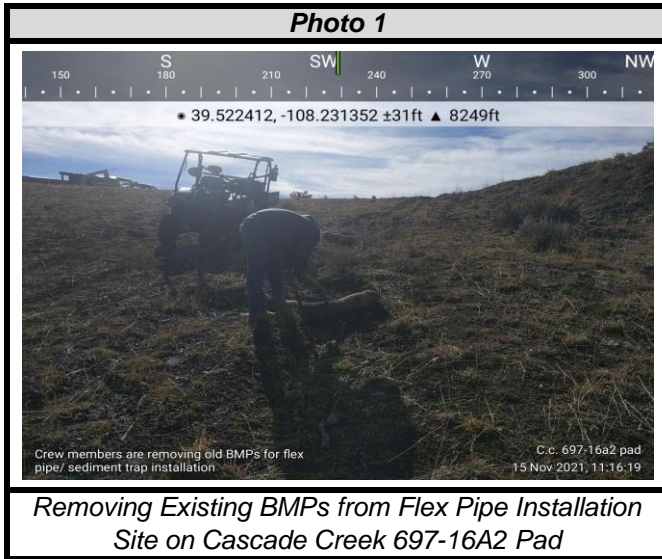
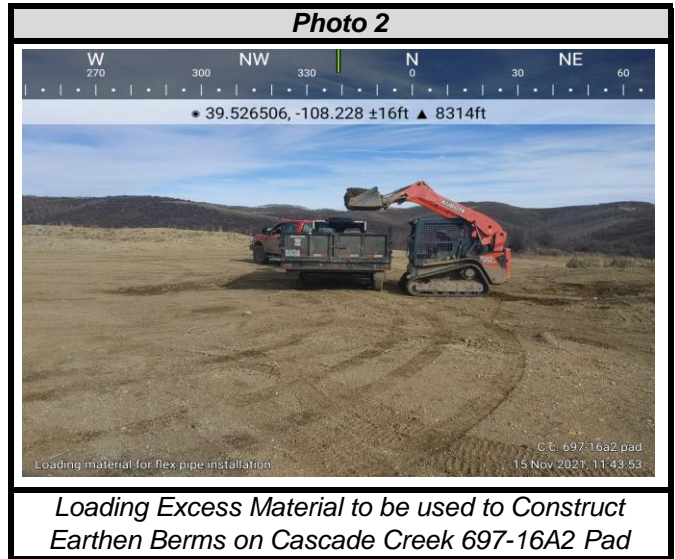
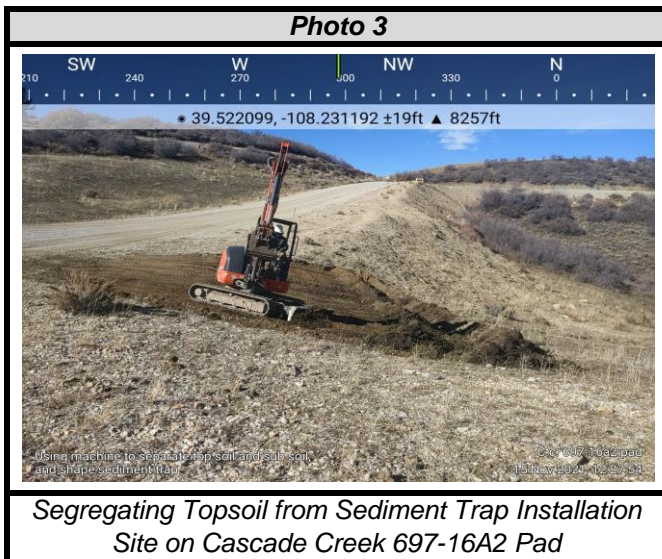
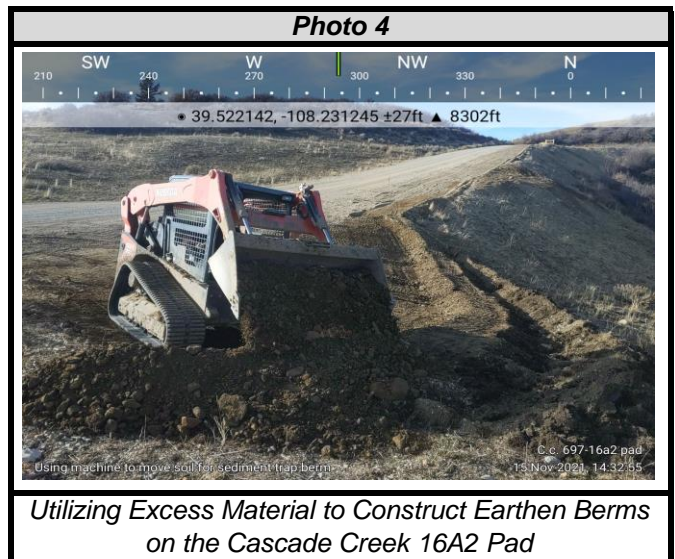
Comments / Descriptions / Explanations
<p>One BMP crew began working on the Cascade Creek 697-16A2 pad to address items called out by COGCC in Document #696203346. The crew began converting an existing channel with multiple rock sock and wattle checks installed into a sediment trap with underground flex pipe outlet. This will correct the issues identified in Photo #1, #2, and #3. A one-call is now active for the construction area to allow new excavations to occur. The crew used a skid steer and mini-ex to begin installing a sediment trap on the north side of the pad. Topsoil was segregated and preserved from the sediment trap installation site. Excess material from other areas and existing subsoil was used to begin installing containment berms which will ultimately create the sediment trap.</p>

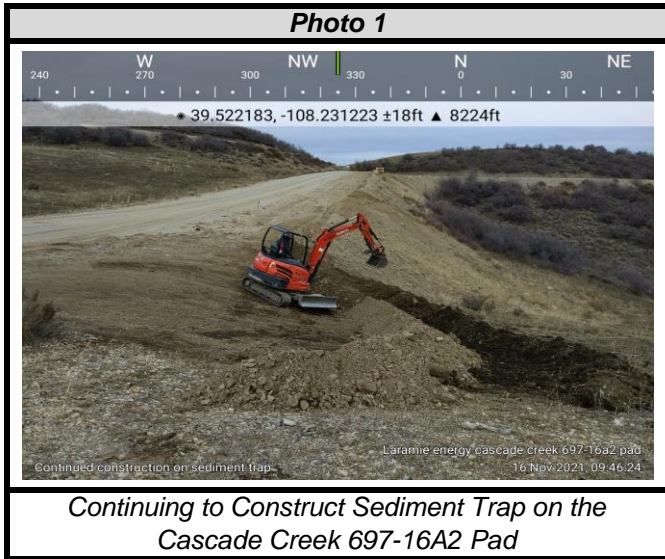
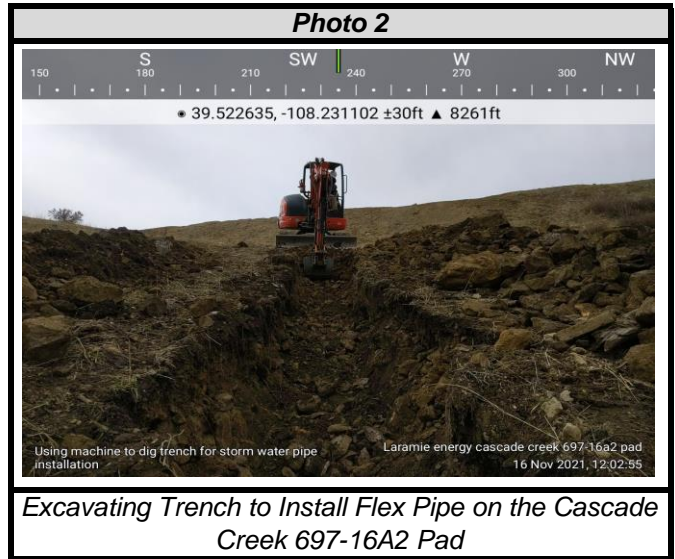
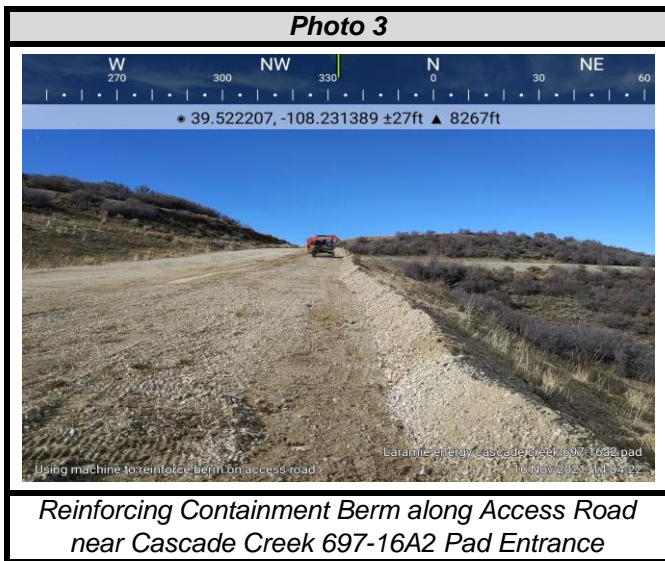
Comments / Descriptions / Explanations	
<p>One BMP crew continued to operate on the Cascade Creek 697-16A2 pad addressing issues identified by COGCC in Document #696203346. A mini-ex and skid steer were used to continue sediment trap construction and flex pipe installation on the north side of the Cascade Creek 697-16A2 pad. A skid steer was used to reinforce an existing containment berm located along the access road near the Cascade Creek 697-16A2 pad entrance.</p>

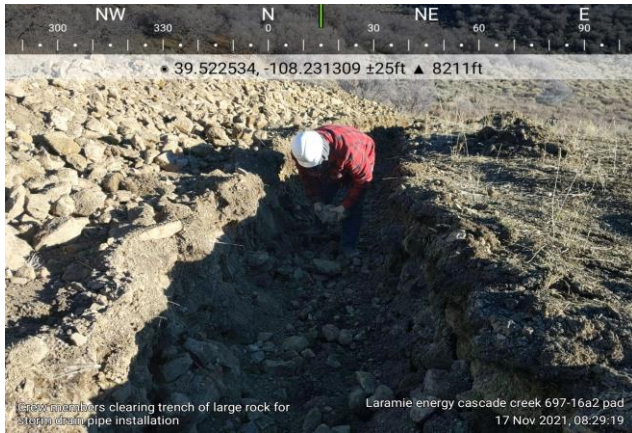
Photo 1

Removing Larger Rock from the Bottom of the Excavation by Hand

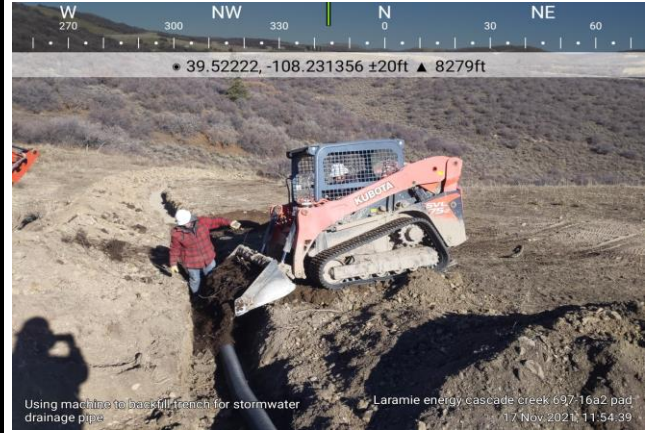
Photo 2

Backfilling Flex Pipe Installation on the Cascade Creek 697-16A2 Pad

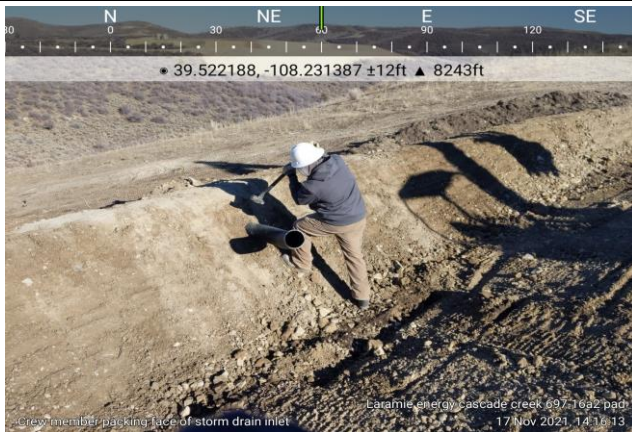
Photo 3

Packing Inlet Flex Hose Face to Create Positive Seal on Cascade Creek 697-16A2 Pad

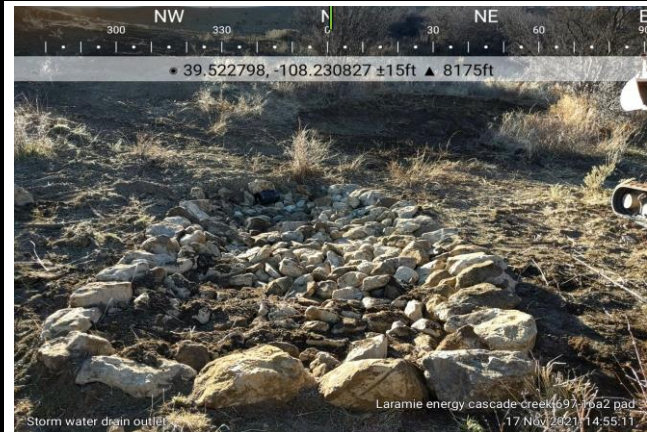
Photo 4

Flex Pipe Outlet and Rock Apron on Cascade Creek 697-16A2 Pad

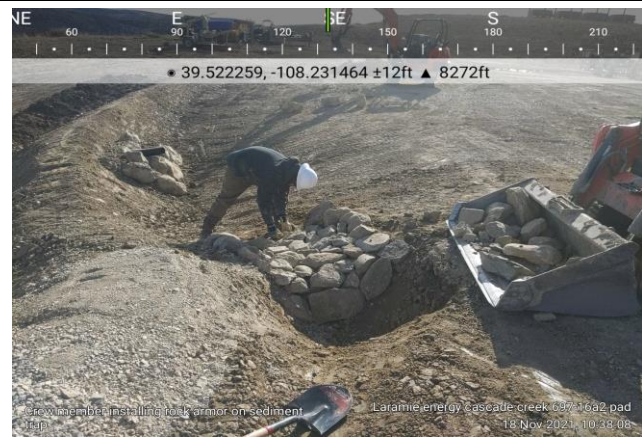
Photo 1

Installing Rock Apron on the Cascade Creek 697-16A2 Pad

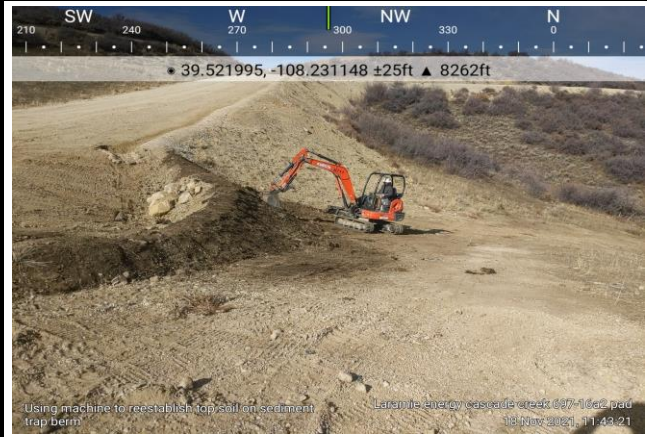
Photo 2

Redistributing Previously Segregated Topsoil over Sediment Trap Berm on CC 697-16A2

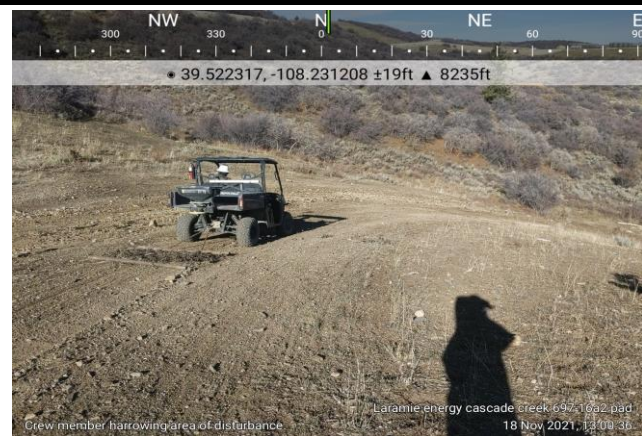
Photo 3

Harowing Seed Broadcasted over Disturbed Soils on Cascade Creek 697-16A2 Pad

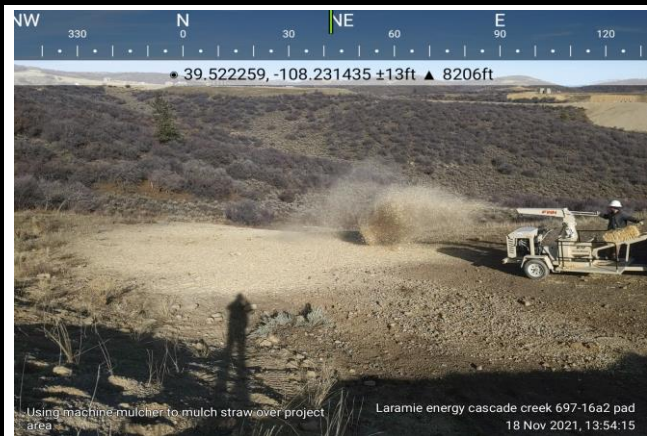
Photo 4

Applying Straw Mulch on Cascade Creek 697-16A2 Pad
