Inspection Photos

API: 071-06141

Operator: OGRIS OPERATING LLC

Inspection Date: 11/19/2021

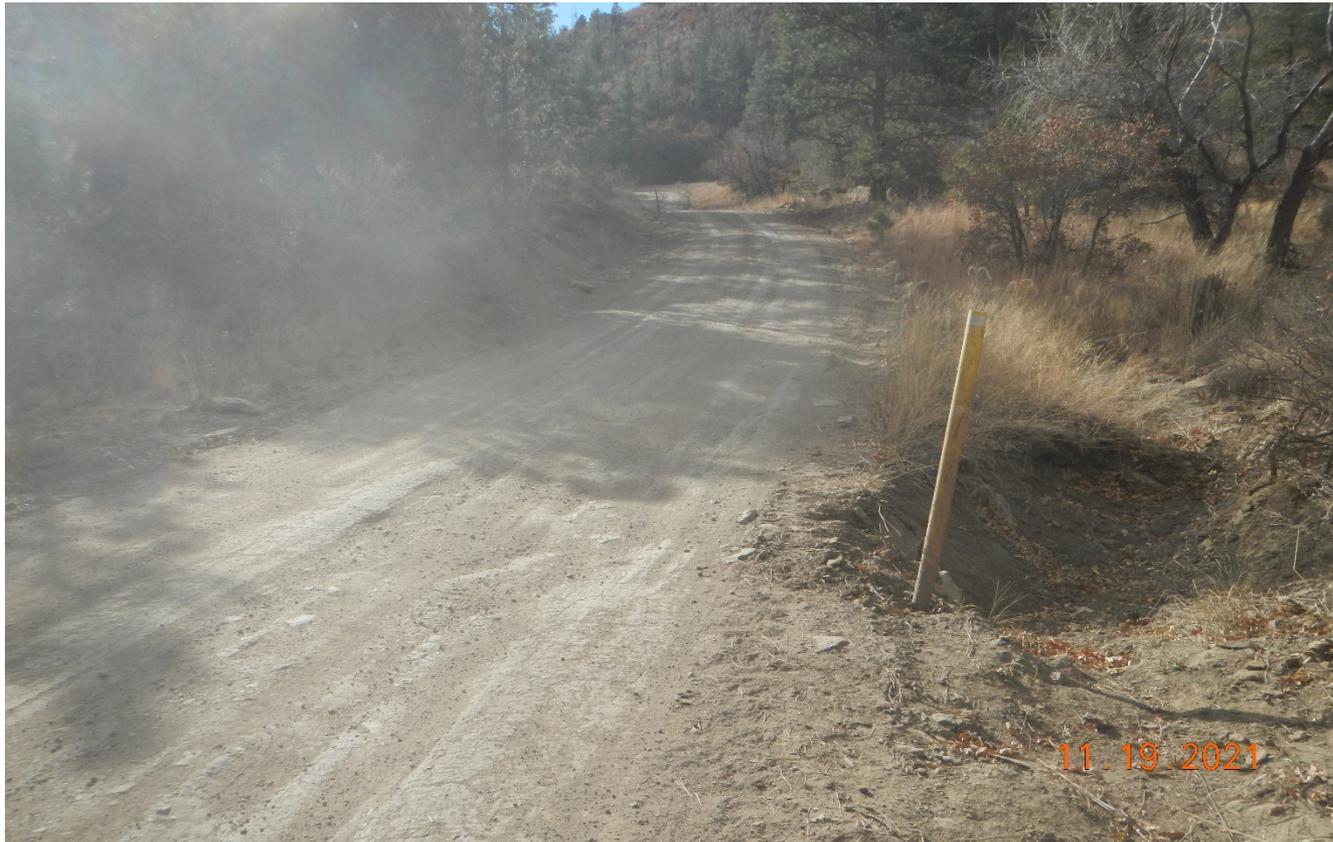
Photo 1. The culverts along the road have been cleaned out and repaired.

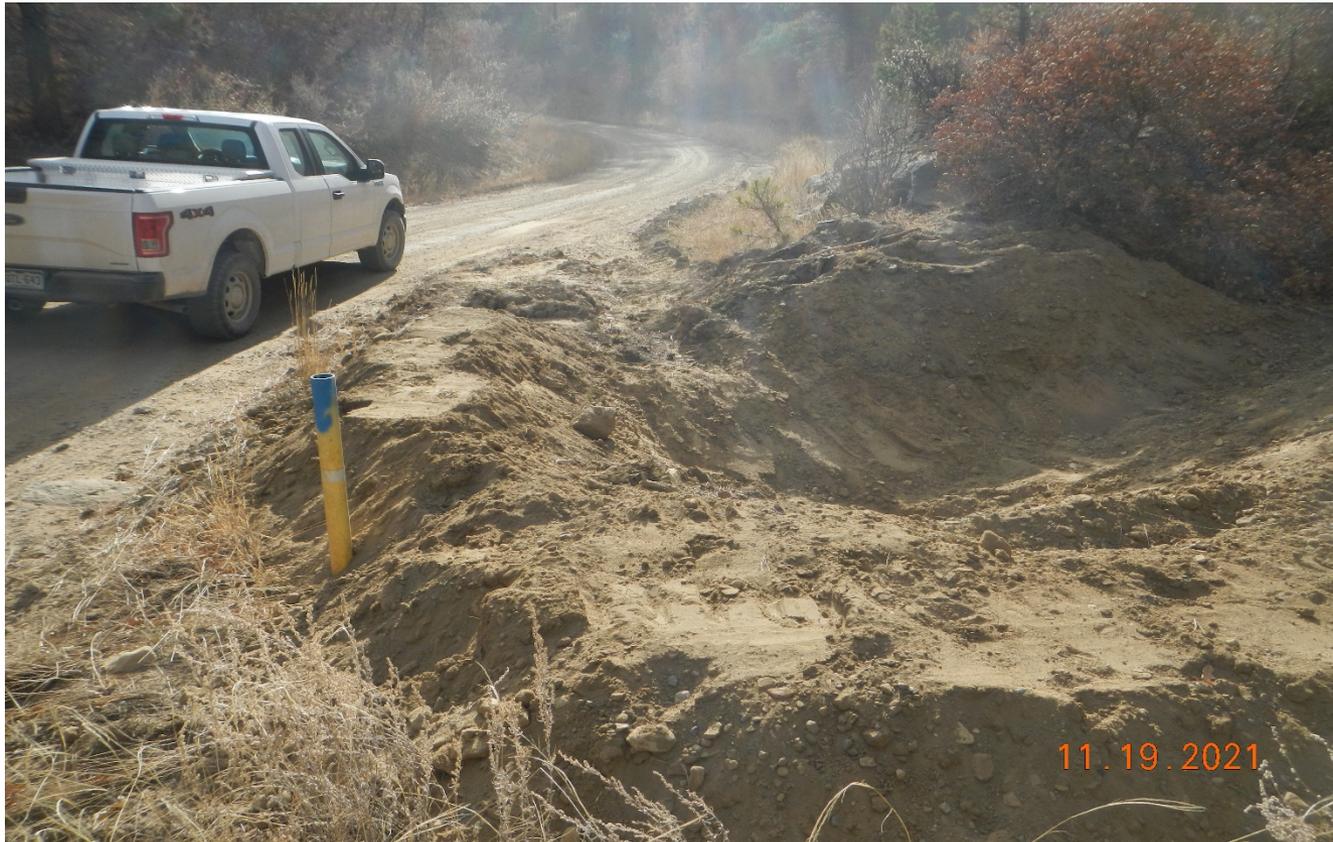
Photo 2. The culvert has been cleaned out. There is sediment piled around the culvert which needs to be reseeded.

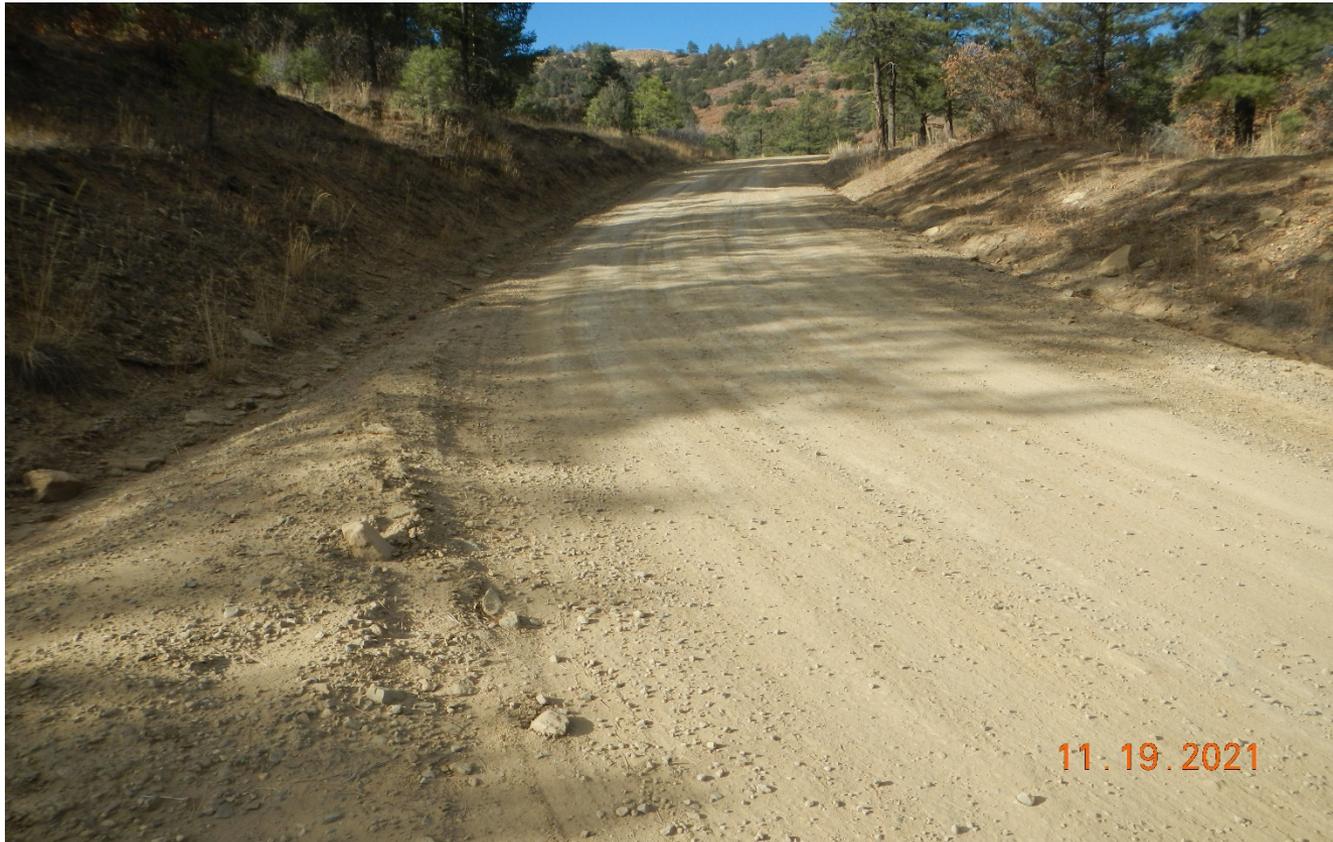
Photo 3. Facing west at the switch back of the road where there was vehicle rutting. The road was graded however, the road was not stabilized and vehicle rutting may occur during wet winter condition.

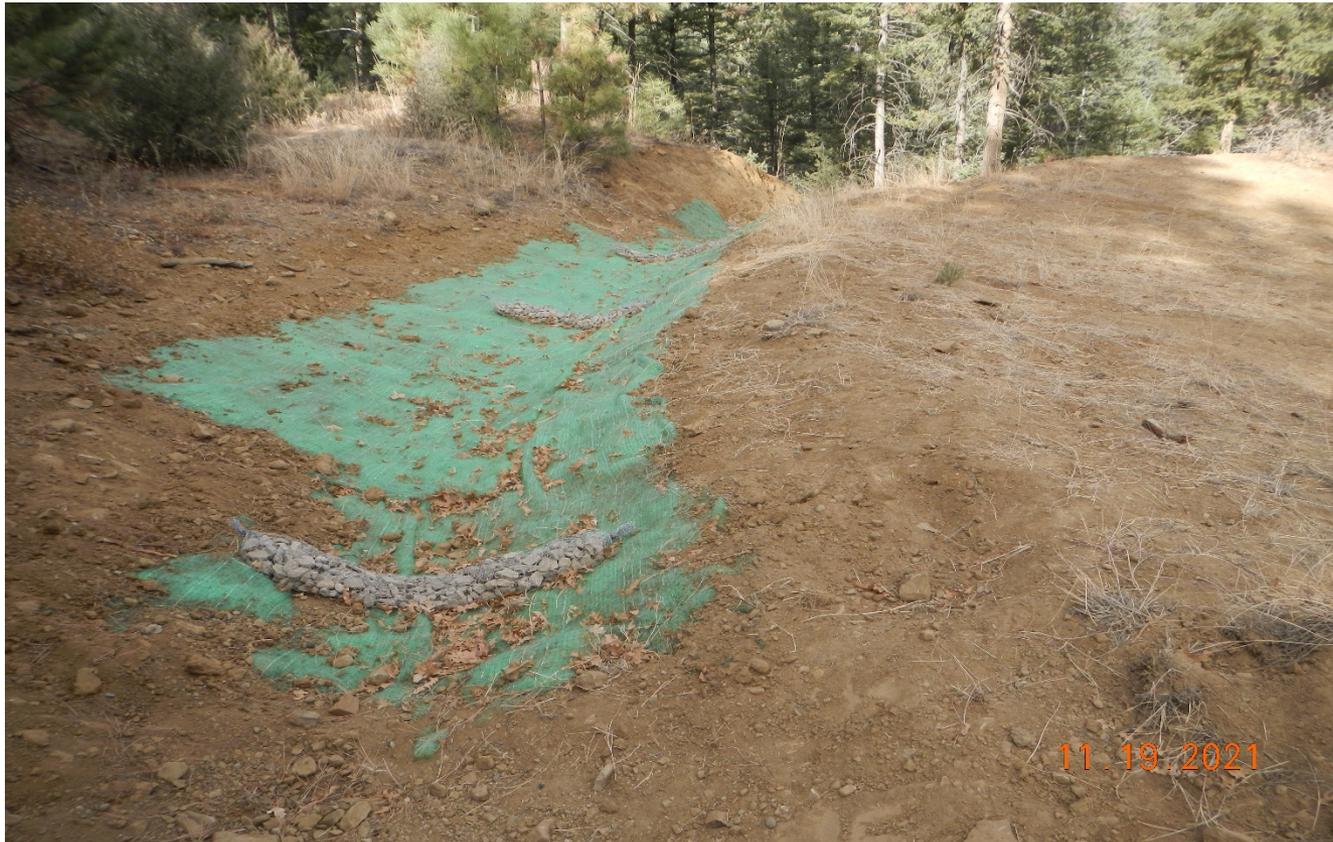
Photo 4. The erosion gully at the second switchback of the road has been reaired and stabilized.

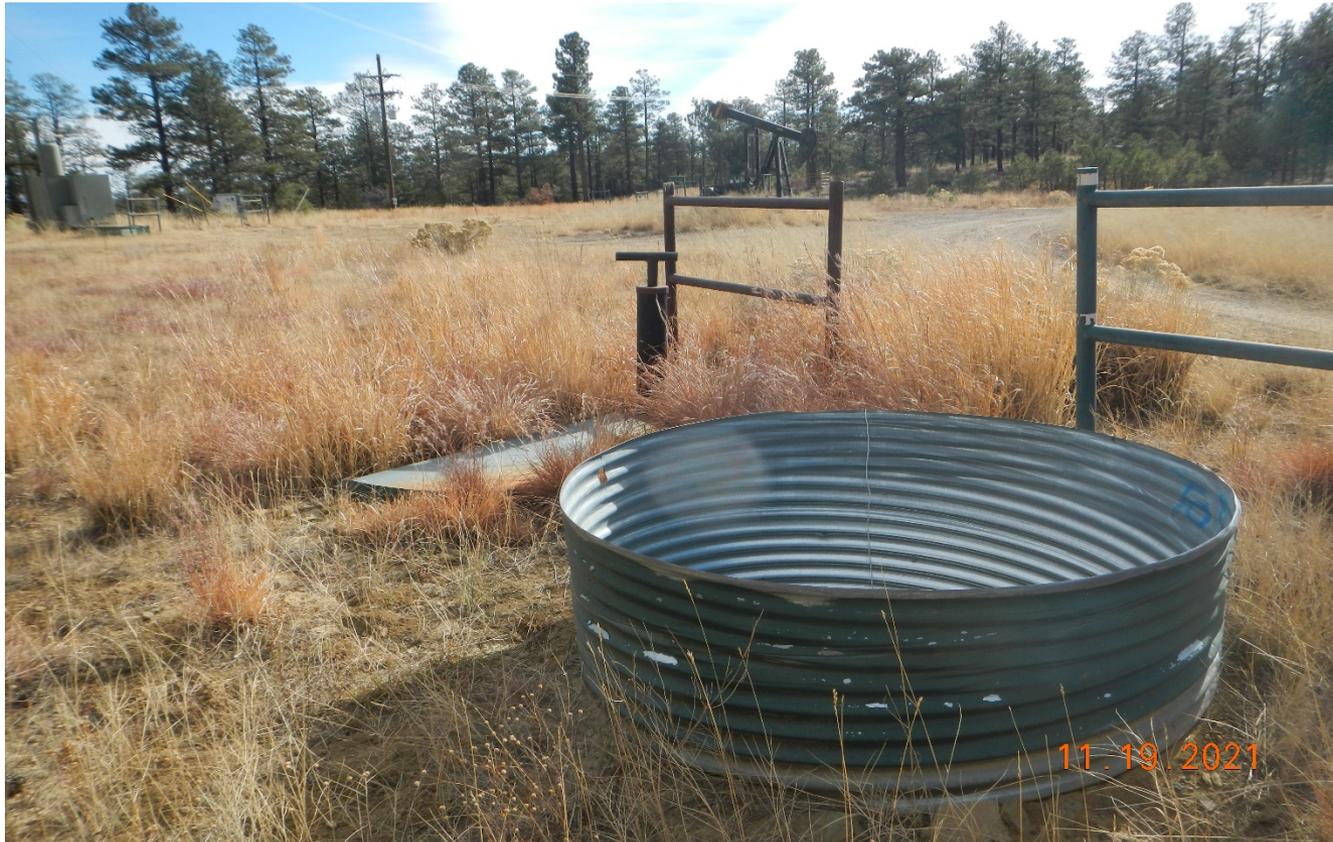
Photo 6. The lid on the culvert needs to be installed to prevent wildlife entry.
