Inspection Photos

11/19/2021

Operator: TEP ROCKY MOUNTAIN LLC #96850

Location ID: 335541

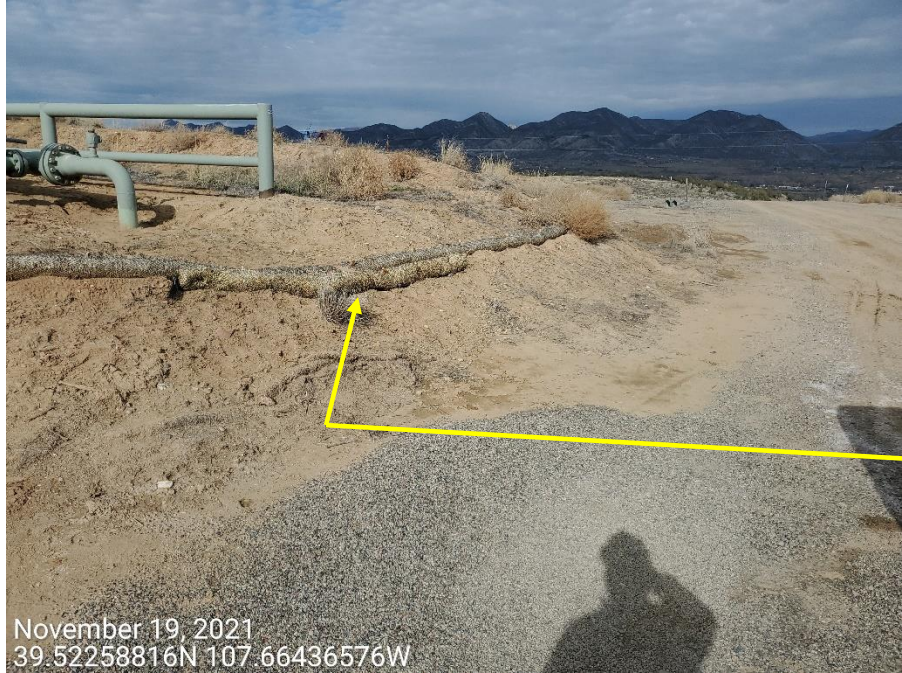
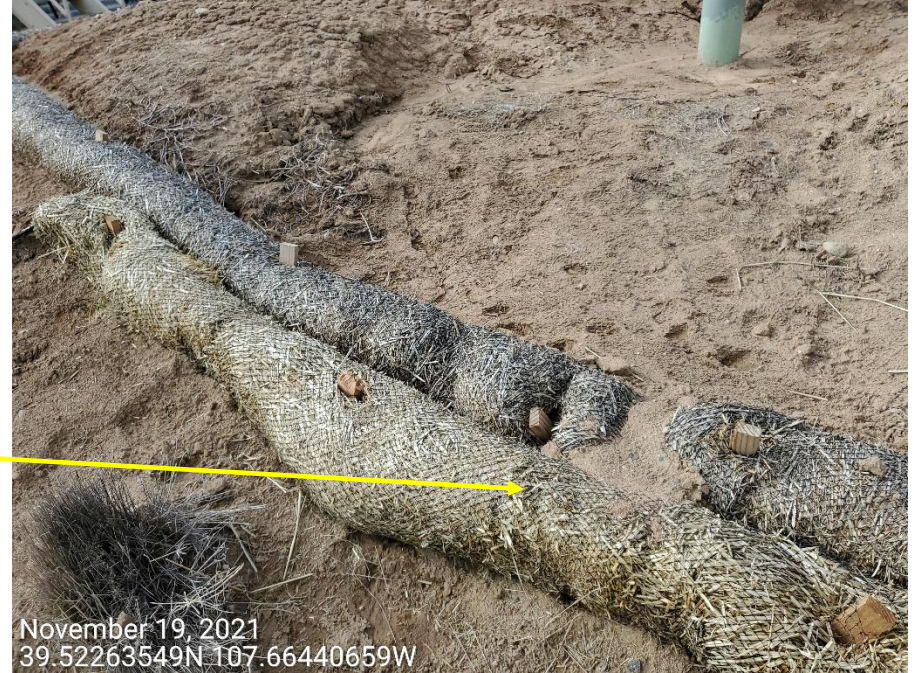
Photo 1: Photos taken from slopes along the west end of the Location. Only work that appears to have been conducted by Operator to address stabilization, erosion and degradation issues at the cut slopes since the previous inspections, is that a second wattle has been installed at this section of the slopes (arrow); stormwater has transported sediment over the wattles; Controls measures to stabilize, and prevent erosion and degradation from the slopes of the Location remain missing or insufficient.

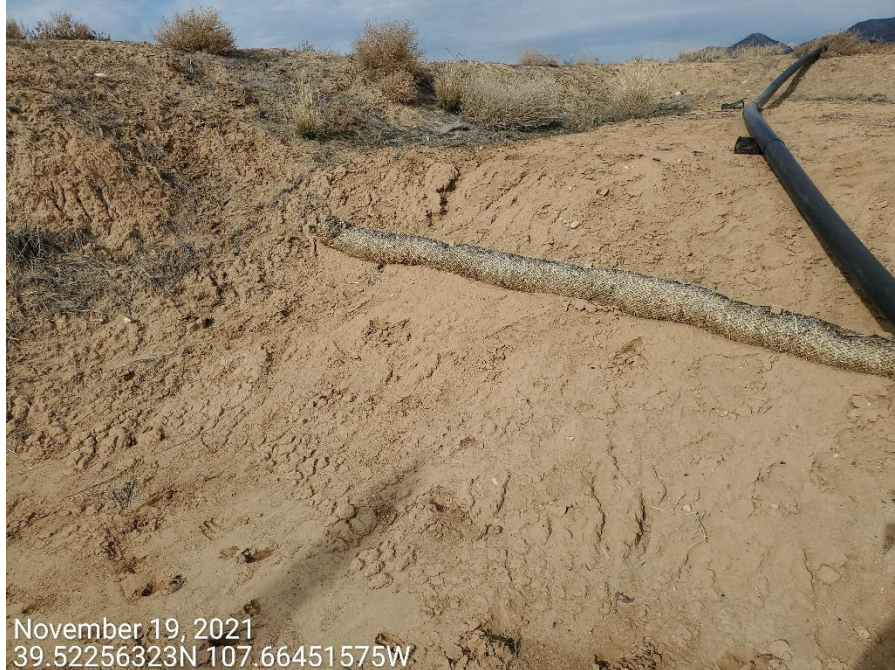
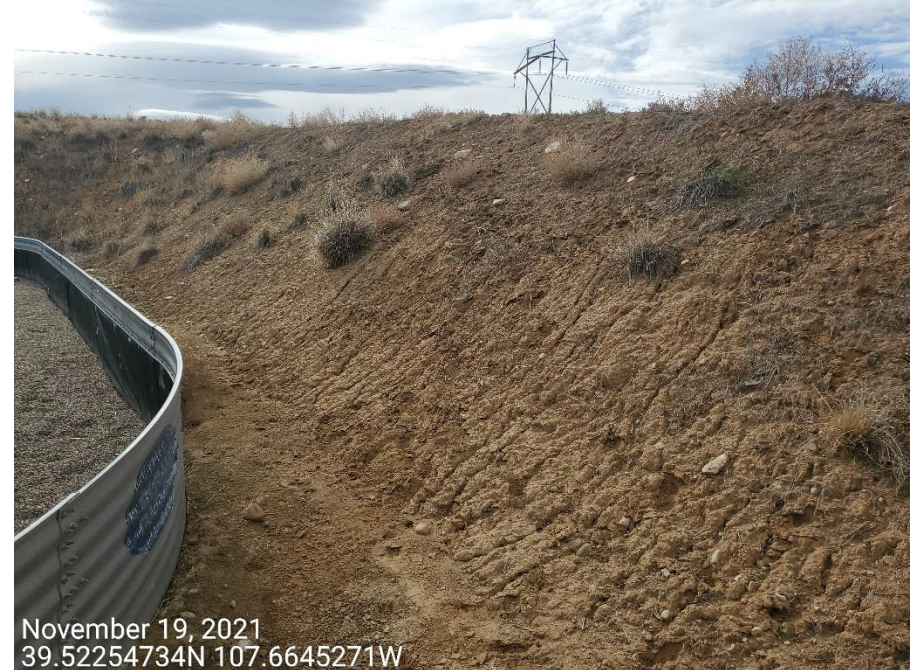
Photo 2: Photos provide examples showing control measures to address stabilization, erosion and degradation issues at the cut slopes of the Location remains missing or insufficient.

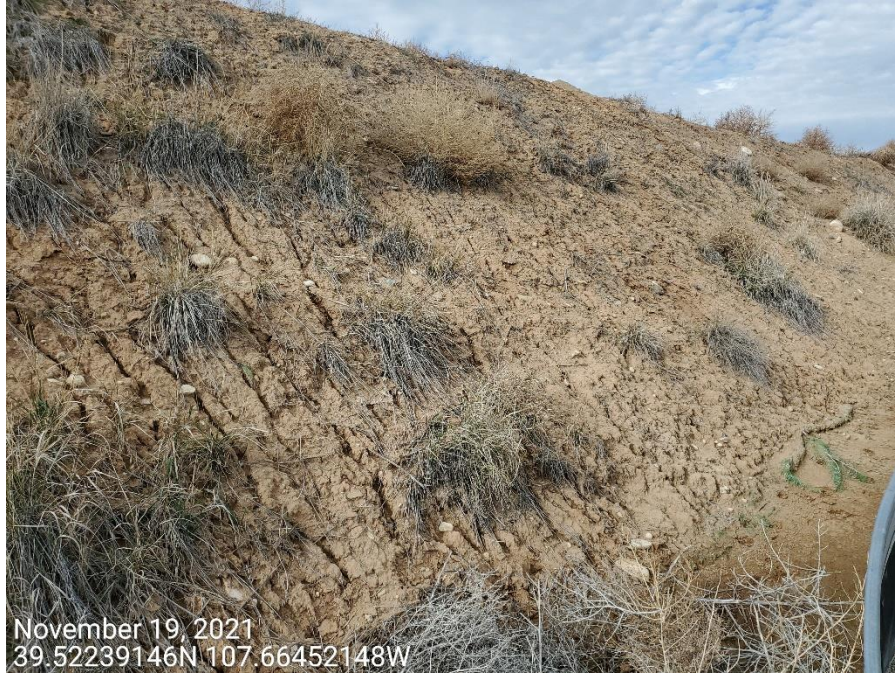
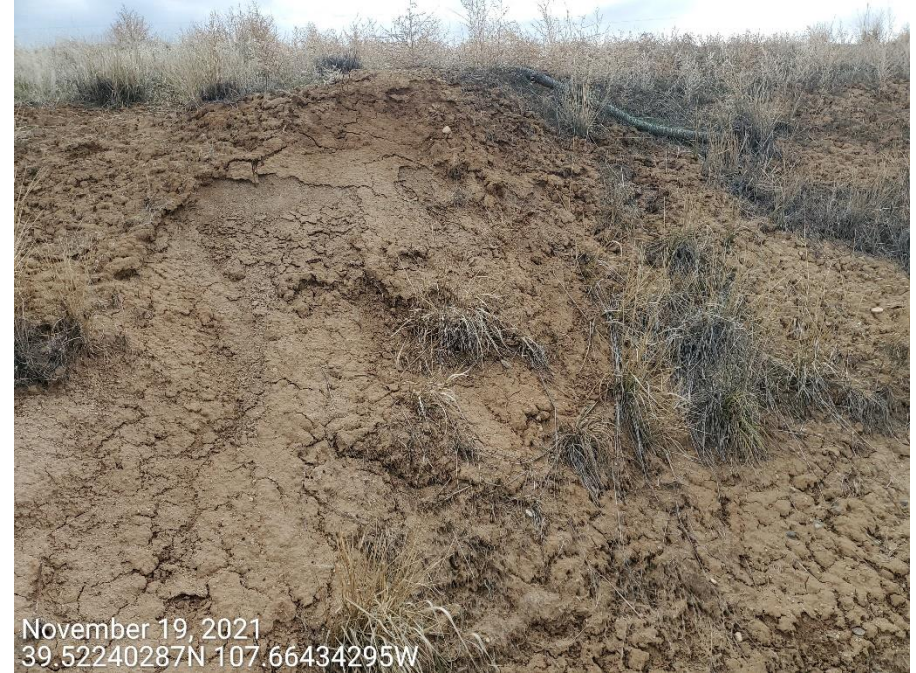
Photo 3: Photos provide examples showing control measures to address stabilization, erosion and degradation issues at the cut slopes of the Location remains missing or insufficient.

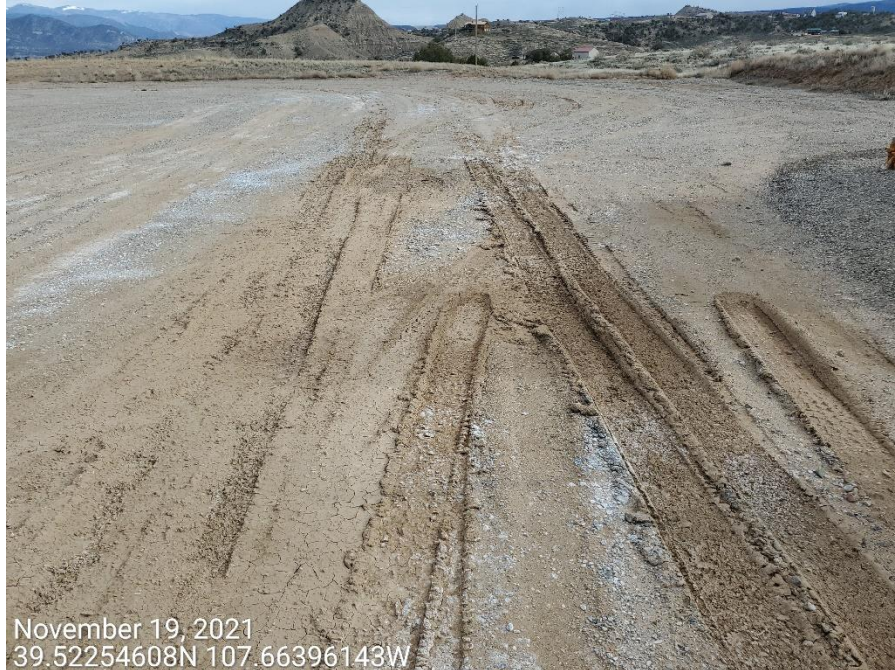
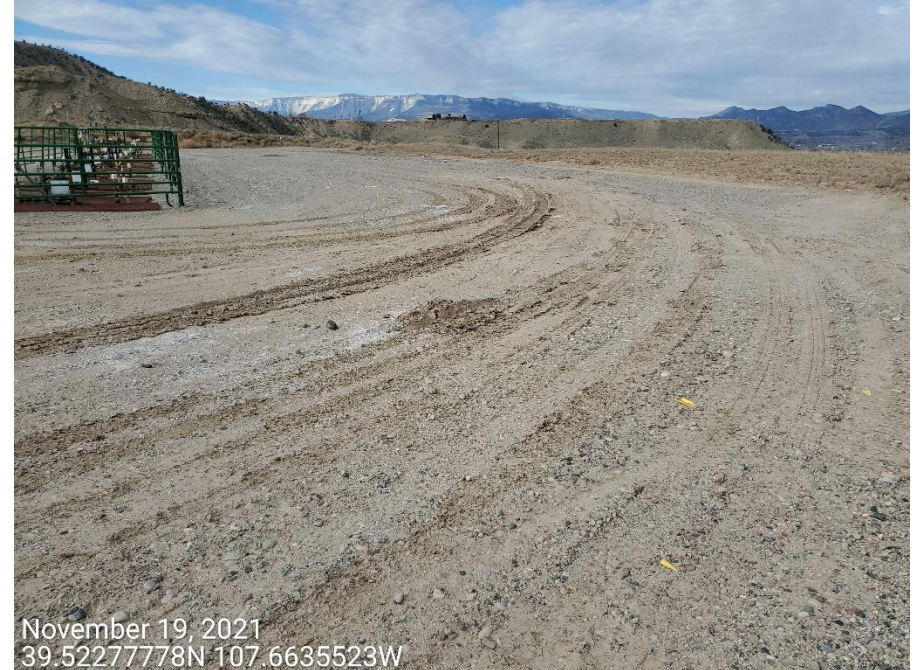
Photo 4: Photos taken from the production areas. Photos show example of stabilization/tracking issues that remain evident on the Location.

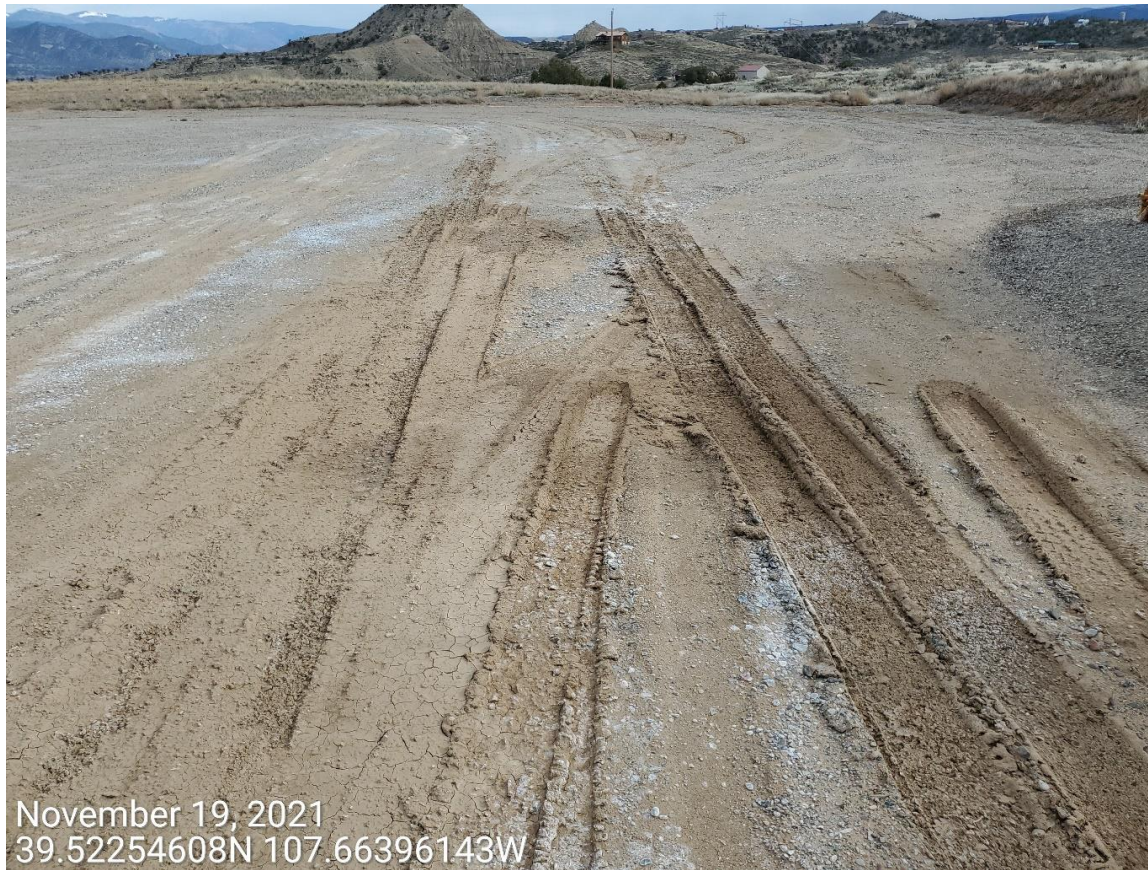
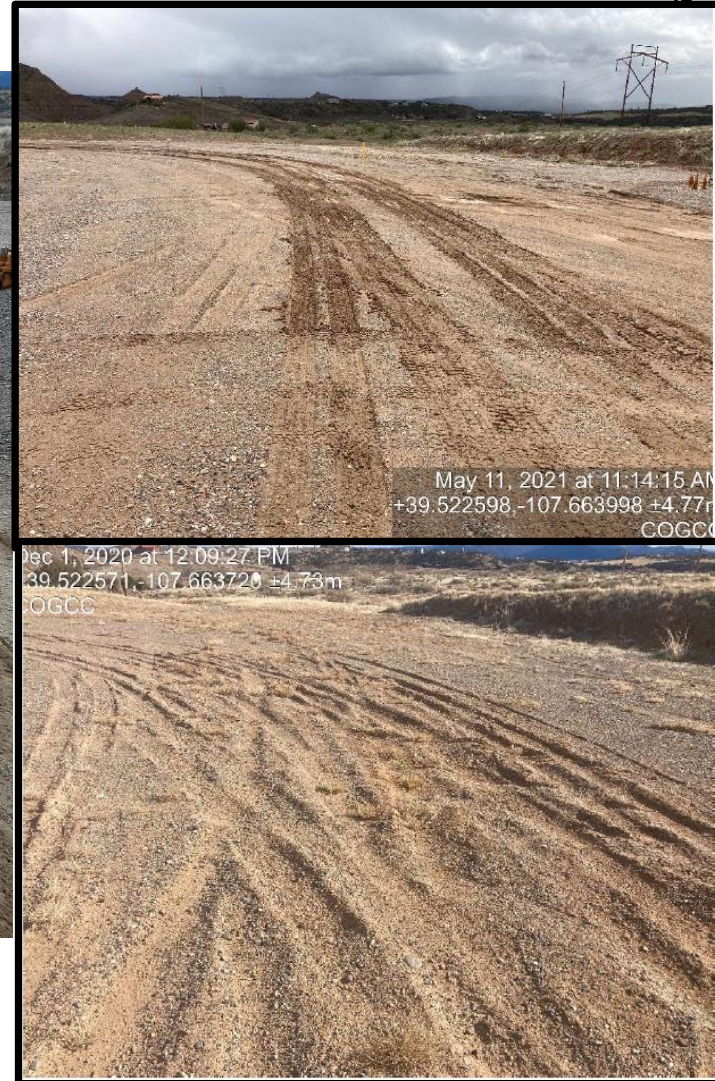
Photo 4.b: Continued from Photo 4. Photo left shows stabilization/tracking issues observed on the south end of the Location. Photos to the right taken from the same areas during the 12/1/2020 and 5/11/2021 inspections showing. Stabilization/tracking issues on the production areas have not been addressed.

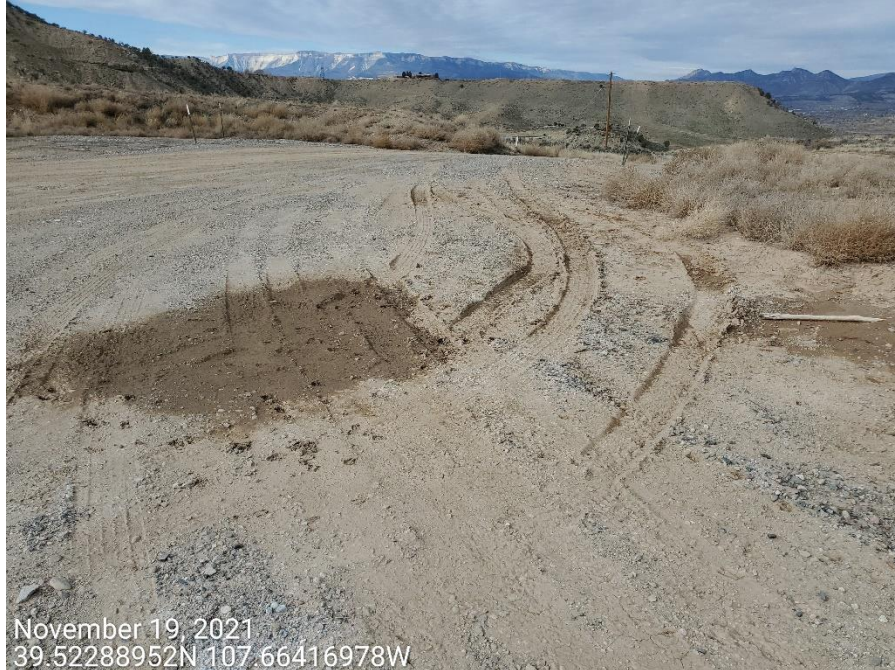
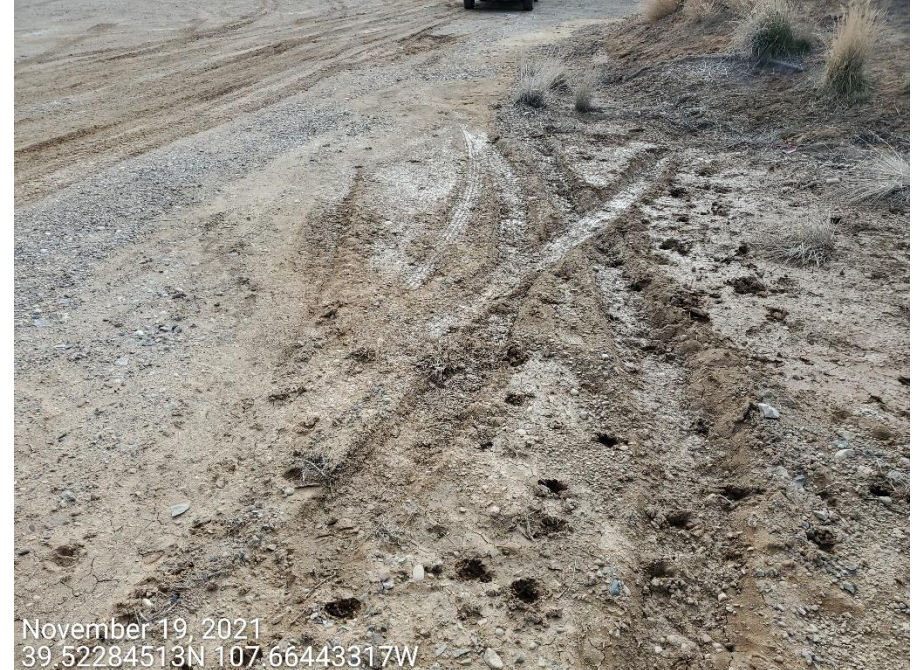
Photo 5: Photos taken from the production areas. Photos show example of stabilization/tracking issues that remain evident on the Location.

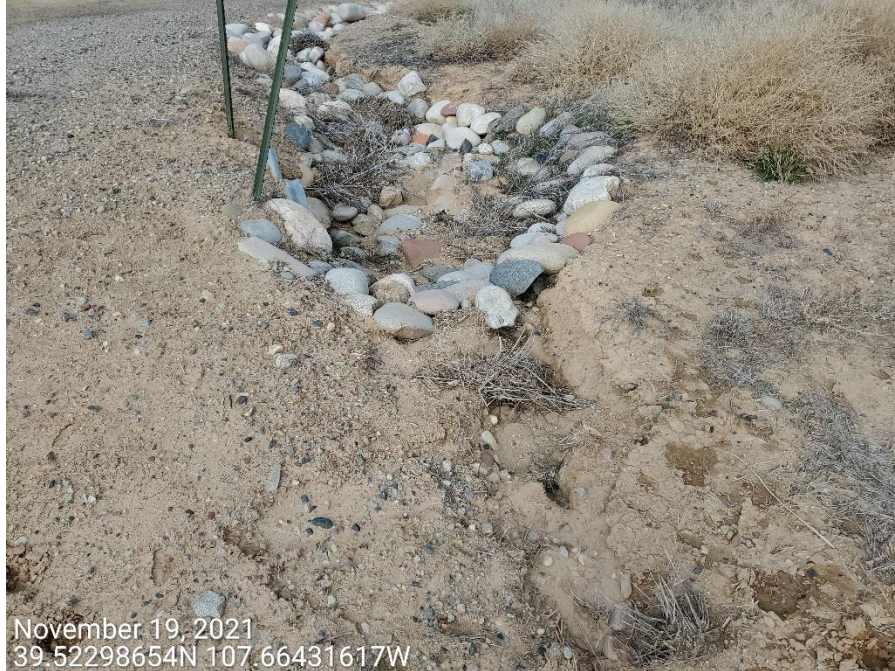
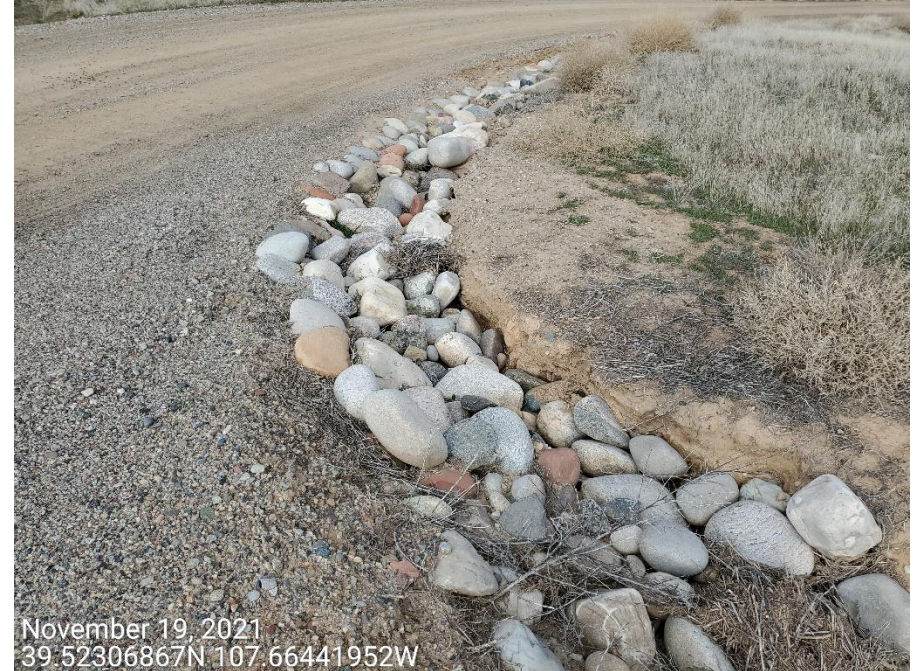
Photo 6: Photo shows the stormwater outlet on the northwest end of the Location. Control measures to manage stormwater runoff from the production area is inadequate; outlet improperly engineered and not maintained; runoff resulting in degradation at the control, and within ditches at access road.

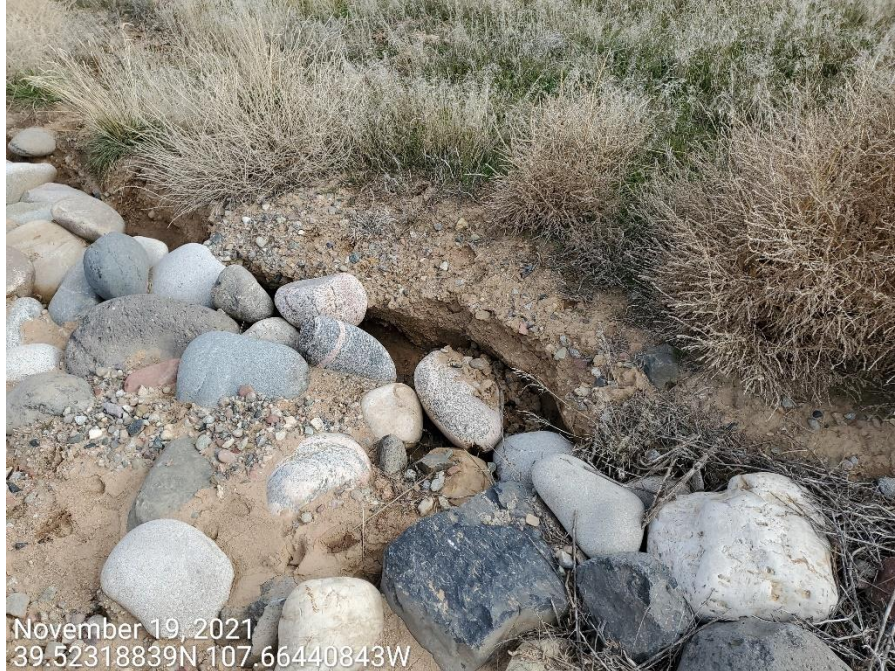
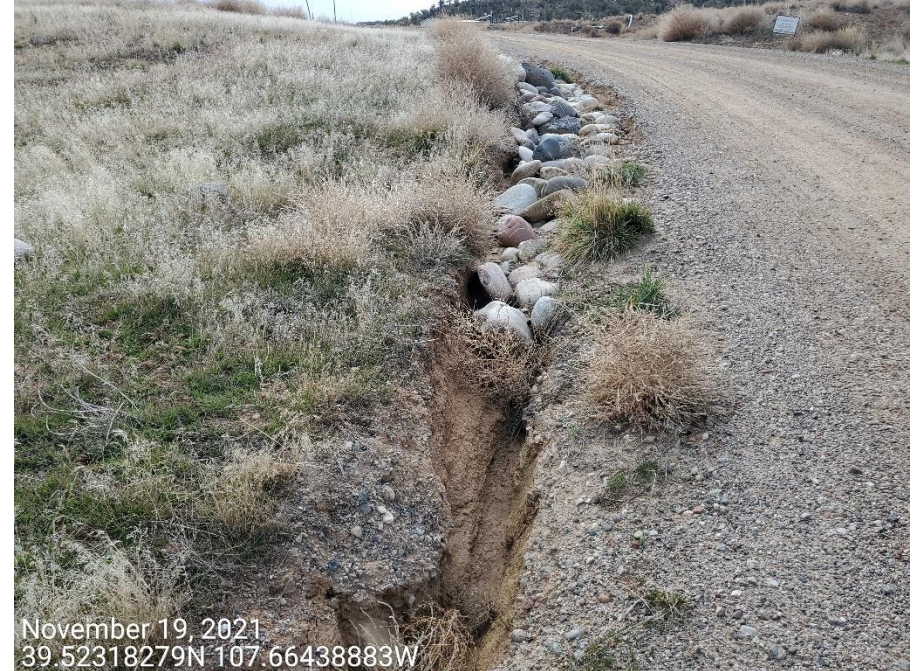
Photo 7: Continued from photo 6. Photo shows degradation to the stormwater outlet and ditch. Control has been constructed without geotextile lining, and with smooth stone rather than angular. This has resulted in stormwater accelerating around the rock material and scouring the sides, and channel, of the control measure.

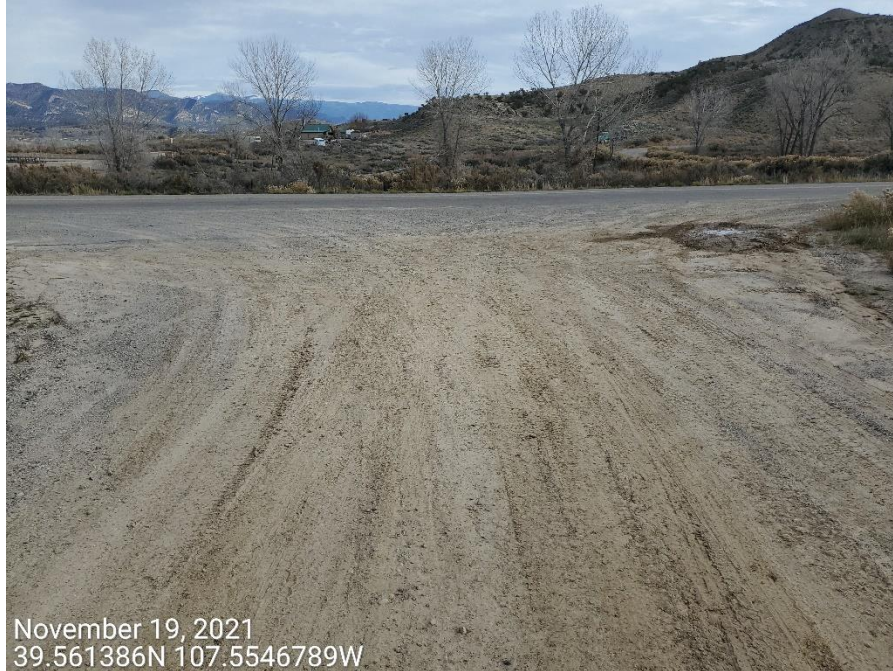
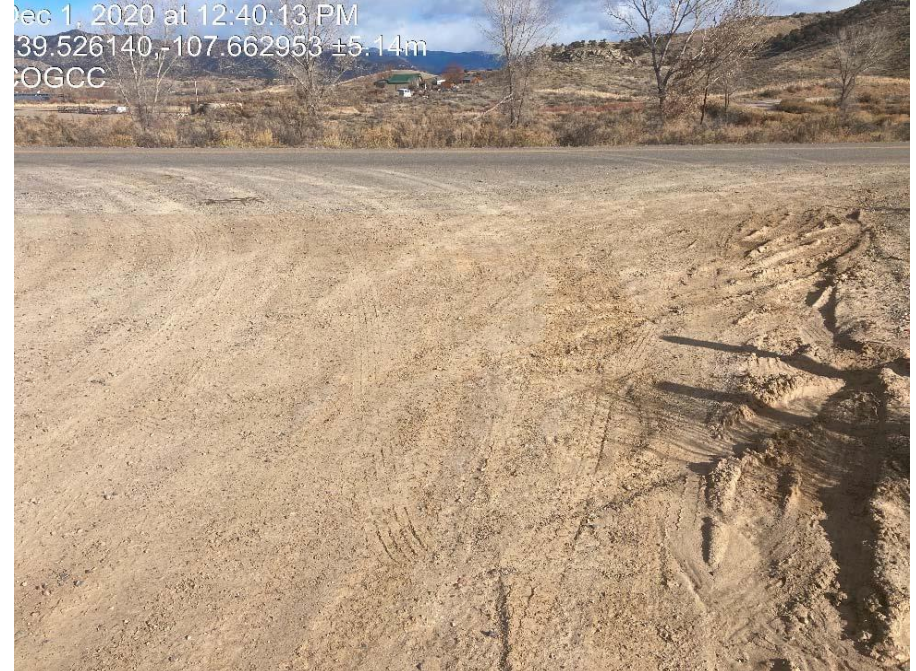
Photo 8: Photos taken from the access road entrance and County Road 331. Photo right shows off-site sediment transport due to vehicle tracking observed during the 12/1/2020 inspection. Photo left (dated 11/19/2021) shows stabilization and tracking issues have not been addressed, resulting in continued off-site sediment transport onto the county road.

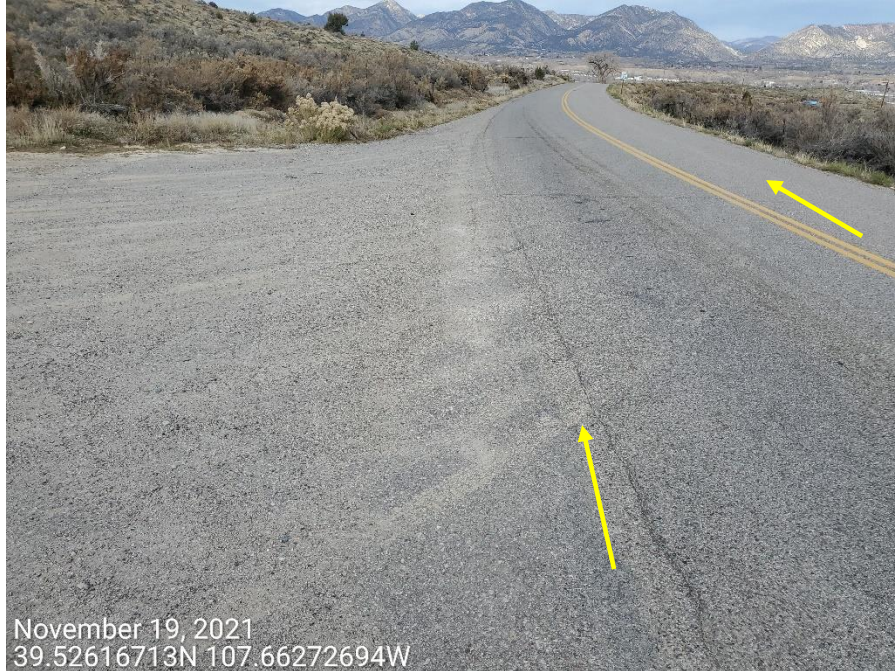
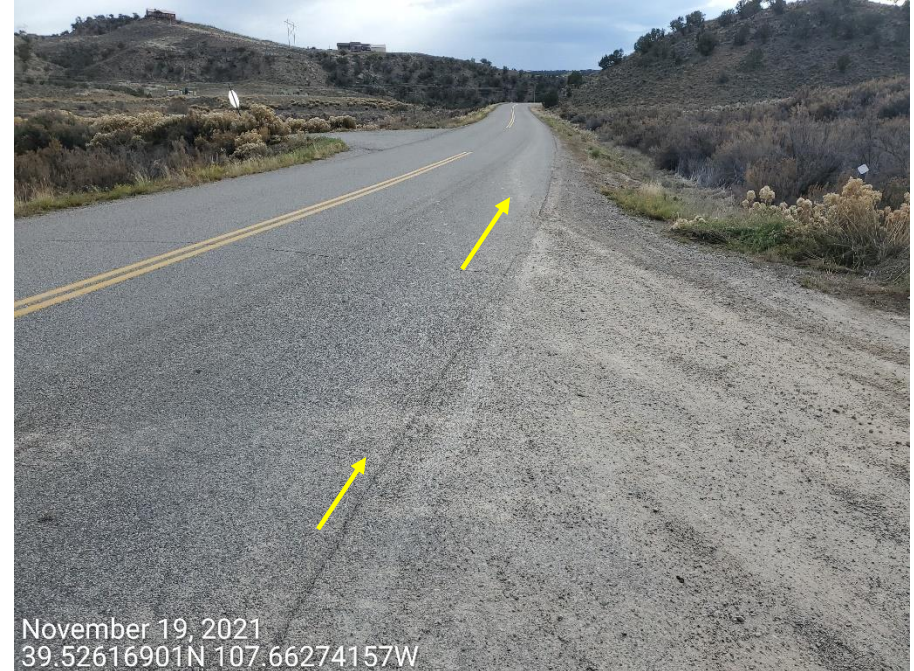
Photo 9: Continued from photo 8. Photo shows sediment transport onto the county road.
